**ROADS SUB-COMMITTEE MEETING AGENDA
TUESDAY, DECEMBER 10, 2019 - 1:30 P.M.
MEETING HELD IN THE COUNCIL CHAMBERS**

DETAILED CONDITION SURVEY REPORT

Bridge Check Canada Ltd. was retained by R.J. Burnside & Associates Ltd. to carry out detailed bridge condition survey for Bridge 013 – 260 Sideroad over Grand River located on 260 Sideroad, 200m East of 7th Line SW (Lot 21 & 22, Con. 6 & 7 SW) in Township of Melancthon, Ontario. First time field investigations were carried out on October 7, 2019. Field crew used chest waders, ladder, and delam 2000 for the inspection of the substructure components.

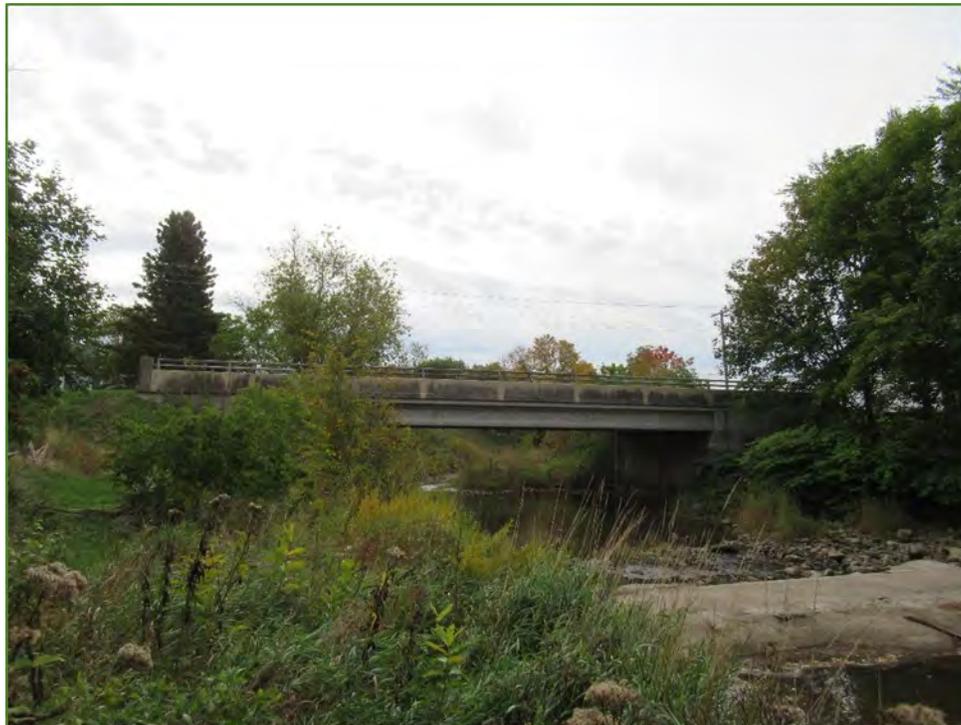
North Elevation of Bridge 013 – 260 Sideroad over Grand River

The site, constructed in 1968, is a single span reinforced cast-in-place concrete slab over precast concrete I beams, overlain with an asphalt wearing surface and carries one traffic lane per direction of 260 Sideroad. The bridge spans over Grand River. The deck cross section consists of seven concrete I beams.

The total span length of the bridge is 18.40 m. The roadway width is 8.60 m. The structure has an east-to-west orientation. The outer limits of the structure have concrete curb with concrete parapet wall at south side and concrete sidewalk with concrete parapet wall at north side. Photo P1 shows a view of the north elevation of the site. Photo P2 shows the south elevation.

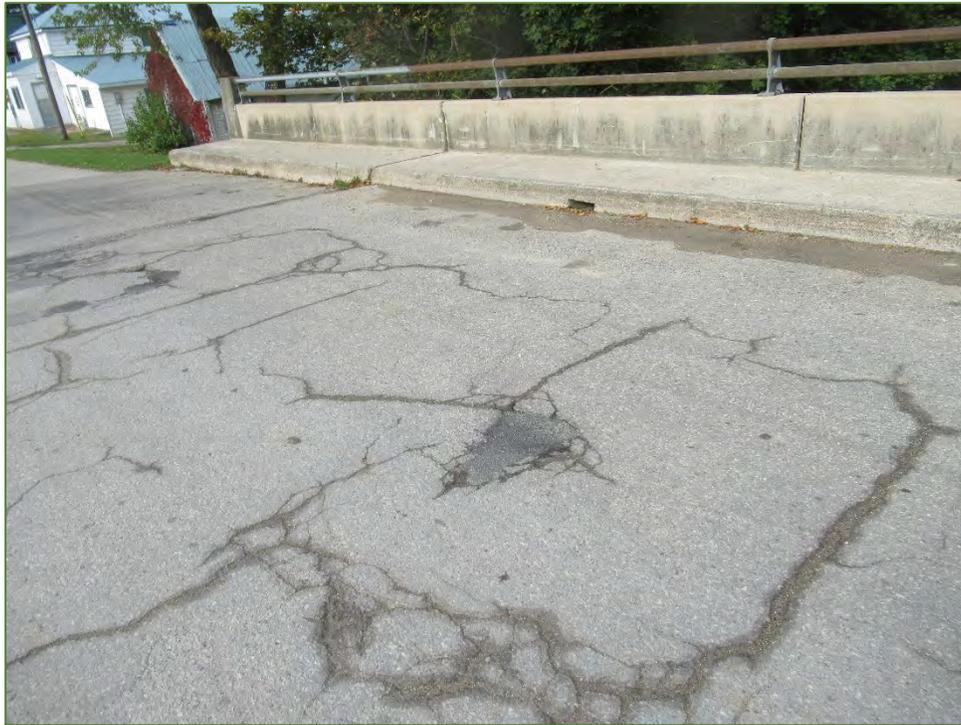
Photo P7 Deck Wearing Surface (unsealed cracks, pot holes and patched area)

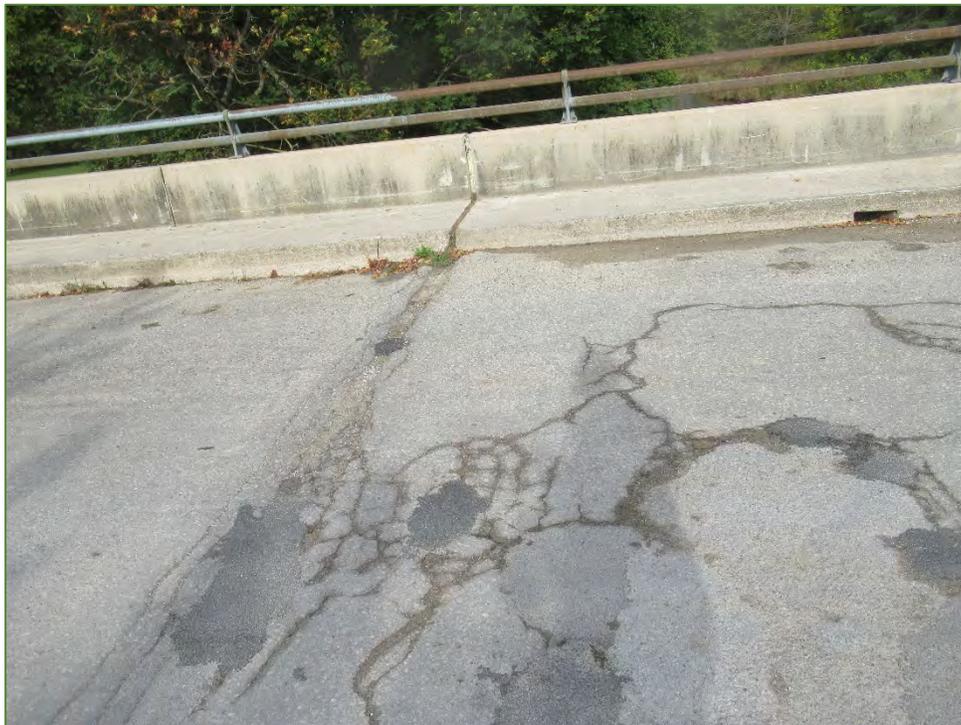
Photo P8 Deck Wearing Surface (unsealed cracks, pot holes and patched area)

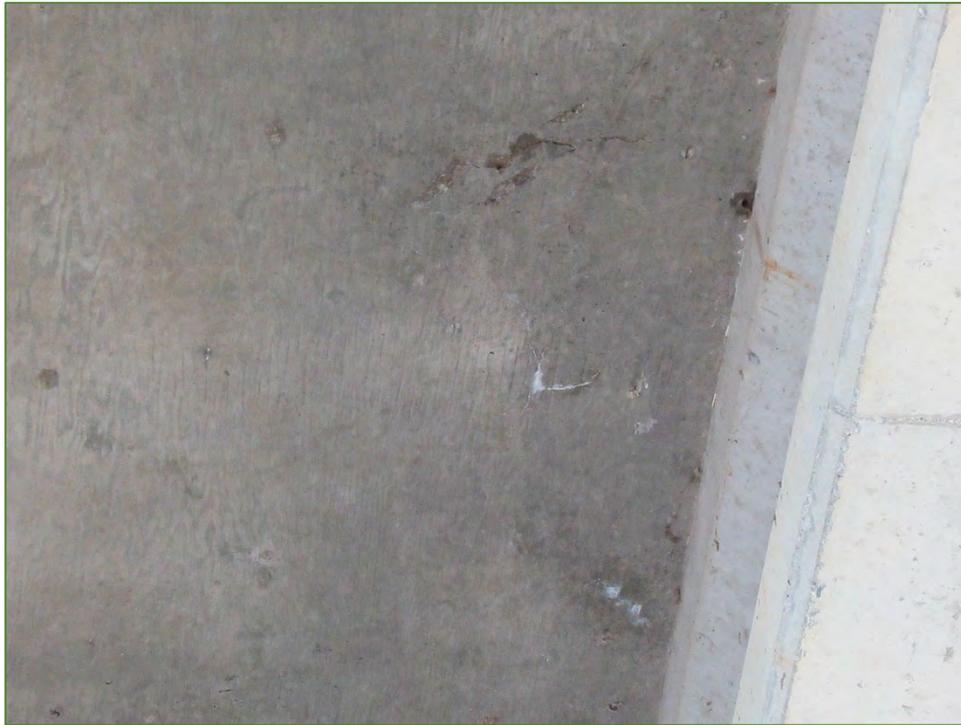
Photo P11 Soffit at East Abutment (cracks and delamination)

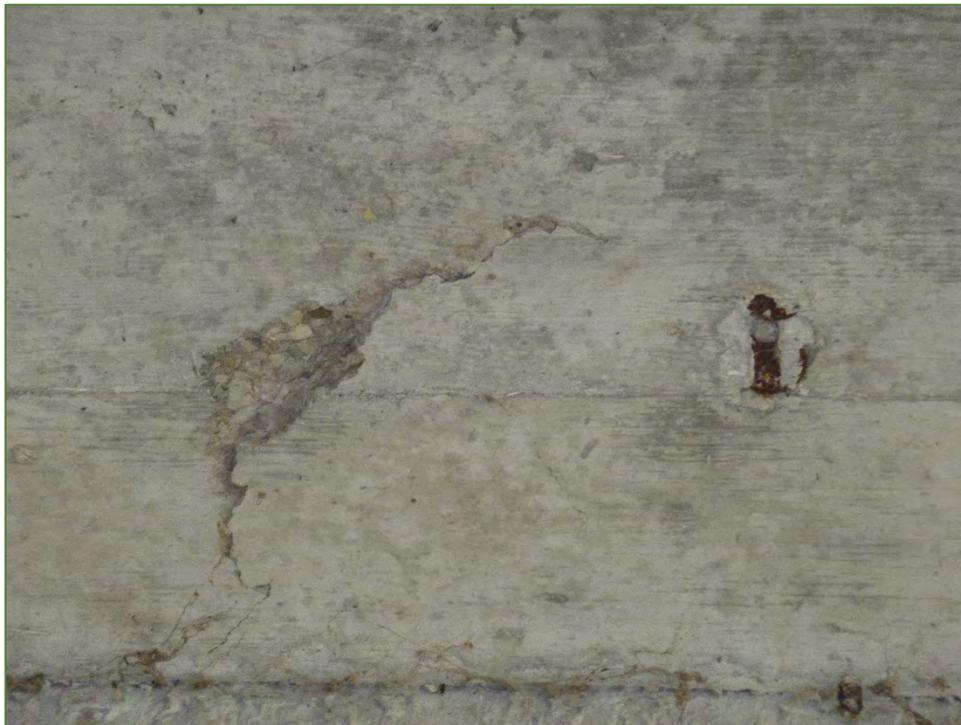
Photo P12 Soffit between East Abutment and West Abutment (spall and delamination)

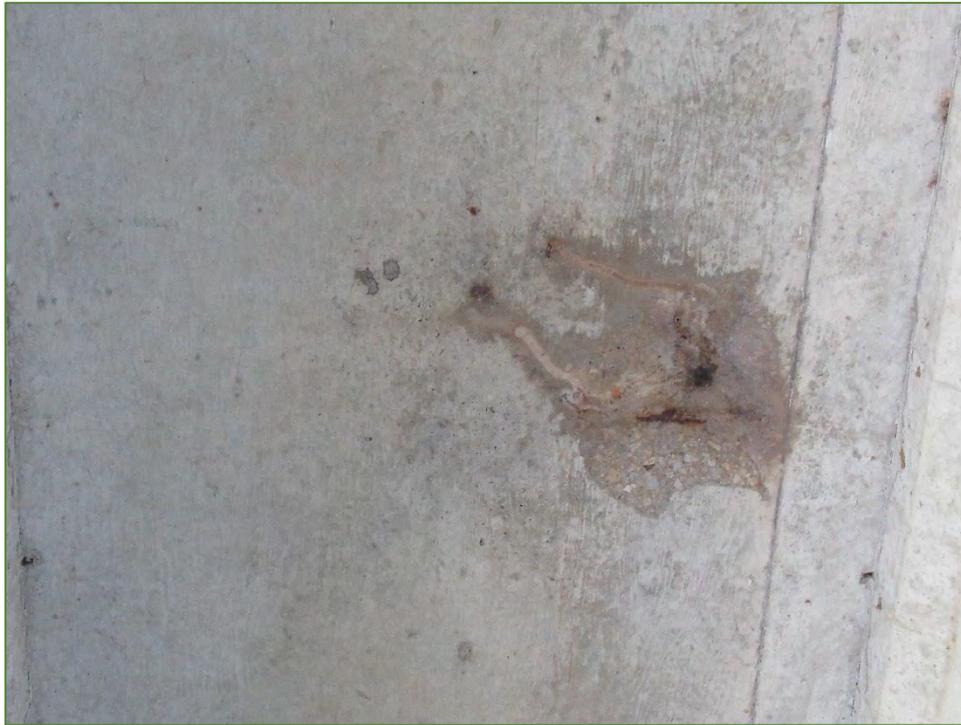
Photo P13 Soffit between East Abutment and West Abutment (spall and wet area)

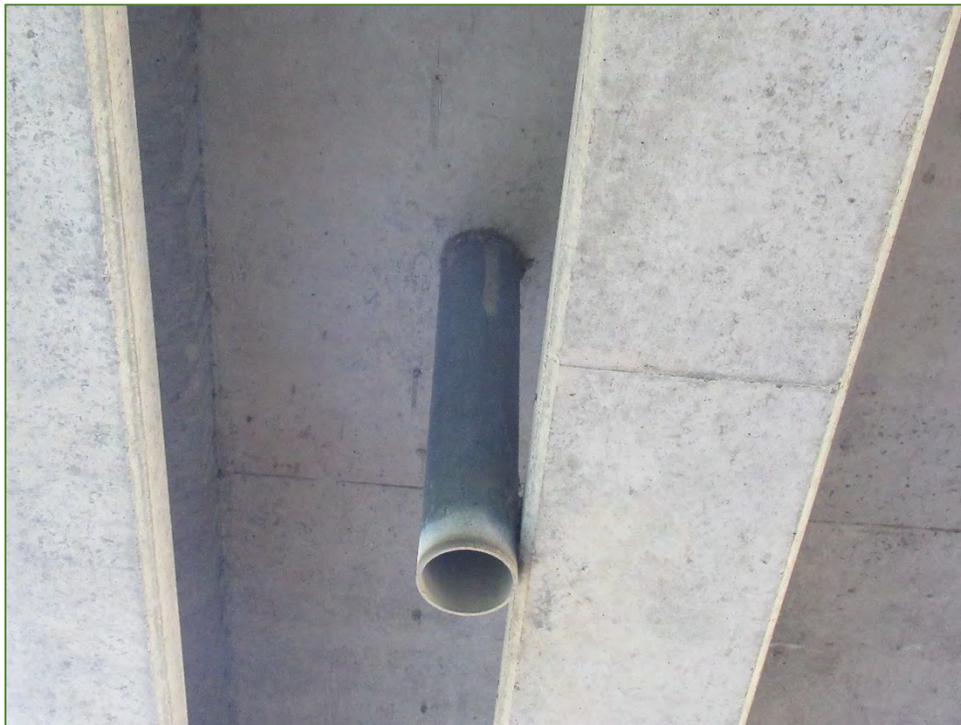
Photo P14 Soffit between East Abutment and West Abutment (cracks) and Girders

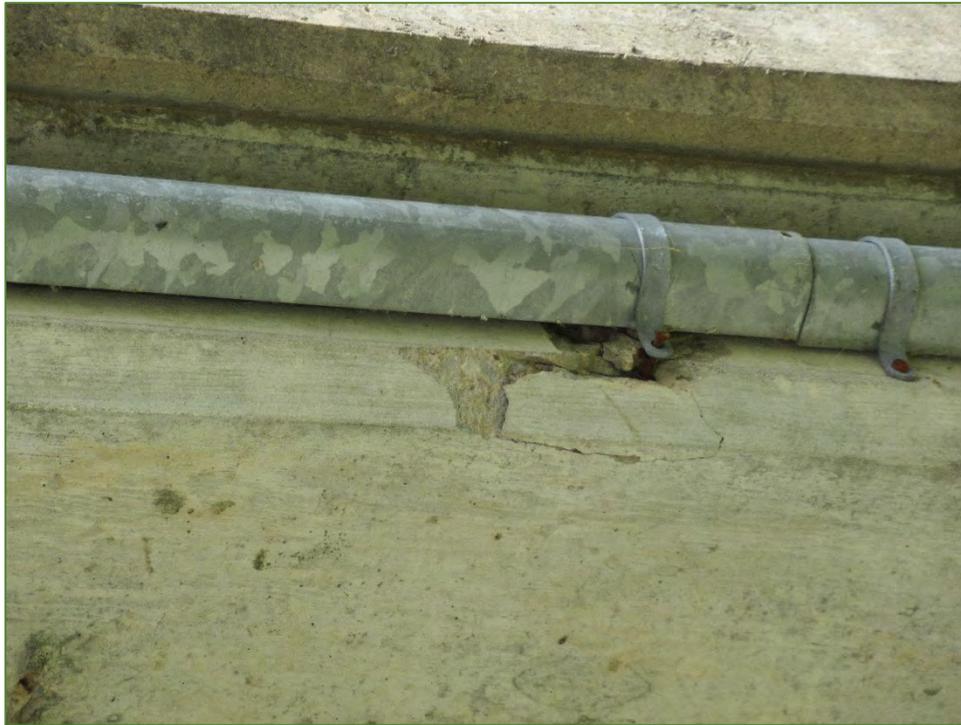
Photo P15 Soffit between East Abutment and West Abutment, south edge (spall and delamination)

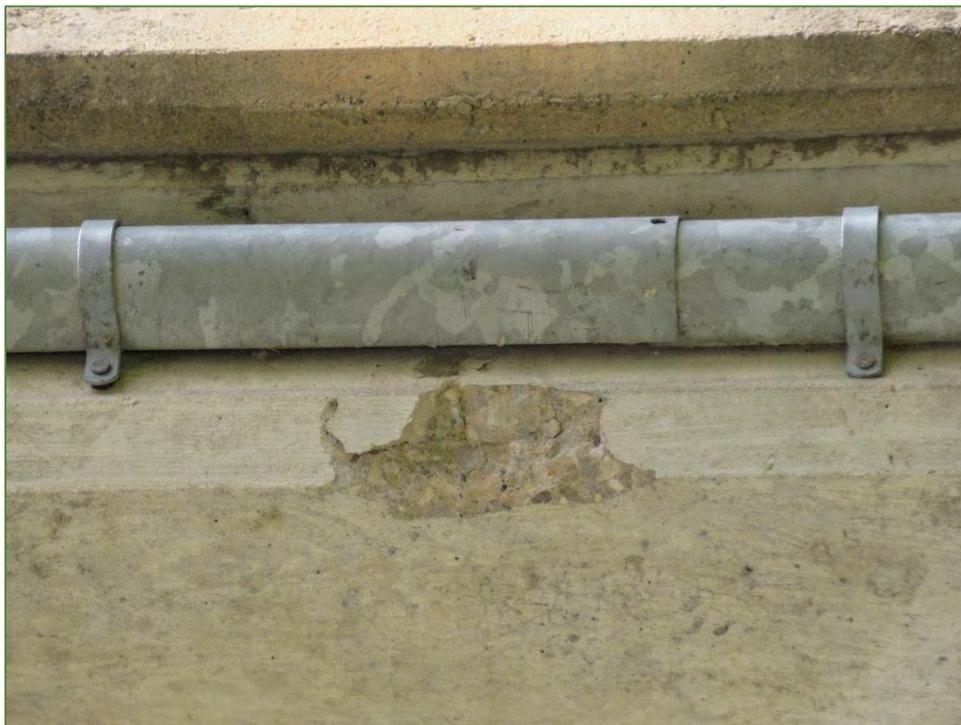
Photo P16 Soffit between East Abutment and West Abutment, south edge (spall)

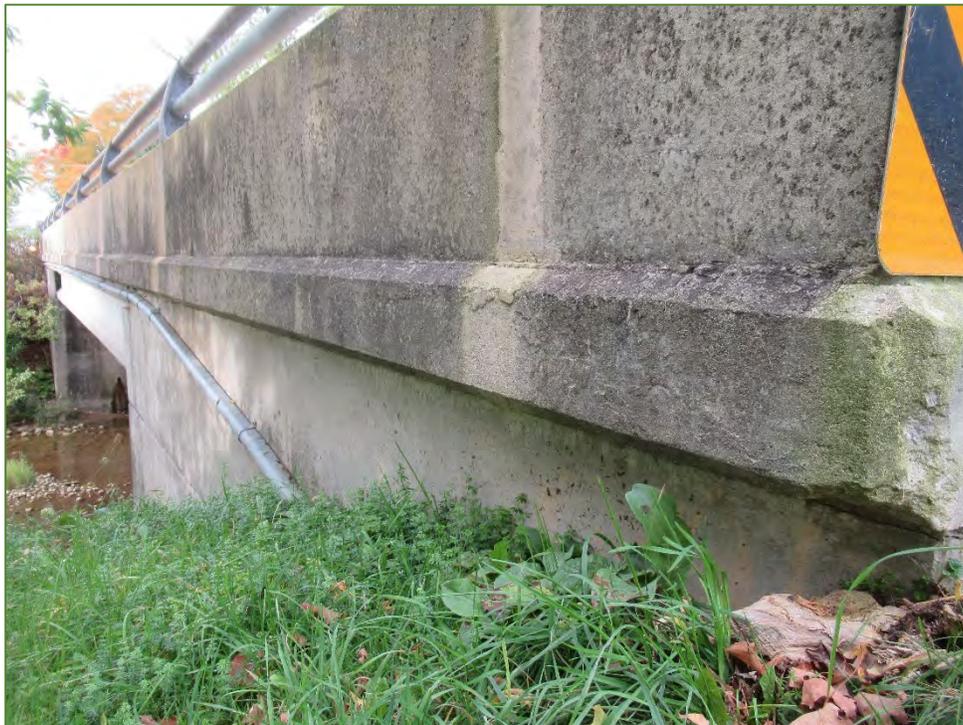
Photo P20 South Elevation – Fascia (light scaling)

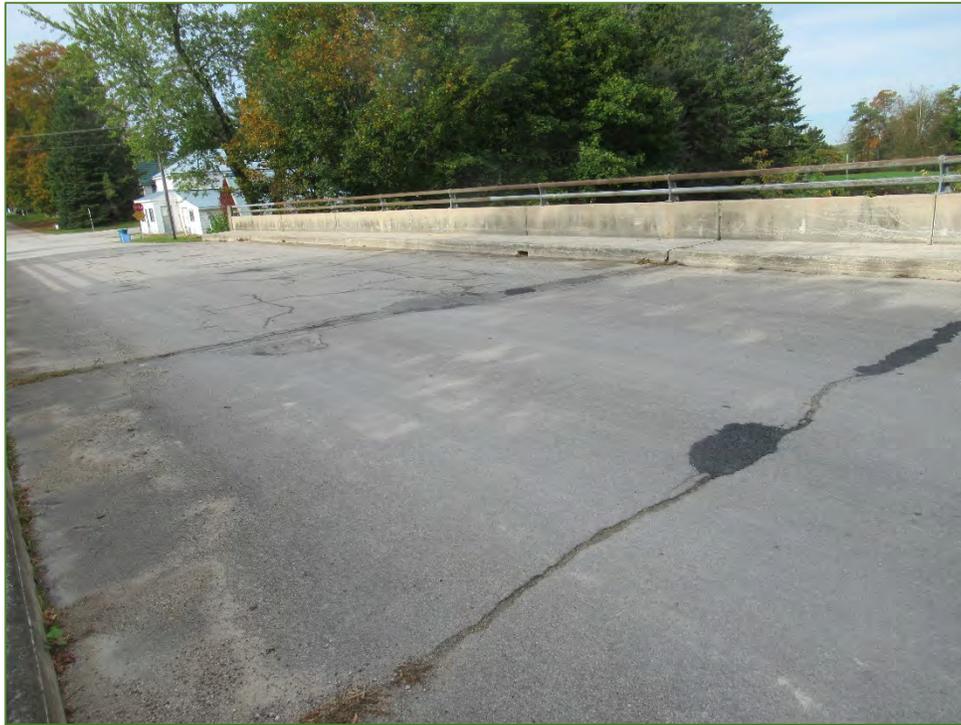
Photos P21 and P22 show the general condition of the bridge approaches. The asphalt on the approaches was in fair condition with unsealed cracks and patches. Observation of corehole C1, located in the west approach, confirmed the presence of granular materials beneath 60 mm of asphalt. Photo P80 shows the inside of the corehole C1.

Photo P21 East Approach Wearing Surface (fair to good condition - unsealed cracks and patched area)

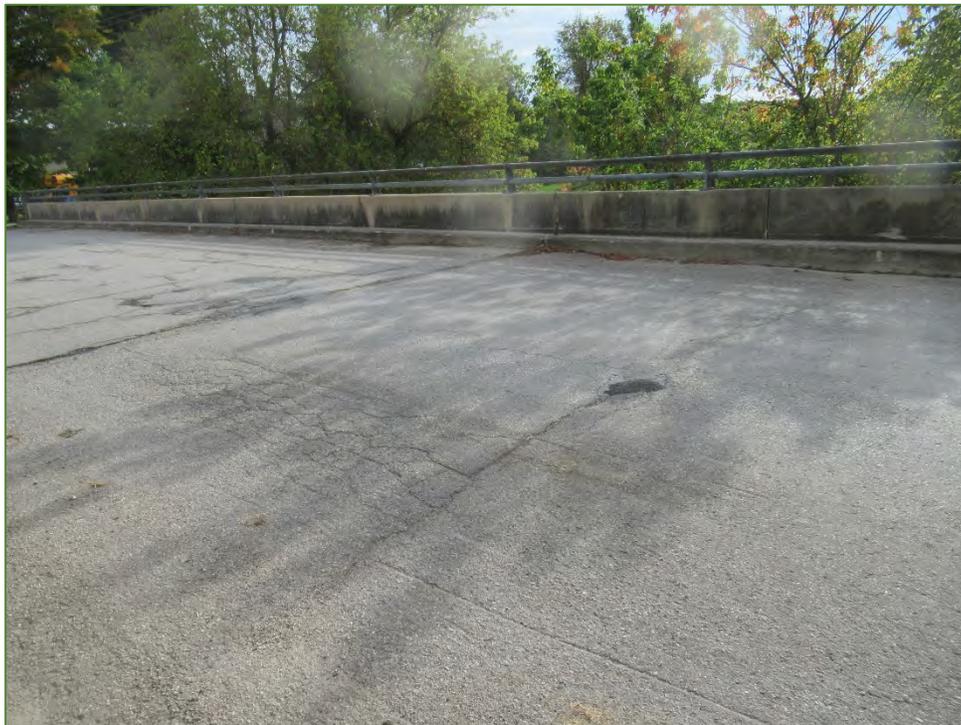
Photo P22 West Approach Wearing Surface (fair condition - unsealed cracks and patched area)

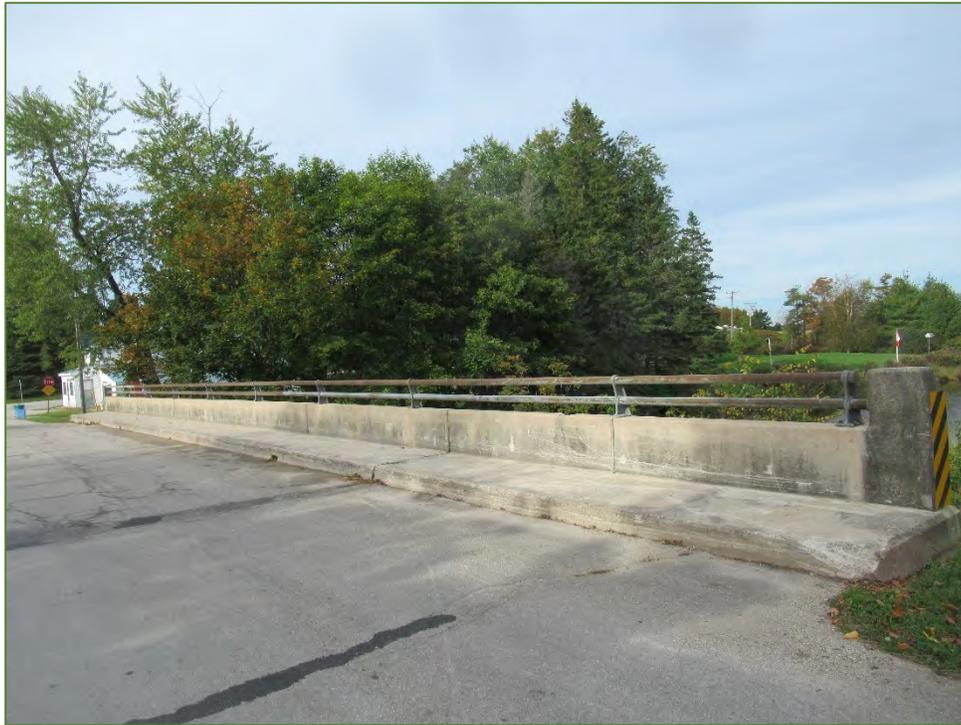
Photo P27 North Sidewalk (fair to good condition – cracks, spall and light scaling) and **Parapet Wall** (fair to good condition – cracks, spall, and light scaling)

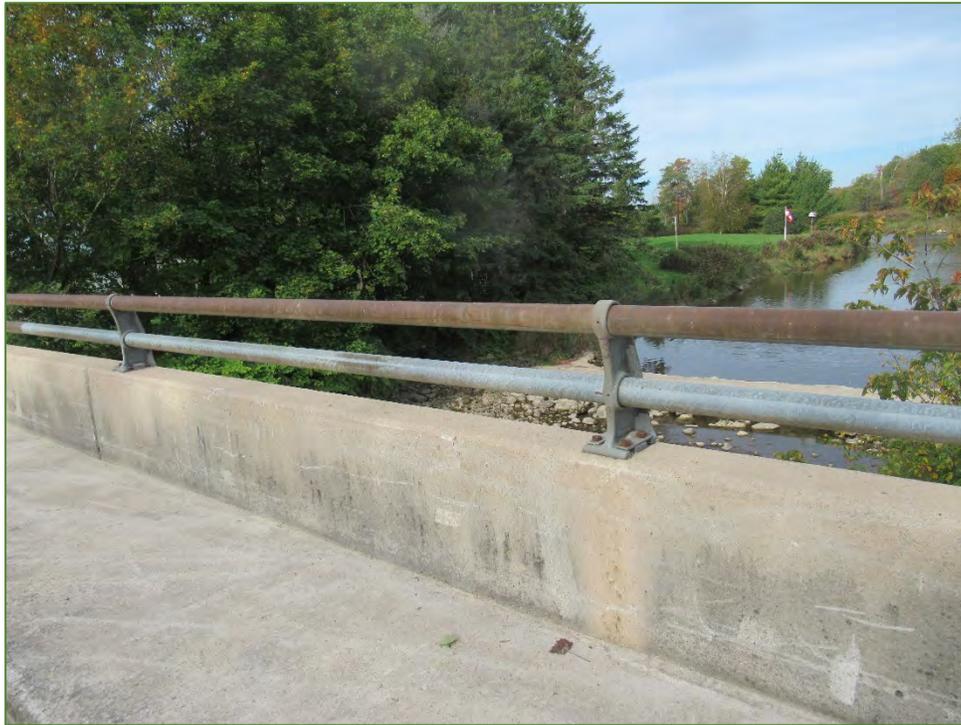
Photo P29 North Sidewalk (light scaling) and Parapet Wall (spall, and light scaling)

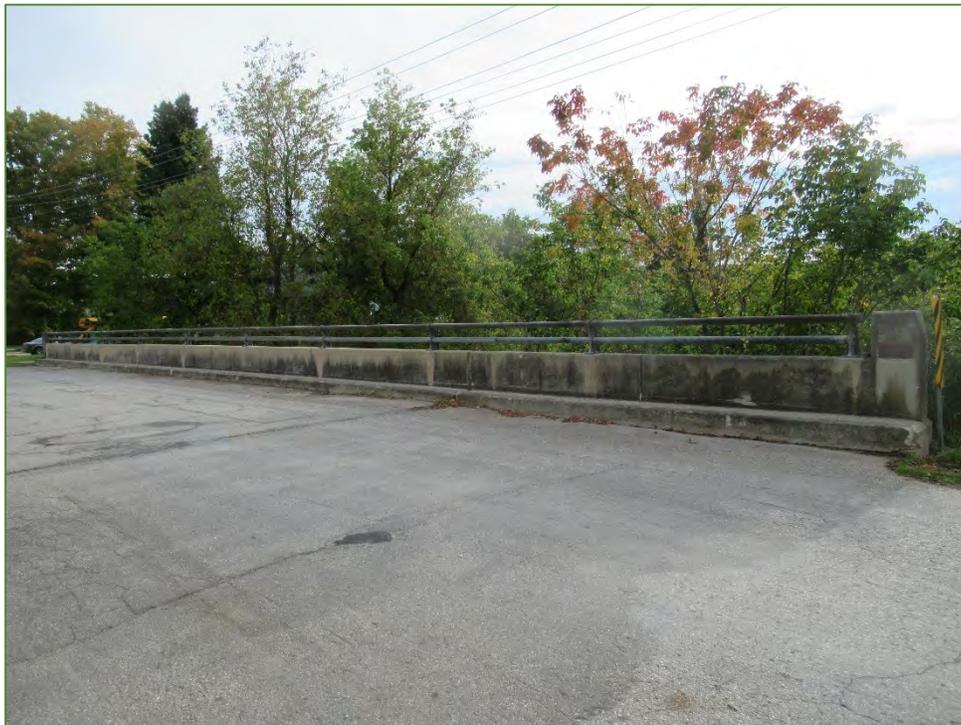
Photo P30 South Curb (fair to good condition – cracks, spall, and light scaling) and Parapet Wall (fair to good condition – cracks, spall, and light scaling)

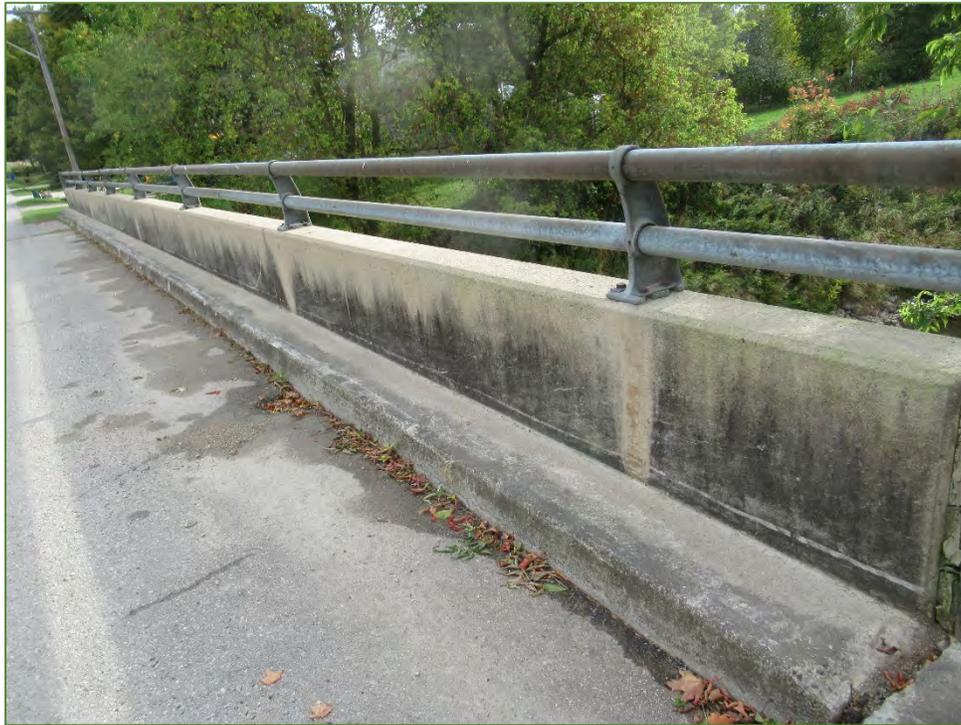
Photo P31 South Curb (spall and, light scaling) **and Parapet Wall** (cracks, and light scaling) and note, light corrosion on handrail

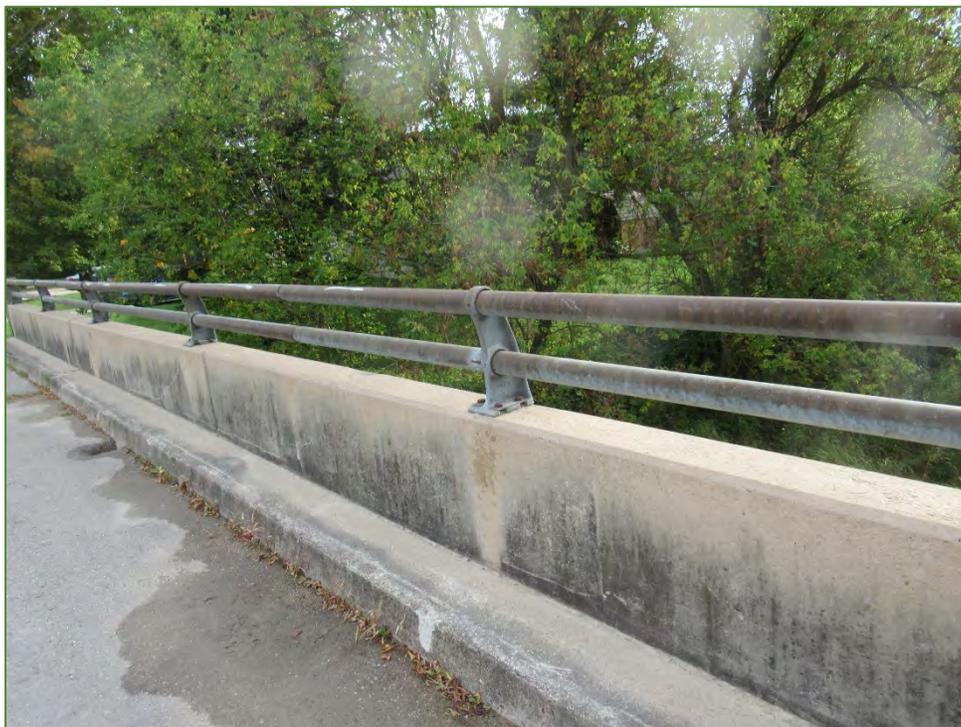
Photo P32 South Curb (spall and, light scaling) **and Parapet Wall** (cracks, and light scaling) and note, light corrosion on handrail

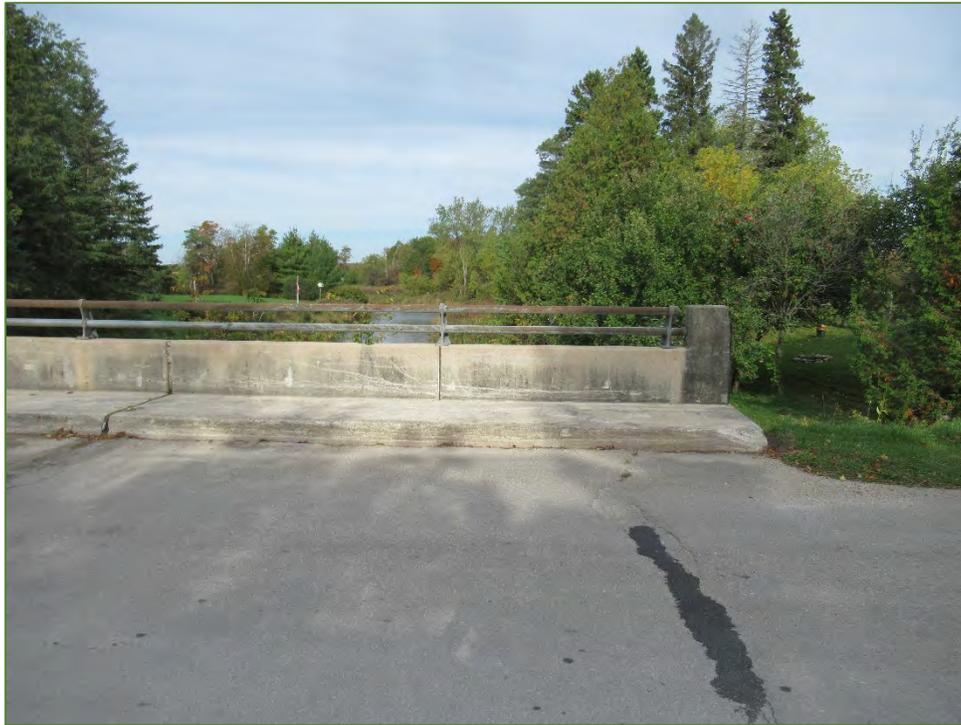
Photo P33 Northeast End Post (fair to good condition – cracks, spall and light scaling) note, spall on the sidewalk

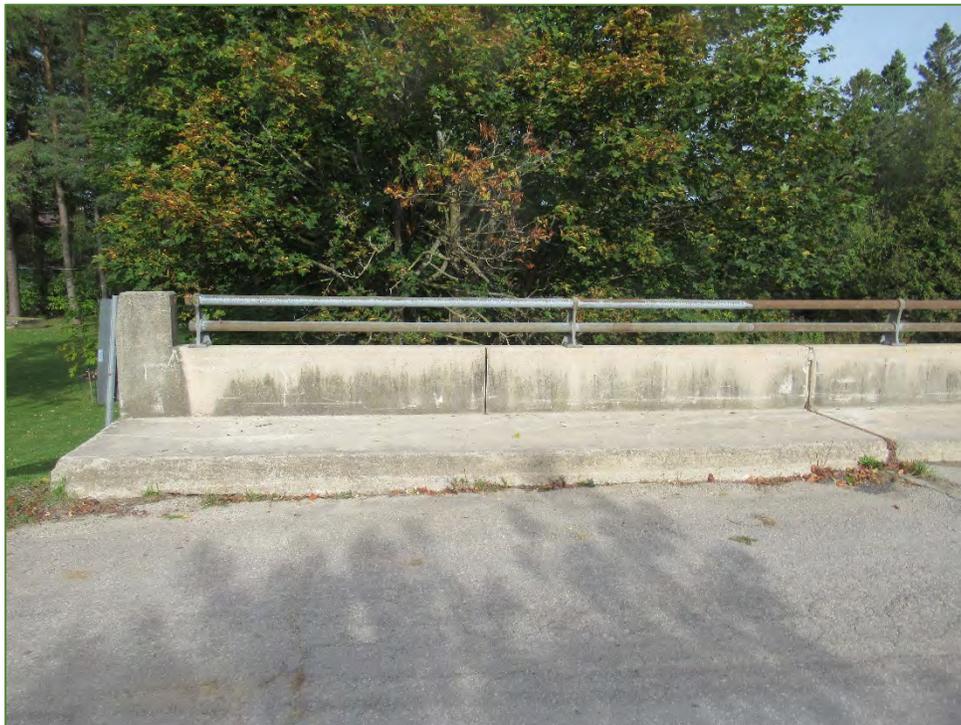
Photo P34 Northwest End Post (fair to good condition – cracks, spall and light scaling)

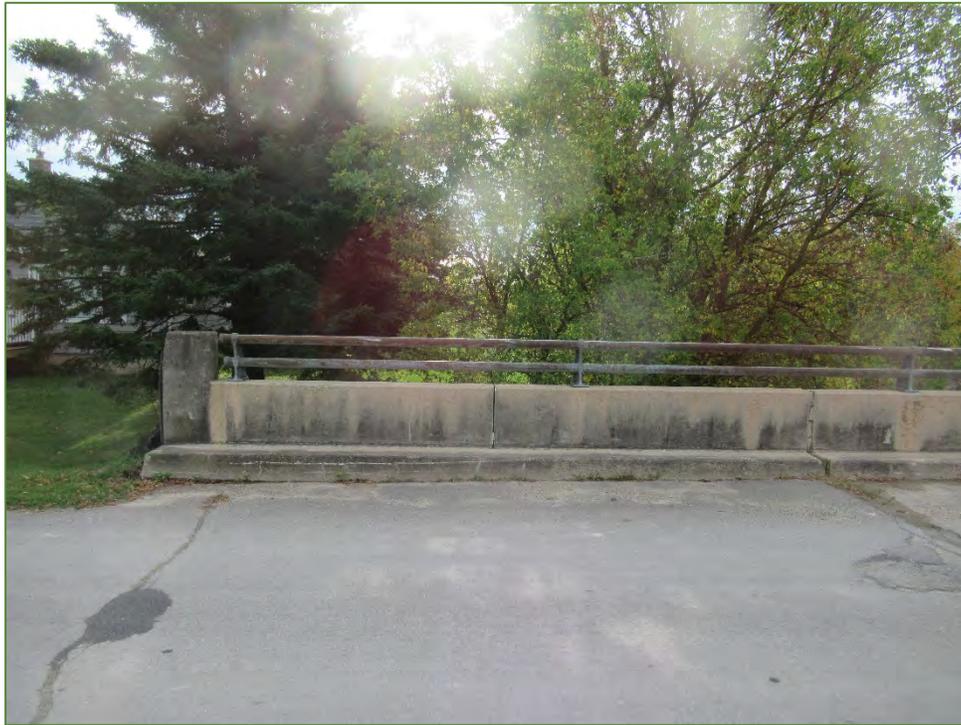
Photo P35 Southeast End Post (good condition –light scaling) note, settlement beyond the approach

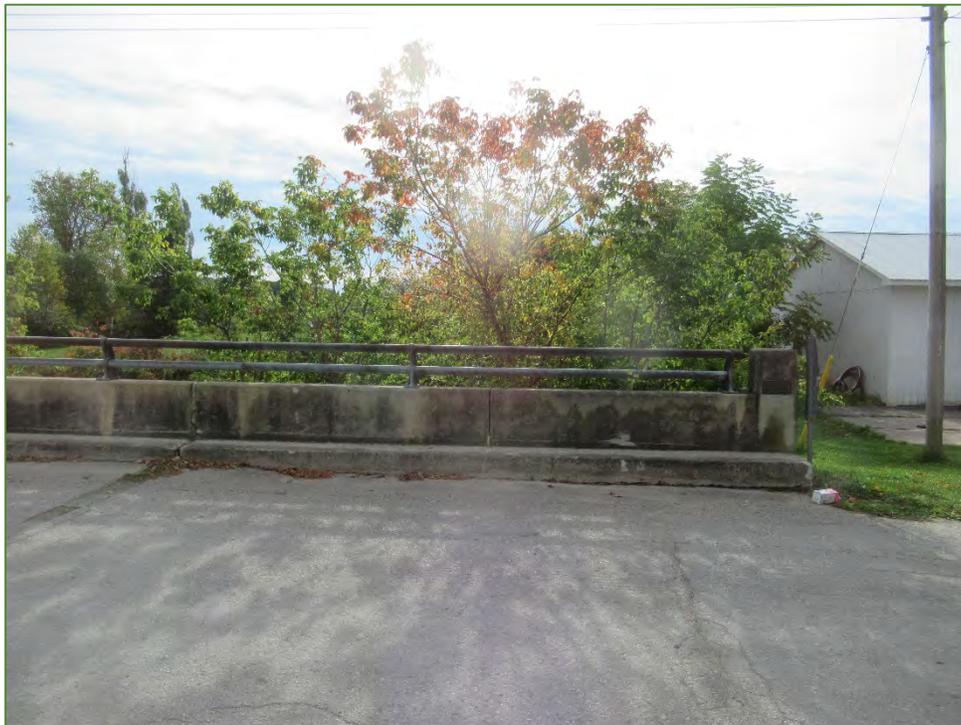
Photo P36 Southwest End Post (good condition – light scaling)

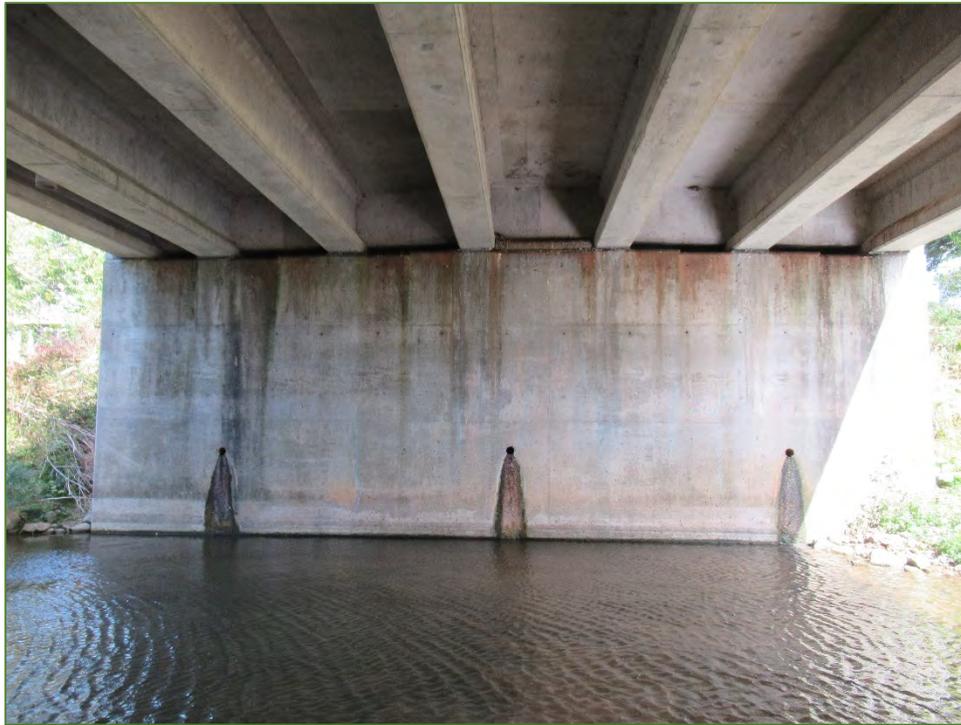
Photo P37 East Abutment (good condition – cracks and wet area)

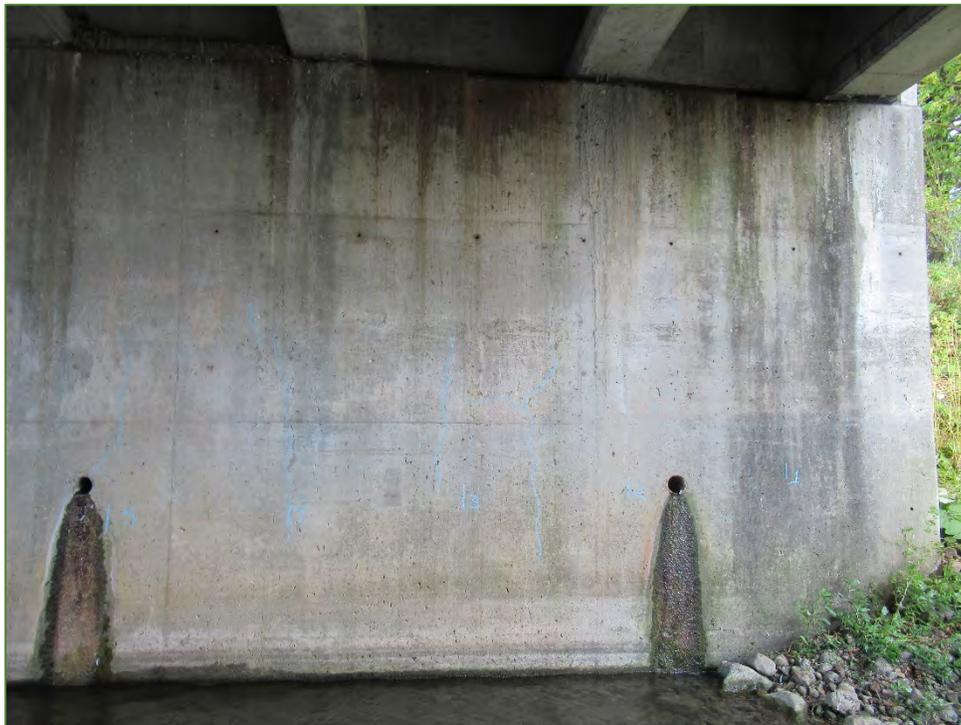
Photo P38 East Abutment (cracks and wet area)

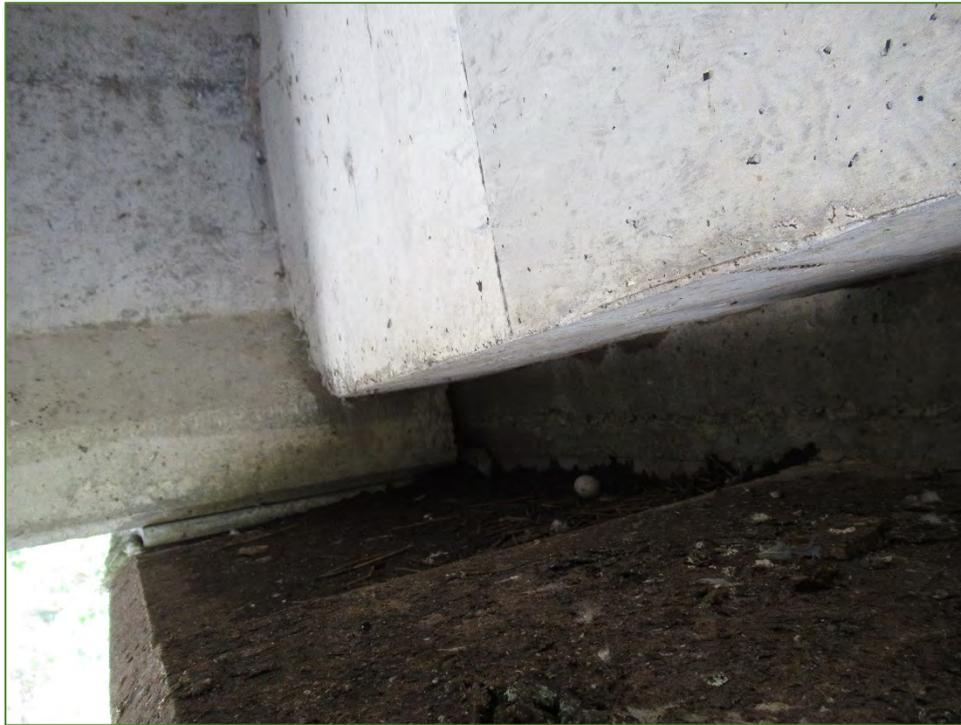
Photo P39 East Abutment Bearing Seat (wet area) note-debris on bearing seat

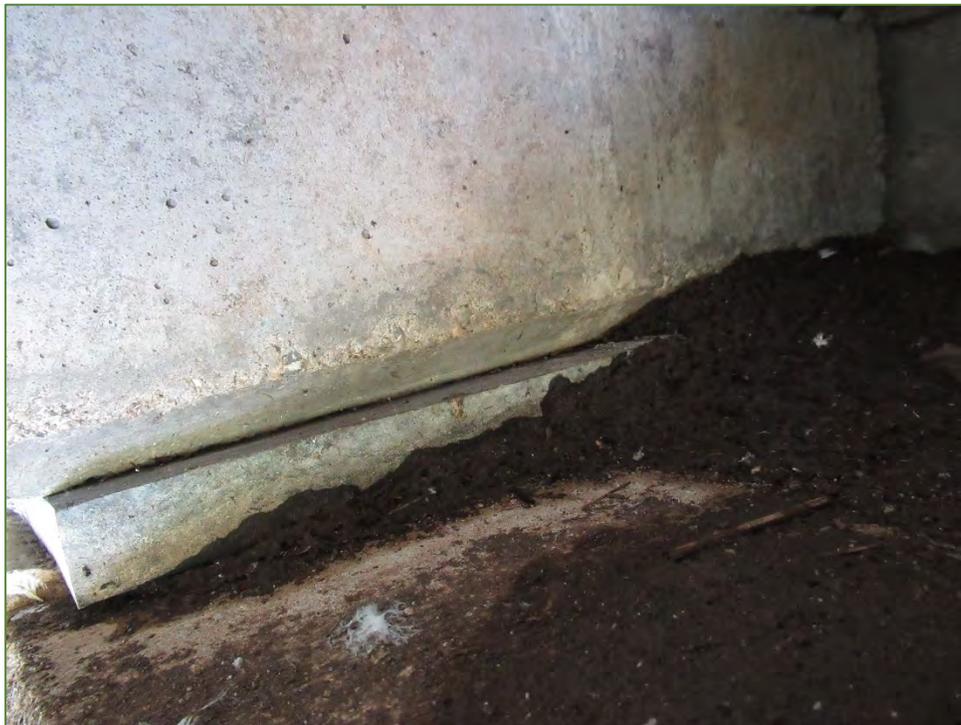
Photo P40 East Abutment Elastomeric Bearing - 1st bearing from north (fair to good condition – squeezed)

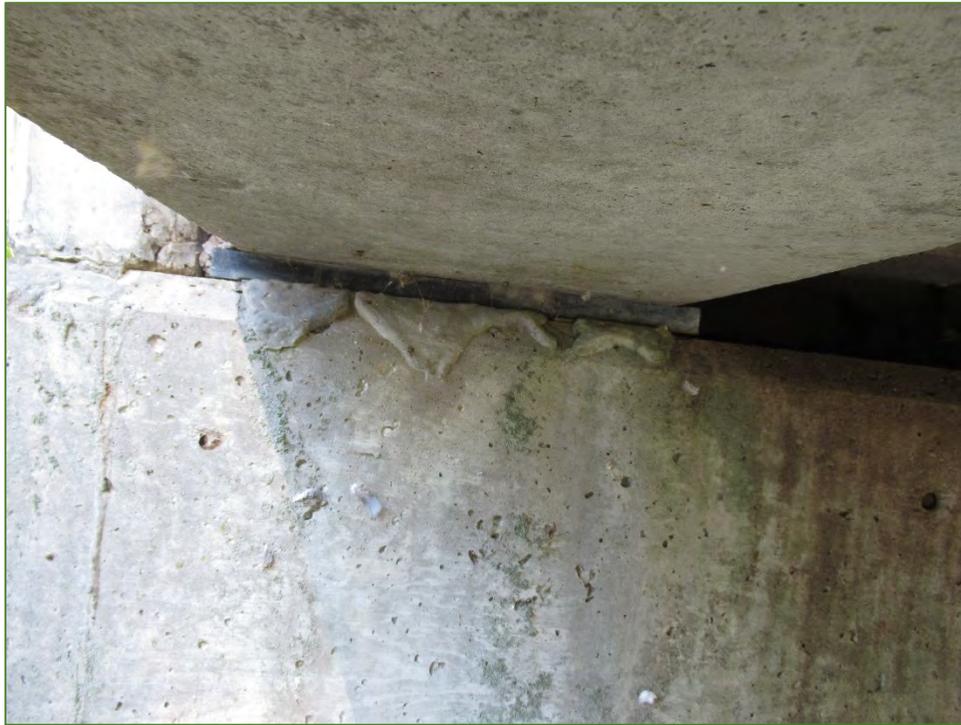
Photo P41 East Abutment Elastomeric Bearing - 1st bearing from north (squeezed)

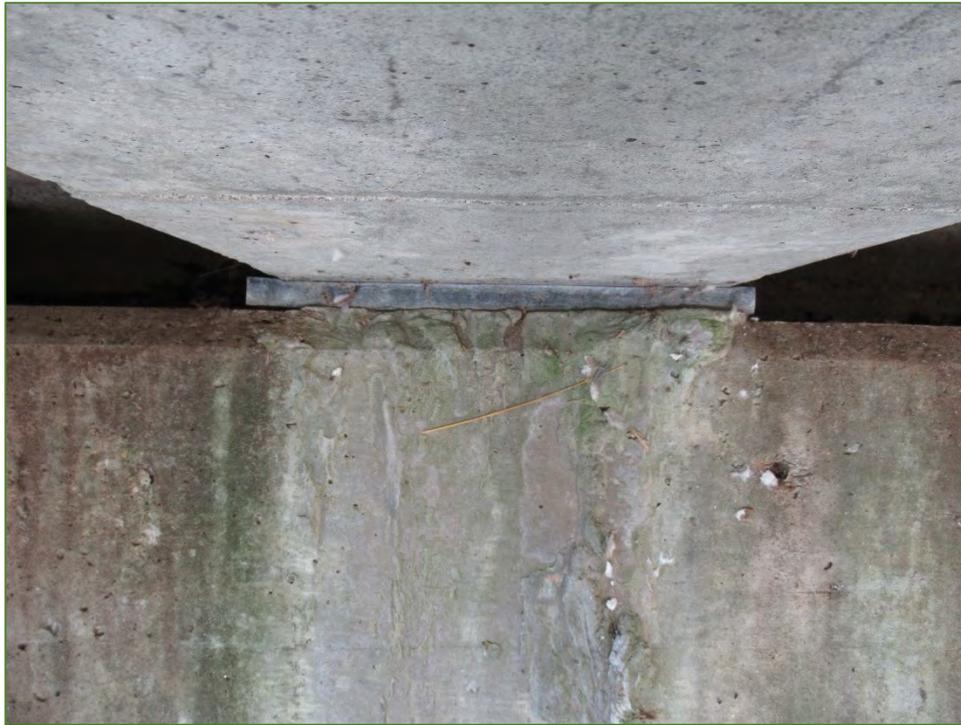
Photo P43 East Abutment Elastomeric Bearing - 2nd bearing from north (squeezed)

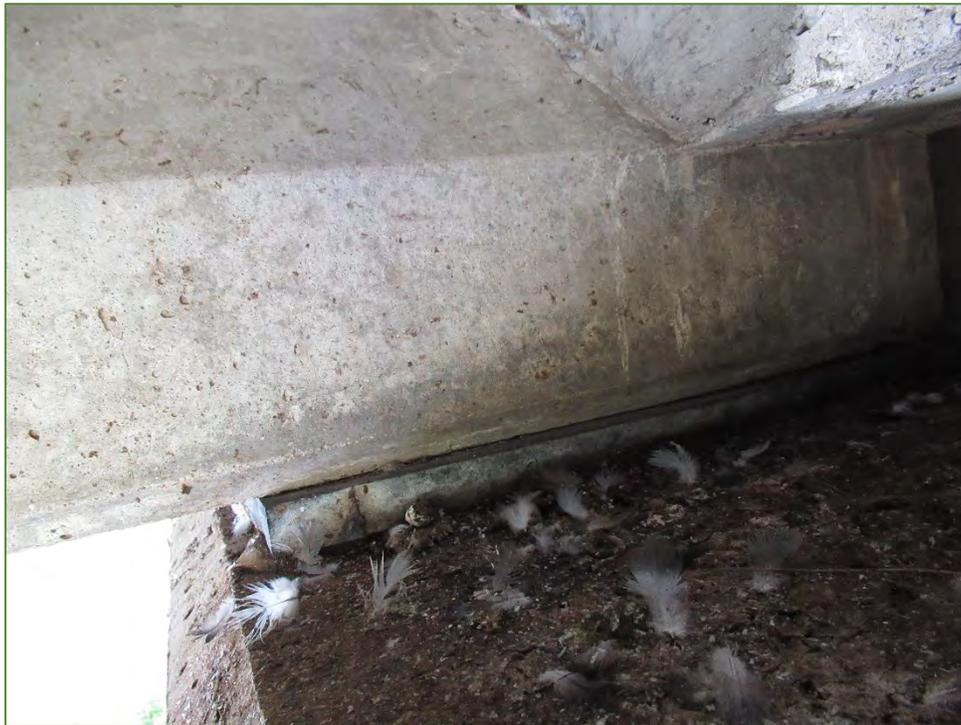
Photo P44 East Abutment Elastomeric Bearing – 3rd bearing from north (fair to good condition – squeezed)

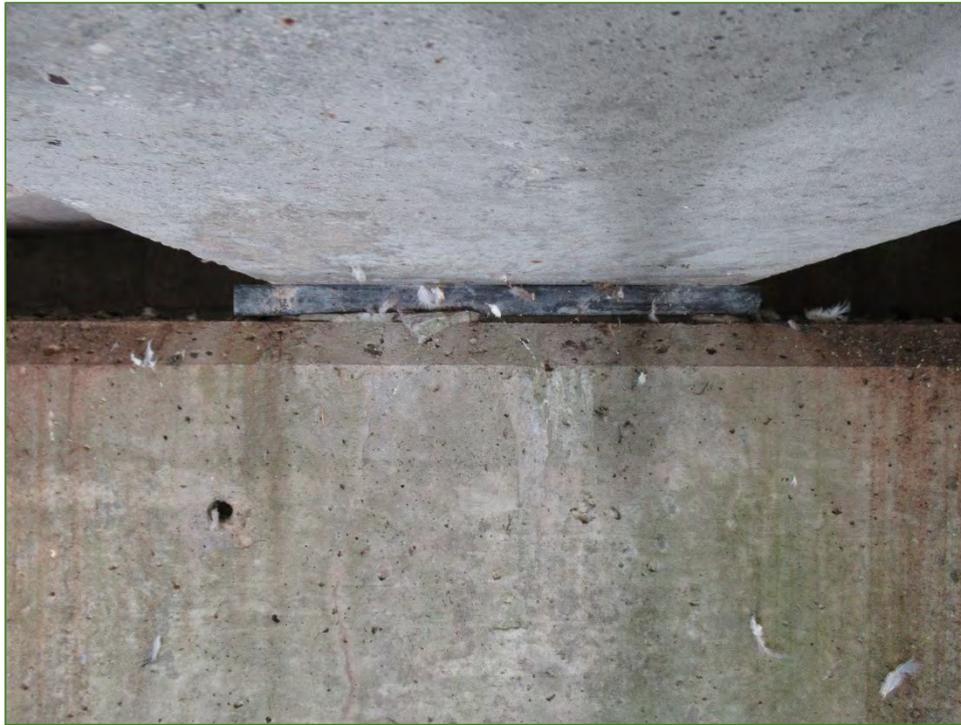
Photo P45 East Abutment Elastomeric Bearing - 3rd bearing from north (squeezed)

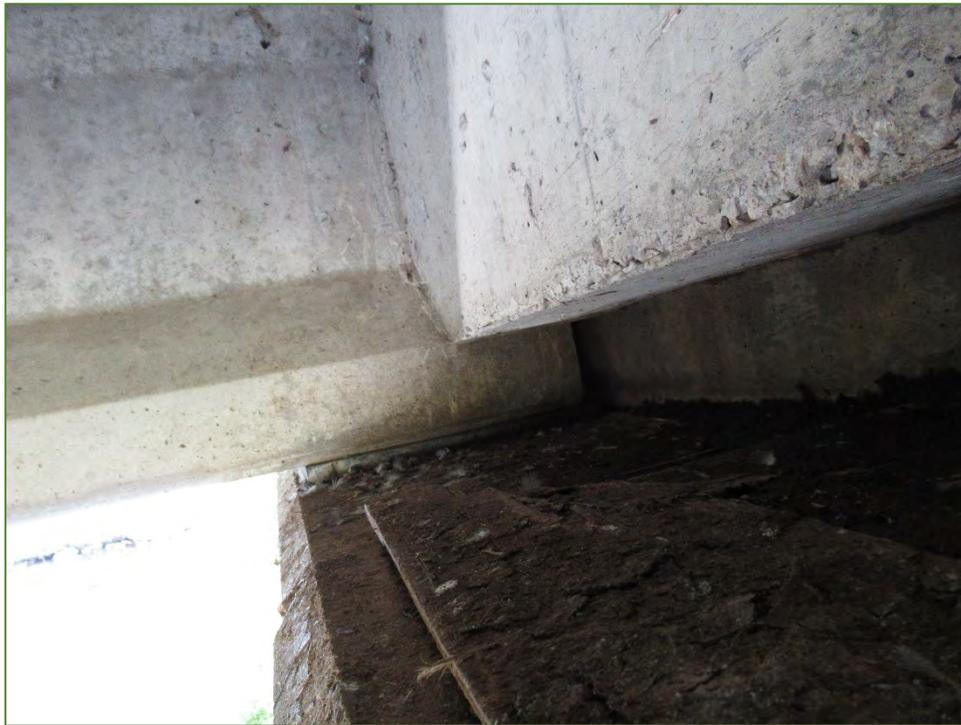
Photo P46 East Abutment Elastomeric Bearing – 4th bearing from north (fair to good condition – squeezed)

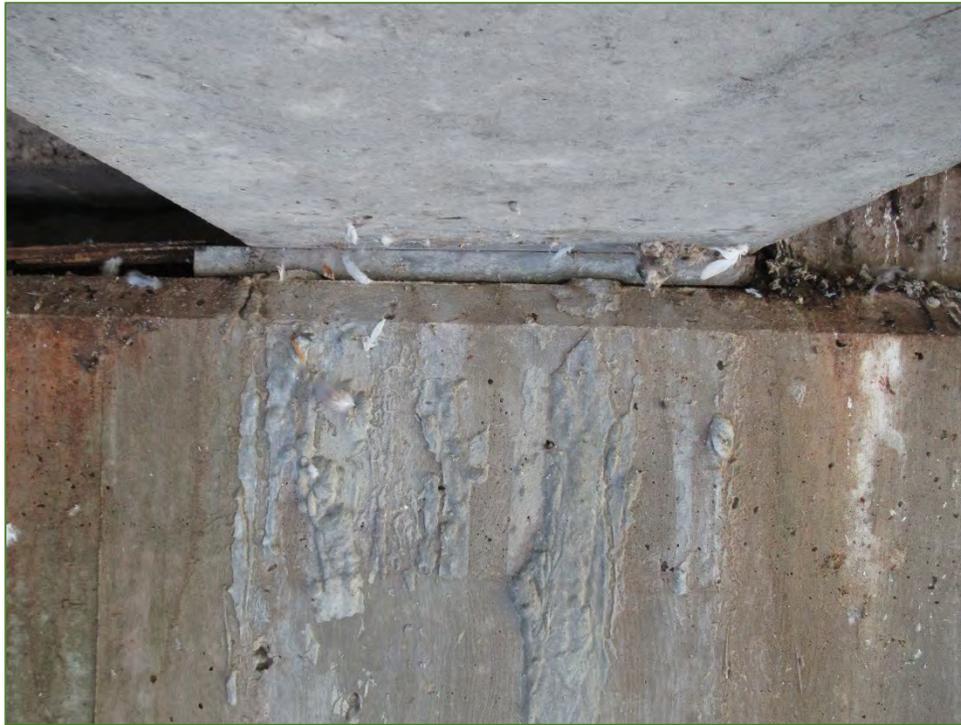
Photo P47 East Abutment Elastomeric Bearing - 4th bearing from north (squeezed)
