**ROADS SUB-COMMITTEE MEETING AGENDA
TUESDAY, DECEMBER 10, 2019 - 1:30 P.M.
MEETING HELD IN THE COUNCIL CHAMBERS**

DETAILED CONDITION SURVEY REPORT

Bridge Check Canada Ltd. was retained by R.J. Burnside & Associates Ltd. to carry out detailed bridge condition survey for Bridge 013 – 260 Sideroad over Grand River located on 260 Sideroad, 200m East of 7th Line SW (Lot 21 & 22, Con. 6 & 7 SW) in Township of Melancthon, Ontario. First time field investigations were carried out on October 7, 2019. Field crew used chest waders, ladder, and delam 2000 for the inspection of the substructure components.

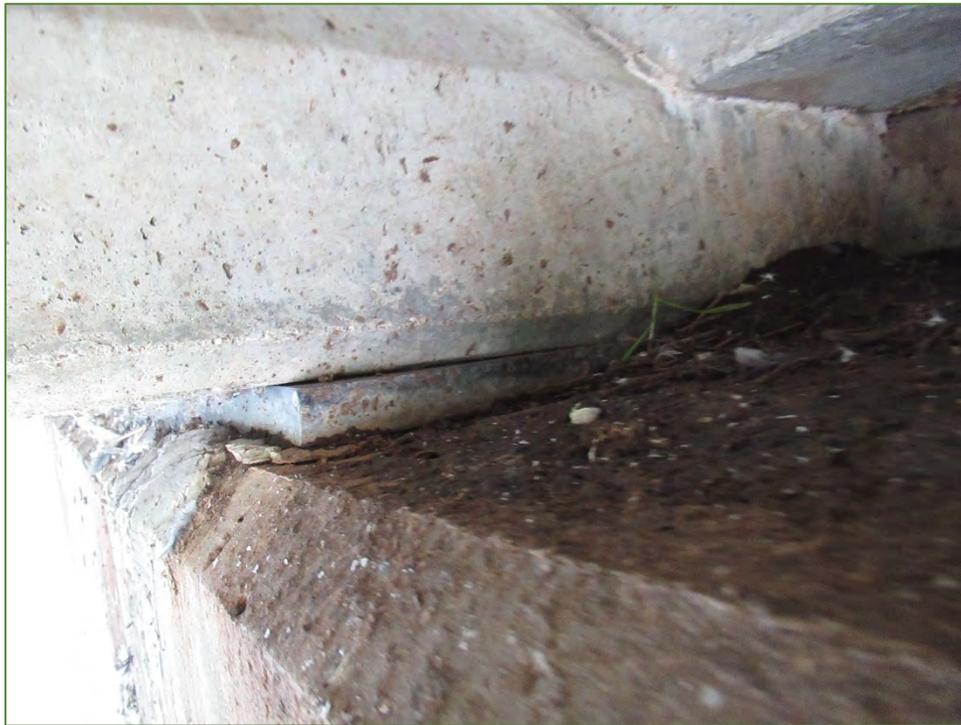
Photo P48 East Abutment Elastomeric Bearing – 5th bearing from north (fair to good condition – squeezed)

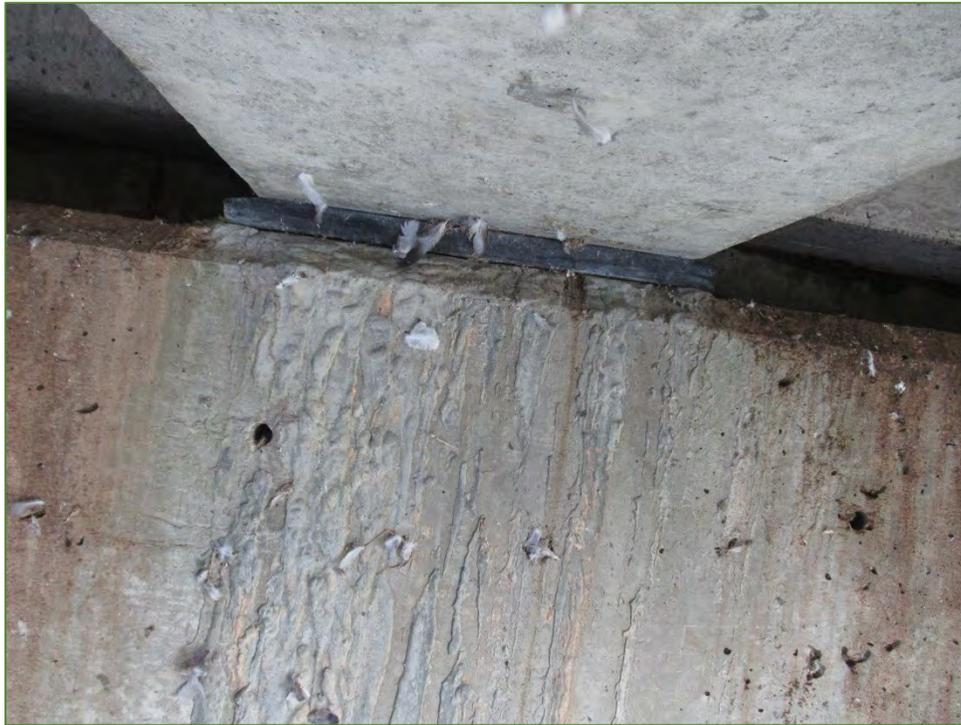
Photo P52 East Abutment Elastomeric Bearing – 7th bearing from north (fair condition – squeezed and moved out)

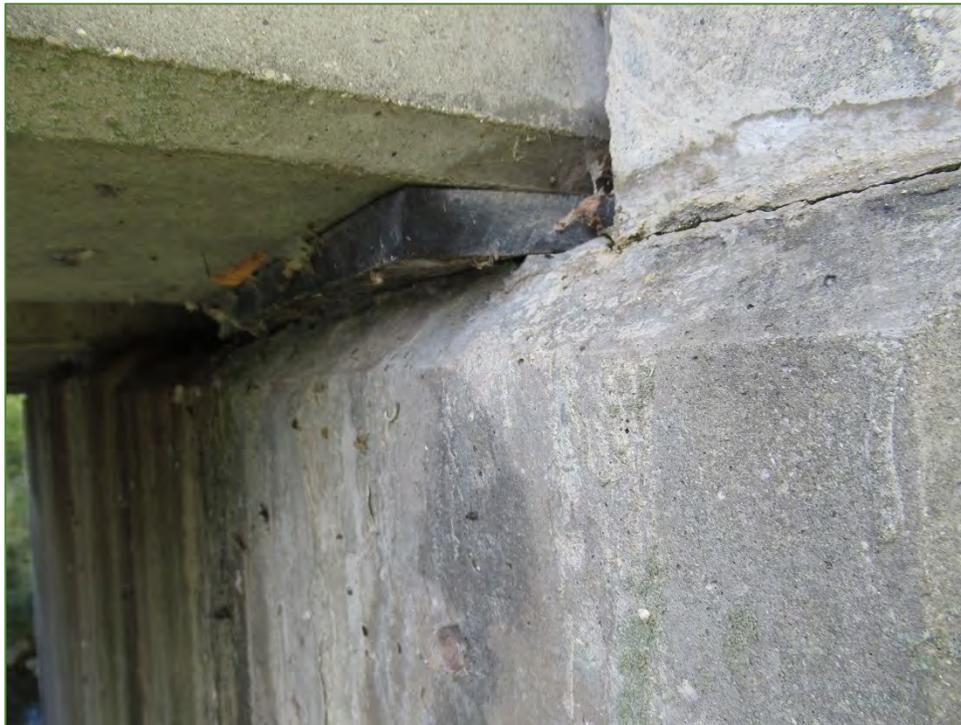
Photo P53 East Abutment Elastomeric Bearing – 7th bearing from north (squeezed and moved out)

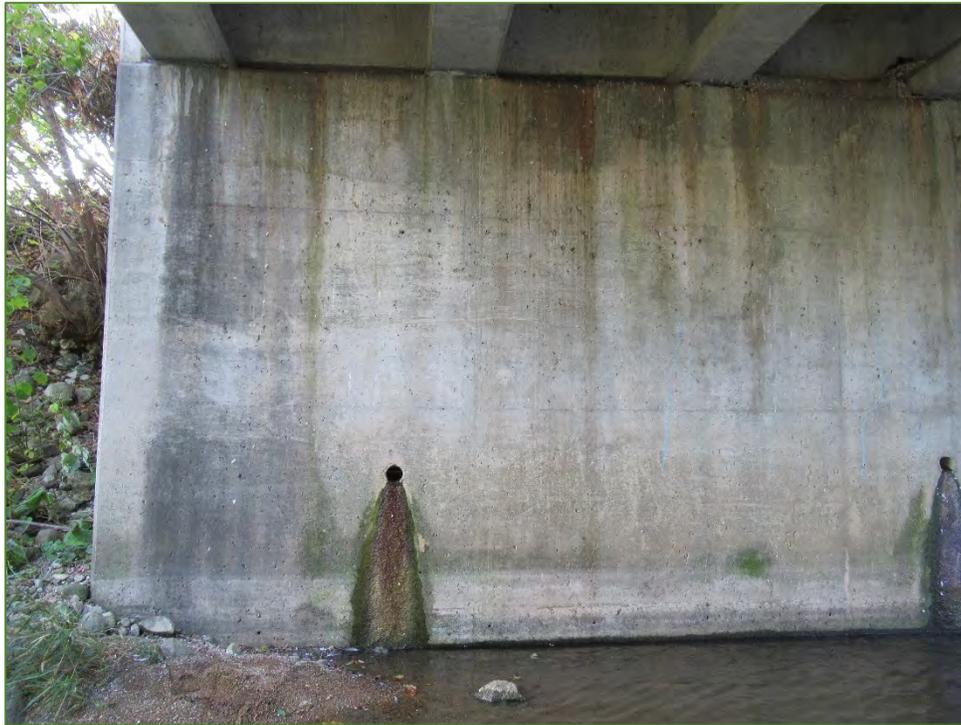
Photo P56 West Abutment (cracks and wet area)

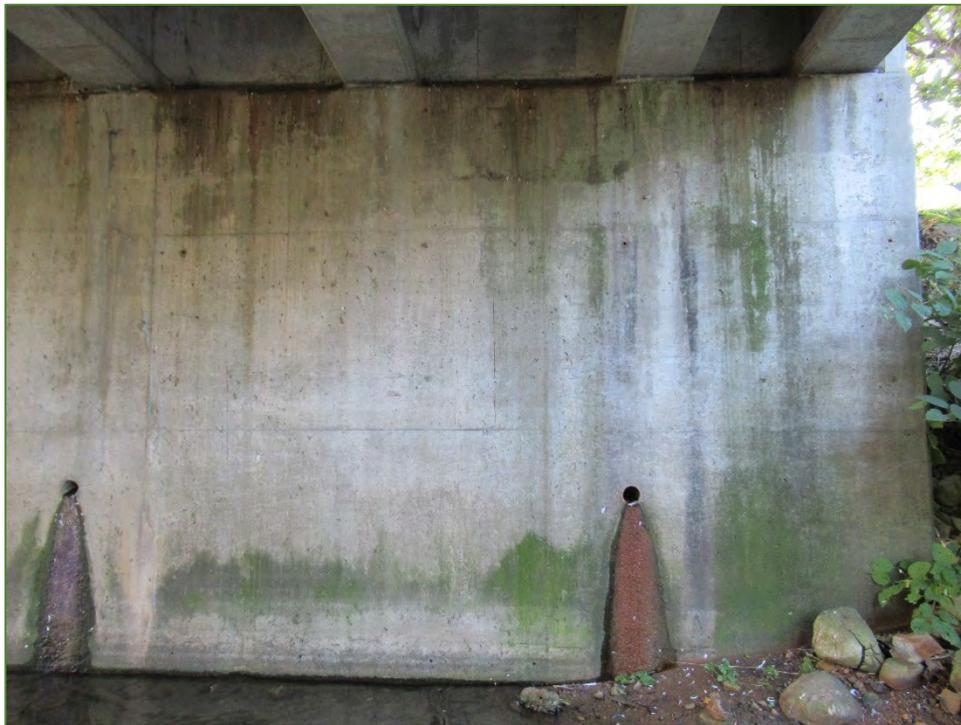
Photo P57 West Abutment Ballast Wall and Bearing Seat (wet area) note- debris on bearing seat

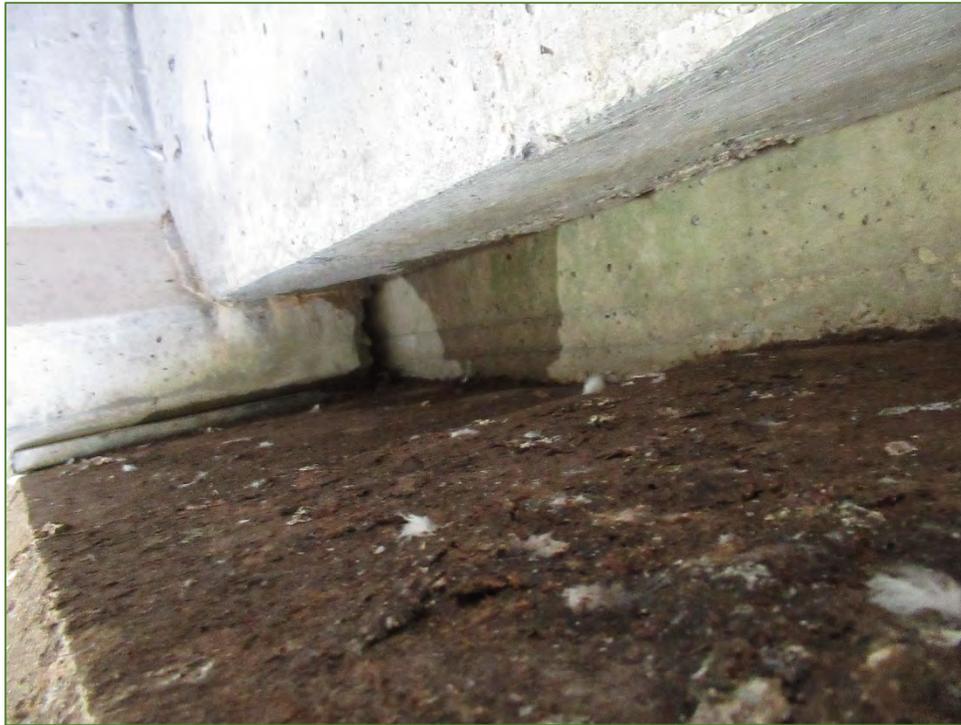
Photo P58 West Abutment Elastomeric Bearing - 1st bearing from north (fair to good condition – squeezed)

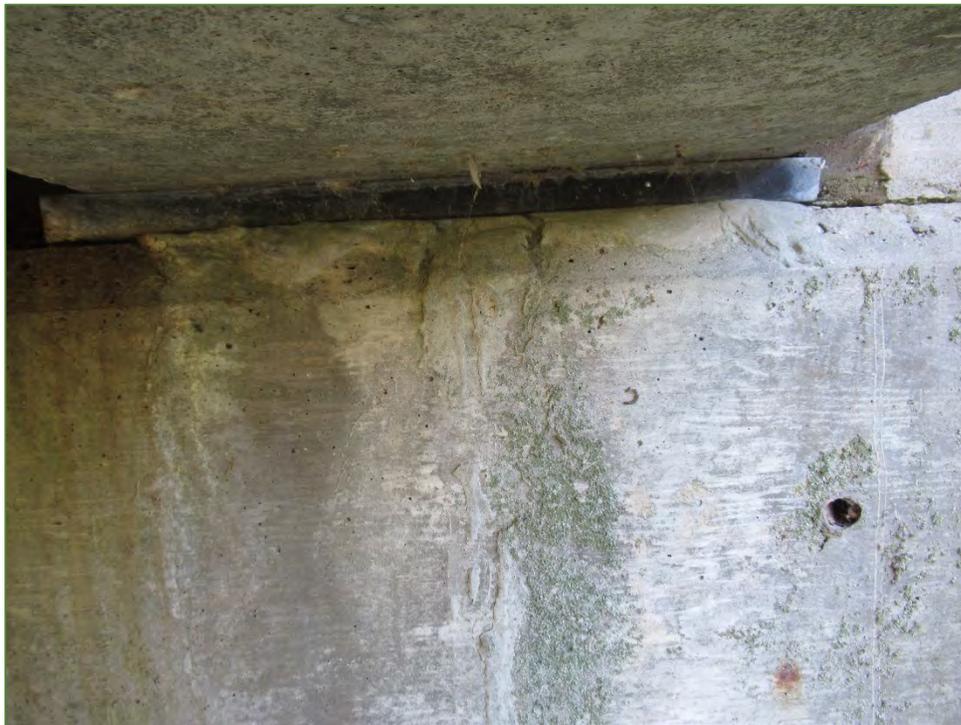
Photo P59 West Abutment Elastomeric Bearing - 1st bearing from north (squeezed)

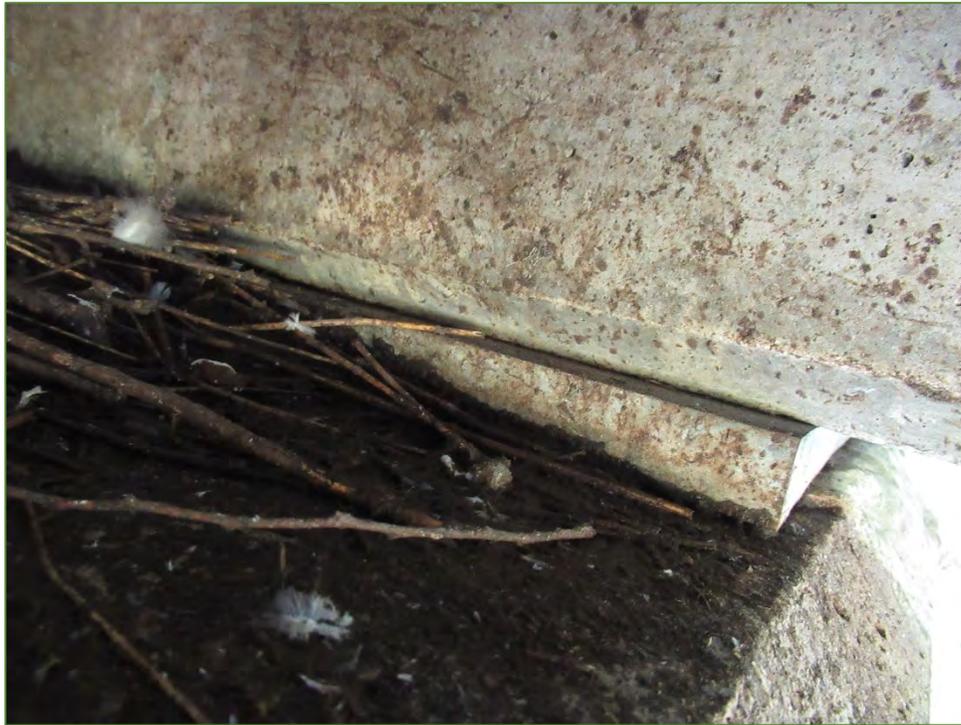
Photo P60 West Abutment Elastomeric Bearing – 2nd bearing from north (fair to good condition – squeezed)

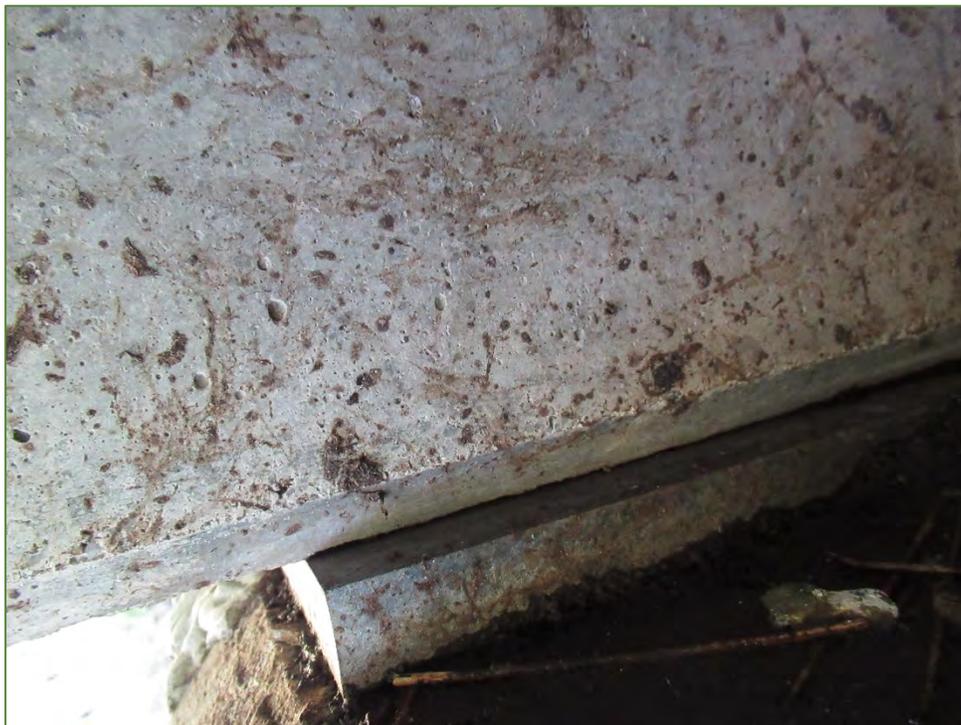
Photo P61 West Abutment Elastomeric Bearing - 2nd bearing from north (squeezed)

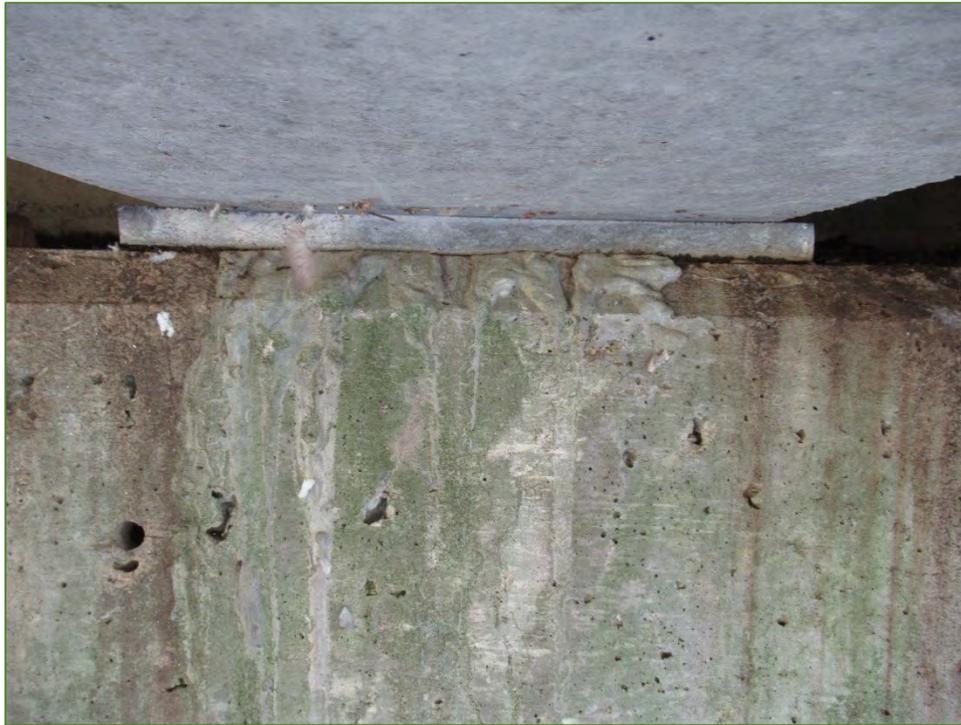
Photo P62 West Abutment Elastomeric Bearing – 3rd bearing from north (fair to good condition – squeezed)

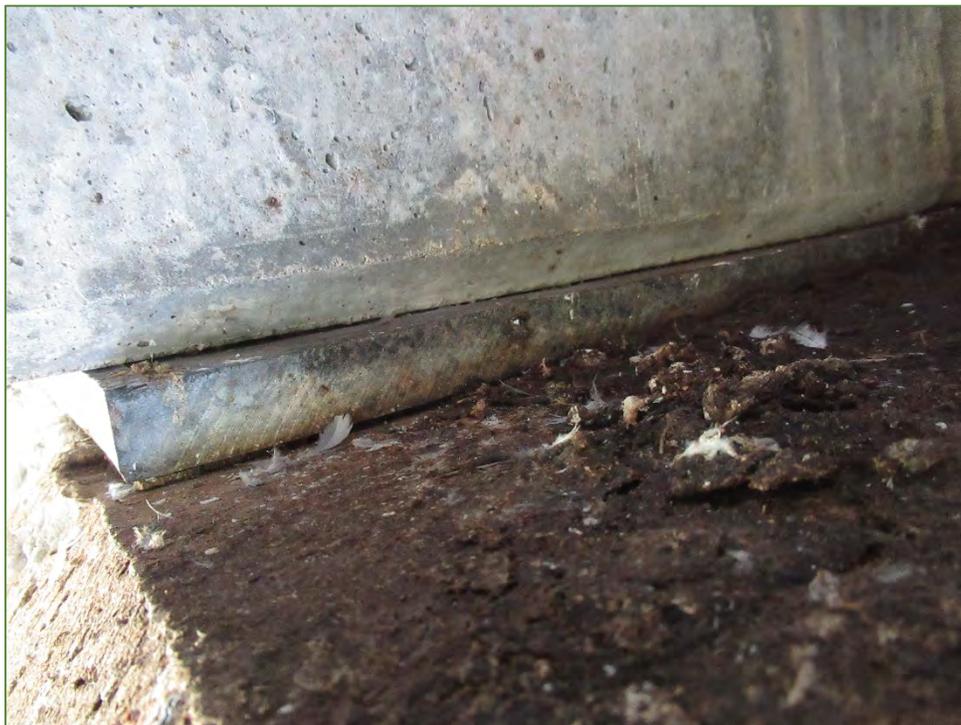
Photo P63 West Abutment Elastomeric Bearing - 3rd bearing from north (squeezed)

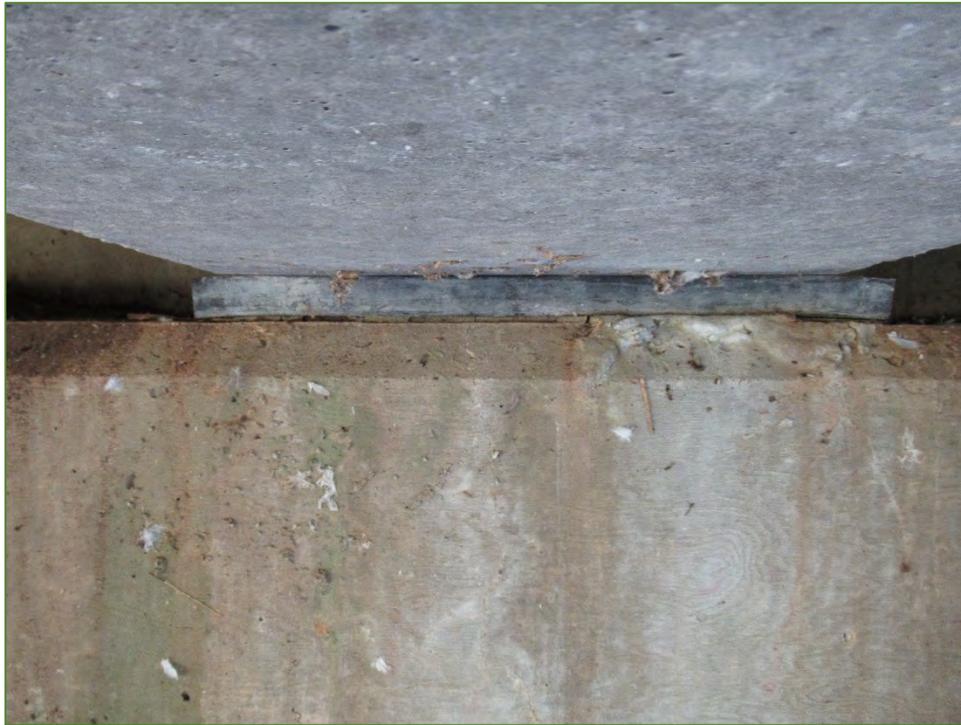
Photo P64 West Abutment Elastomeric Bearing – 4th bearing from north (fair to good condition – squeezed)

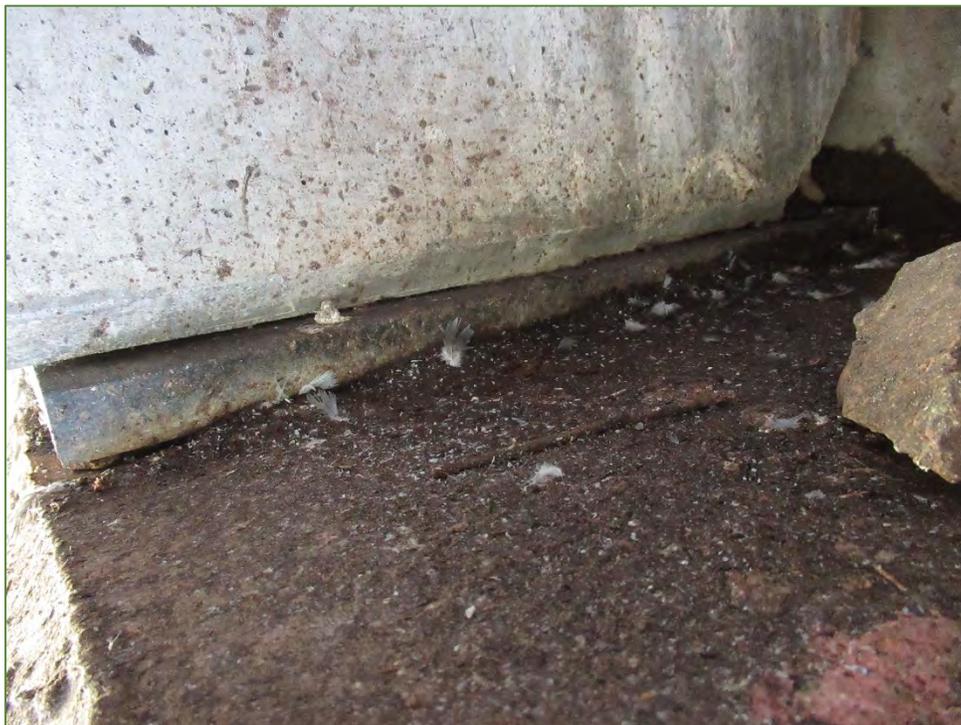
Photo P65 West Abutment Elastomeric Bearing - 4th bearing from north (squeezed)

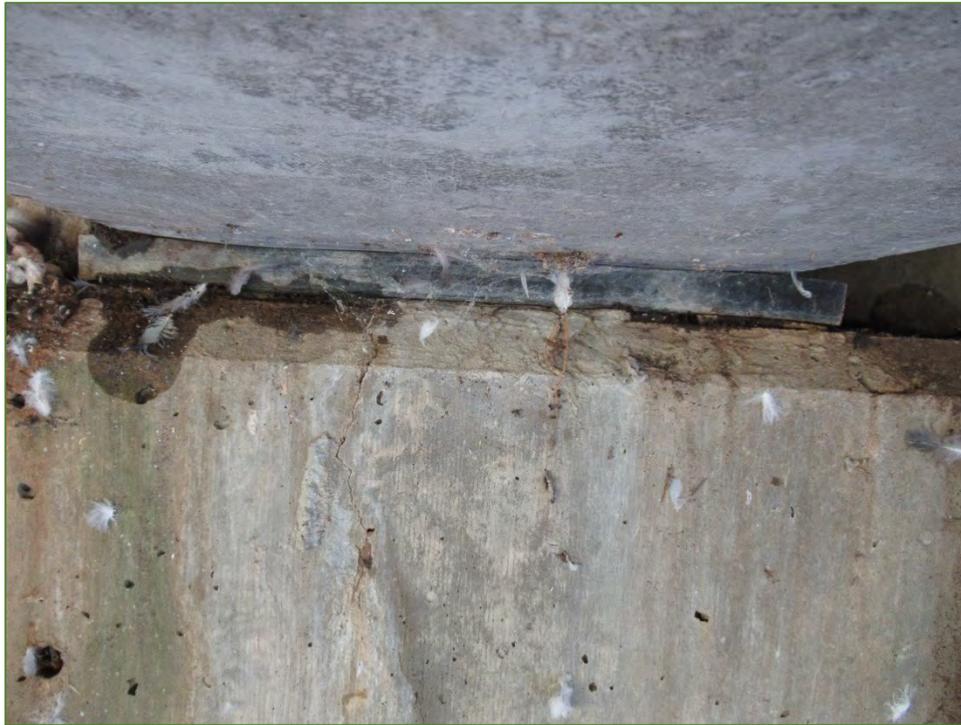
Photo P66 West Abutment Elastomeric Bearing - 5th bearing from north (fair to good condition – squeezed)

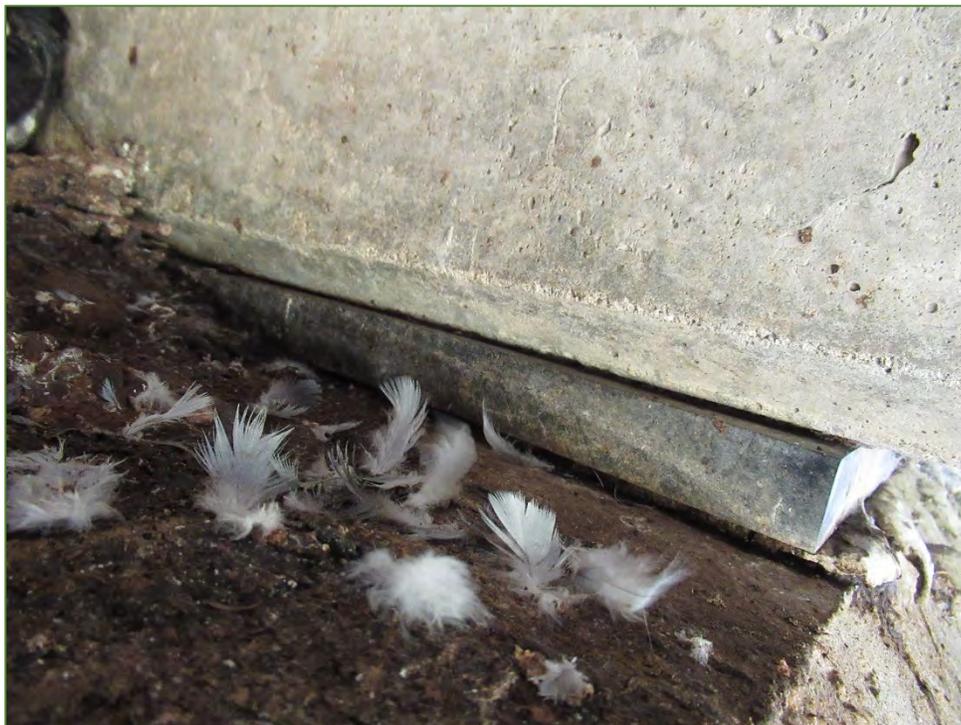
Photo P67 West Abutment Elastomeric Bearing - 5th bearing from north (squeezed)

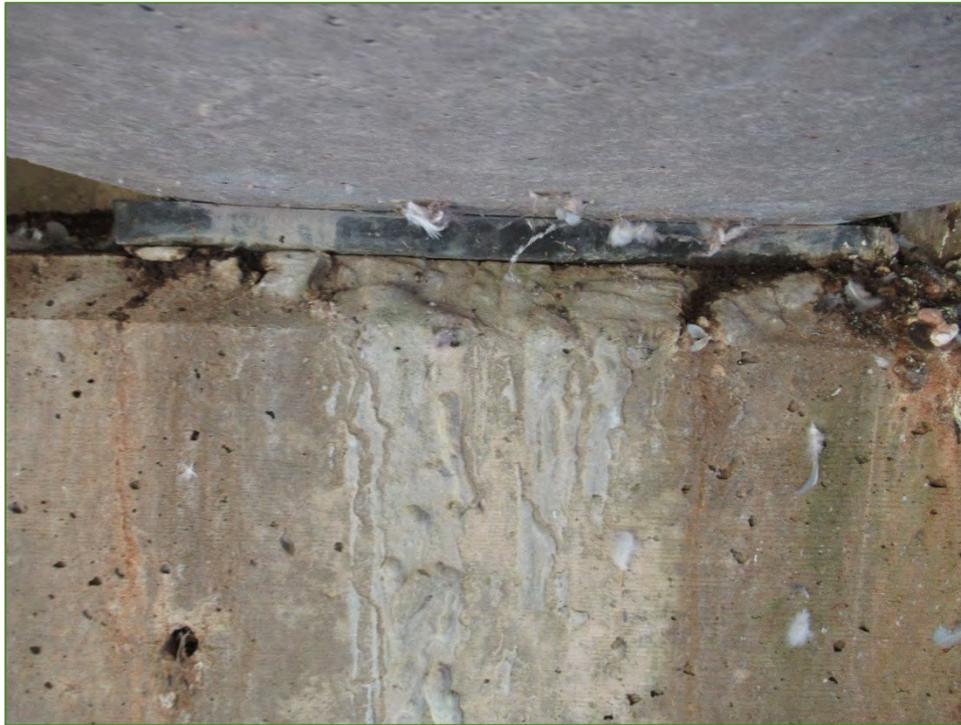
Photo P68 West Abutment Elastomeric Bearing - 6th bearing from north (fair to good condition – squeezed)

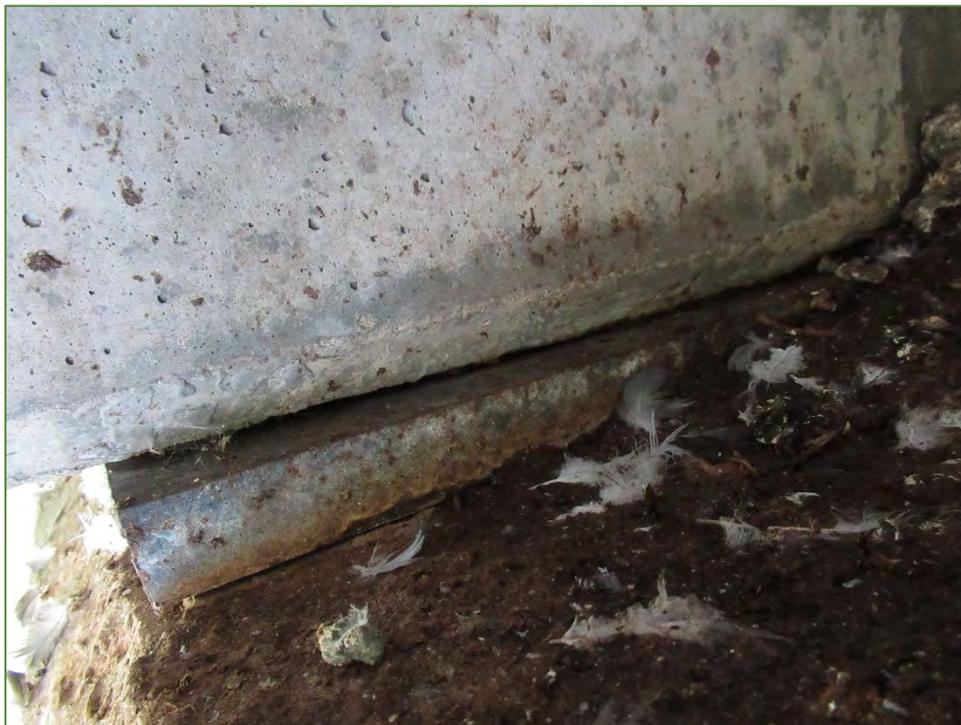
Photo P69 West Abutment Elastomeric Bearing - 6th bearing from north (squeezed)

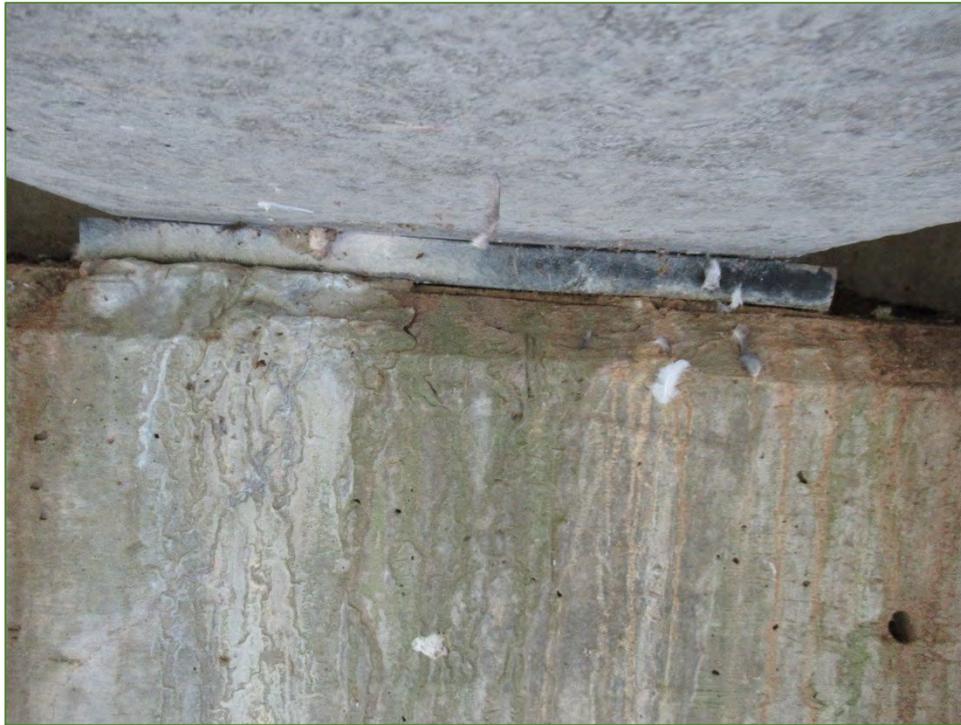
Photo P70 West Abutment Elastomeric Bearing - 7th bearing from north (fair to good condition – squeezed)

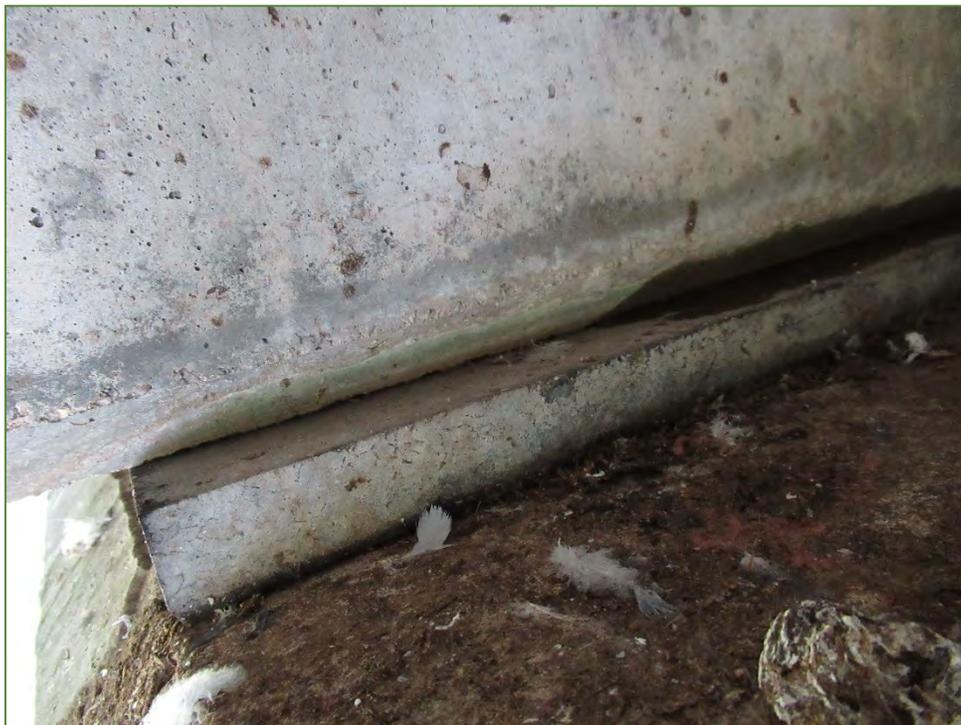
Photo P71 West Abutment Elastomeric Bearing - 7th bearing from north (squeezed)

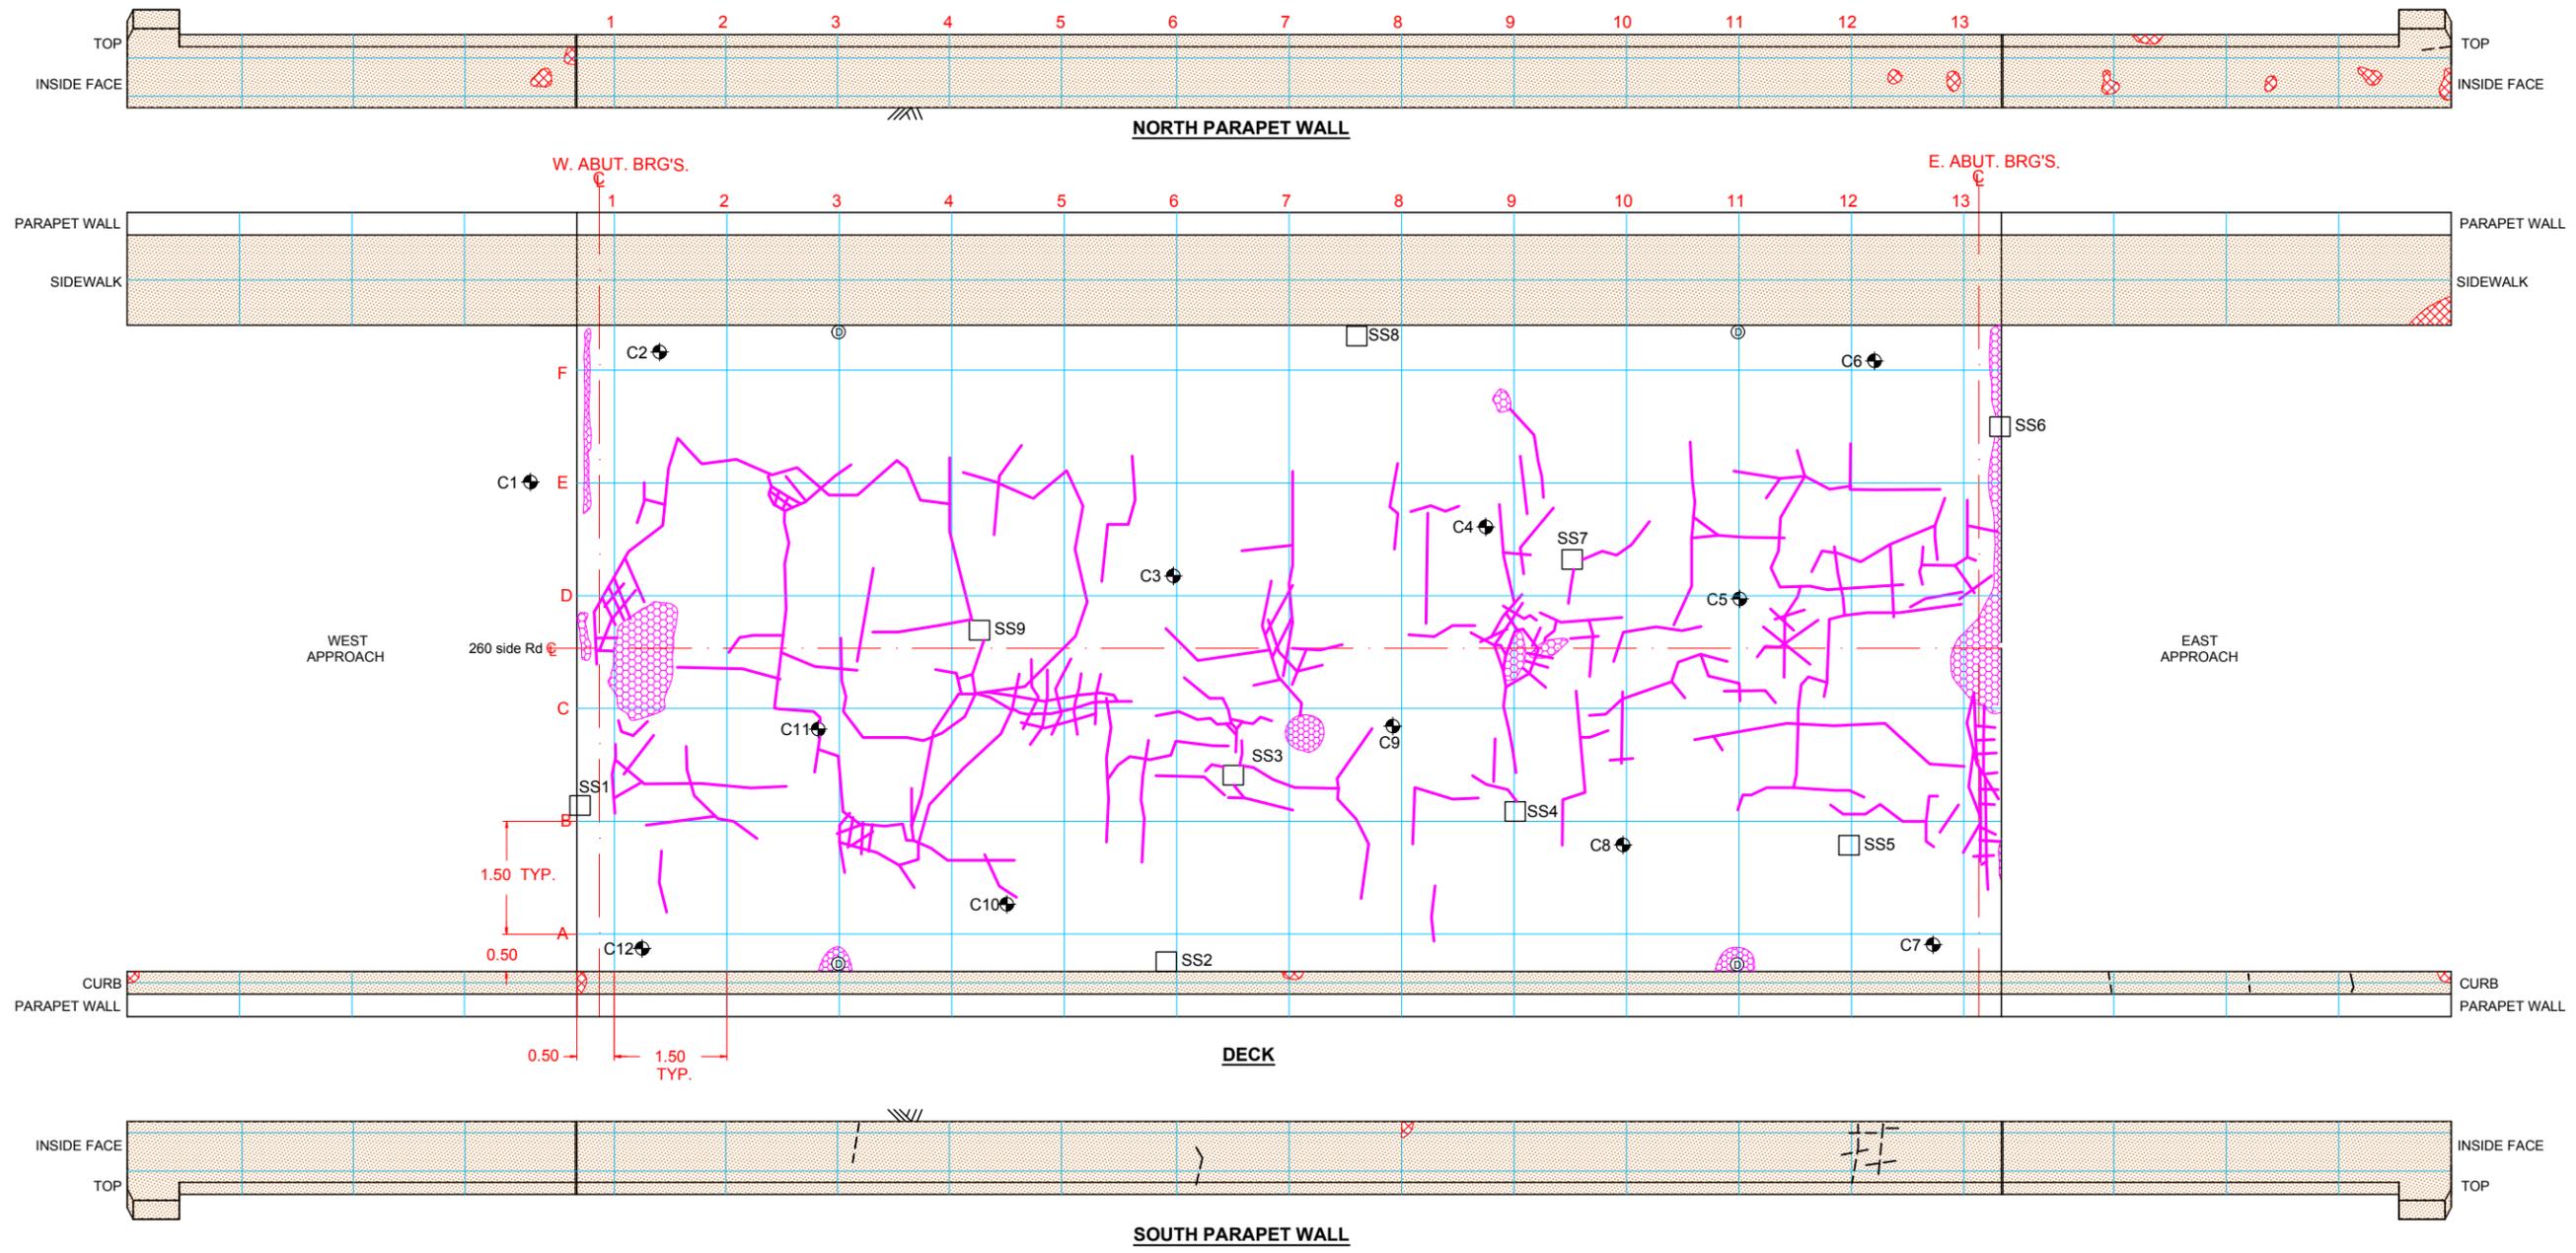
TITLE:
 SURFACE DETERIORATION OF ASPHALT ON DECK, CONCRETE SIDEWALK, CURB AND PARAPET WALLS

The width of the asphalt covered bridge deck at abutments is 8.60 m, with a total surveyed area of 163.40 m². The condition of the asphalt wearing surface on the bridge deck was identified through visual field observations and review of cores and sawn asphalt samples. Drawing 1 shows the deteriorations as well as the location of the cores and sawn asphalt samples. The general pavement surface condition is shown in Photos P3 to P8. The asphalt wearing surface on the concrete deck was generally in poor condition with unsealed transverse cracks (30.0 m), longitudinal (17.0 m), and random cracks (134.0 m), and potholes/patches (3.10 m²). The total asphalt depth, measured in the drilled holes, coreholes, and sawn asphalt samples, varied from 20 mm to 60 mm with an average thickness of 38 mm (refer to Drawing 2).

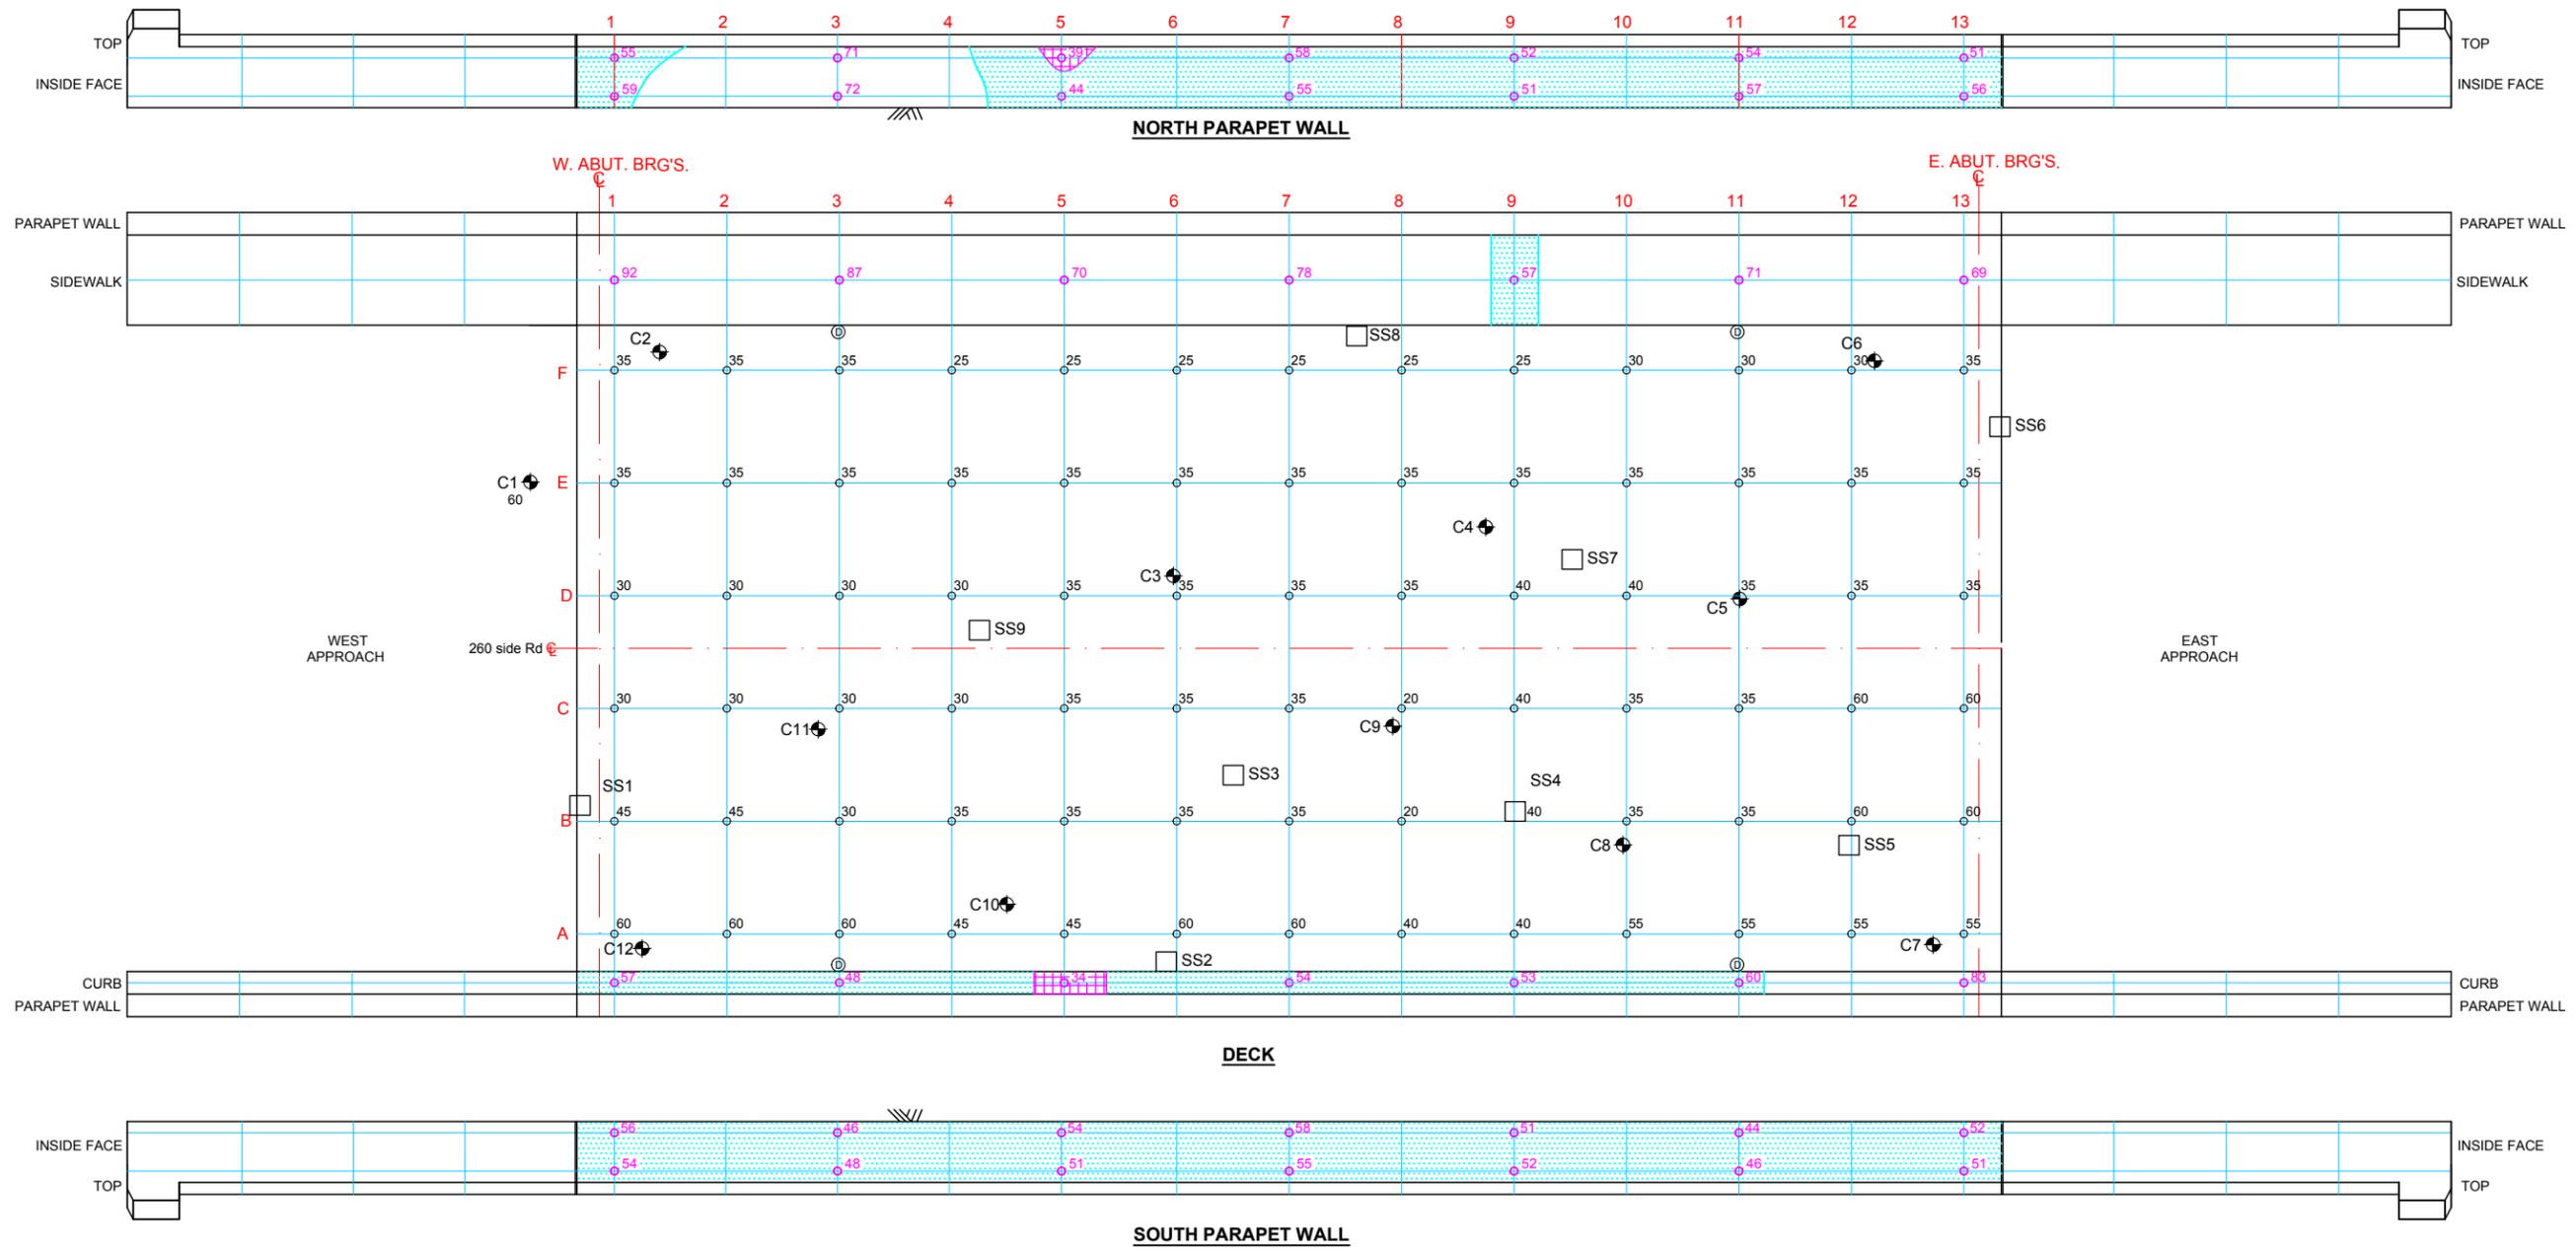
TITLE:
CORROSION POTENTIAL OF DECK, SIDEWALK, CURB AND PARAPET WALLS

Corrosion potential values obtained from the half-cell test carried out on the asphalt covered deck ranged from -0.101 V to -0.427 V with an average value of -0.282 V. The half-cell survey indicated that 16.7% of the deck area likely had no corrosion activity, with corrosion potential values between 0.000 V and -0.199 V. The half-cell survey indicated uncertain low corrosion activity for 70.5% (33.3%+37.2%) of the deck area, with values ranging from -0.200 V to -0.349 V. Probable active corrosion was detected for 12.8% (12.8%+0.0%) of the deck area with corrosion potential values more negative than -0.350 V. Drawing 3 shows the corrosion potential readings in deck.
