**ROADS SUB-COMMITTEE MEETING AGENDA
TUESDAY, DECEMBER 10, 2019 - 1:30 P.M.
MEETING HELD IN THE COUNCIL CHAMBERS**

DETAILED CONDITION SURVEY REPORT

Bridge Check Canada Ltd. was retained by R.J. Burnside & Associates Ltd. to carry out detailed bridge condition survey for Bridge 013 – 260 Sideroad over Grand River located on 260 Sideroad, 200m East of 7th Line SW (Lot 21 & 22, Con. 6 & 7 SW) in Township of Melancthon, Ontario. First time field investigations were carried out on October 7, 2019. Field crew used chest waders, ladder, and delam 2000 for the inspection of the substructure components.

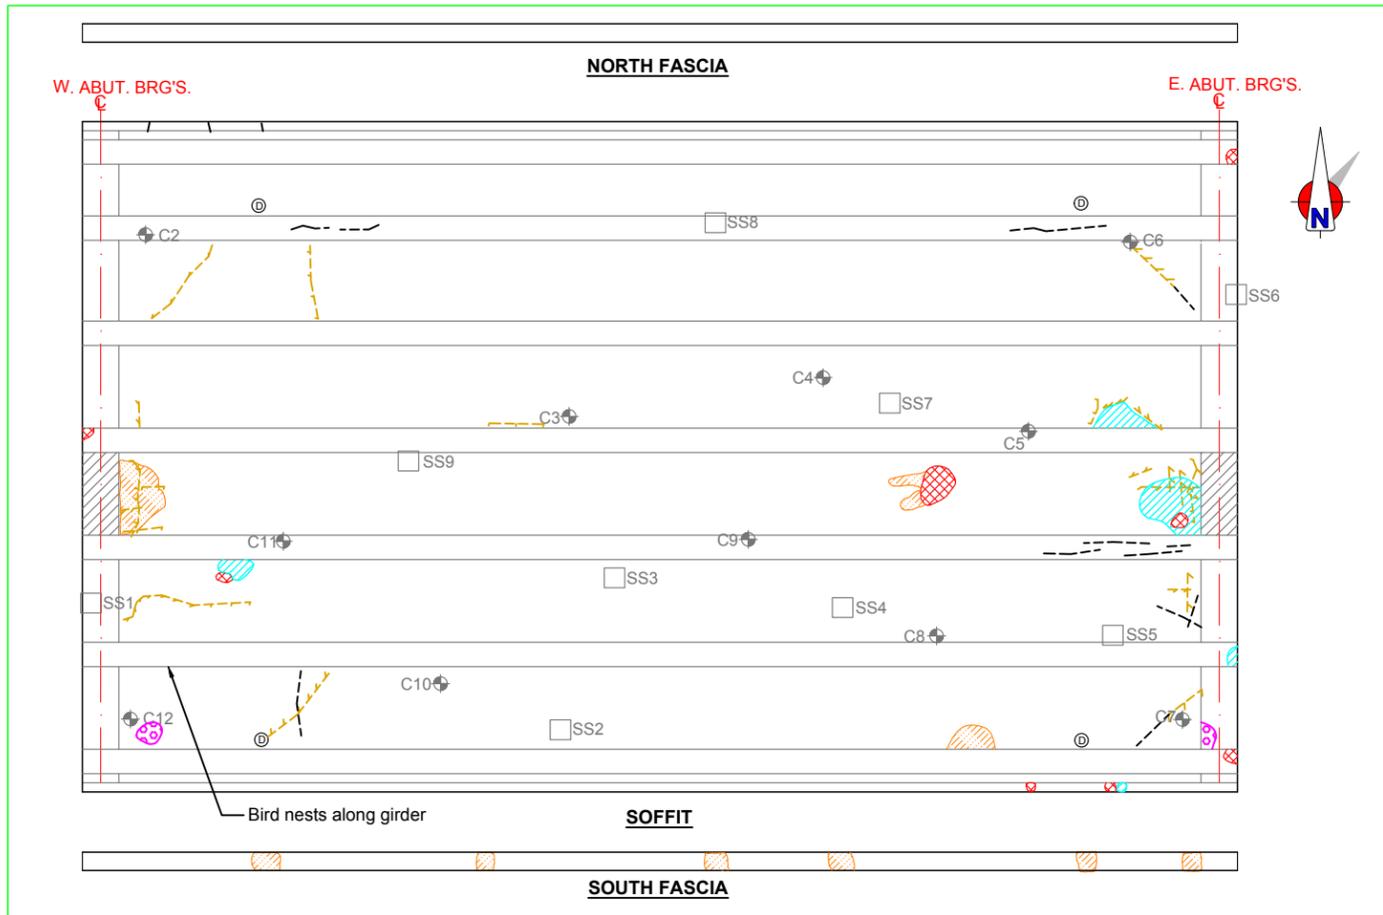
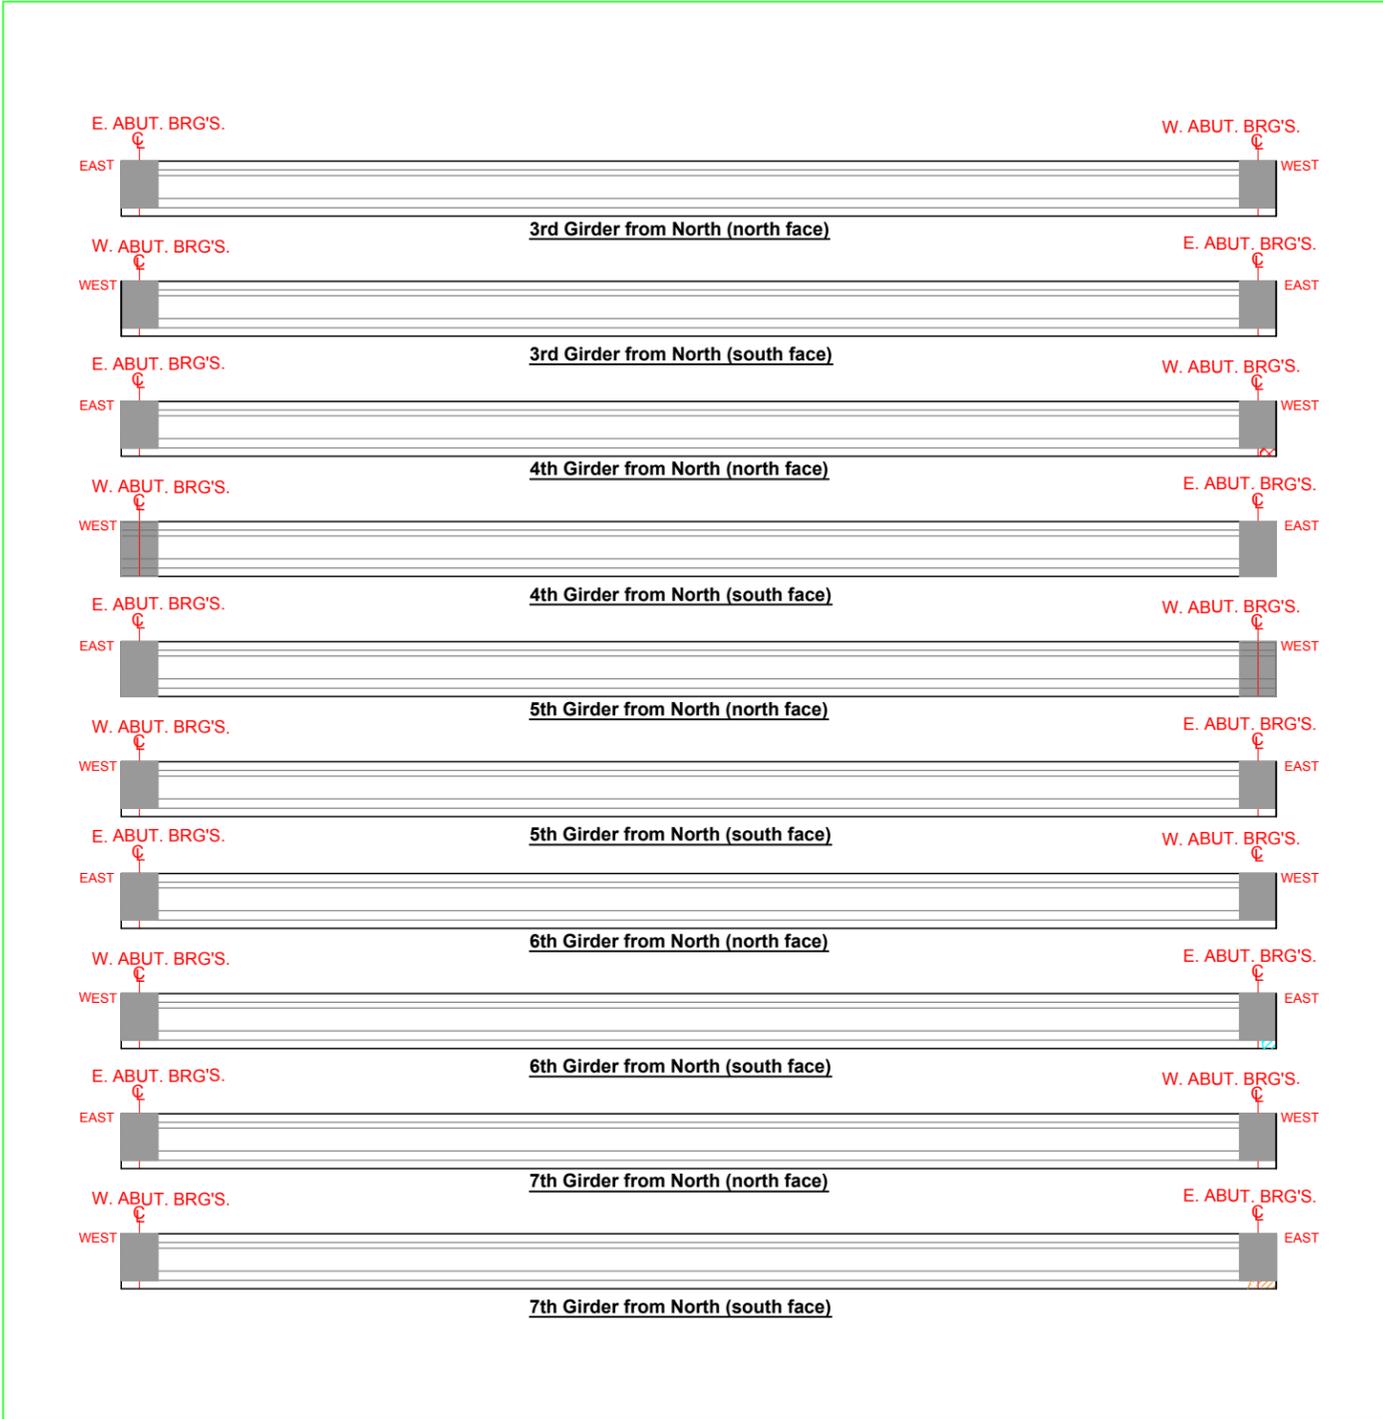
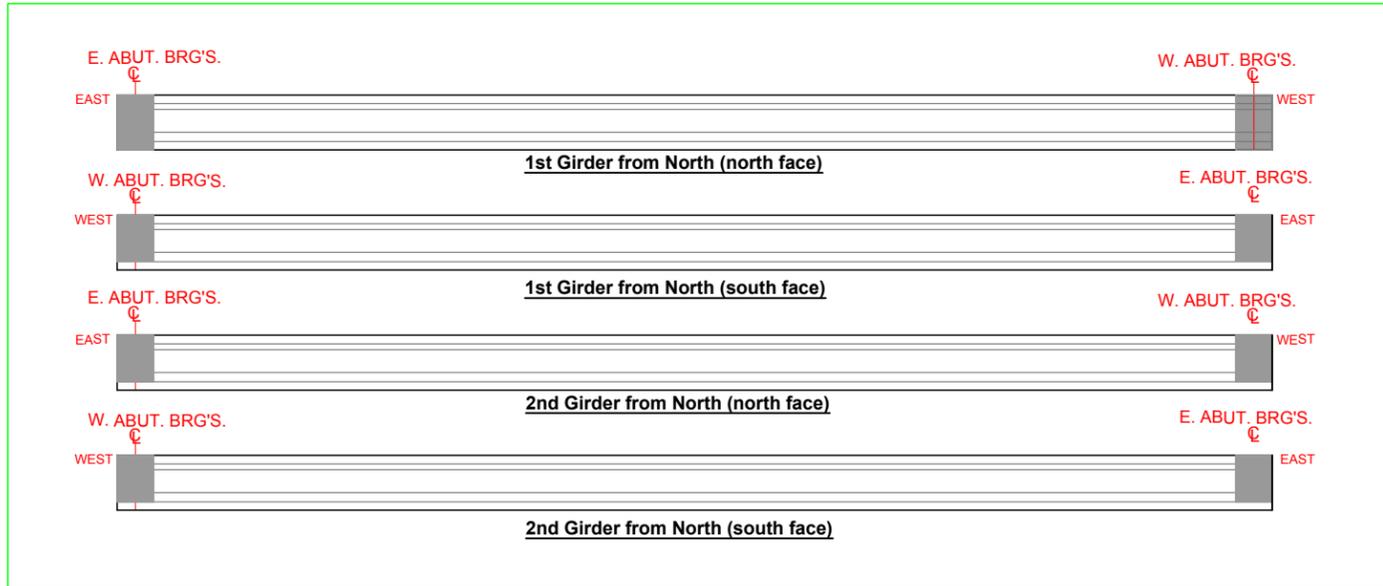
SURFACE DETERIORATION OF SOFFIT AND GIRDERS

The visual inspection of deck soffit, girders, and diaphragms was carried out and deteriorations were recorded. Drawing 4 and Photos P9 to P20 show the general condition of the soffit, girders, and diaphragms.

The bridge deck soffit, with a total surveyed area of 220.50 m², was in fair-to-good condition with clean/stained medium width cracks (22.0 m), delaminations (1.35 m²), spalls (0.65 m²), honeycombing (0.20 m²), and wet areas (1.70 m²).

The concrete I girders, with a total surveyed area of 291.00 m², were in fair-to-good condition with clean medium width cracks (6.0 m), delaminations (0.10 m²), spalls (0.15 m²) and wet areas (0.10 m²).

The diaphragms, with a total surveyed area of 61.00 m², were in fair condition with clean medium width cracks (4.0 m), delaminations (0.75 m²), and honeycombing (0.35 m²).
