**BURNSIDE**

## **2025 OSIM Bridge Inspections Report**

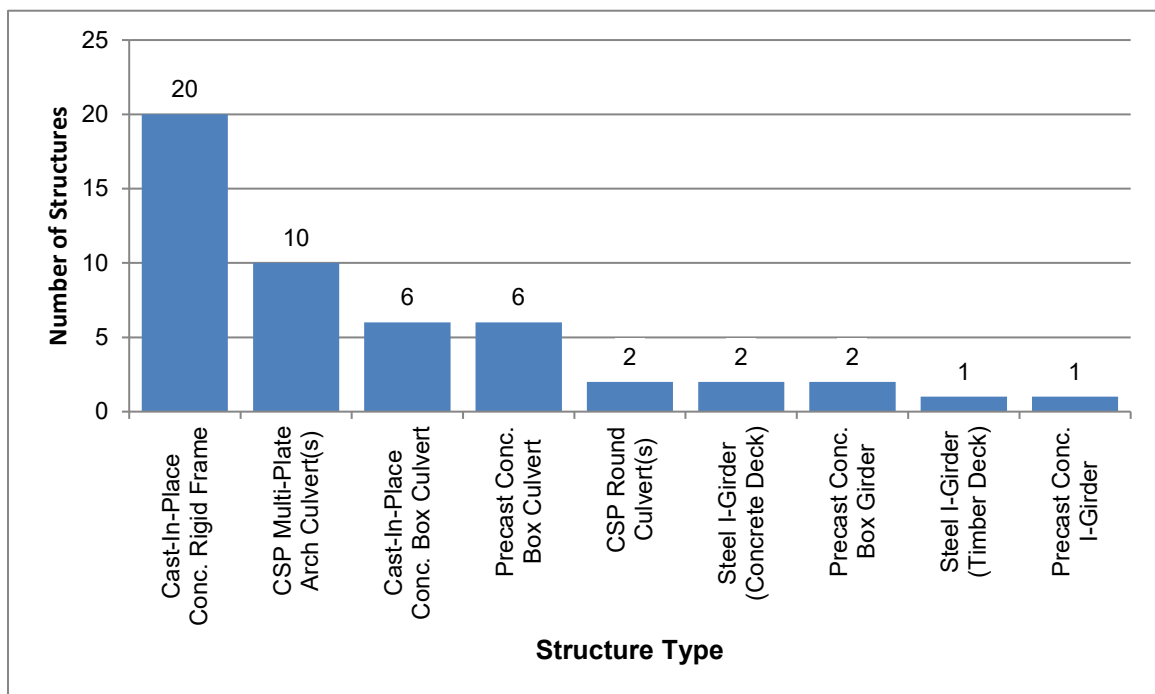
Depending on the condition of each structure, some level of remedial action is usually required. The recommendations for remedial work are provided in three classifications: routine maintenance, additional investigations, and repair, rehabilitation or replacement.

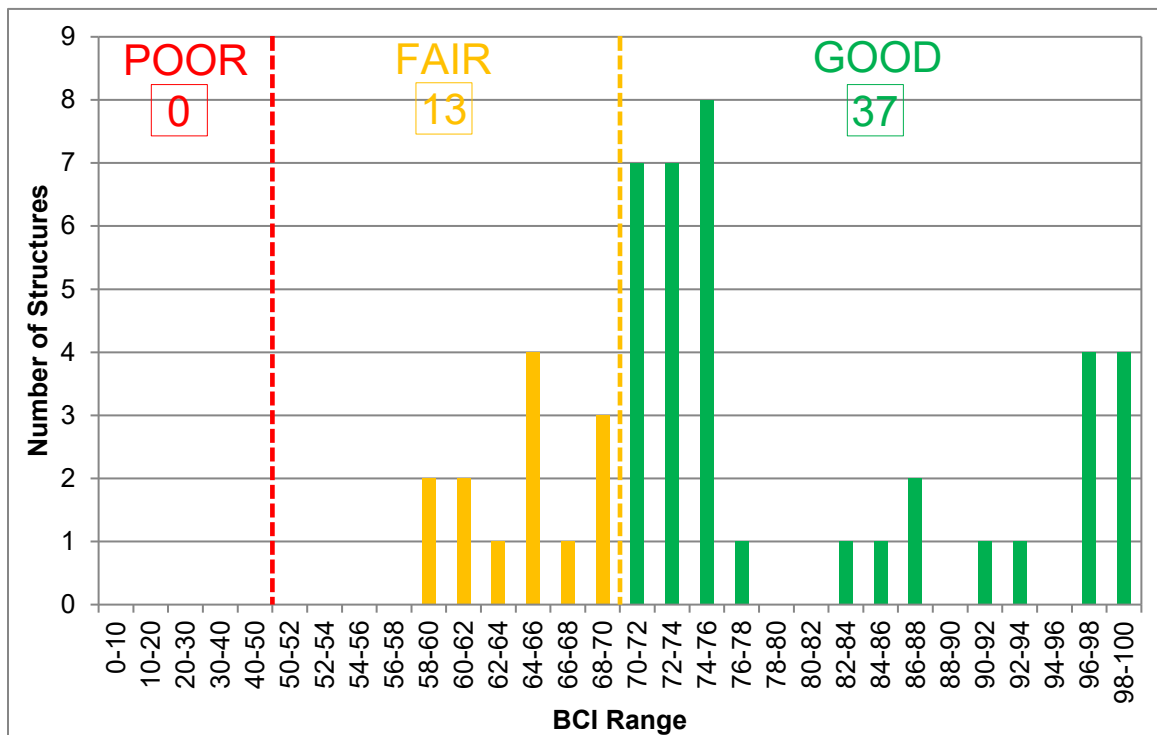
**Figure 3: Bridge Condition Index Historical Trend**

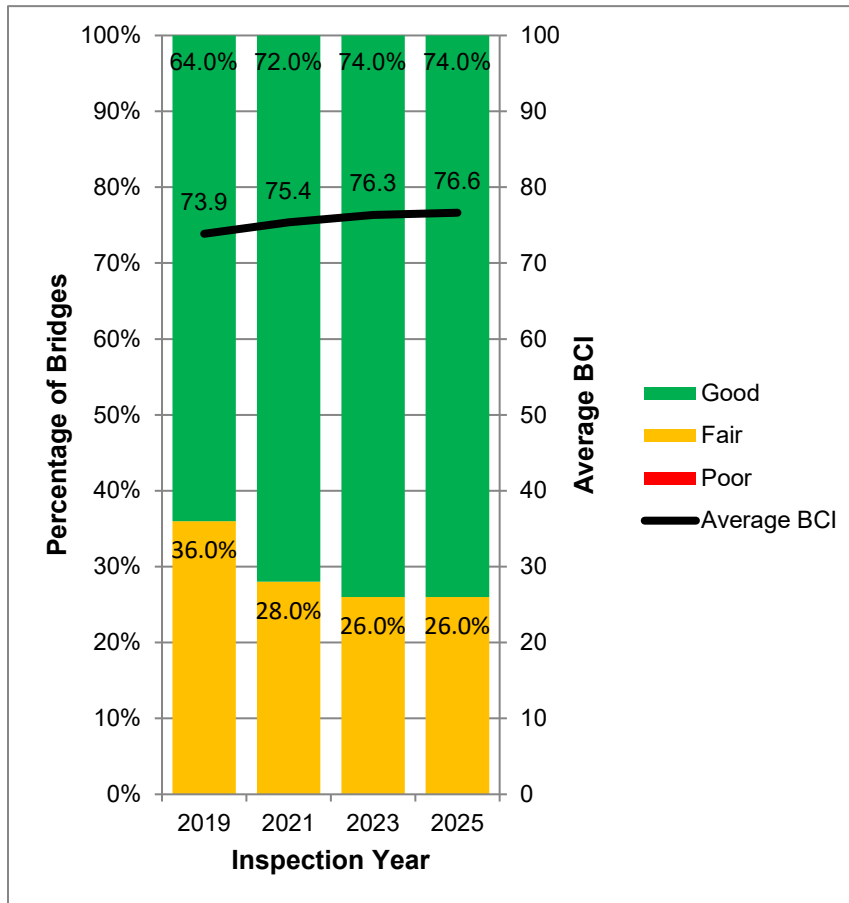
Currently, only approximately 74.0% of the Municipality’s structures are within the “good” range, with 26.0% of the structures classified as “fair” and 0% classified as “poor”, as illustrated in Figure 3 above. Of interest, the MTO has established a goal of maintaining 85% of their structures in “good” condition (BCI  $\geq$  70) by addressing rehabilitations and replacements as necessary. Burnside recognizes that the above goal was not established by the Township, but it is noted that, based on the current state of the inspected structures, the Township is underperforming on the management of their bridge assets when compared to the MTO’s established goal, however for a smaller municipality, in relative terms the Township is performing well on the management of their bridge assets.

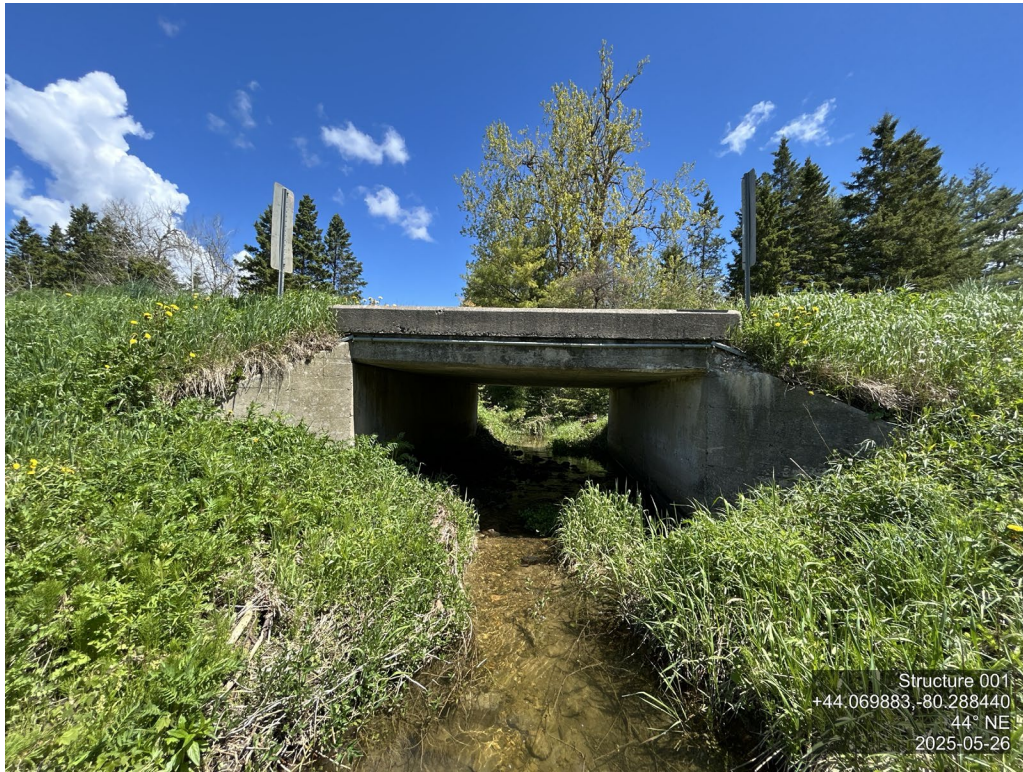
Structure 001  
+44.069883, -80.288440  
.44° NE  
2025-05-26

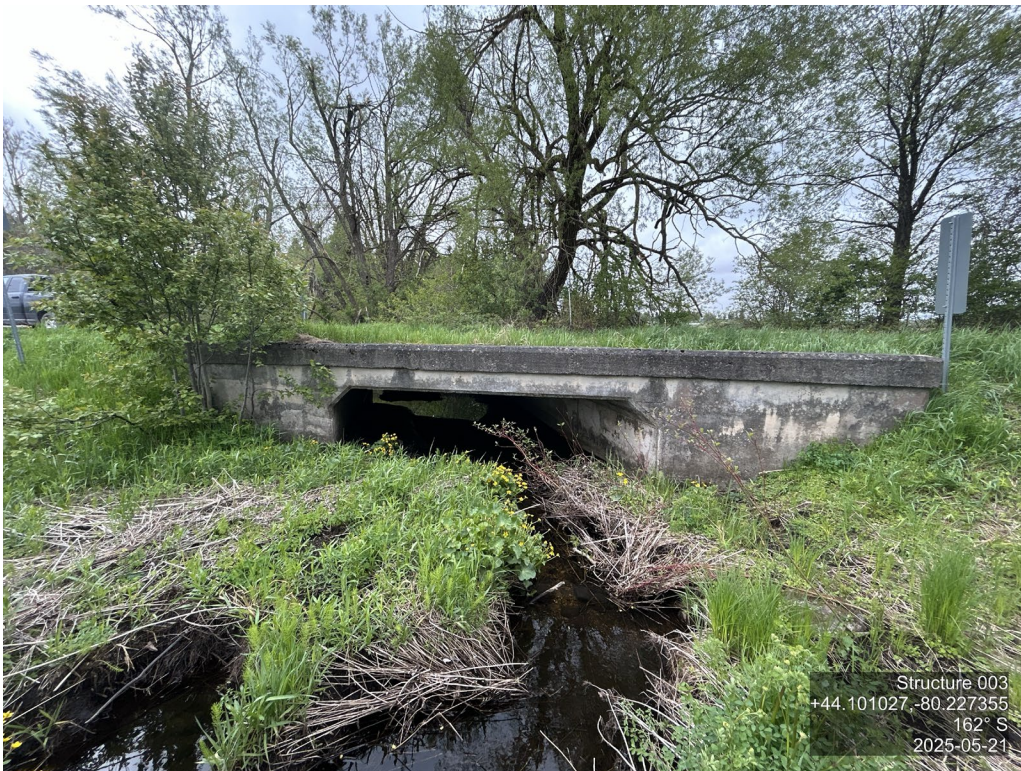
Structure 003  
+44.101027, -80.227355  
162° S  
2025-05-21

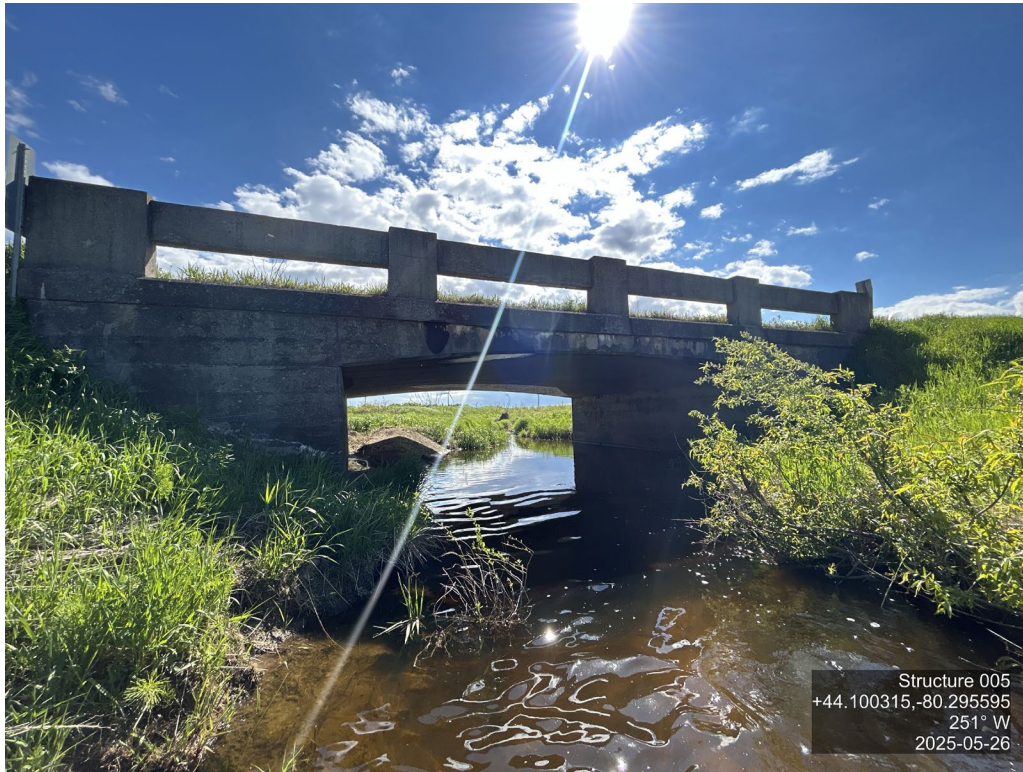
Structure 005  
+44.100315,-80.295595  
-251° W  
2025-05-26

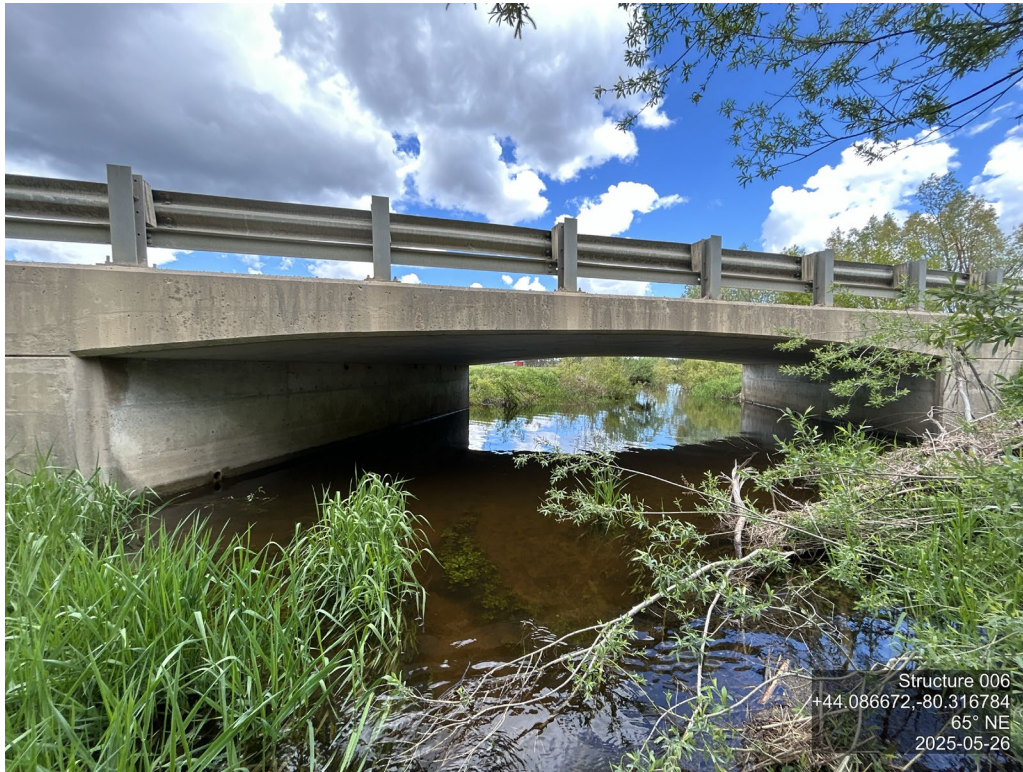
Structure 006  
+44.086672,-80.316784  
65° NE  
2025-05-26

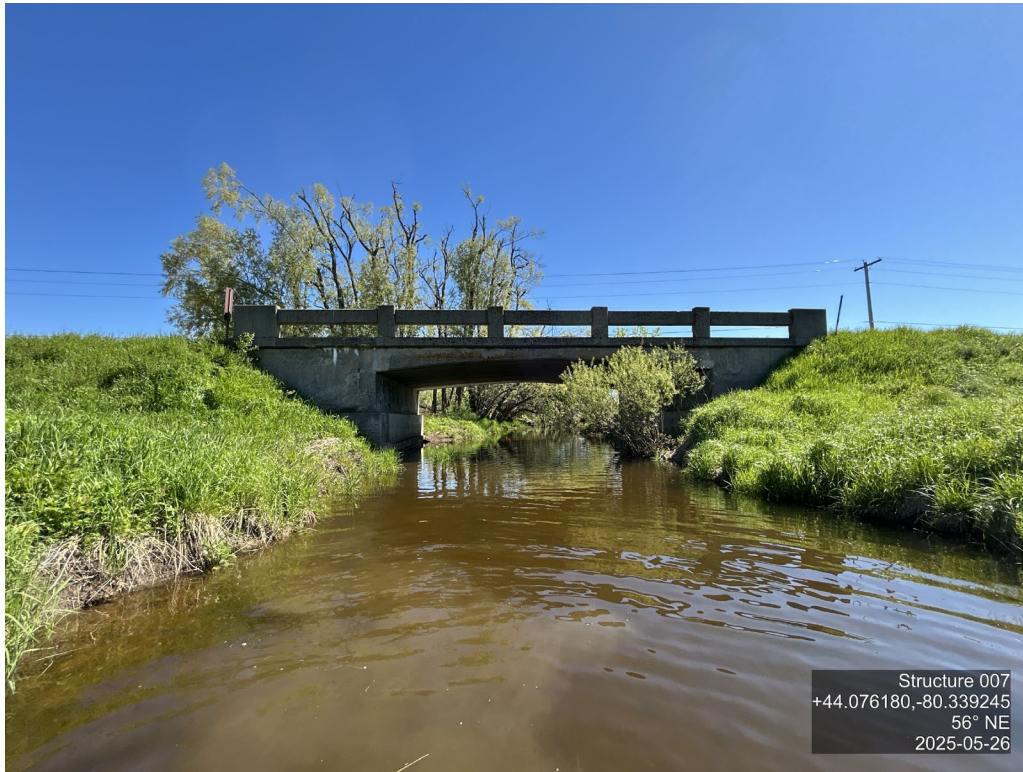
Structure 007  
+44.076180, -80.339245  
56° NE  
2025-05-26

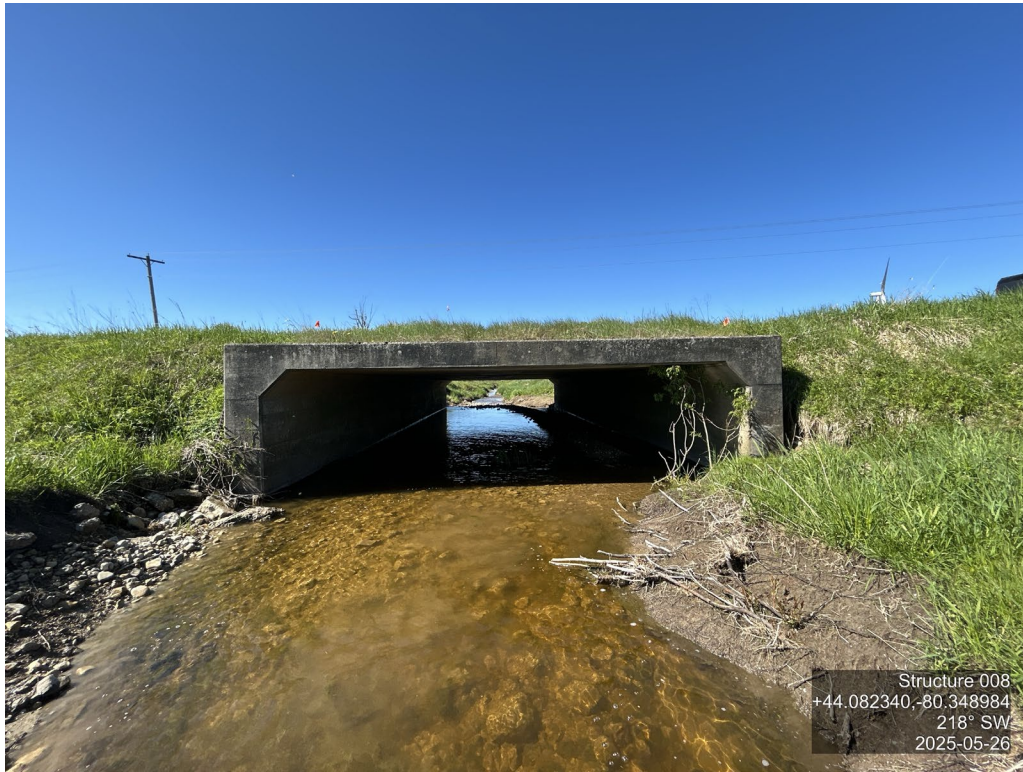
Structure 008  
+44.082340, -80.348984  
218° SW  
2025-05-26

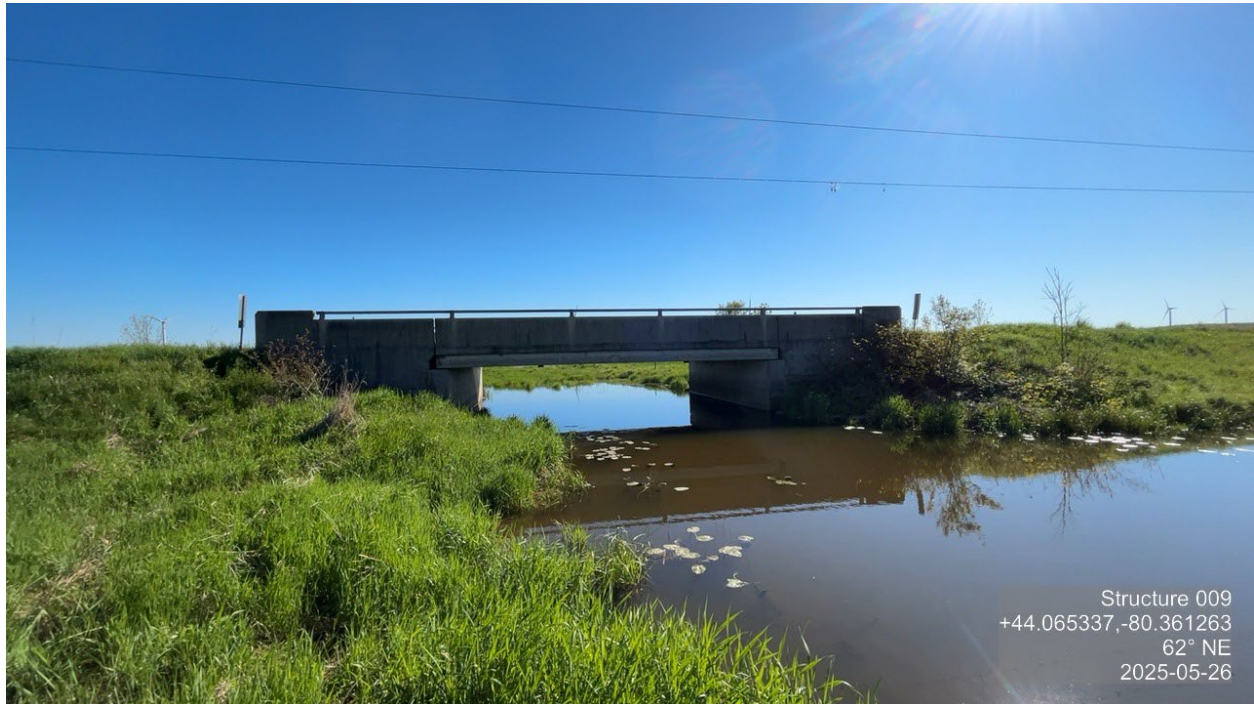
Structure 009  
+44.065337,-80.361263  
62° NE  
2025-05-26

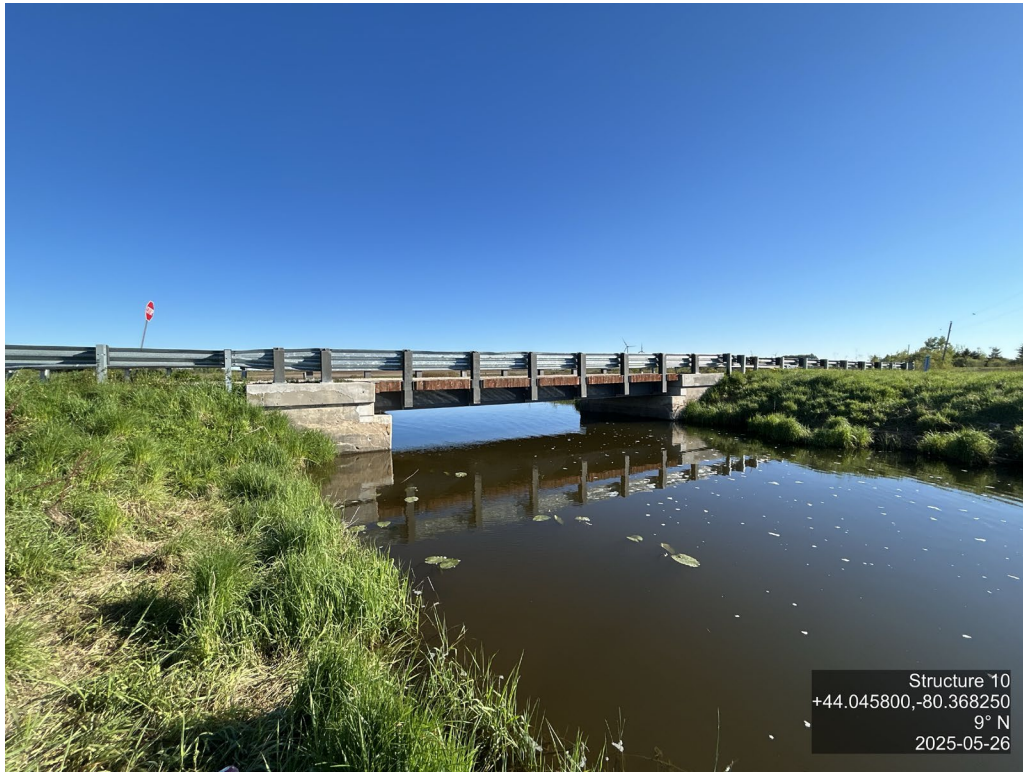
Structure 10  
+44.045800,-80.368250  
9° N  
2025-05-26

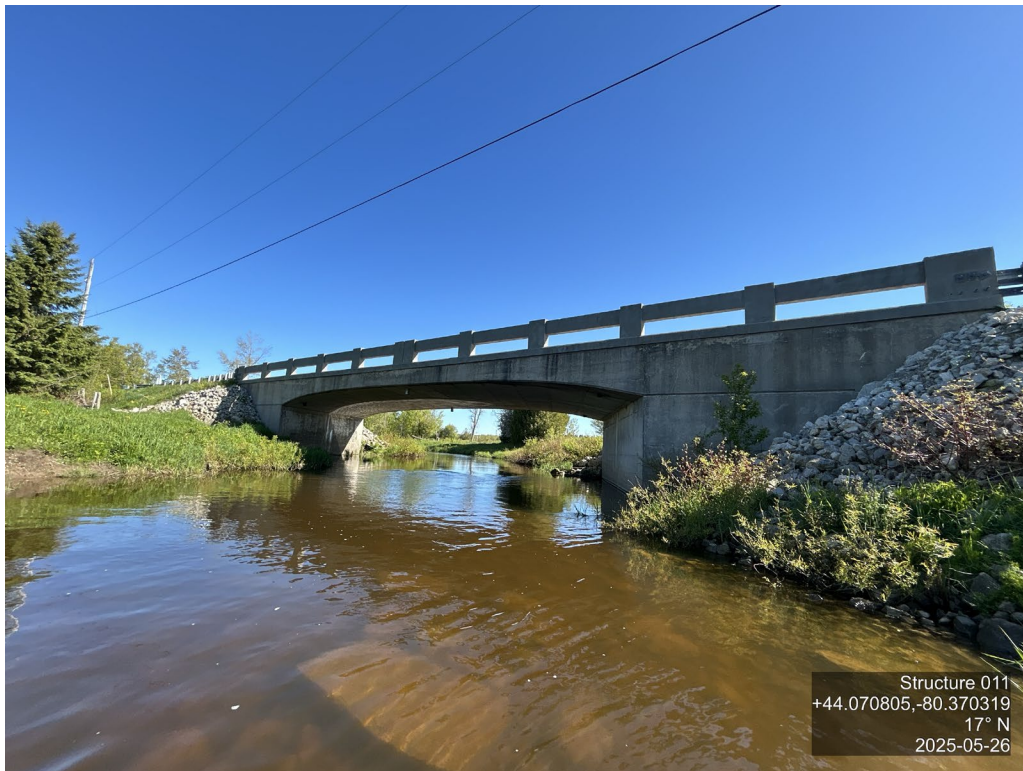
Rehabilitation	Replacement
<b>Estimated Capital Works Timelines (Years):</b>	8.8	19.1

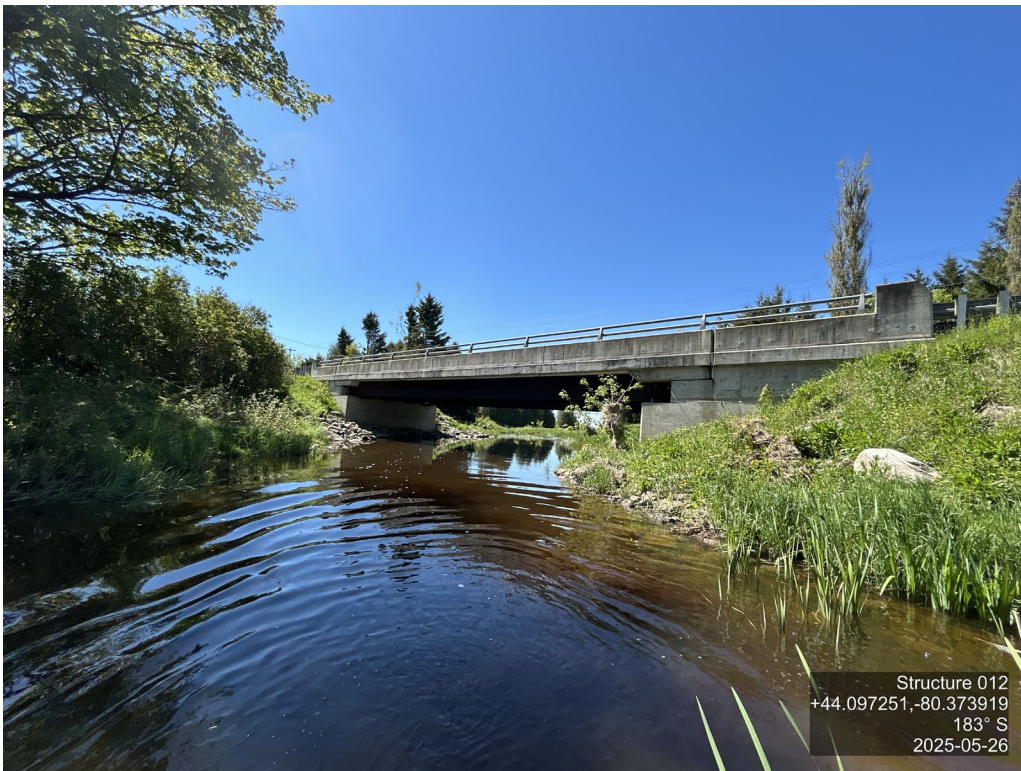
Structure 012  
+44.097251,-80.373919  
183° S  
2025-05-26

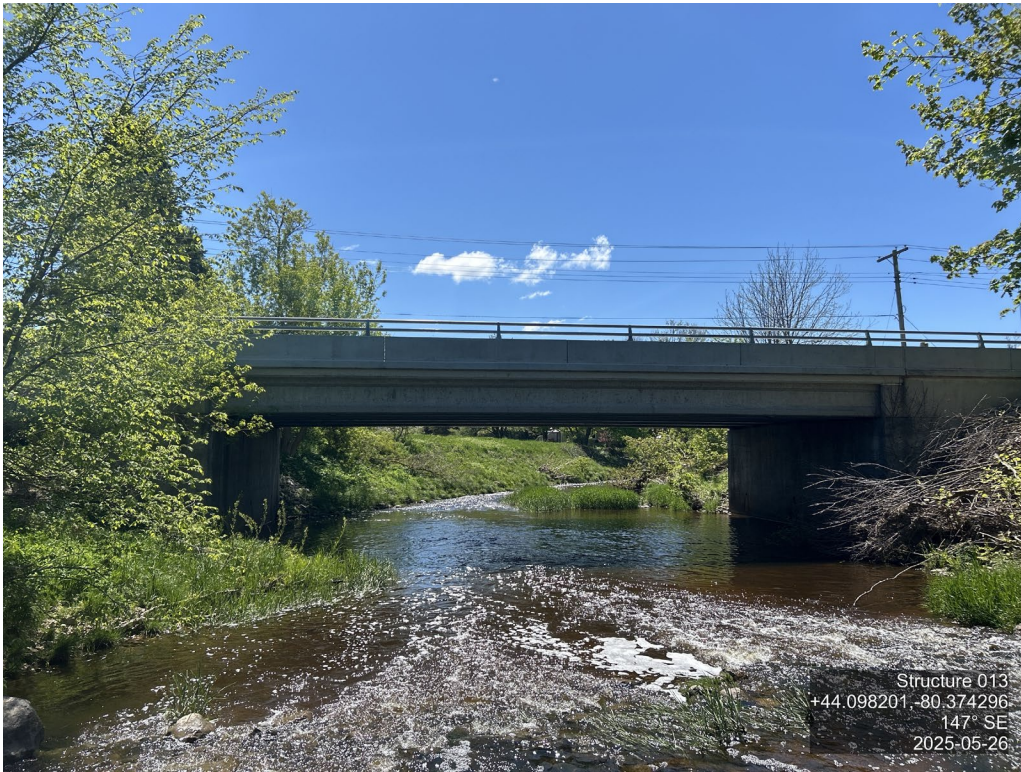
<b>Rehabilitation</b>	<b>Replacement</b>
<b>Estimated Capital Works Timelines (Years):</b>	N/A	30.9

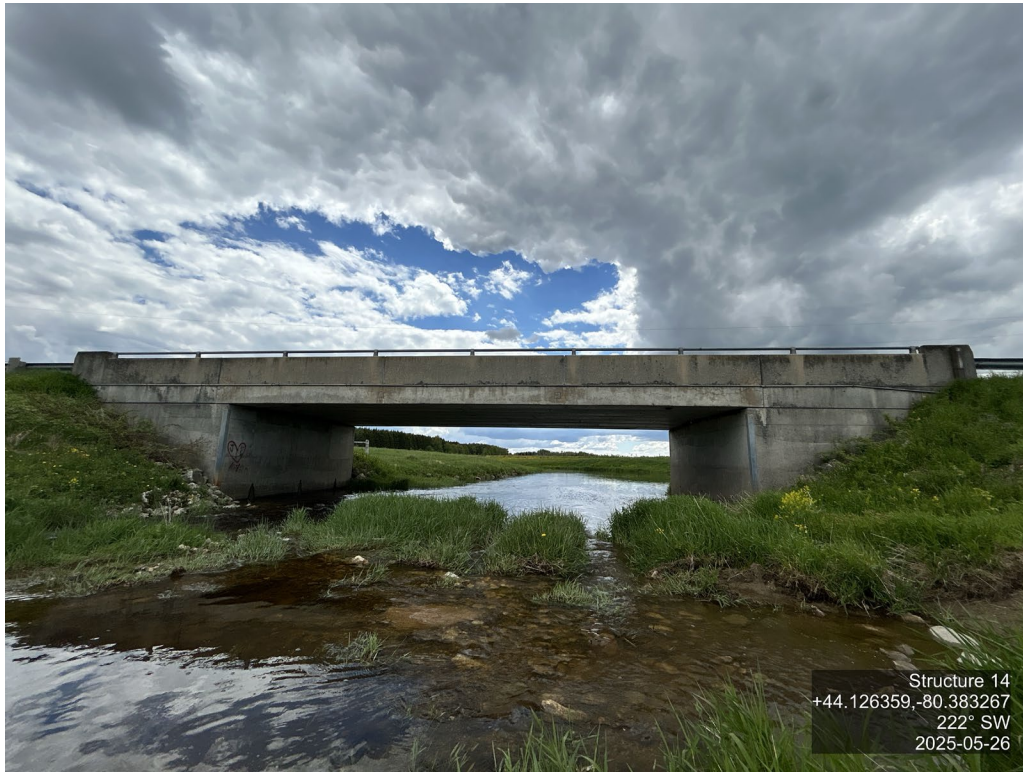
Structure 14  
+44.126359, -80.383267  
222° SW  
2025-05-26

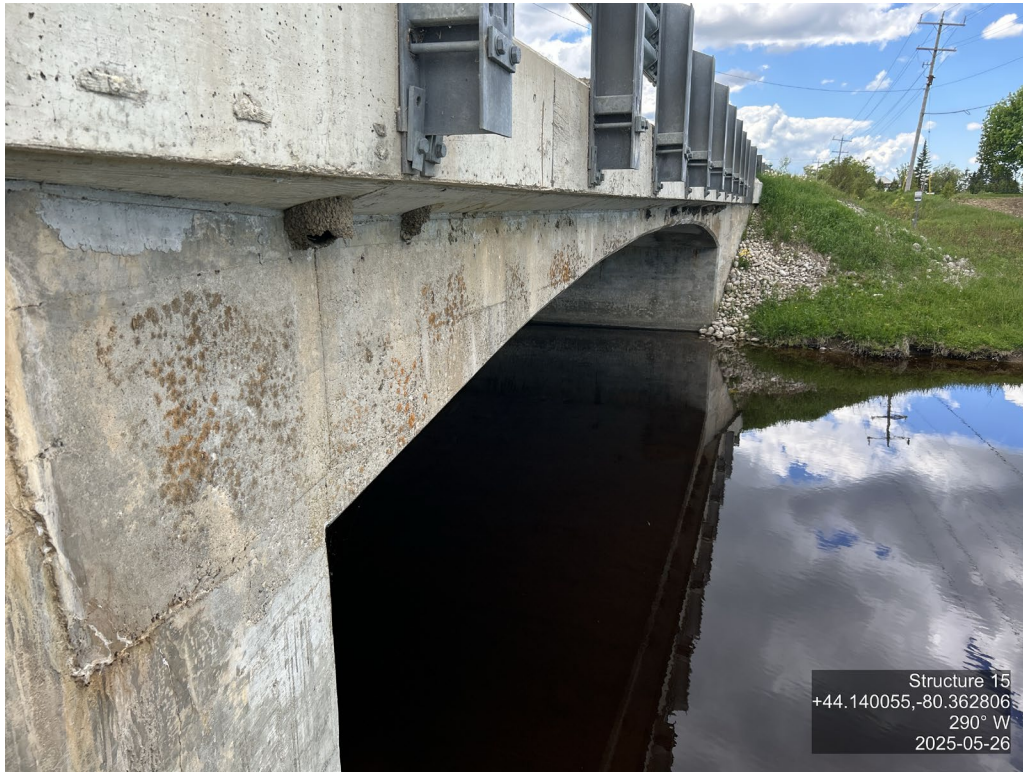
<b>Rehabilitation</b>	<b>Replacement</b>
<b>Estimated Capital Works Timelines (Years):</b>	N/A	17.7

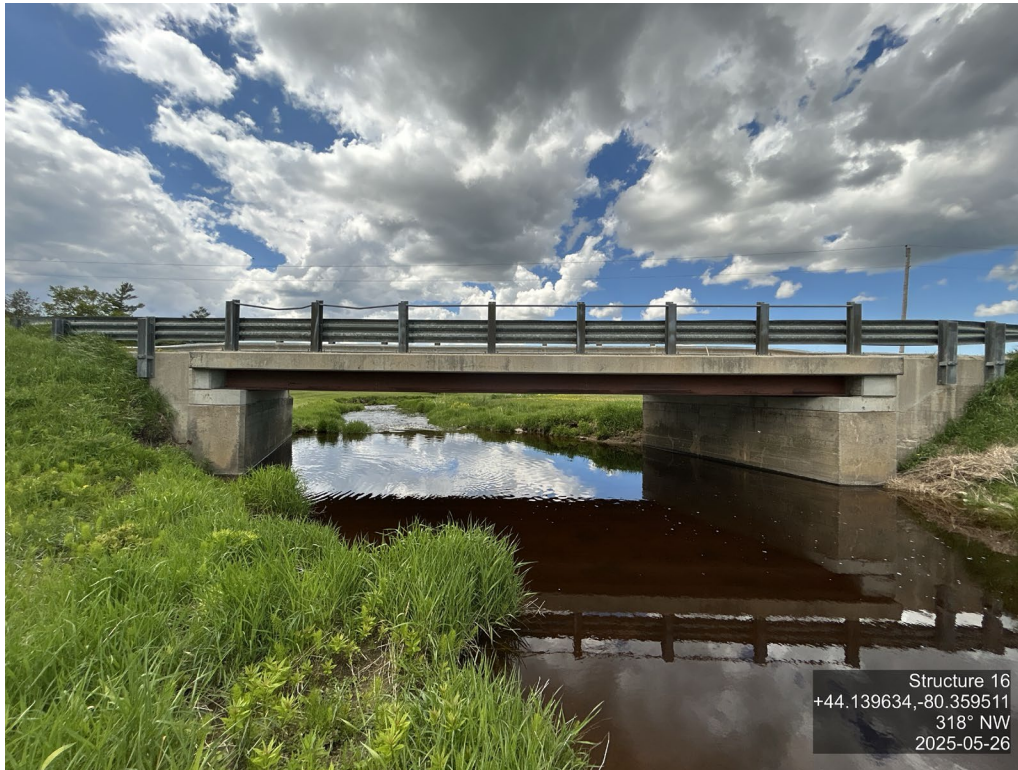
Structure 16  
+44.139634,-80.359511  
318° NW  
2025-05-26

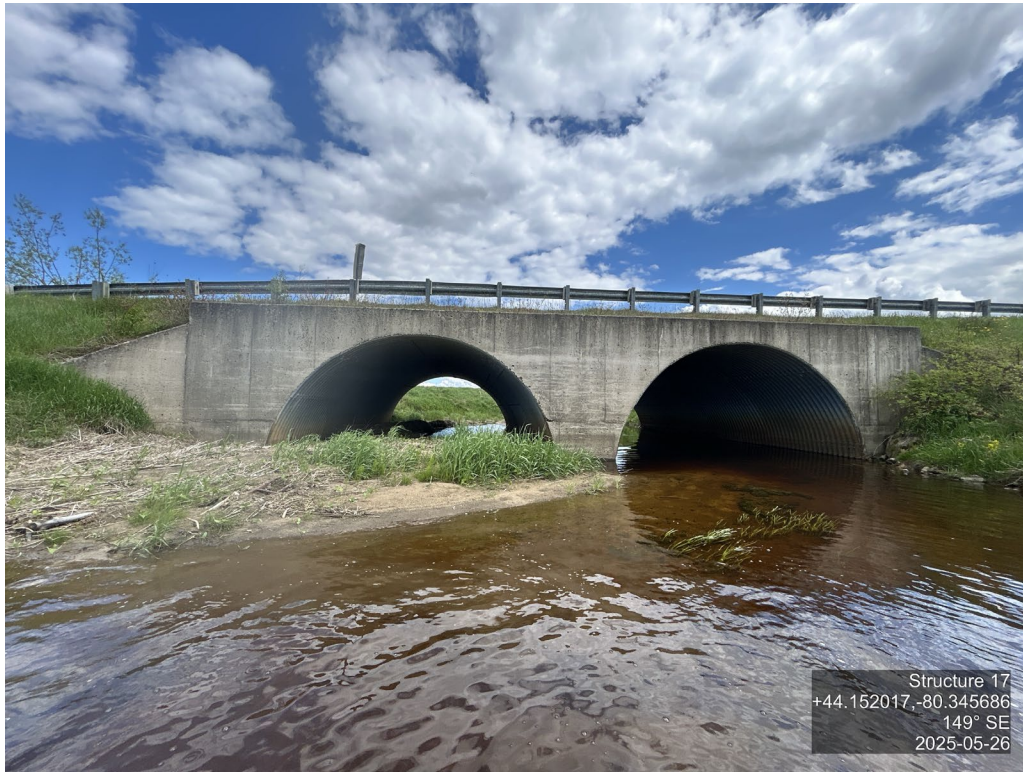
<b>Rehabilitation</b>	<b>Replacement</b>
<b>Estimated Capital Works Timelines (Years):</b>	N/A	17.6

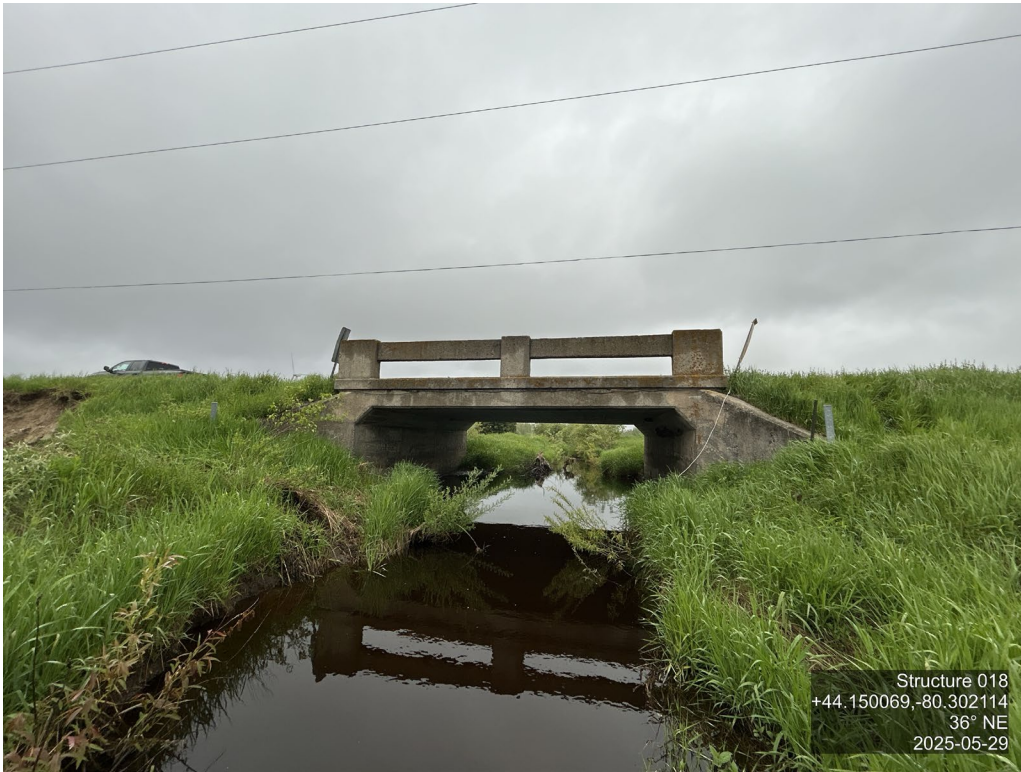
Structure 018  
+44.150069,-80.302114  
36° NE  
2025-05-29

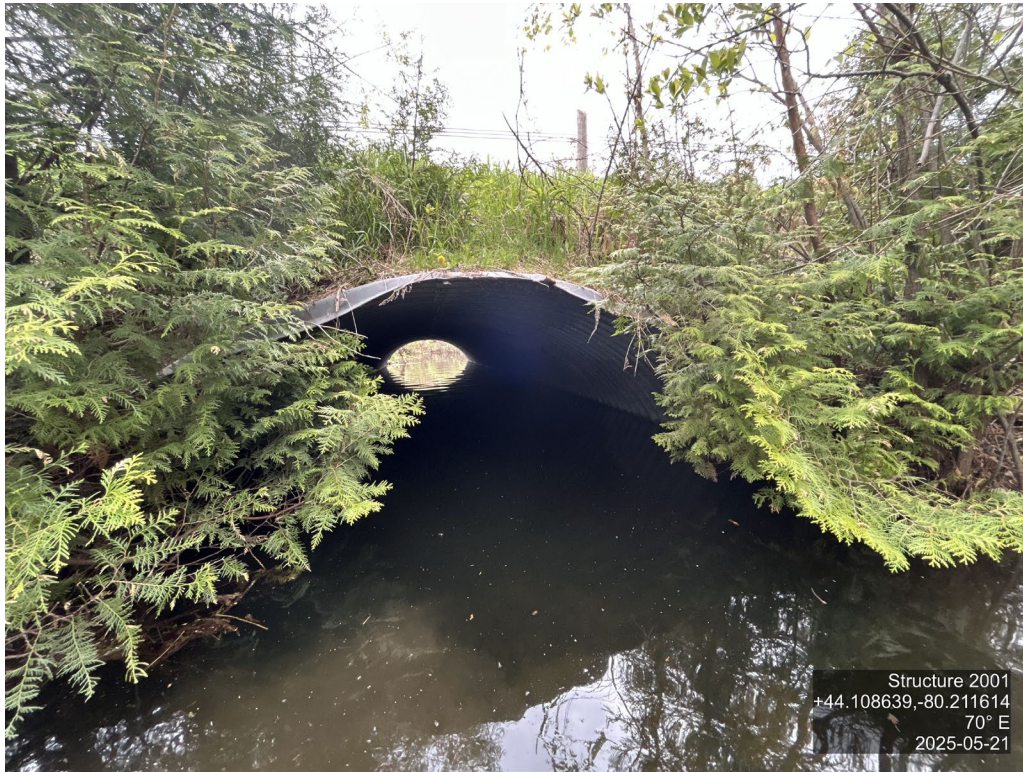
Structure 2001  
+44.108639,-80.211614  
70° E  
2025-05-21

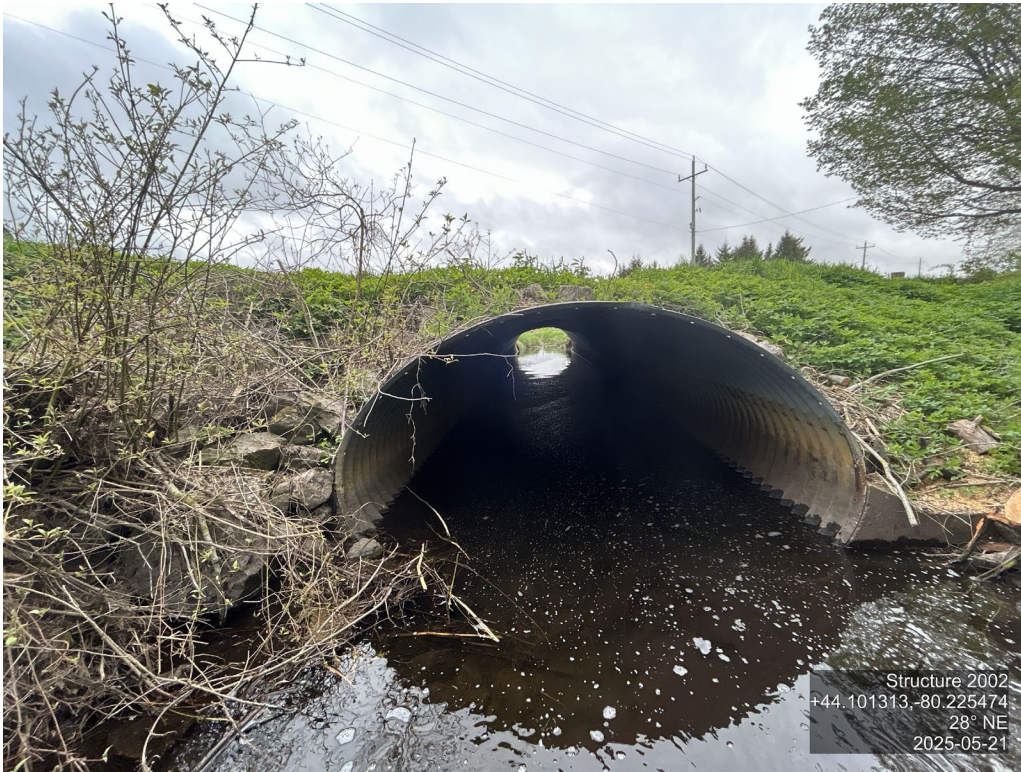
Structure 2002  
+44.101313, -80.225474  
28° NE  
2025-05-21

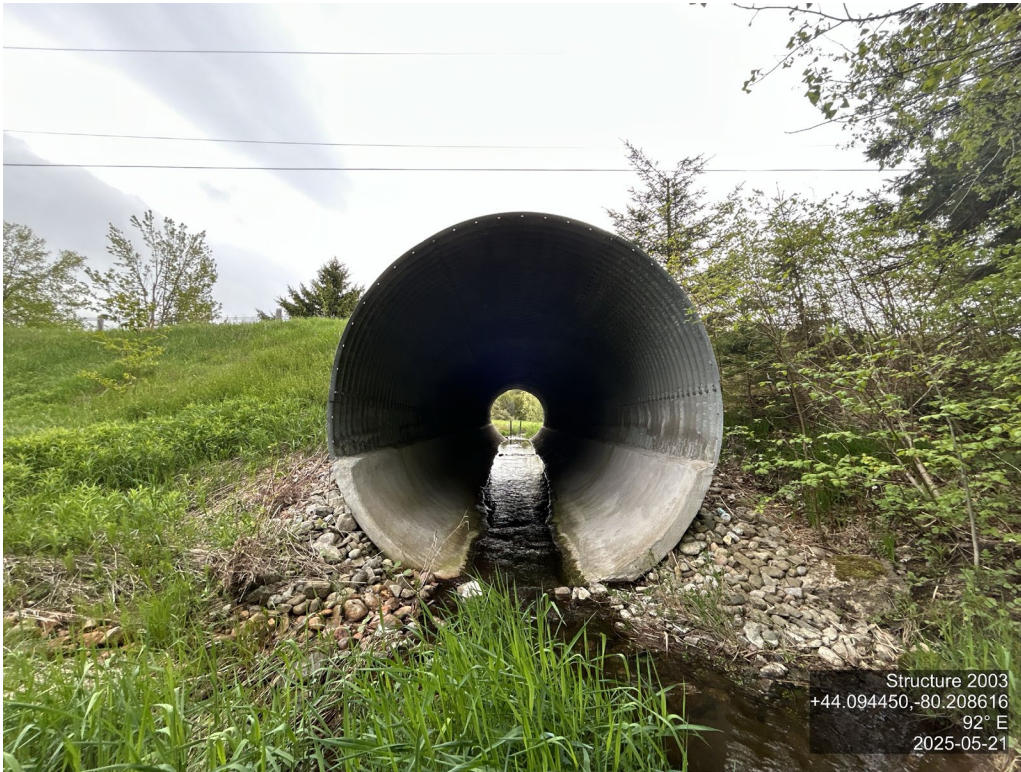
<b>Rehabilitation</b>	<b>Replacement</b>
<b>Estimated Capital Works Timelines (Years):</b>	N/A	17.7

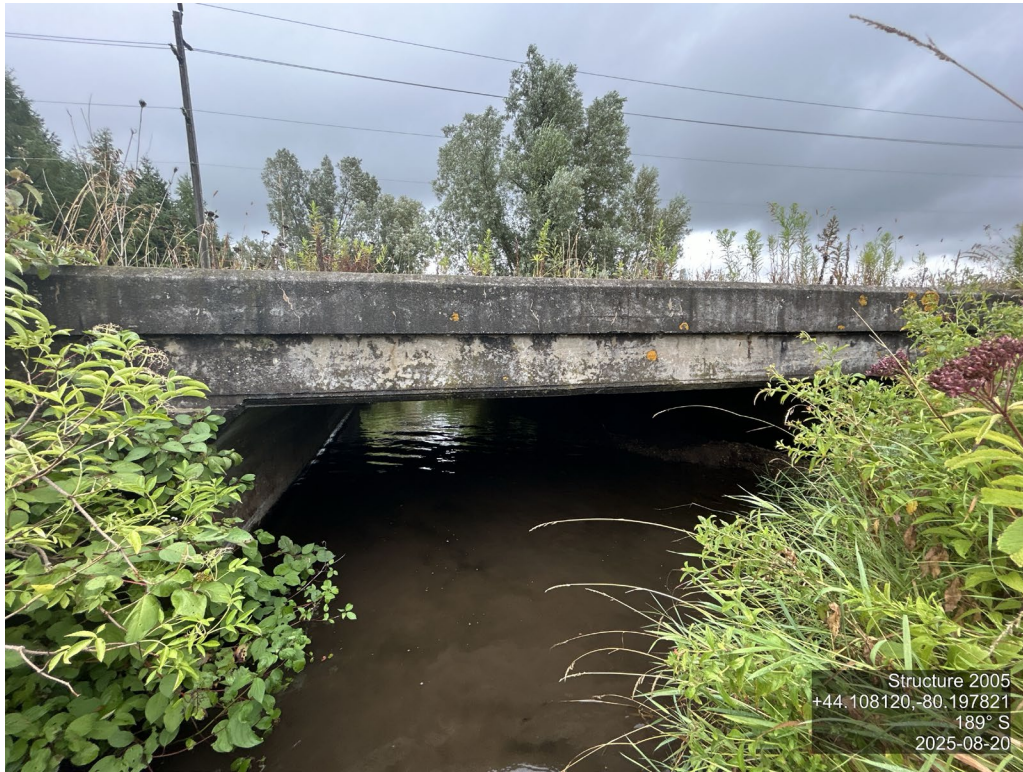
<b>Rehabilitation</b>	<b>Replacement</b>
<b>Estimated Capital Works Timelines (Years):</b>	13.8	23.8

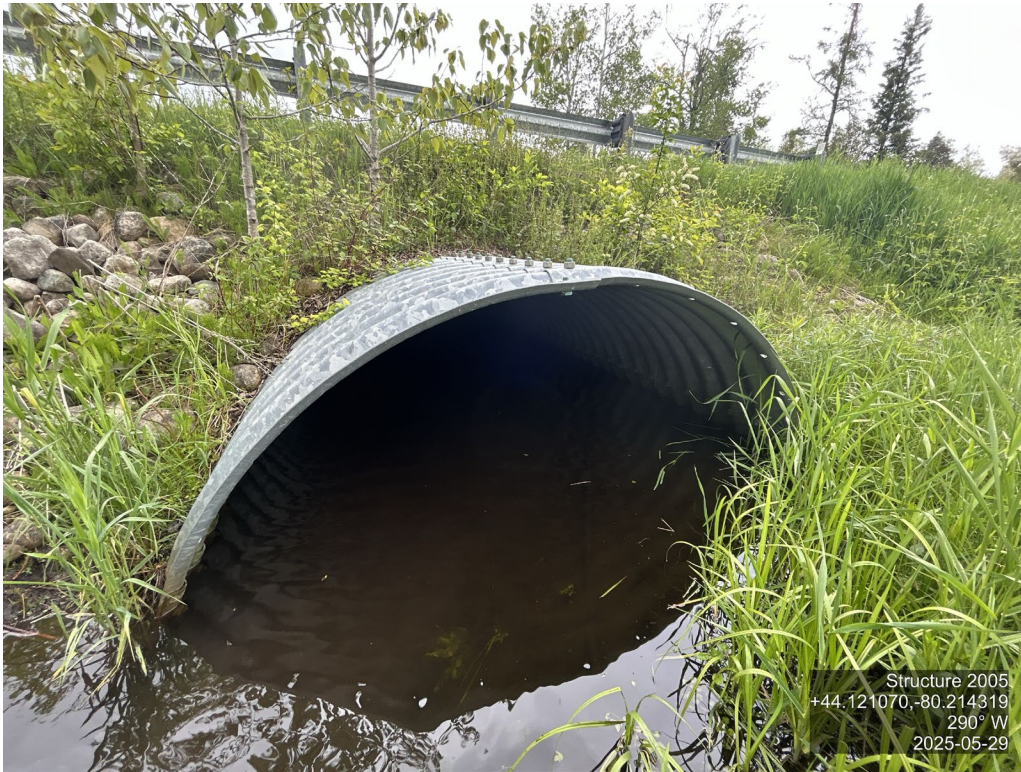
<b>Rehabilitation</b>	<b>Replacement</b>
<b>Estimated Capital Works Timelines (Years):</b>	N/A	31.4

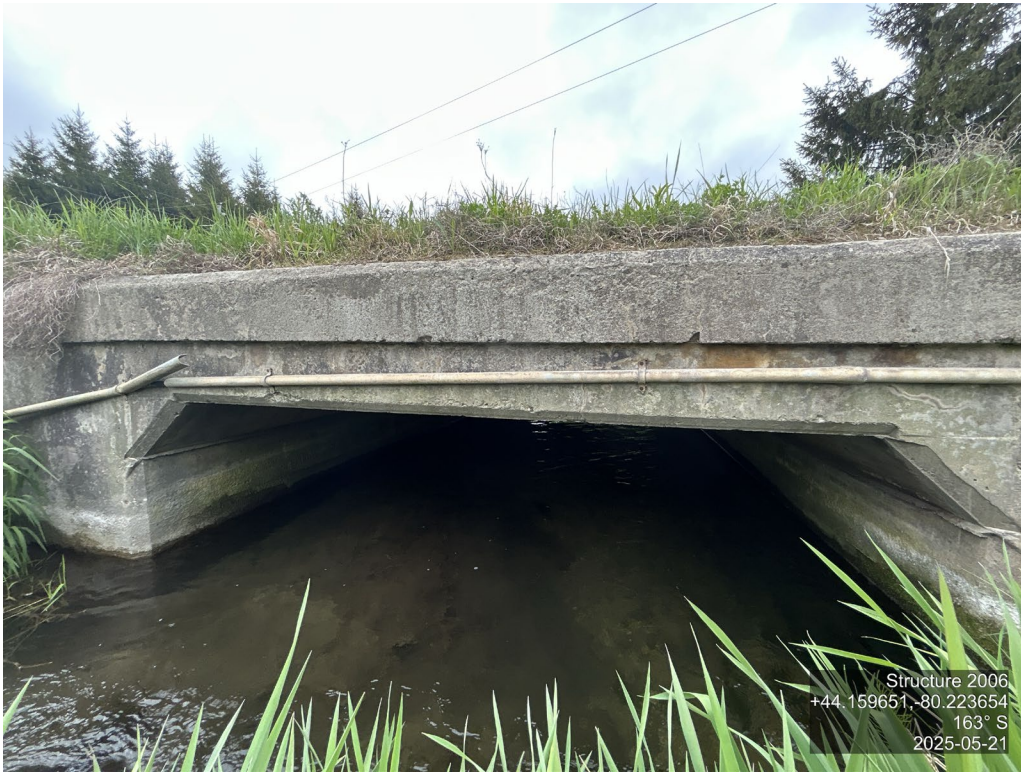
Structure 2006  
+44.159651, -80.223654  
163° S  
2025-05-21

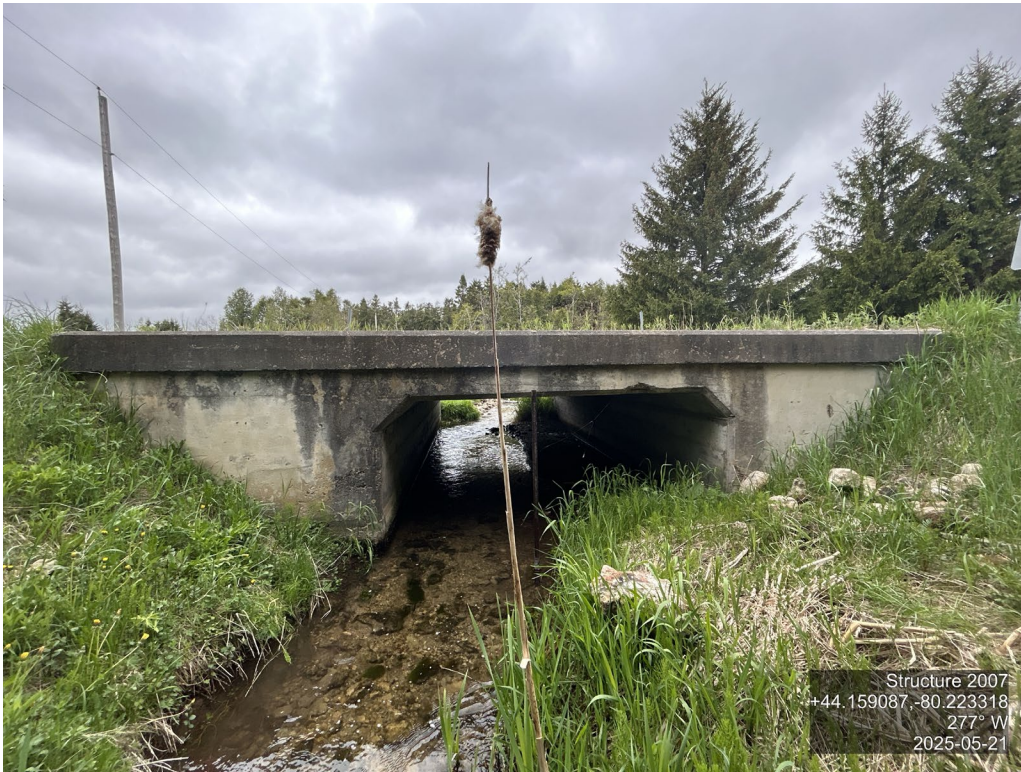
Structure 2007  
 +44.159087, -80.223318  
 277° W  
 2025-05-21

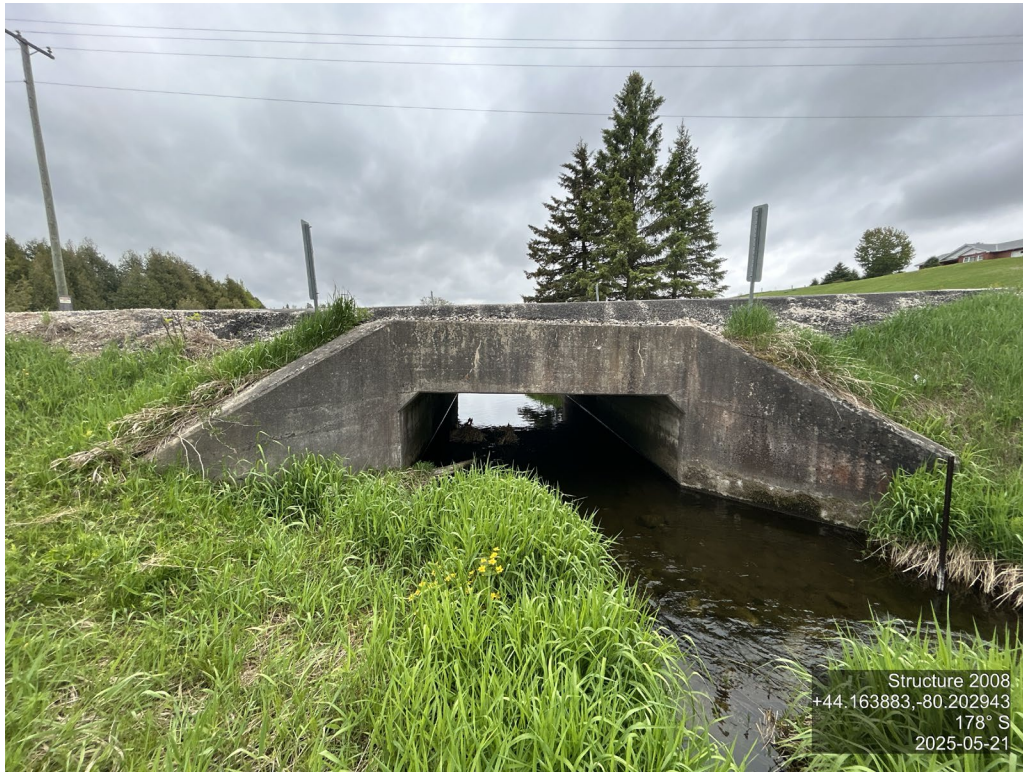
Structure 2008  
+44.163883,-80.202943  
178° S  
2025-05-21

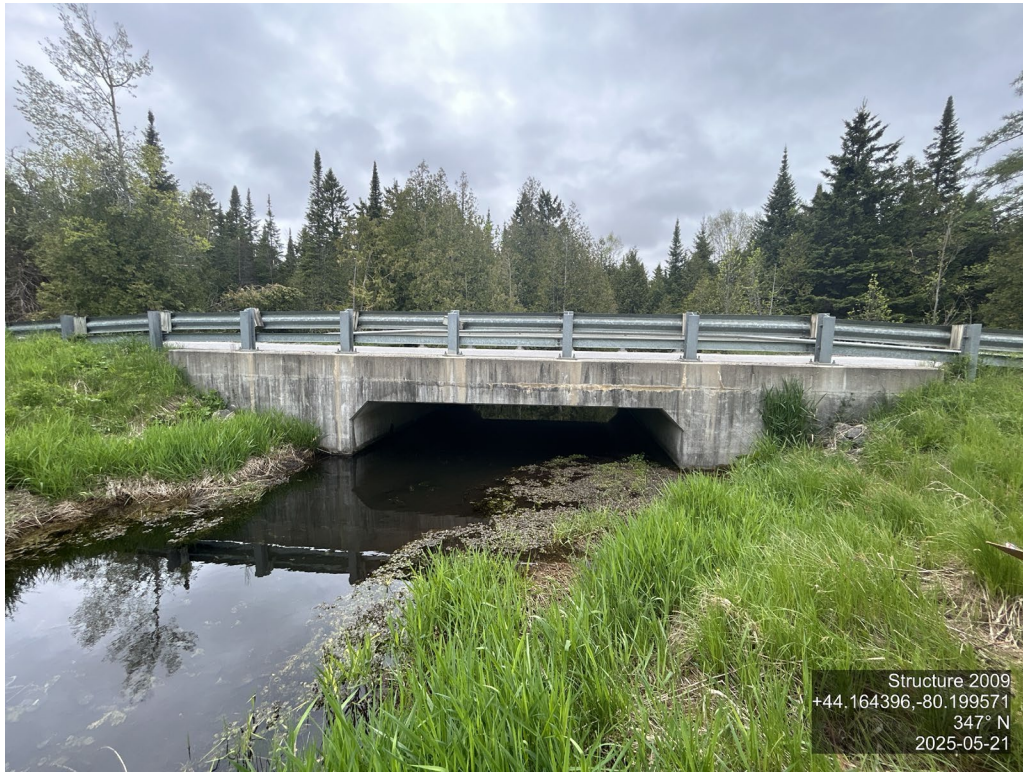
Structure 2009  
+44.164396, -80.199571  
347° N  
2025-05-21
