**BURNSIDE**

## **2025 OSIM Bridge Inspections Report**

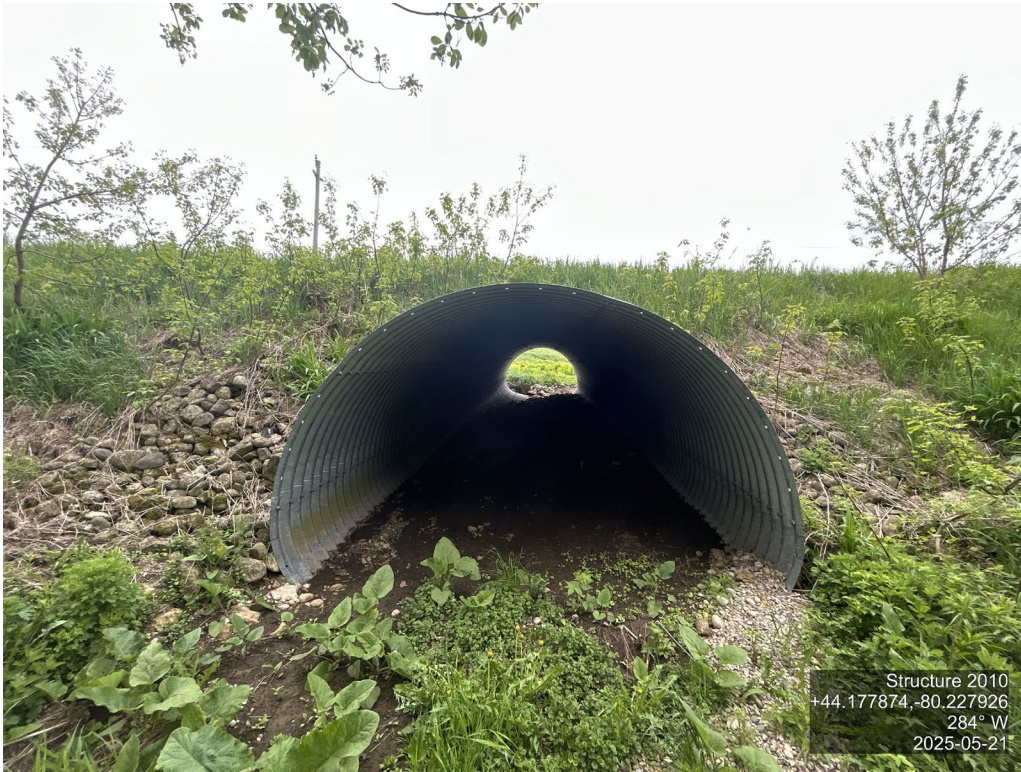
<b>Rehabilitation</b>	<b>Replacement</b>
<b>Estimated Capital Works Timelines (Years):</b>	N/A	31.6

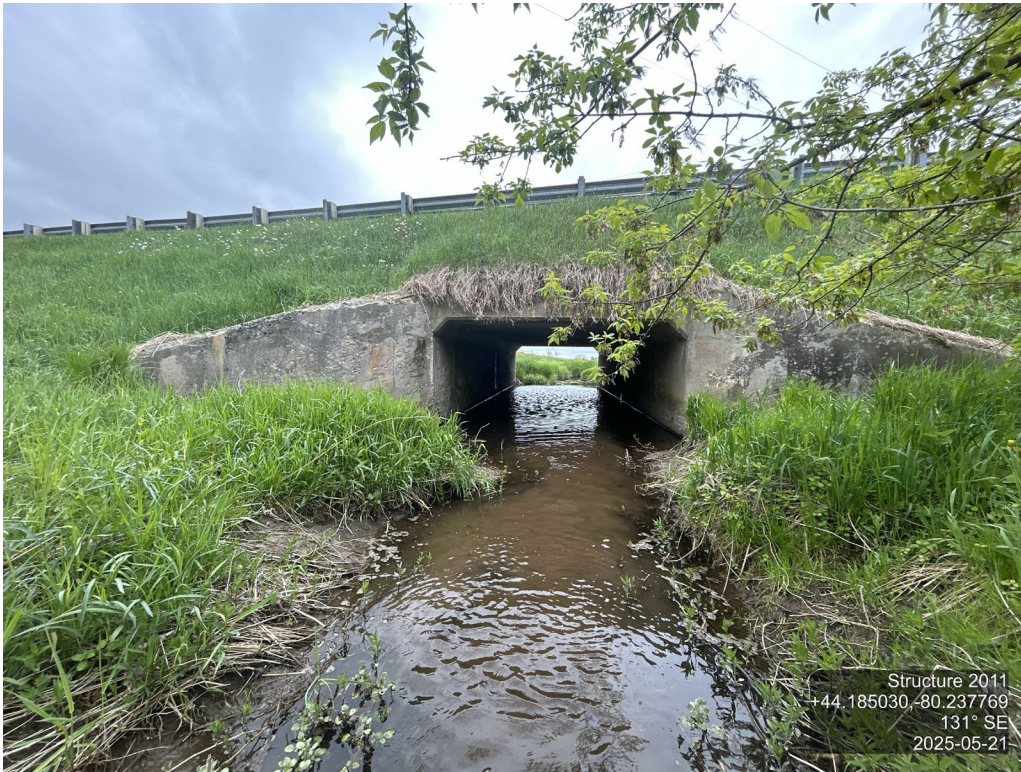
<b>Rehabilitation</b>	<b>Replacement</b>
<b>Estimated Capital Works Timelines (Years):</b>	N/A	7.5

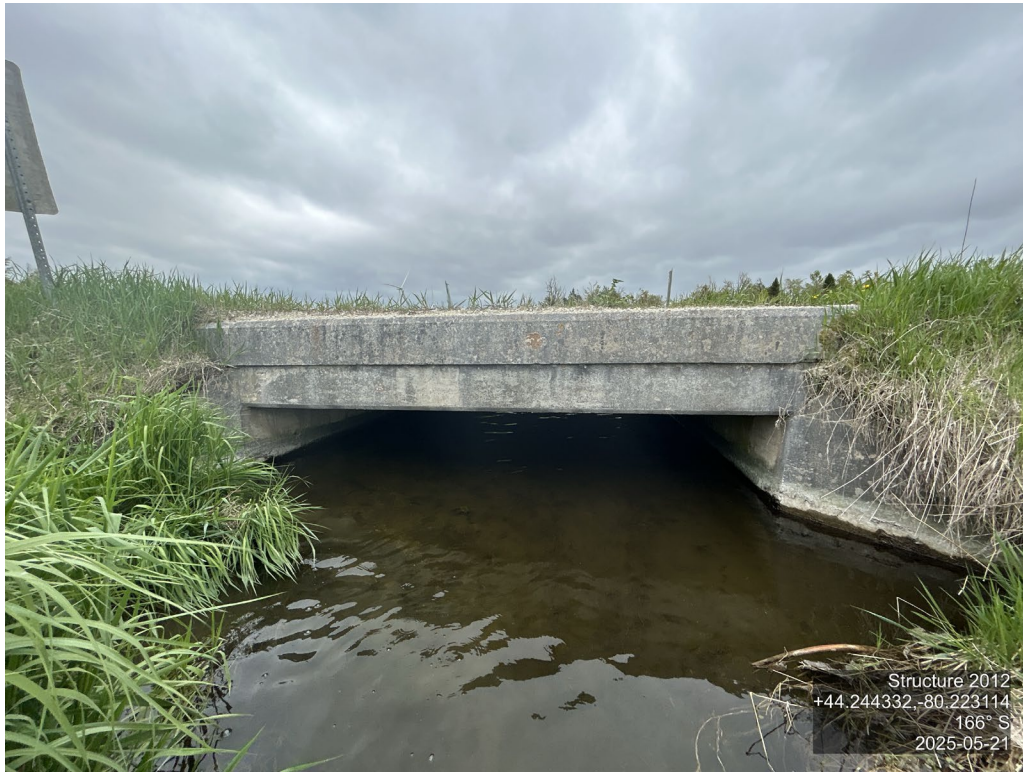
Structure 2012  
+44.244332, -80.223114  
166° S  
2025-05-21

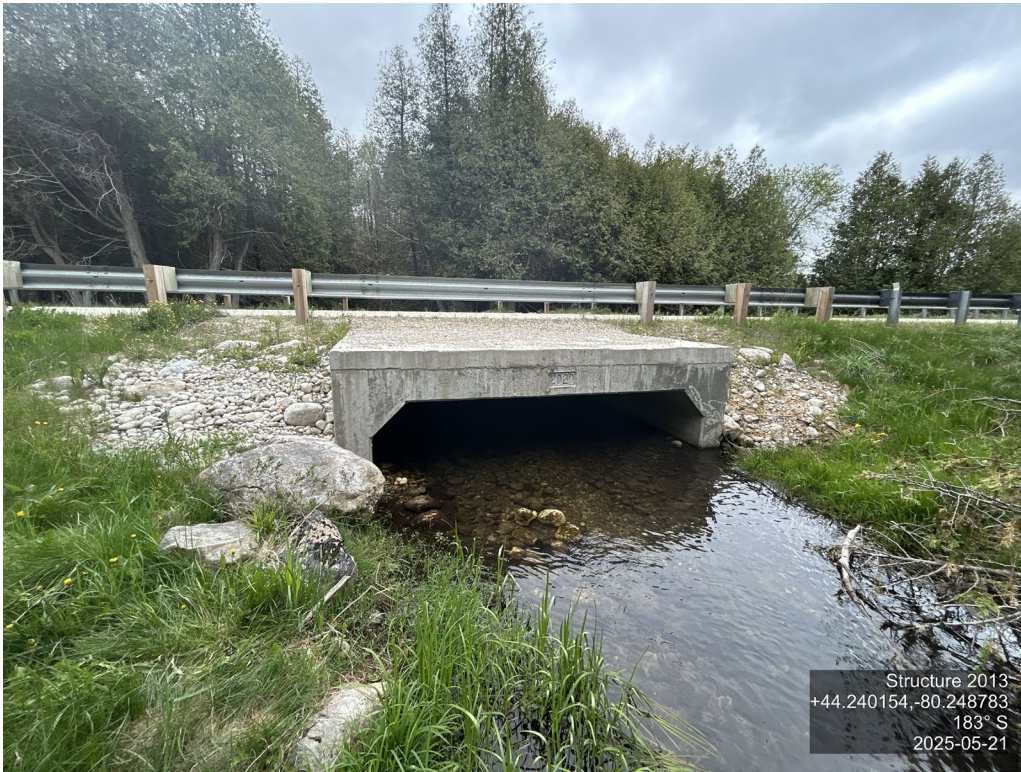
Structure 2013  
+44.240154, -80.248783  
183° S  
2025-05-21

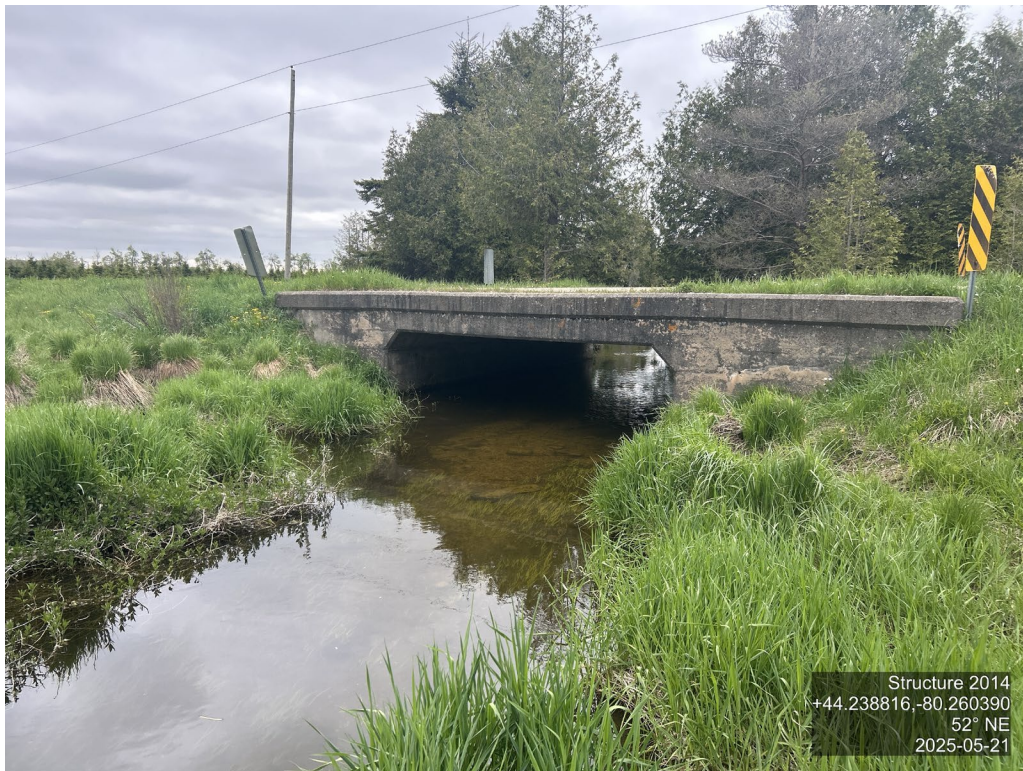
Structure 2014  
+44.238816,-80.260390  
52° NE  
2025-05-21

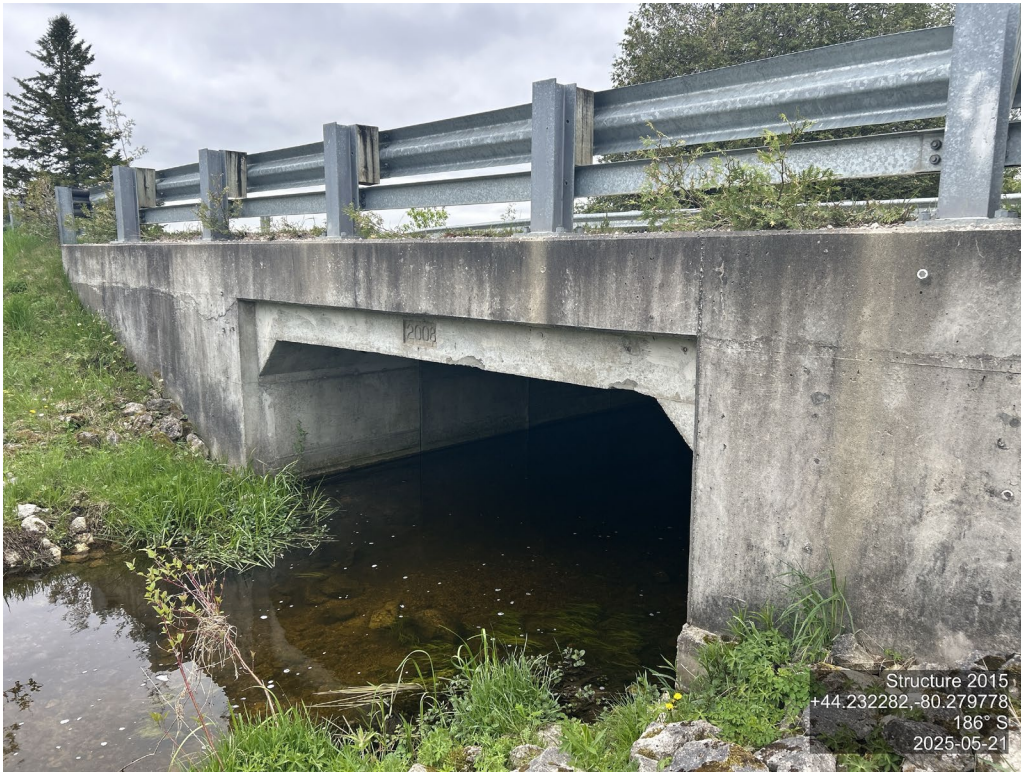
Structure 2015  
+44.232282, -80.279778  
186° S  
2025-05-21

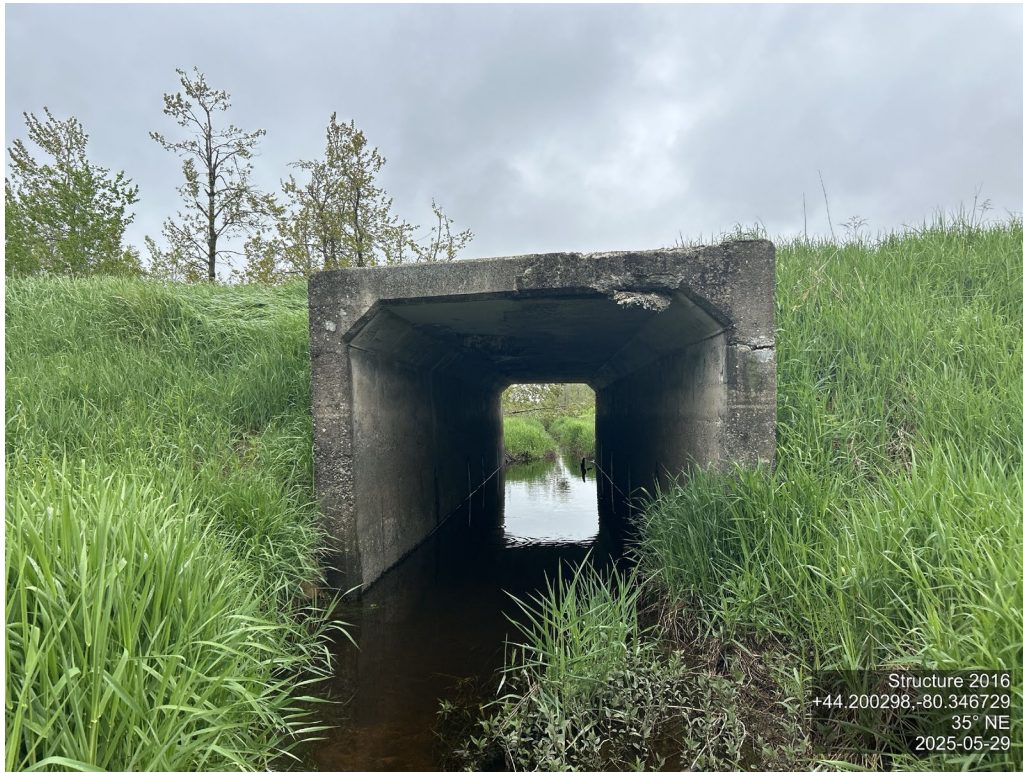
Structure 2016  
+44.200298,-80.346729  
35° NE  
2025-05-29

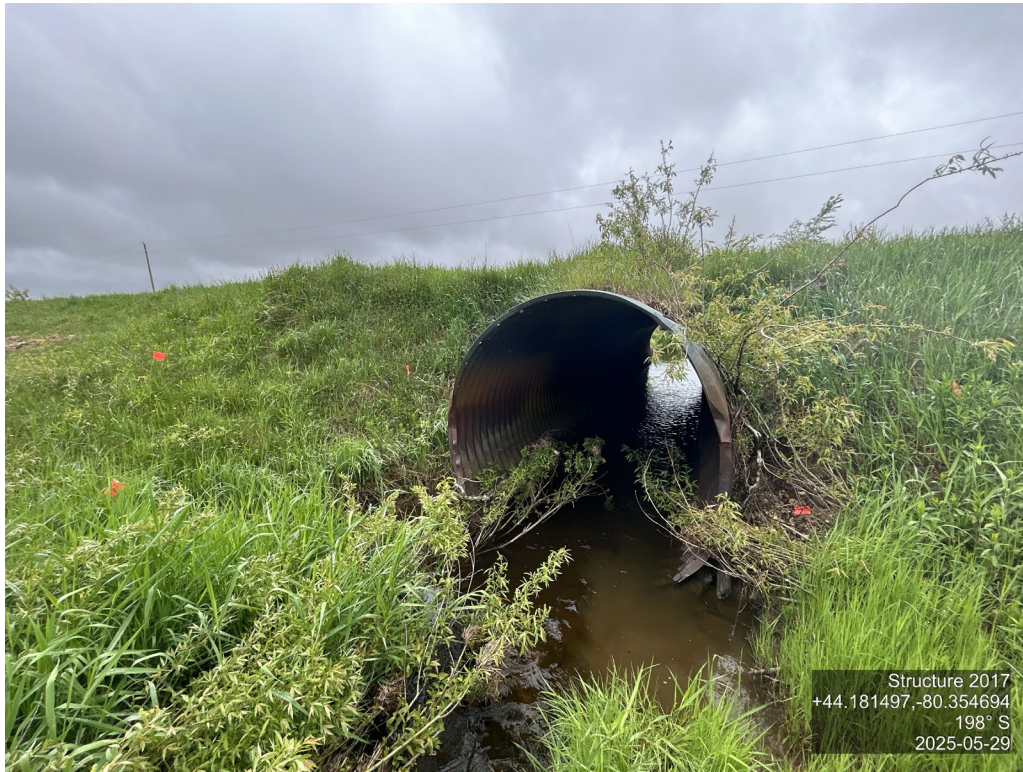
<b>Rehabilitation</b>	<b>Replacement</b>
<b>Estimated Capital Works Timelines (Years):</b>	N/A	9.5

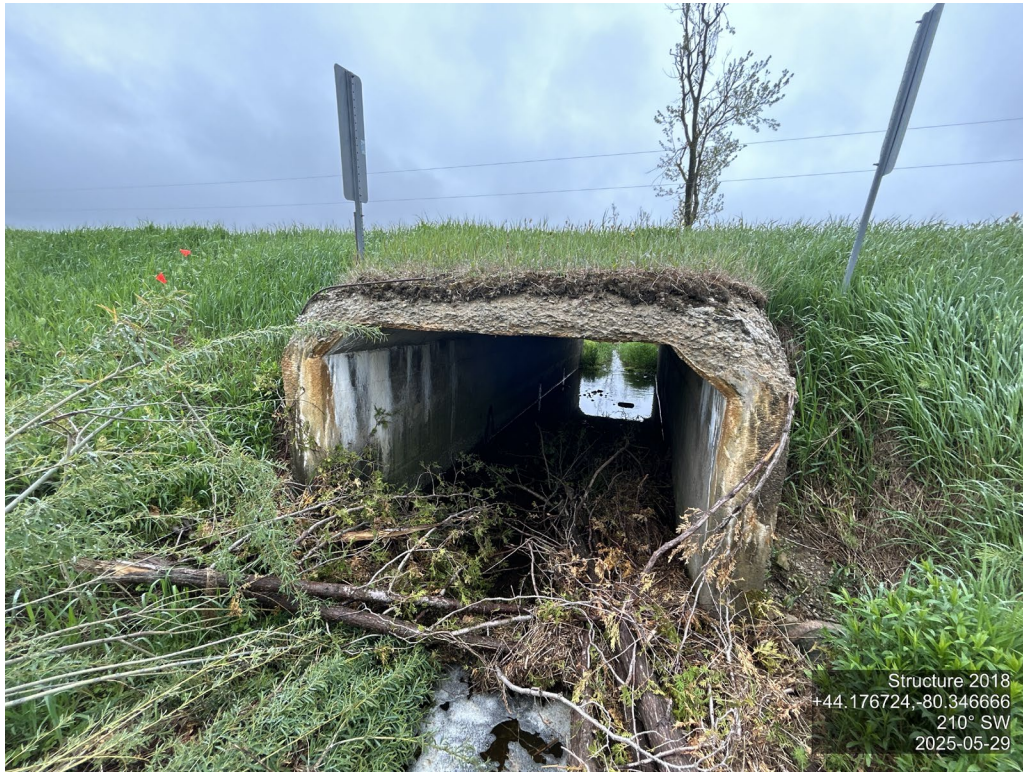
Structure 2018  
 +44.176724, -80.346666  
 210° SW  
 2025-05-29

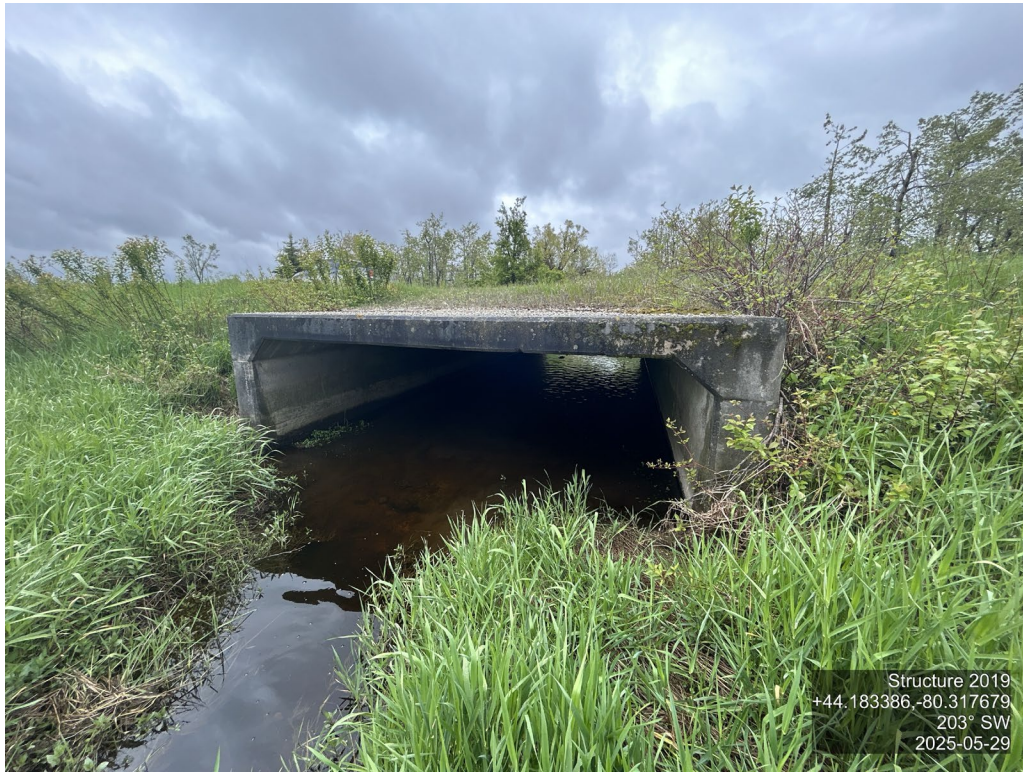
Structure 2019  
+44.183386,-80.317679  
203° SW  
2025-05-29

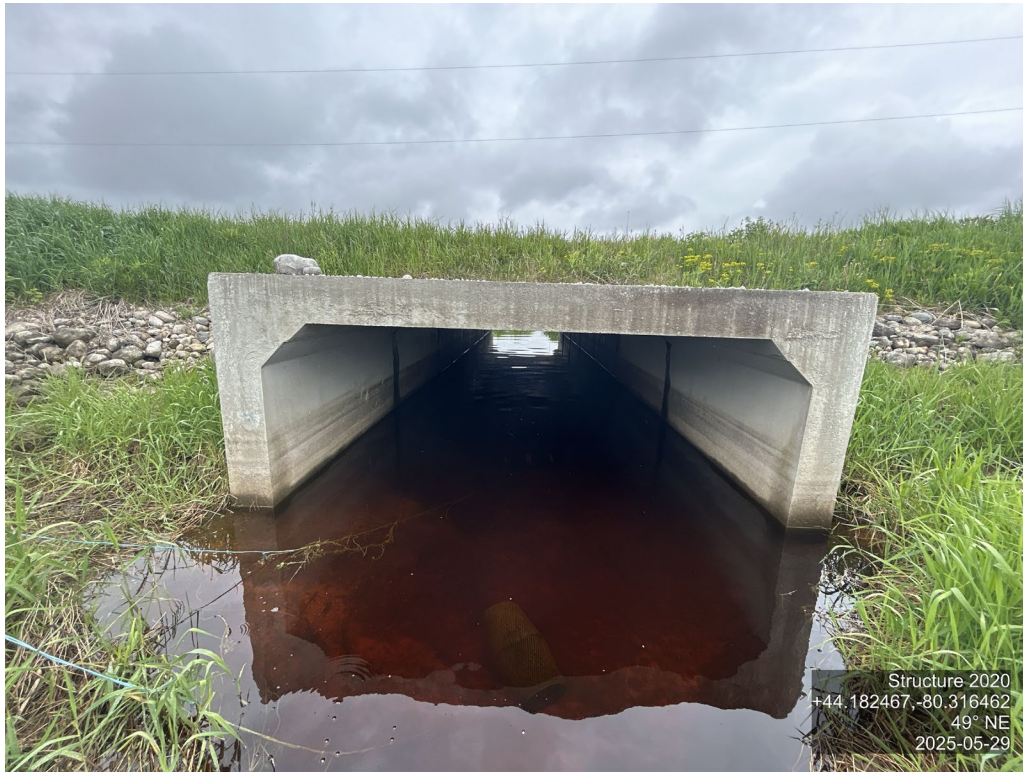
<b>Rehabilitation</b>	<b>Replacement</b>
<b>Estimated Capital Works Timelines (Years):</b>	N/A	44.7

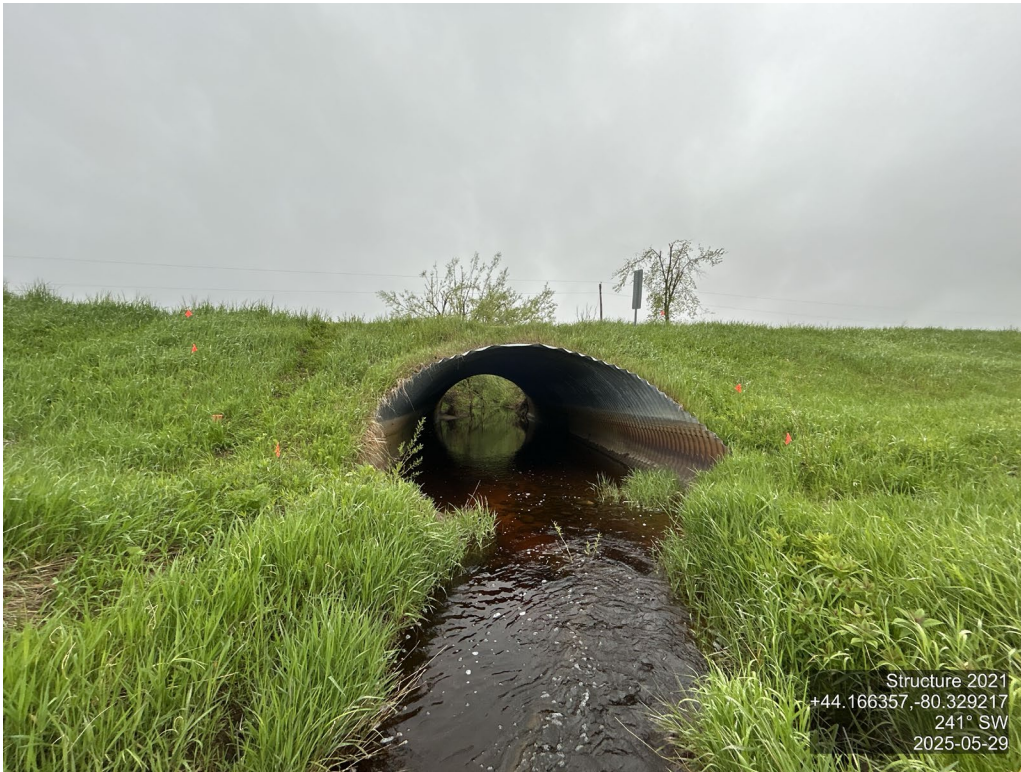
<b>Rehabilitation</b>	<b>Replacement</b>
<b>Estimated Capital Works Timelines (Years):</b>	N/A	11.2

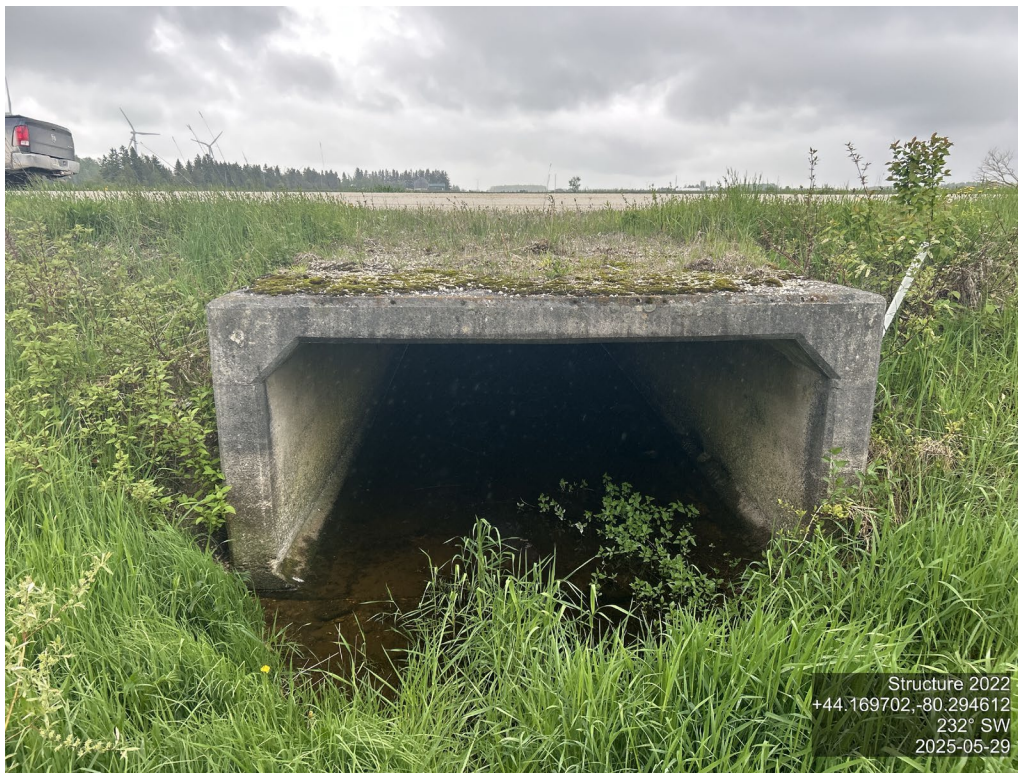
Structure 2022  
+44.169702, -80.294612  
232° SW  
2025-05-29

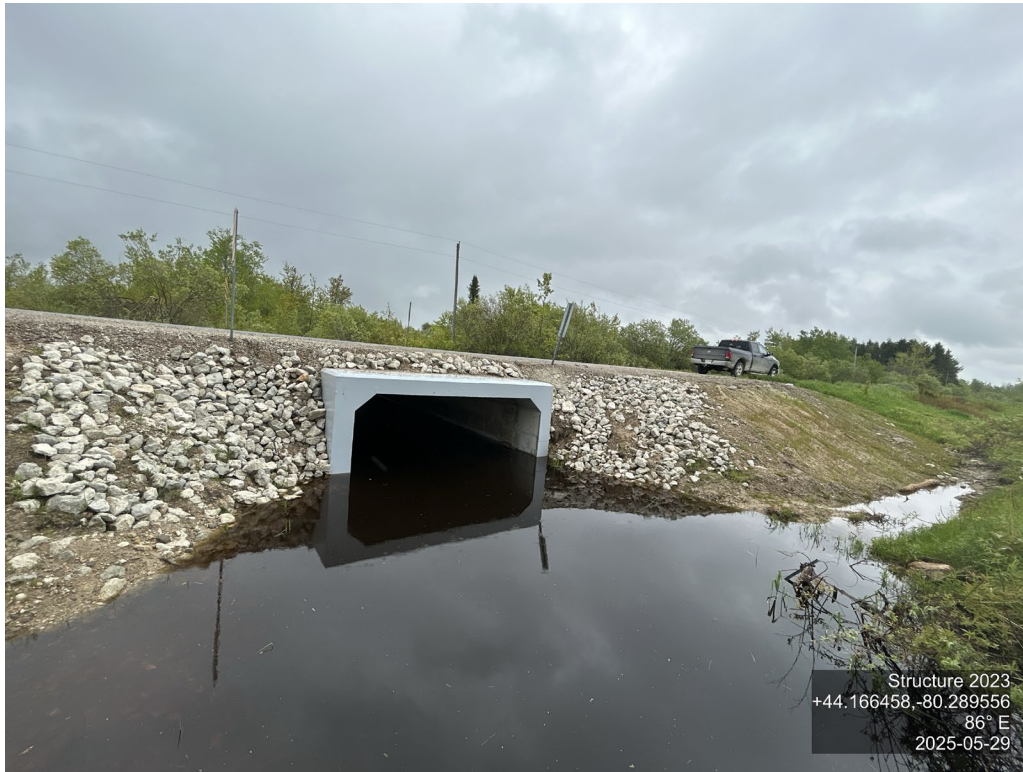
Structure 2023  
 +44.166458, -80.289556  
 86° E  
 2025-05-29

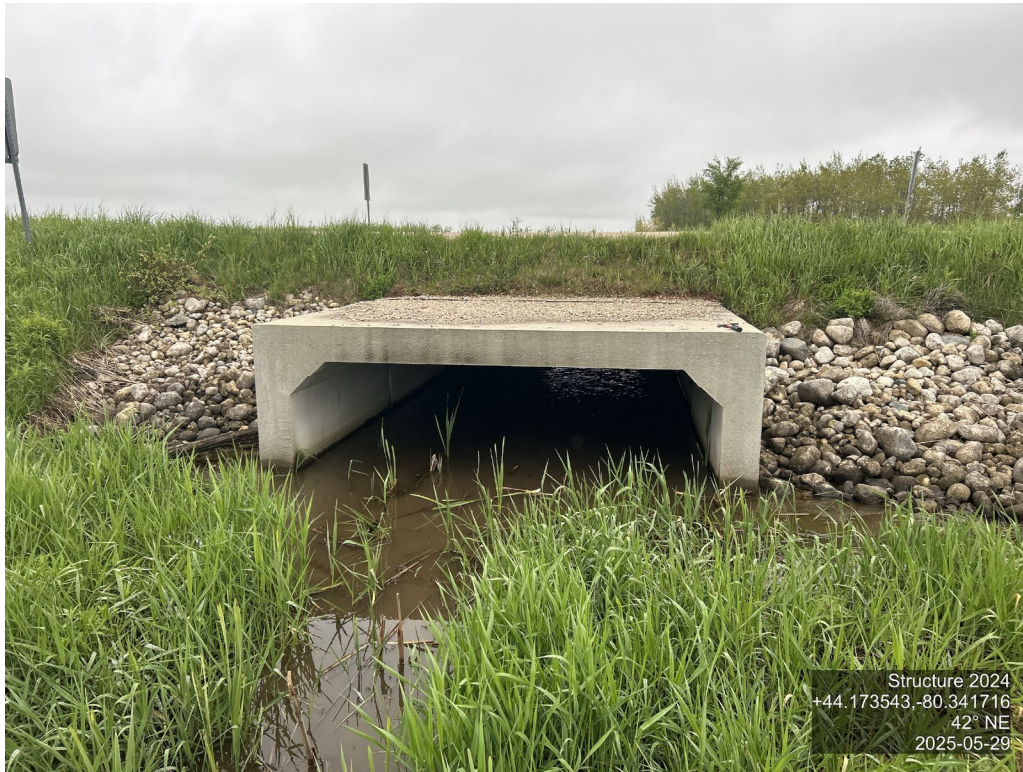
<b>Rehabilitation</b>	<b>Replacement</b>
<b>Estimated Capital Works Timelines (Years):</b>	N/A	42.2

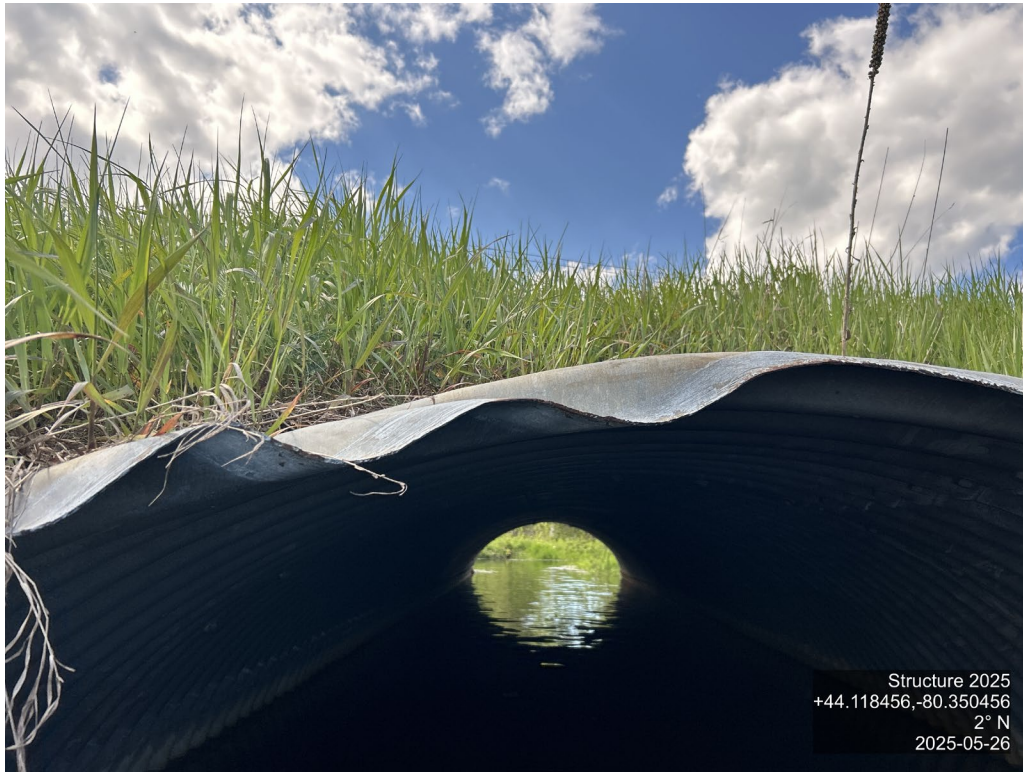
Structure 2025  
+44.118456,-80.350456  
2° N  
2025-05-26

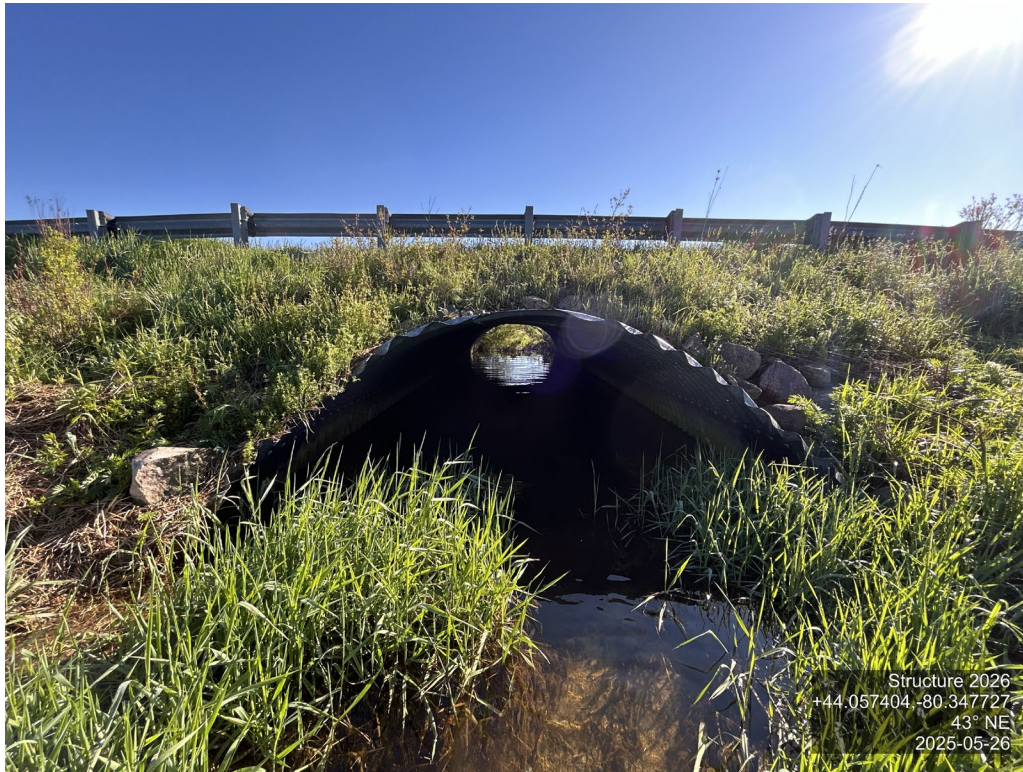
<b>Rehabilitation</b>	<b>Replacement</b>
<b>Estimated Capital Works Timelines (Years):</b>	N/A	22.4

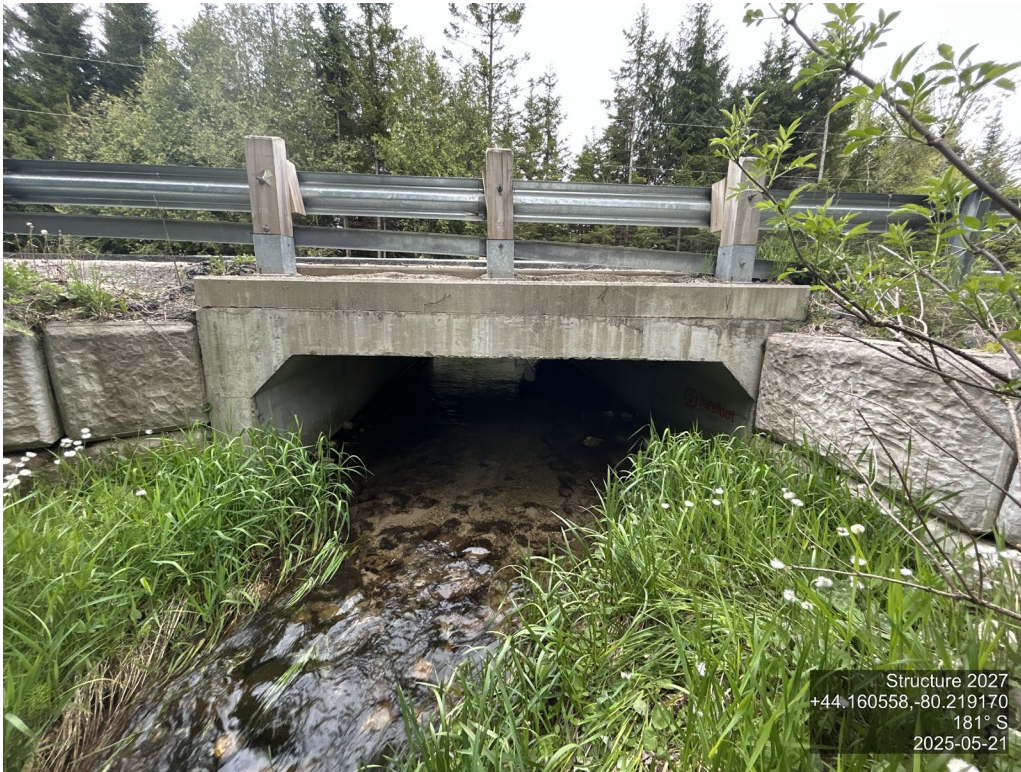
Structure 2027  
+44.160558, -80.219170  
181° S  
2025-05-21

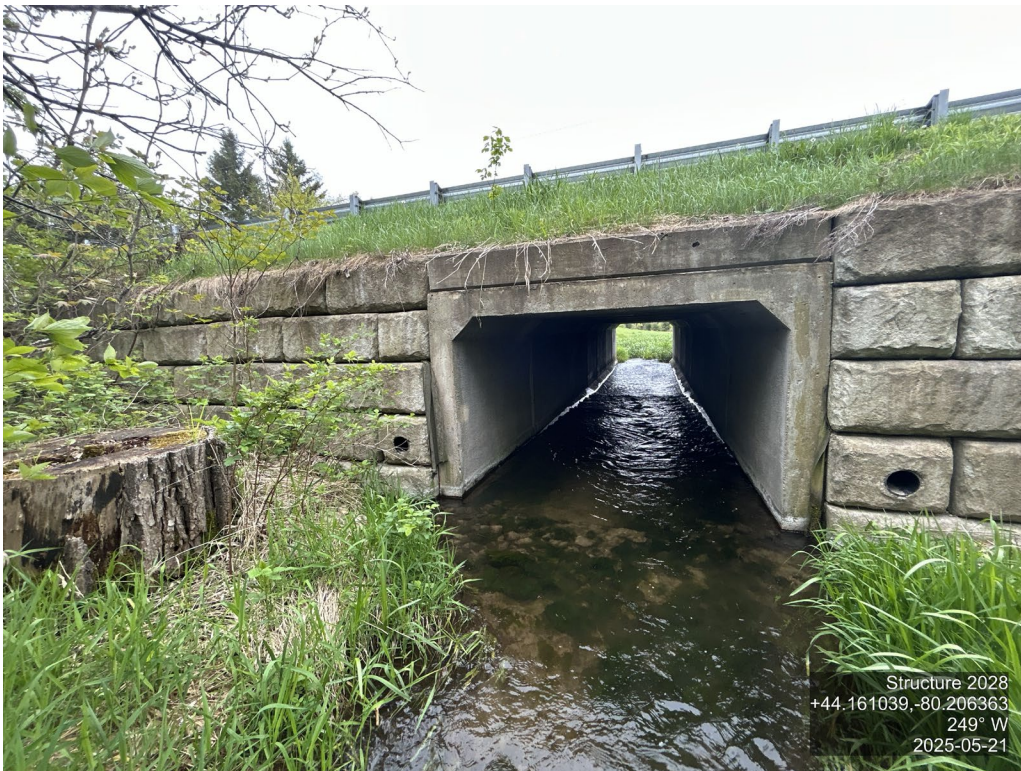
Rehabilitation	Replacement
<b>Estimated Capital Works Timelines (Years):</b>	N/A	41.9

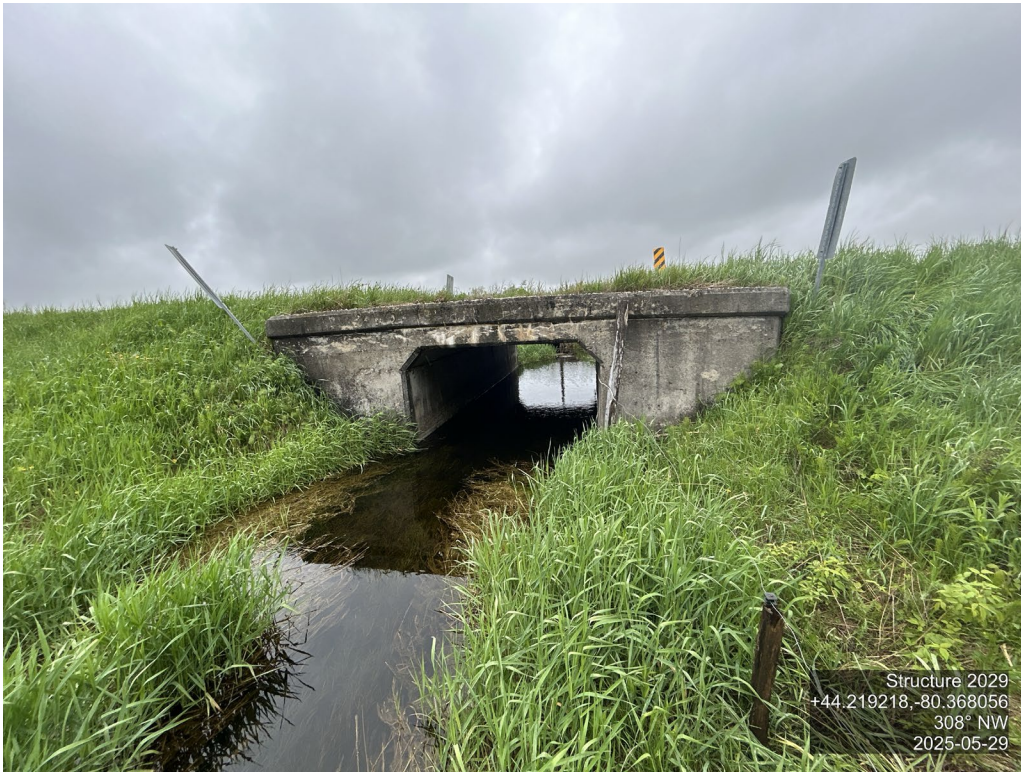
Structure 2029  
 +44.219218, -80.368056  
 308° NW  
 2025-05-29

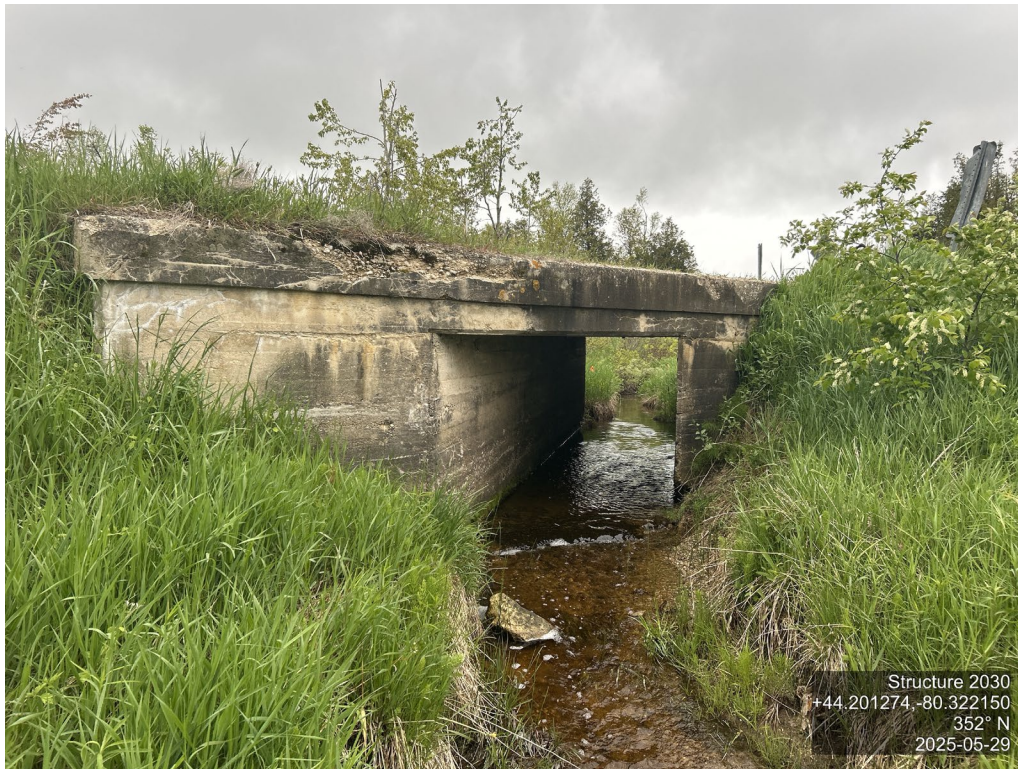
Rehabilitation	Replacement
<b>Estimated Capital Works Timelines (Years):</b>	N/A	10.5

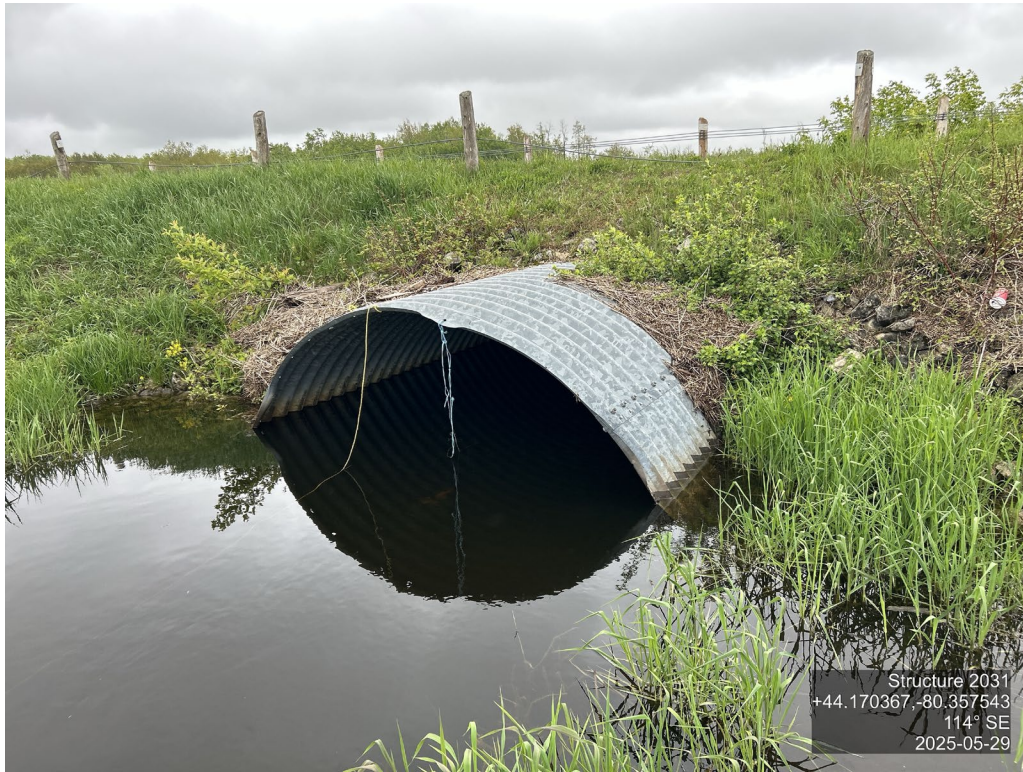
<b>Rehabilitation</b>	<b>Replacement</b>
<b>Estimated Capital Works Timelines (Years):</b>	N/A	23.5

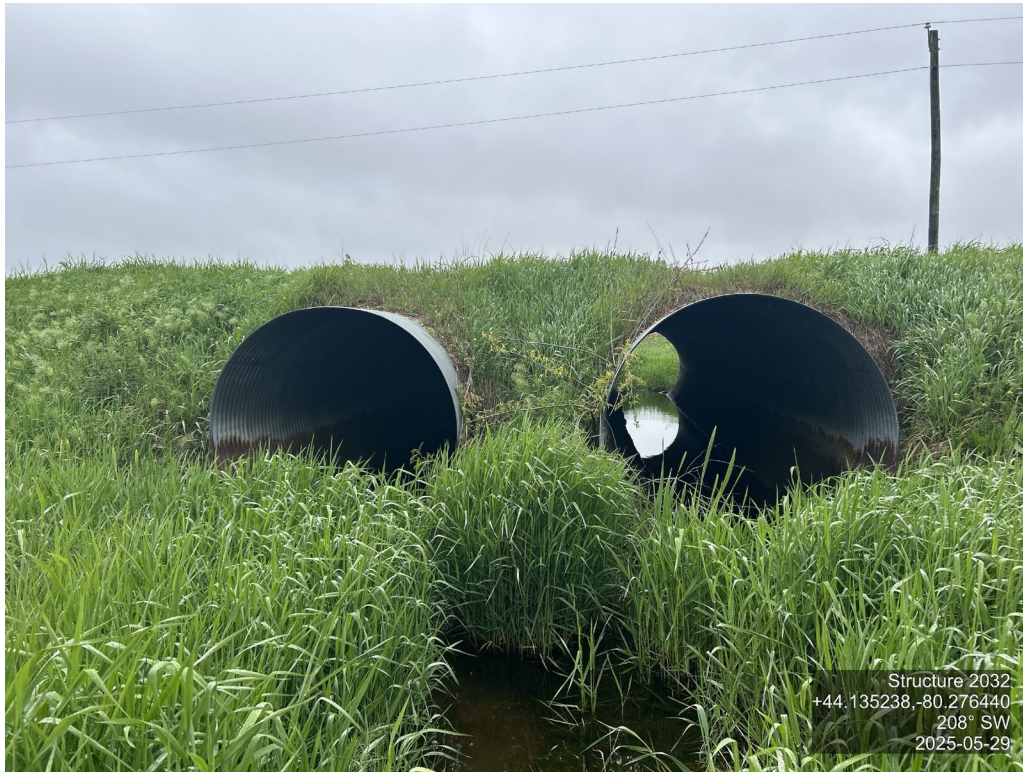
Structure 2032  
+44.135238, -80.276440  
208° SW  
2025-05-29

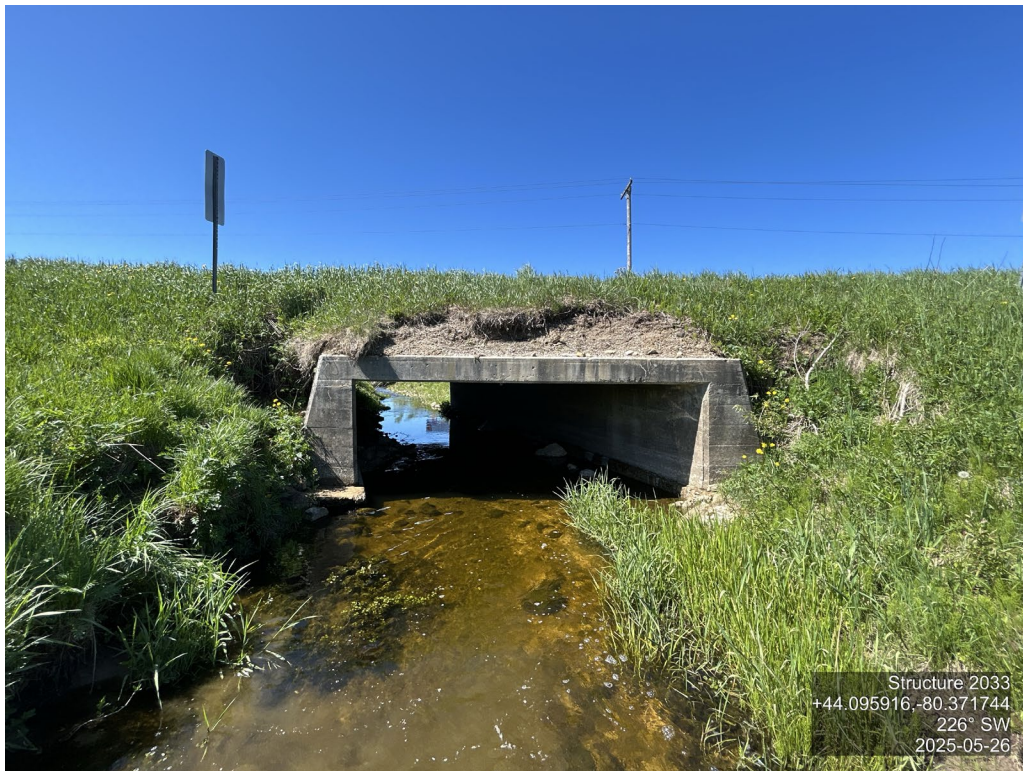
Rehabilitation	Replacement
<b>Estimated Capital Works Timelines (Years):</b>	N/A	18.4

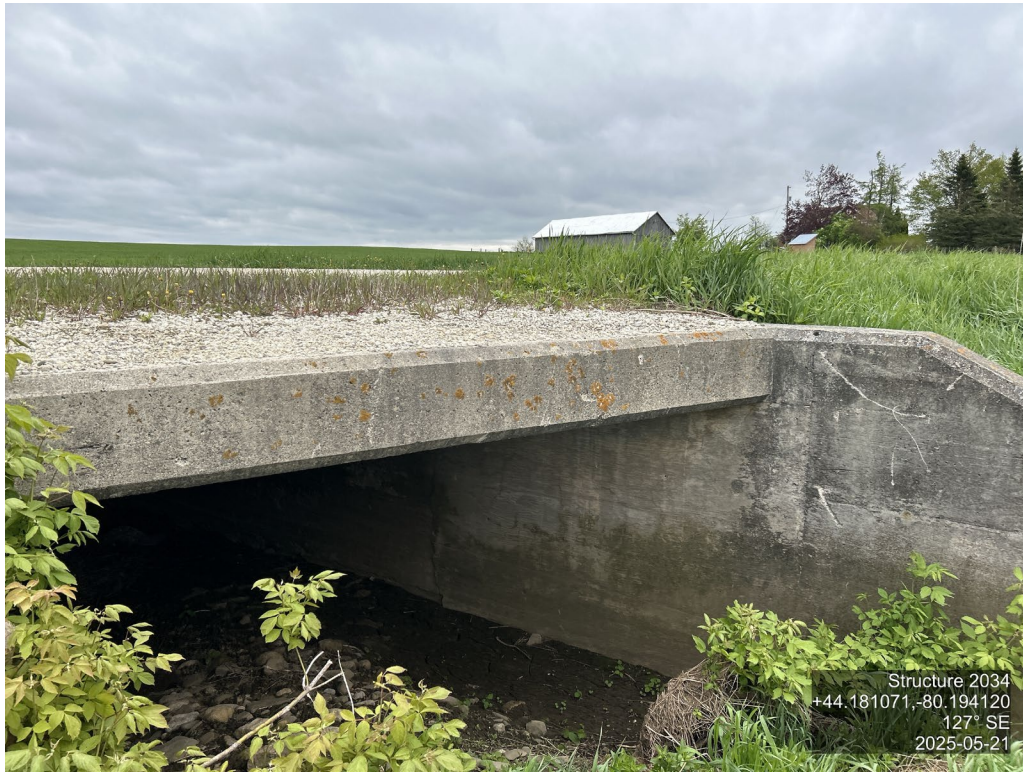
Structure 2034  
+44.181071,-80.194120  
127° SE  
2025-05-21

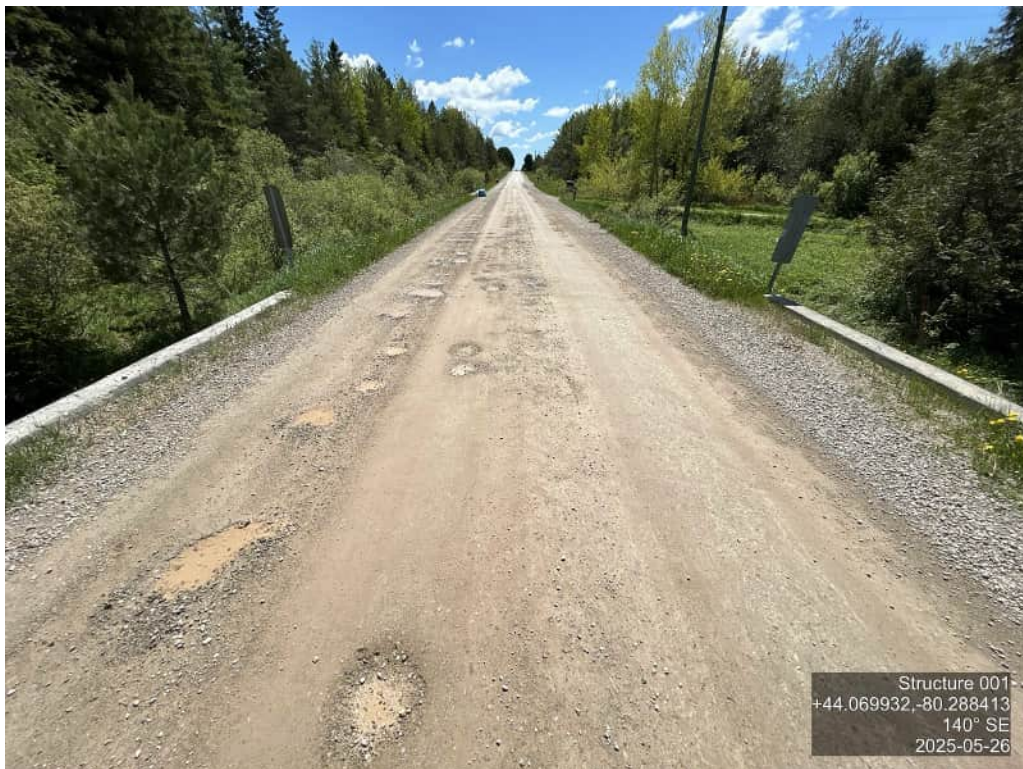
**APPROACH WEARING SURFACE – SOUTHEAST – MEDIUM SIZED POTHOLE**

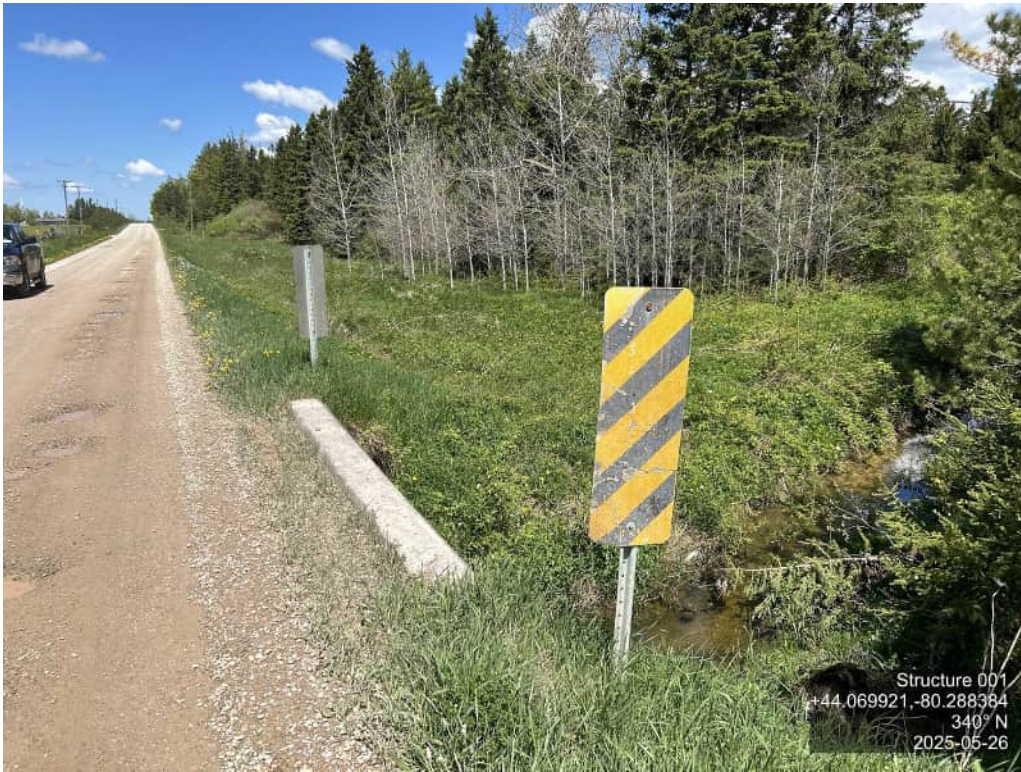
Structure 001  
+44.069921, -80.288364  
340° N  
2025-05-26

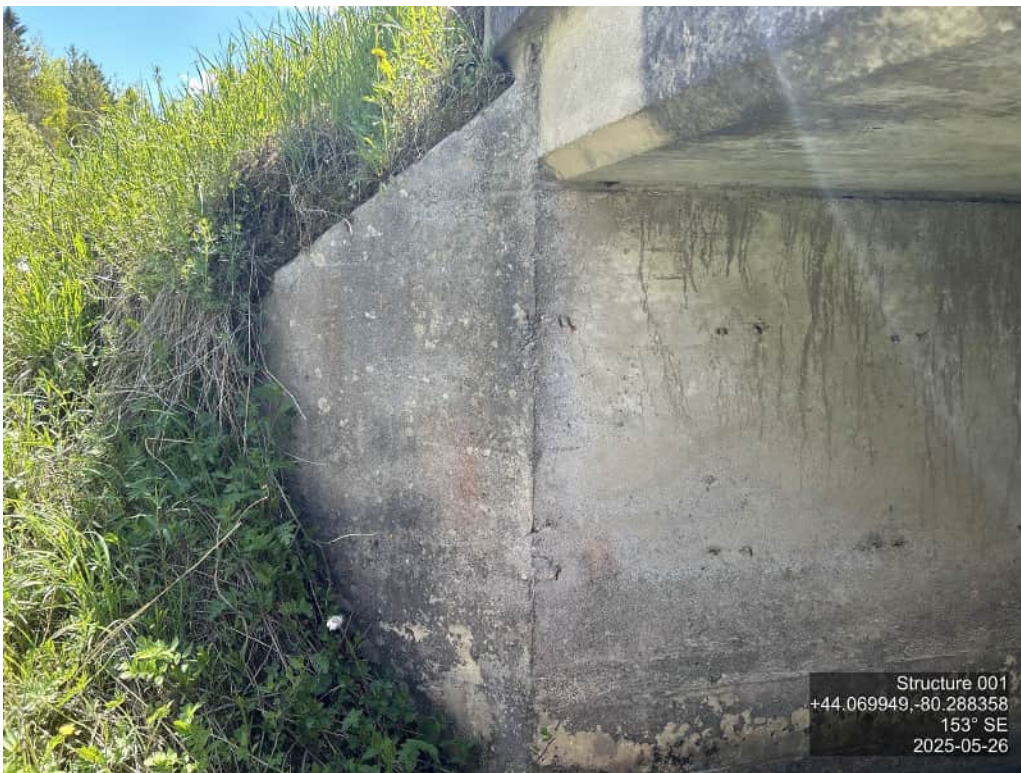
Structure 001  
+44.069949, -80.288358  
153° SE  
2025-05-26
