**BURNSIDE**

## **2025 OSIM Bridge Inspections Report**

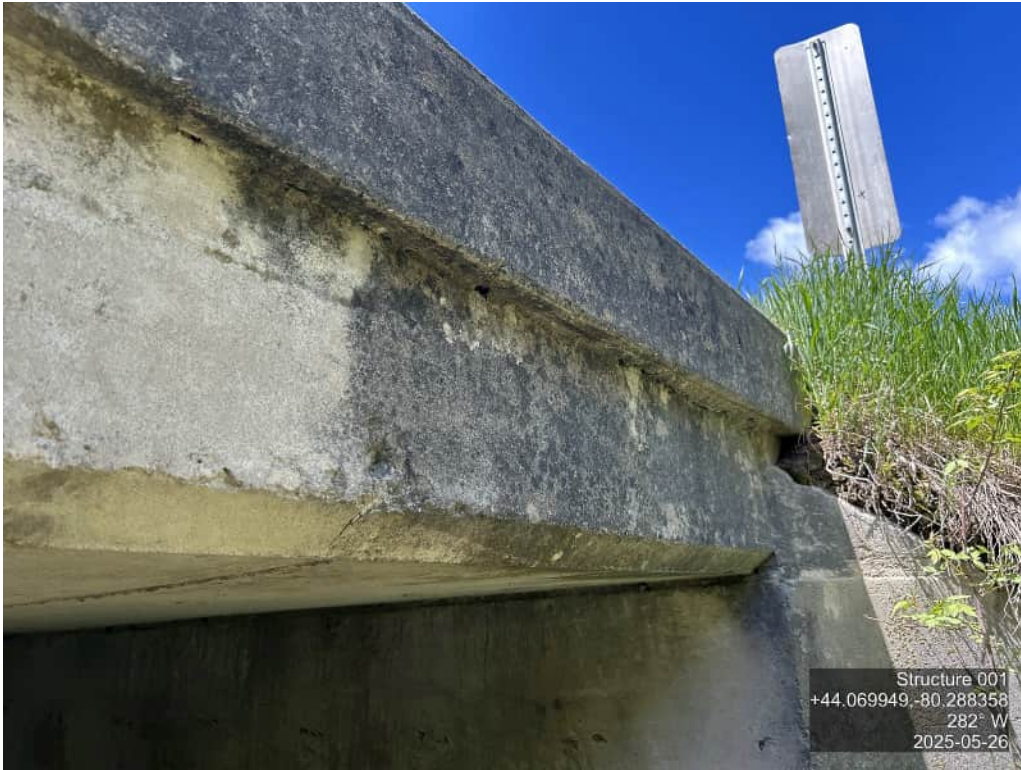
**SOFFIT EXTERIOR – EAST – EFFLORESCENCE STAINED CRACKING**

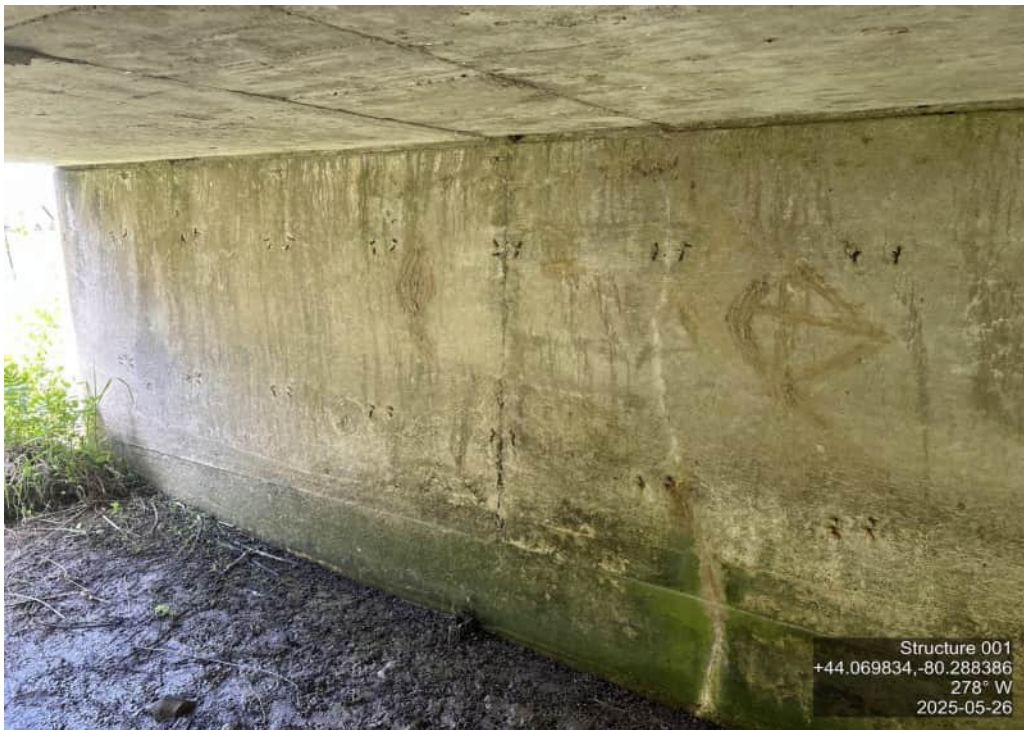
**ABUTMENT WALLS – NORTH – FULL HEIGHT CRACK ON EACH WALL**

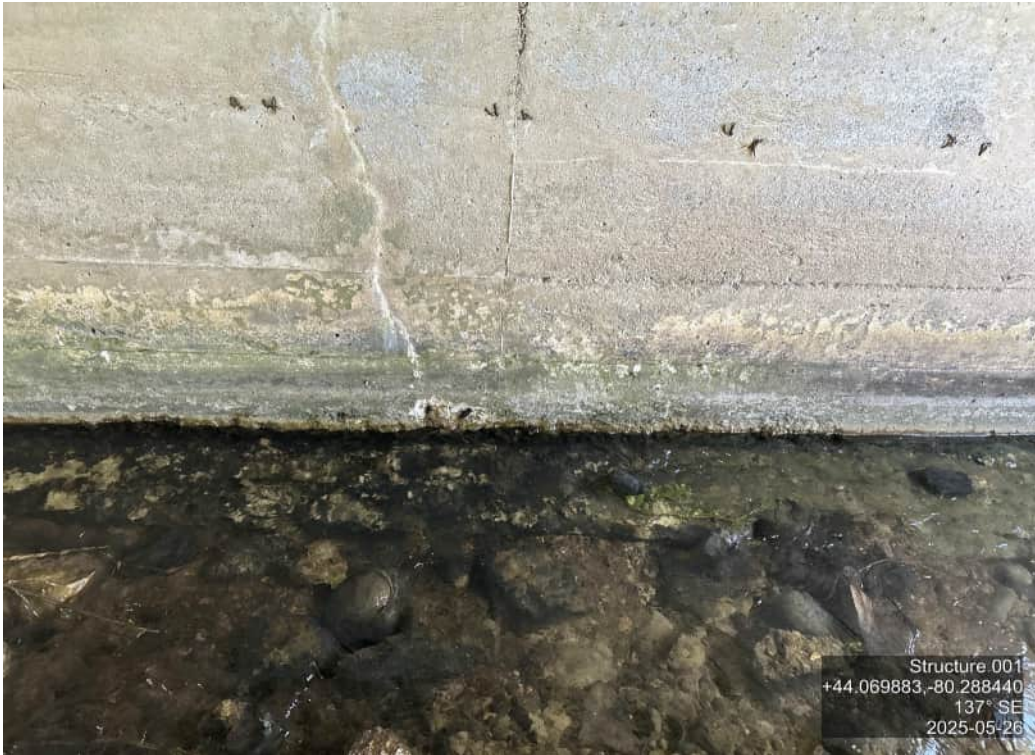
**FOUNDATION – SOUTH – TOP OF FOOTING EXPOSED AND SEVERELY ERODED**

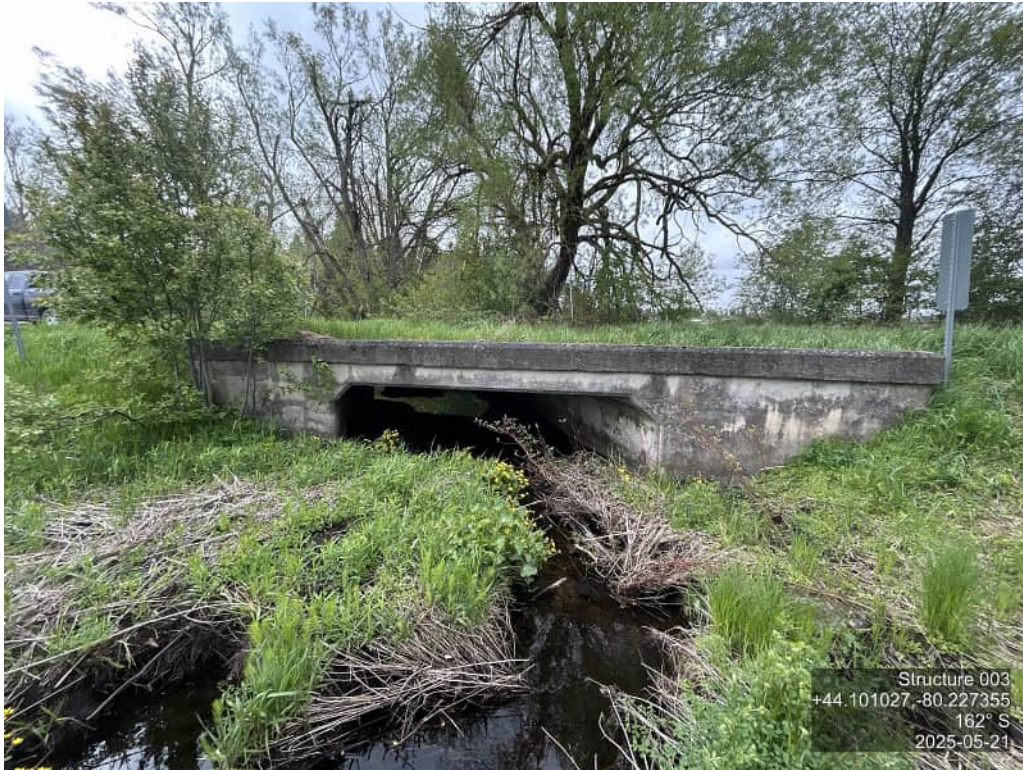
**ELEVATION SHOT – NORTH**

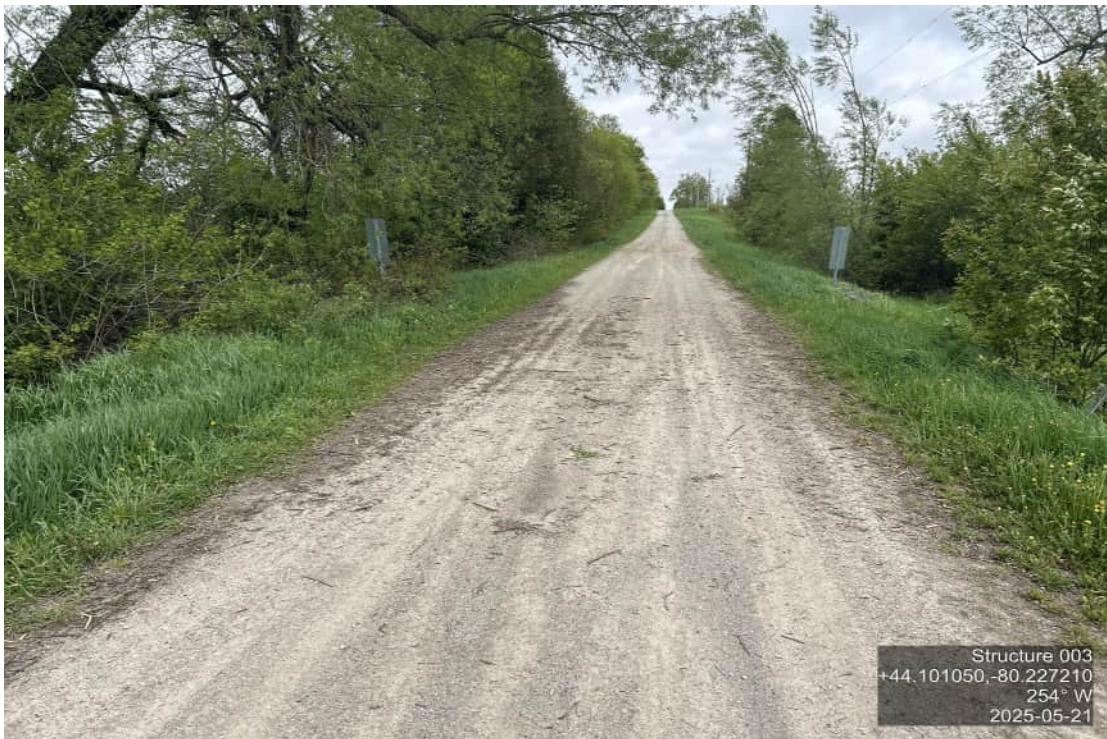
**DECK WEARING SURFACE – EAST – SMALL POTHoles**

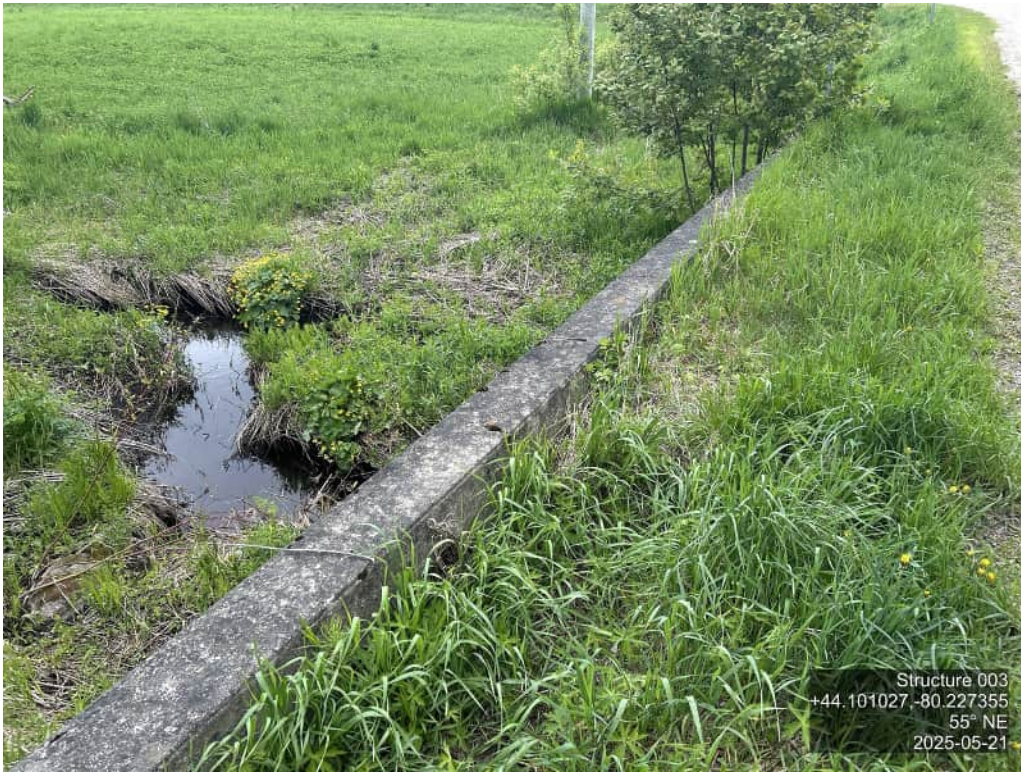
**CURB – NORTH – SPALLS WITH EXPOSED CORRODED REBAR**

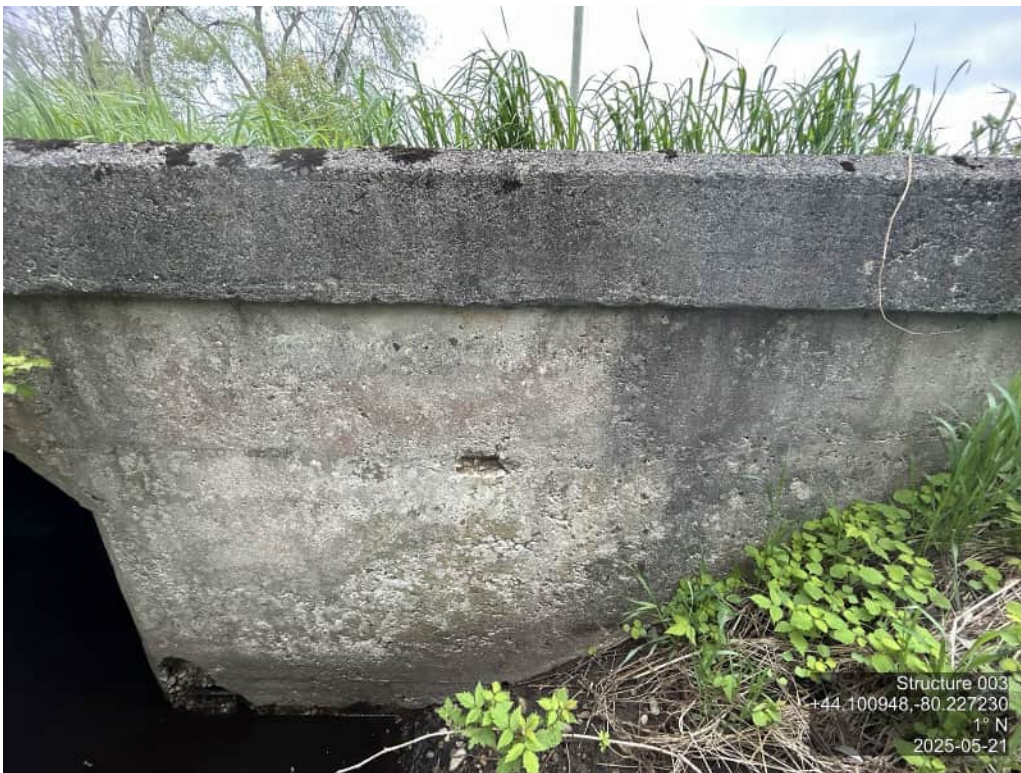
**WINGWALL – NORTHEAST – SEVERE SPALL WITH EXPOSED CORRODED REBAR**

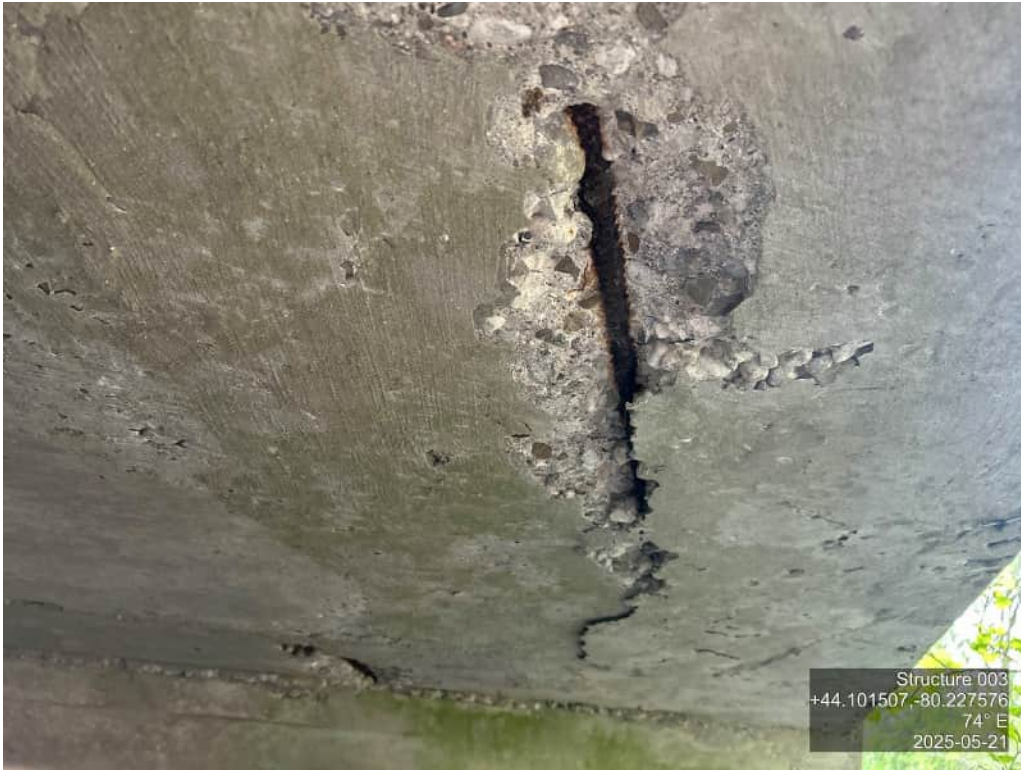
**SOFFIT INTERIOR – UNDERSIDE – SPALLS WITH EXPOSED CORRODED REBAR**

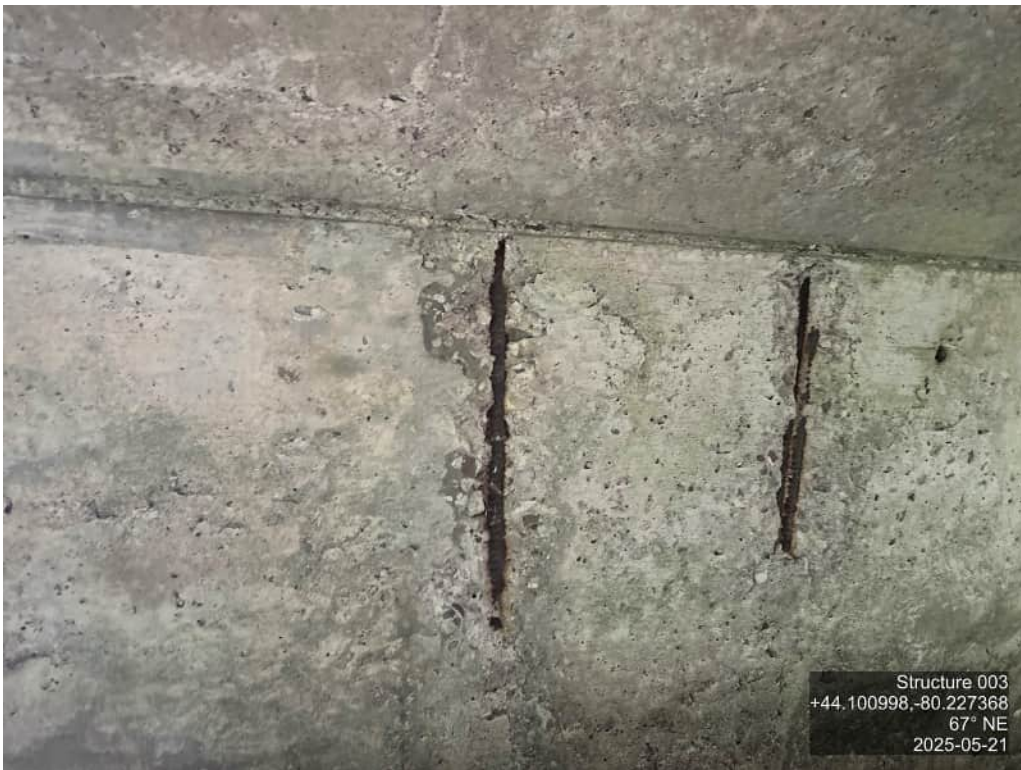
**ABUTMENT WALLS –WITH EXPOSED CORRODED REBAR**

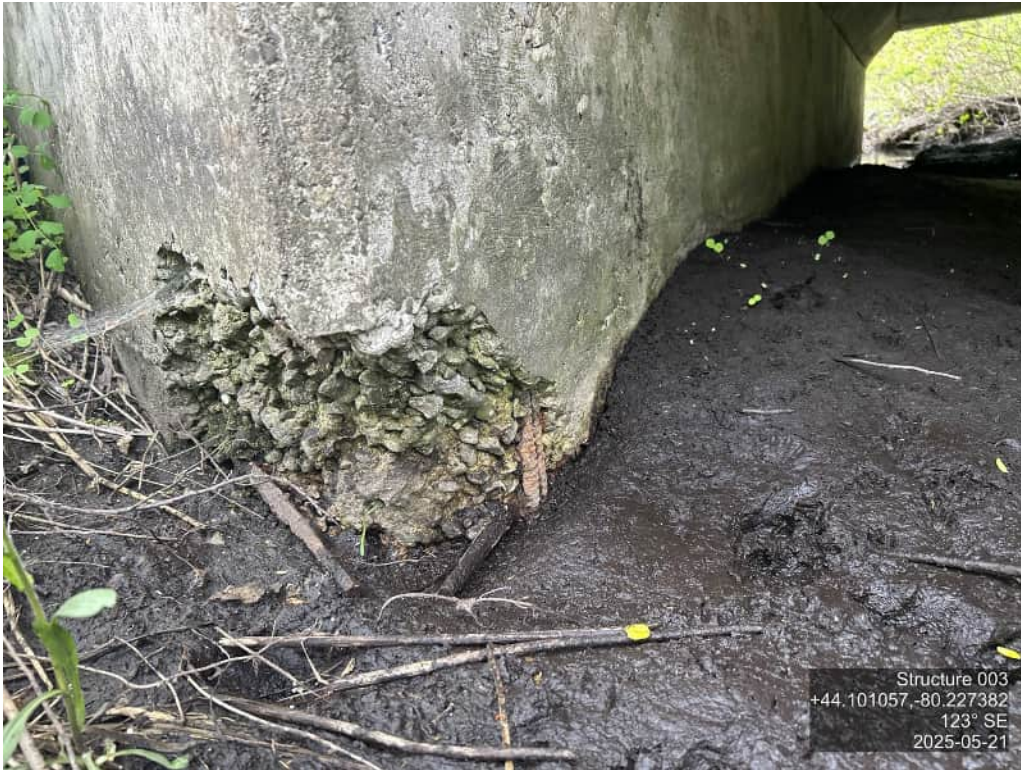
**ABUTMENT – EAST – SCOUR AT CORNER**

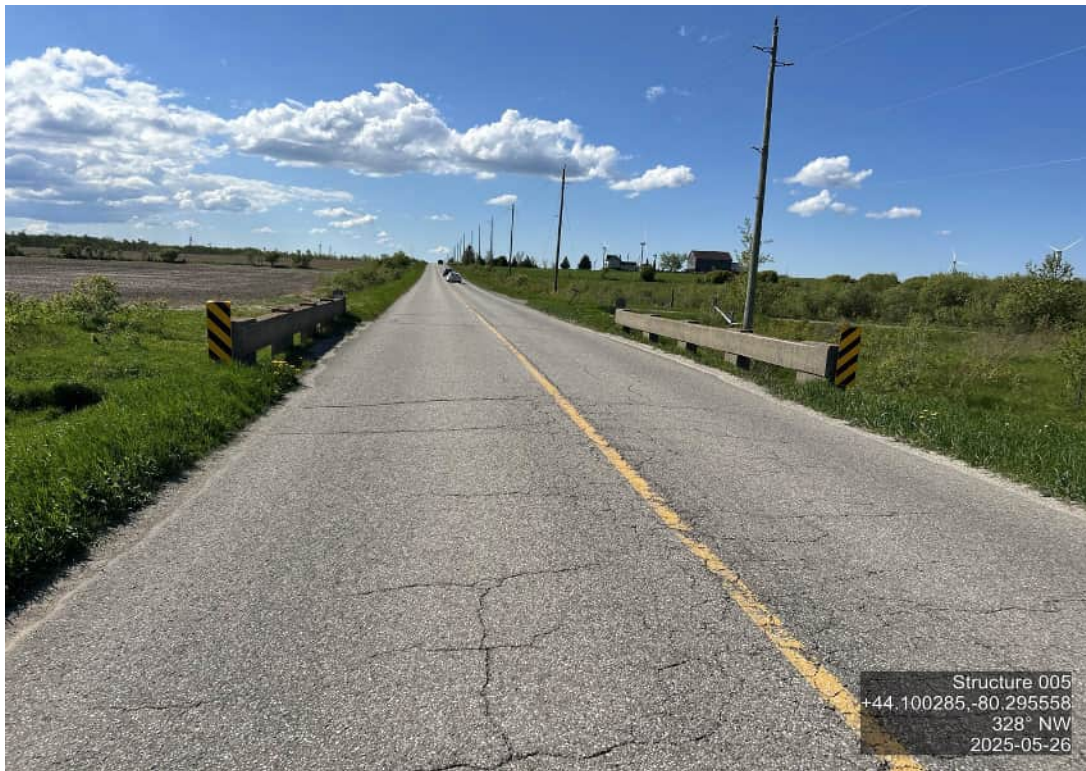
**APPROACH WEARING SURFACE – SOUTH – WIDE PATTERN CRACKING**

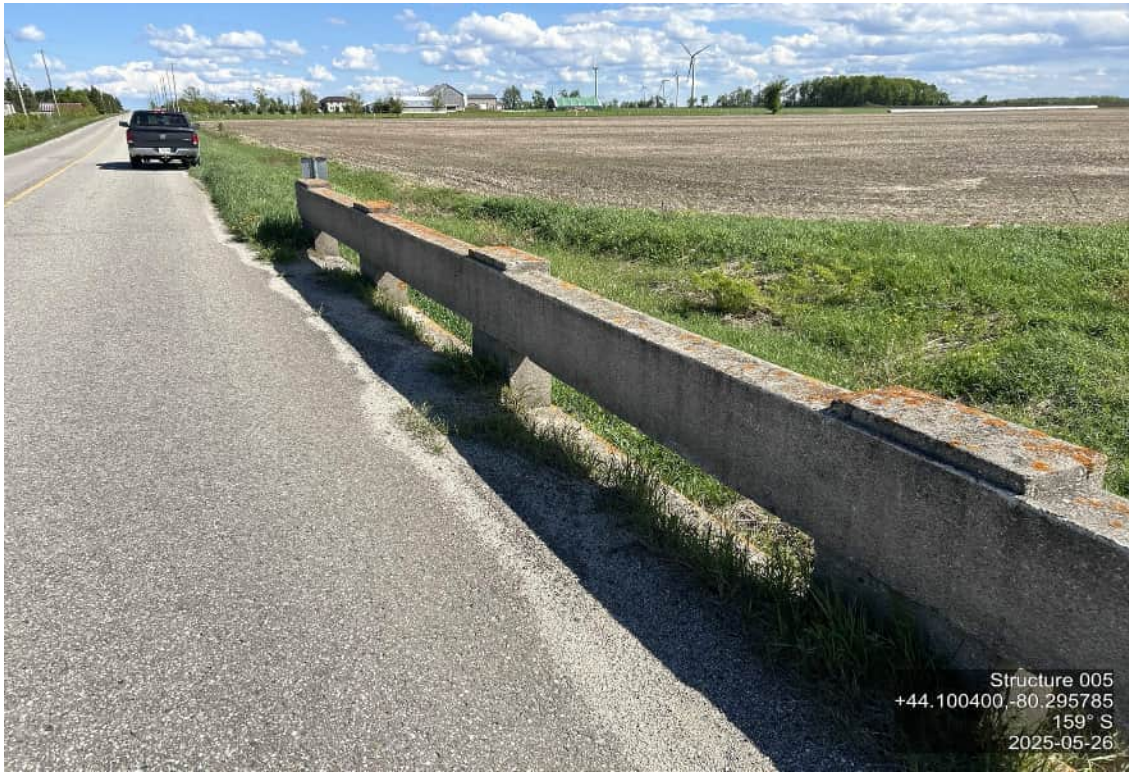
**RAILING SYSTEM – EAST – APPEARS TO BE TOO LOW**

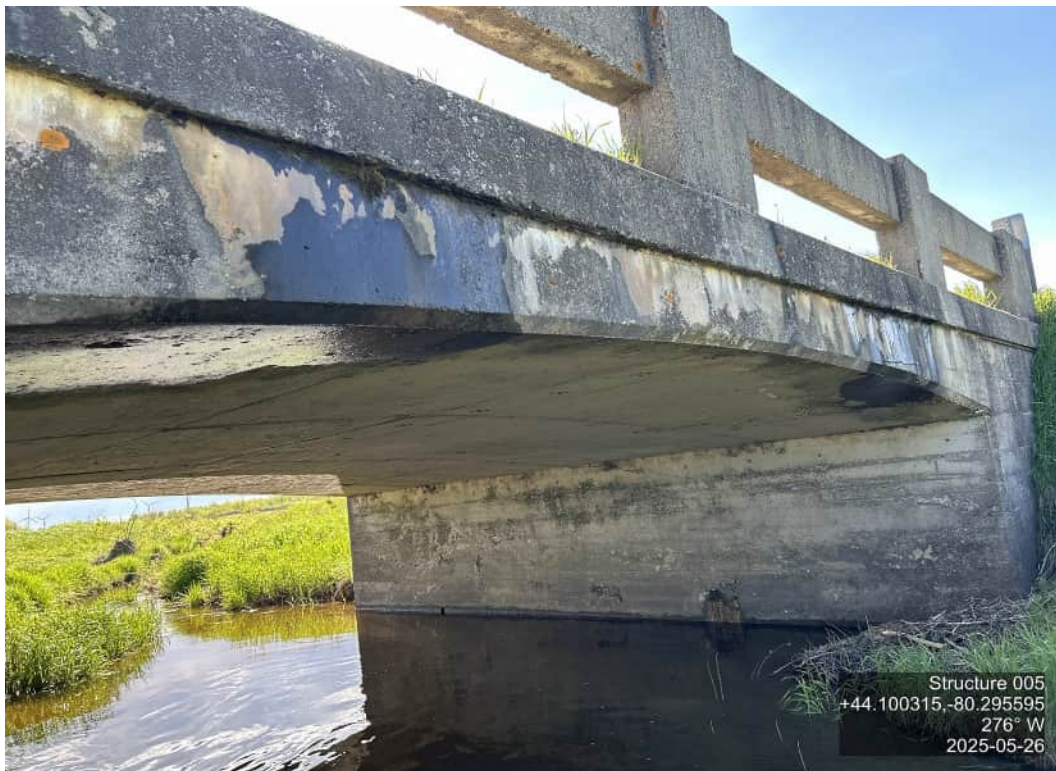
**SOFFIT EXTERIOR – WEST – STAINING WITH DELAMINATIONS AND SECTIONS OF MODERATE HONEYCOMBING**

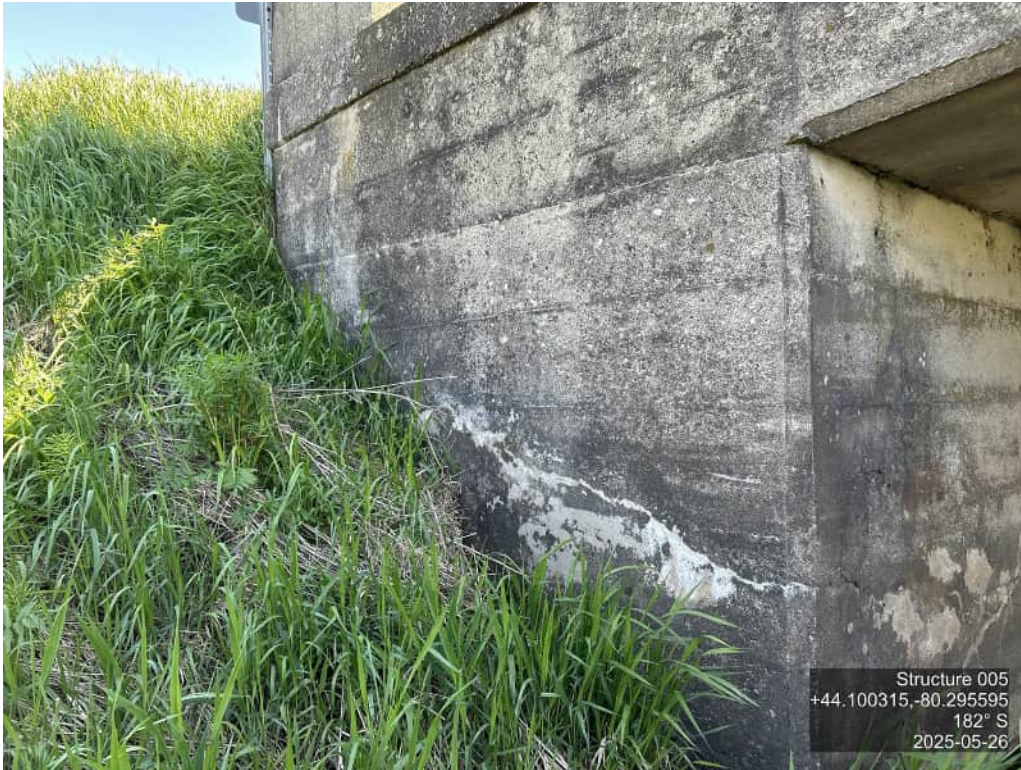
**WINGWALLS – SOUTHEAST – EFFLORESCENCE STAINING**

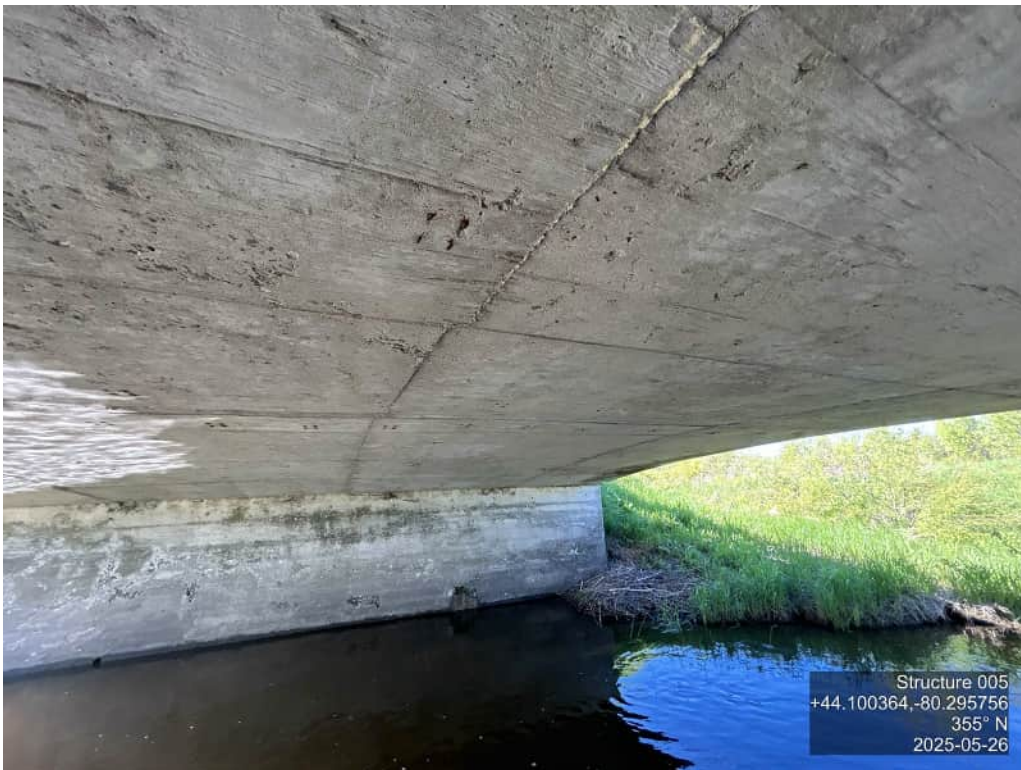
**ABUTMENT WALLS – SOUTHEAST – COLD JOINT, DELAMINATIONS AND SEVERE HONEYCOMBING WITH EXPOSED CORRODED REBAR**

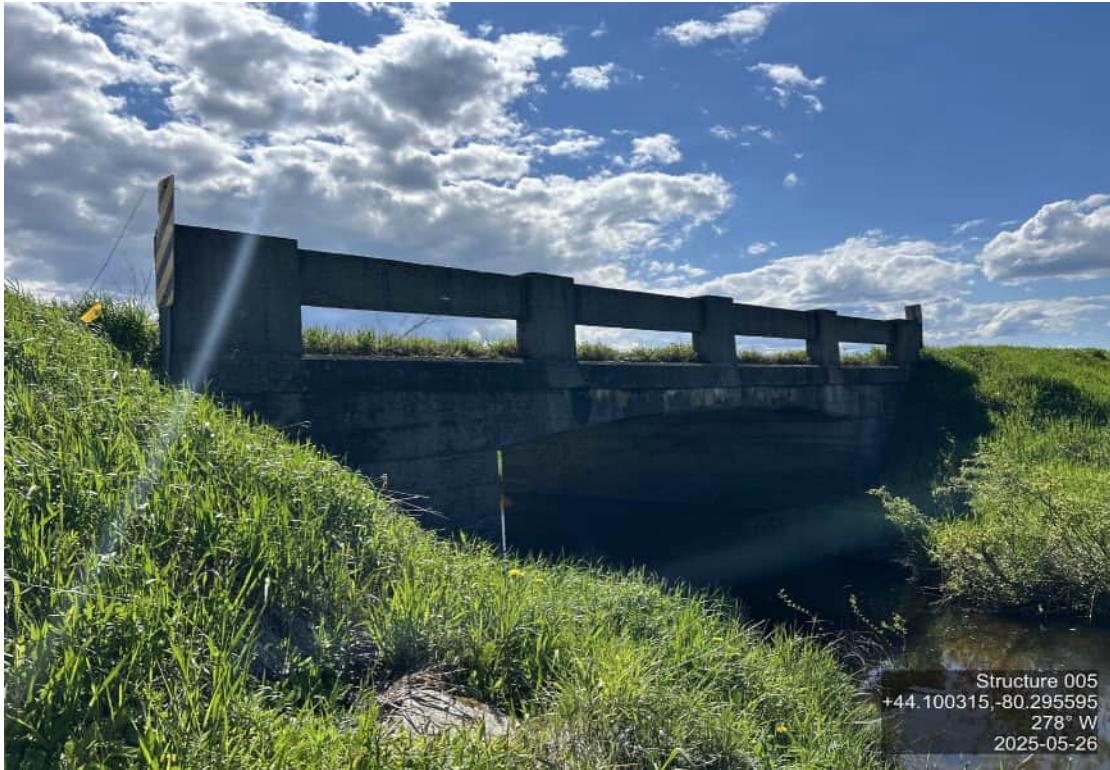
**STREAM – THROUGH STRUCTURE – STREAM FLOWS ON A SKEW**

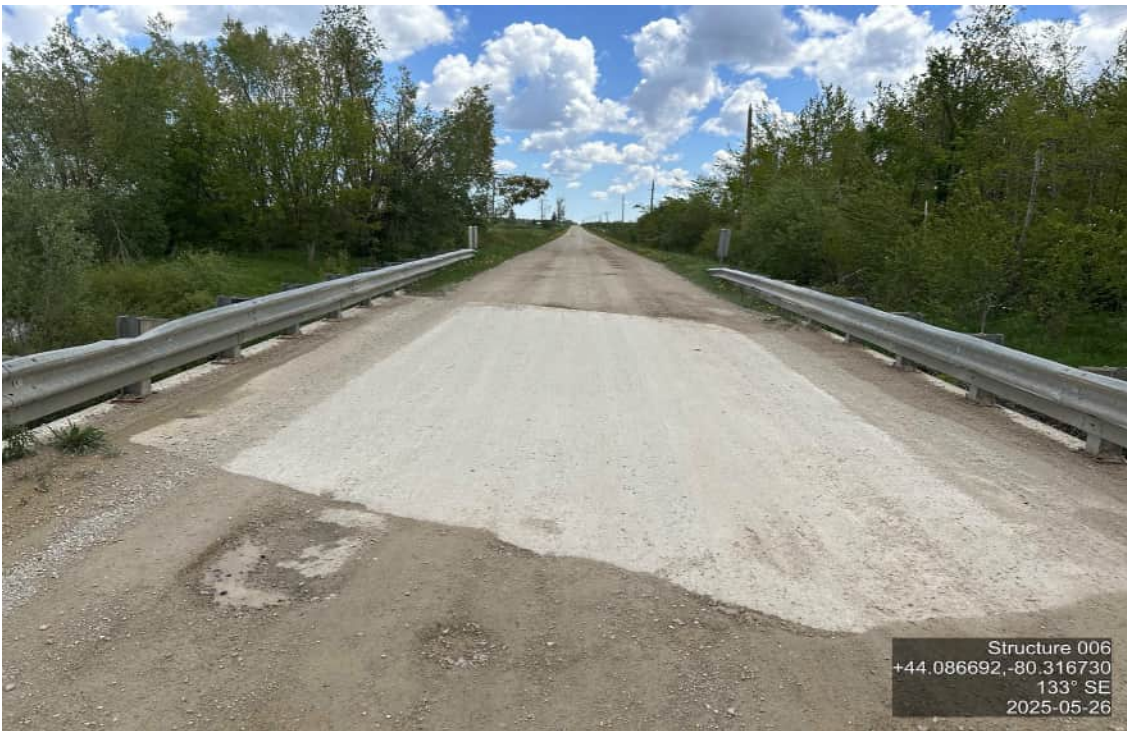
**APPROACH WEARING SURFACE – NORTH APPROACH – SEVERAL LARGE POTHLES**

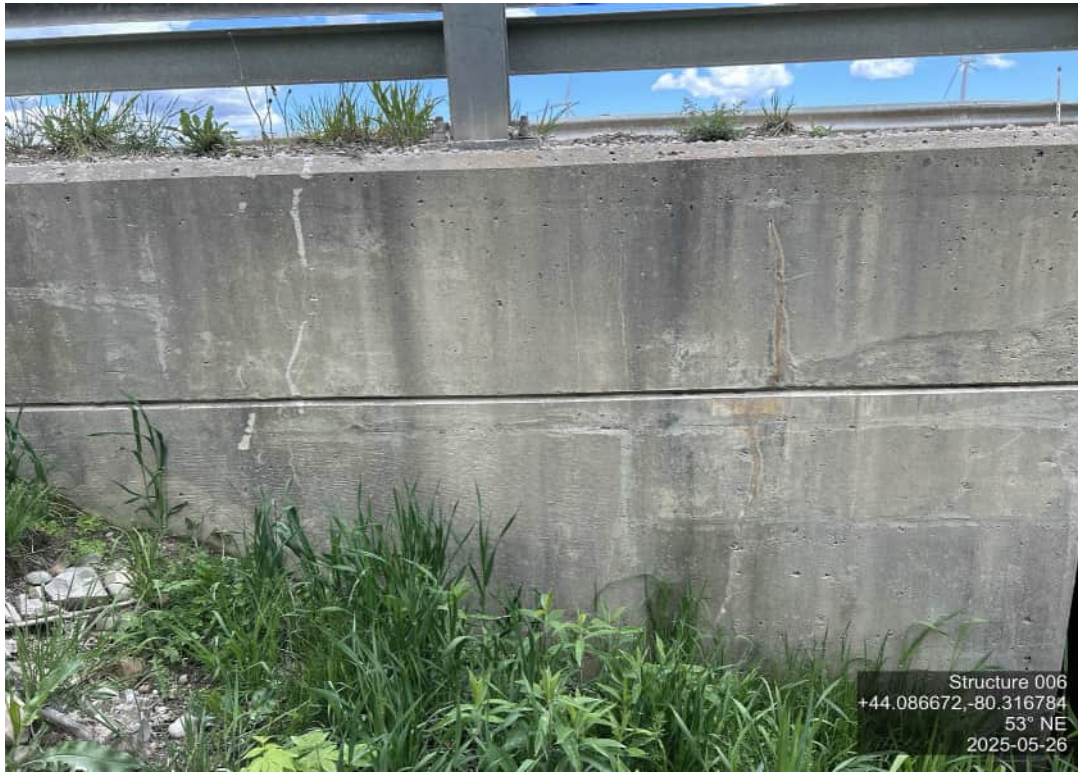
**WINGWALL – SOUTHEAST – NARROW STAINED CRACKS**

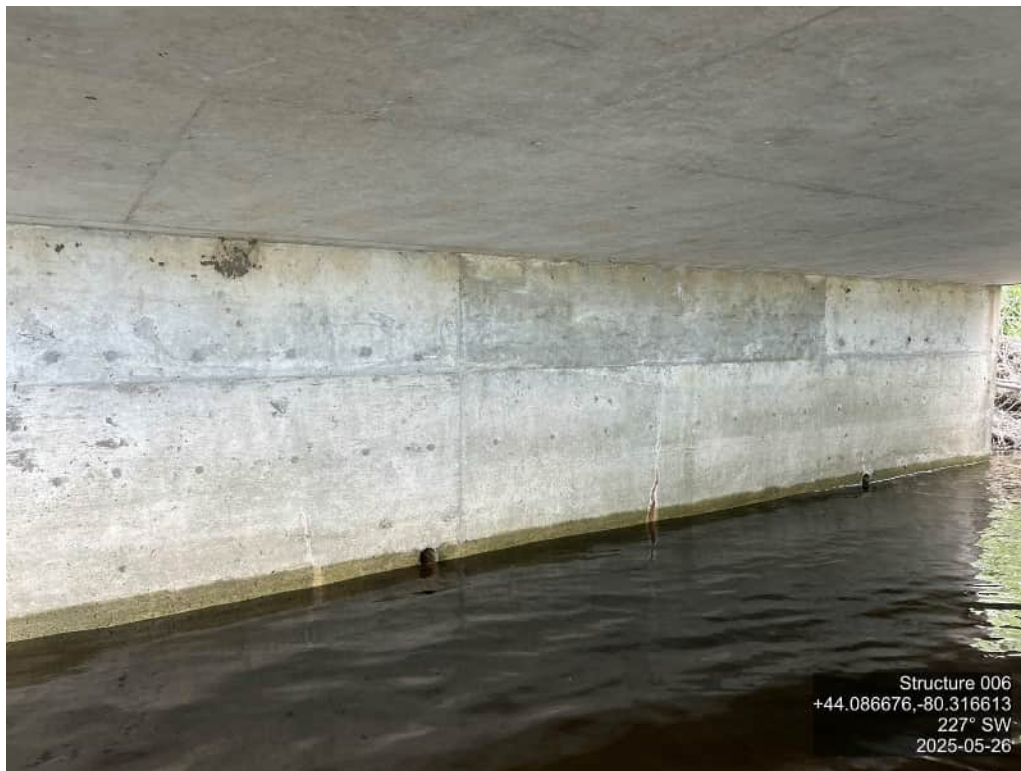
**ABUTMENT WALLS – SOUTH – FULL HEIGHT MEDIUM VERTICAL CRACK**

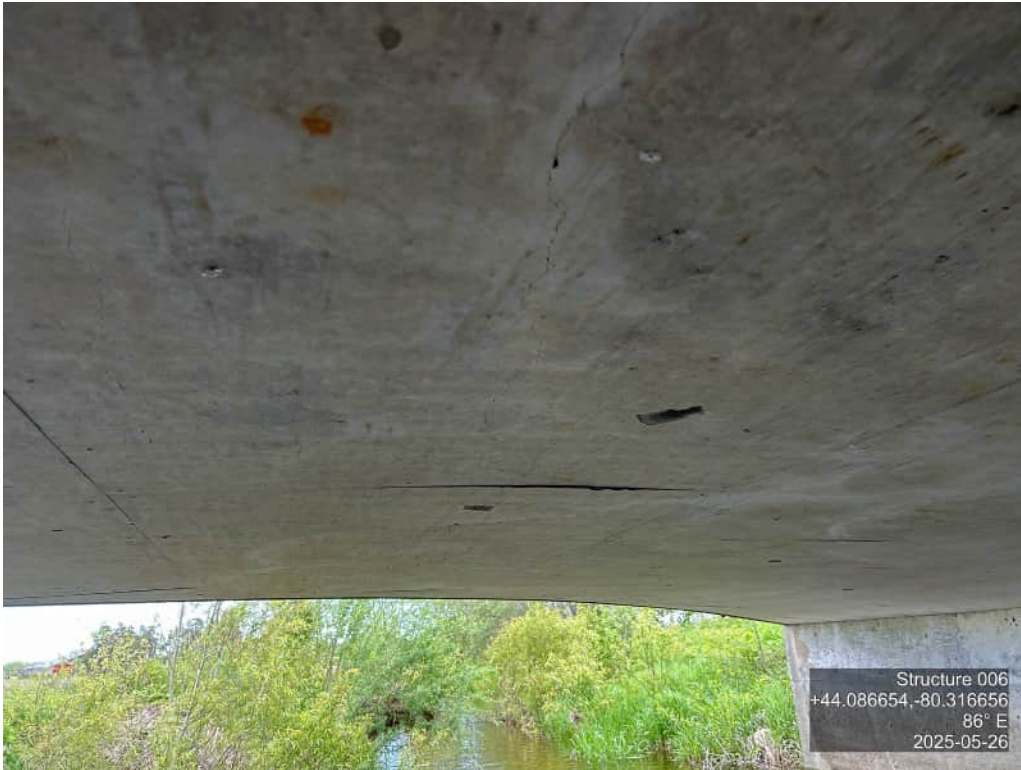
**SOFFIT INTERIOR – MIDSPAN – TRANSVERSE CRACK FULL WIDTH**

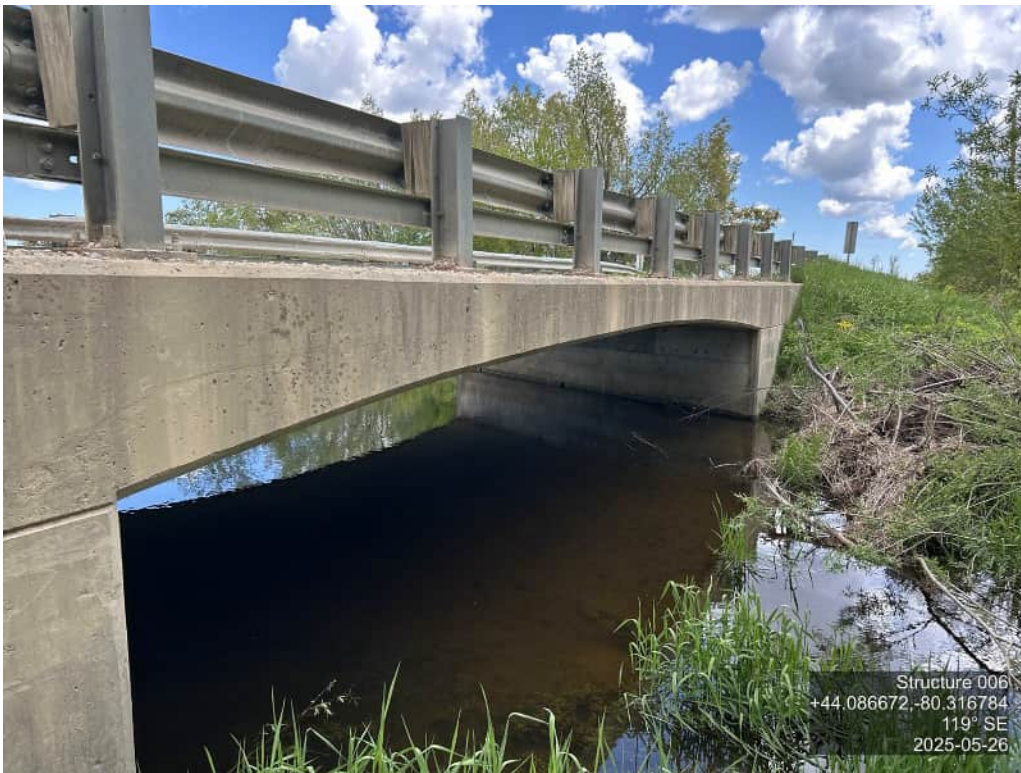
**EMBANKMENT – SOUTHEAST**

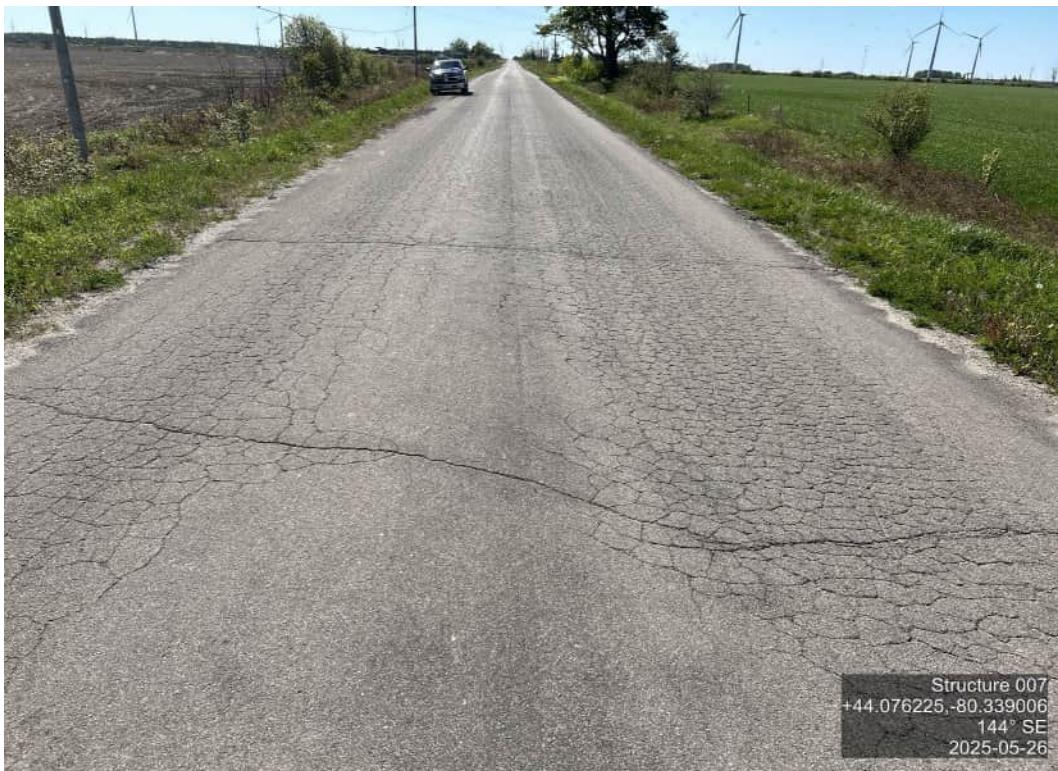
**APPROACH WEARING SURFACE – SOUTH – SEVERE ALLIGATOR CRACKING**

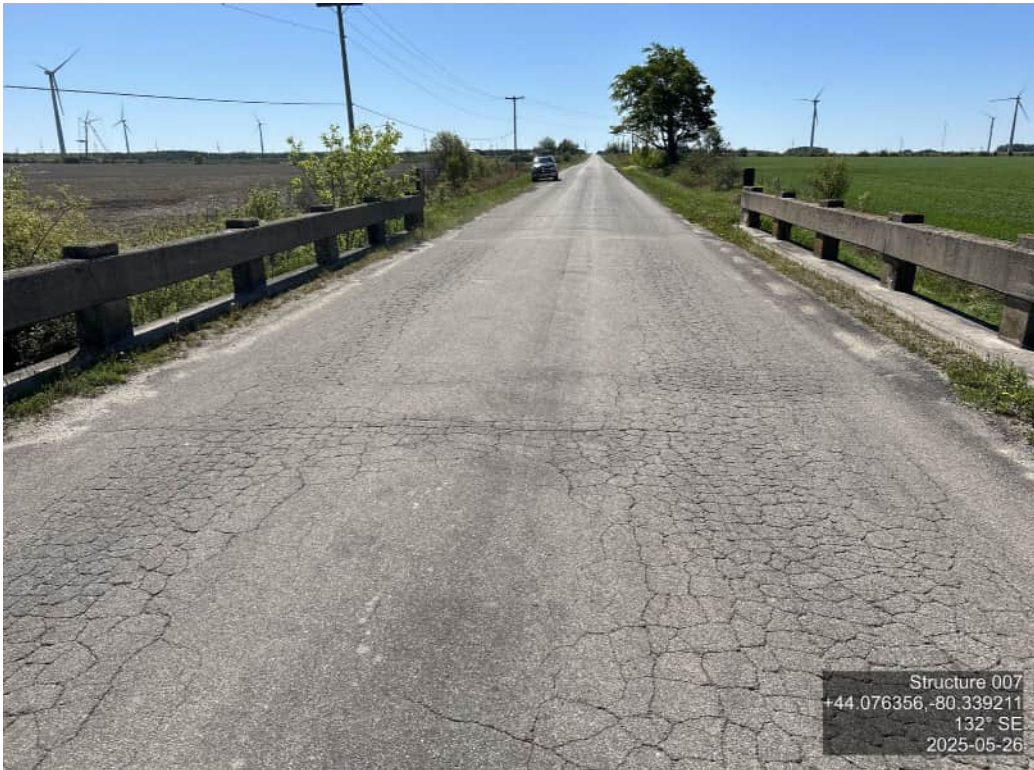
**DECK WEARING SURFACE – SOUTH – SEVERE ALLIGATOR CRACKING**

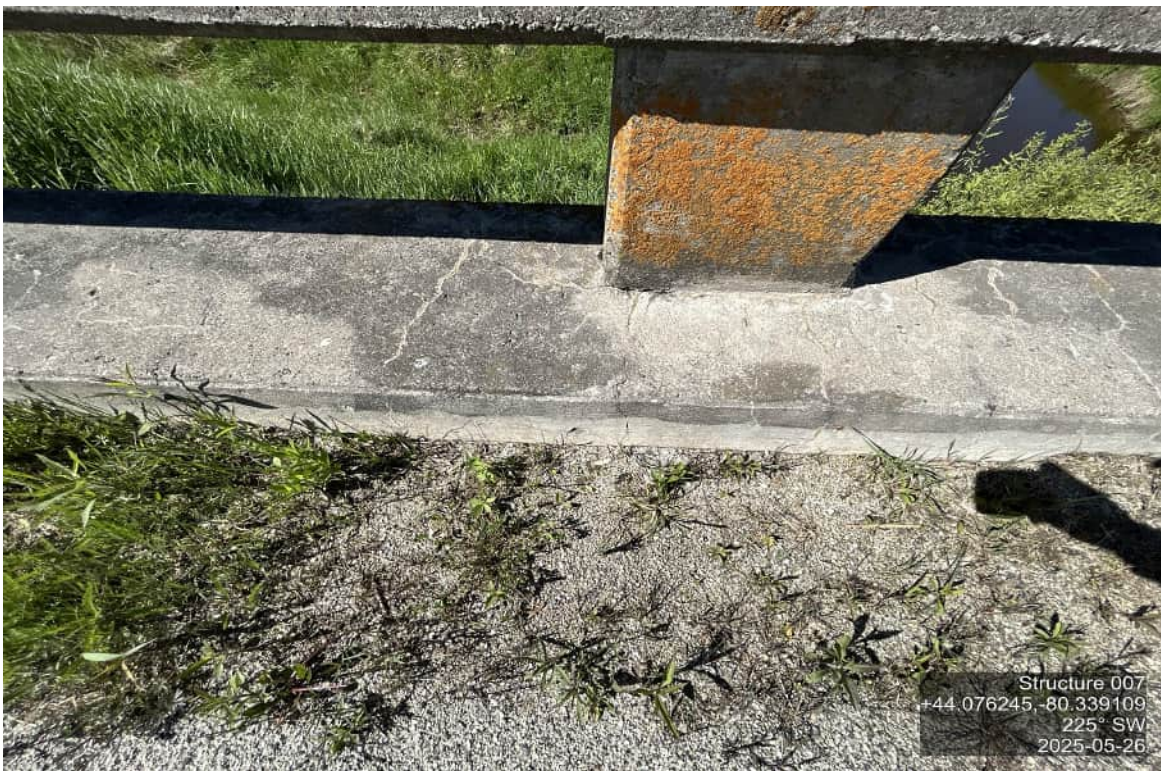
**CURB– WEST - NARROW STAINED CRACKS, DELAMINATIONS AND ABRASIONS**

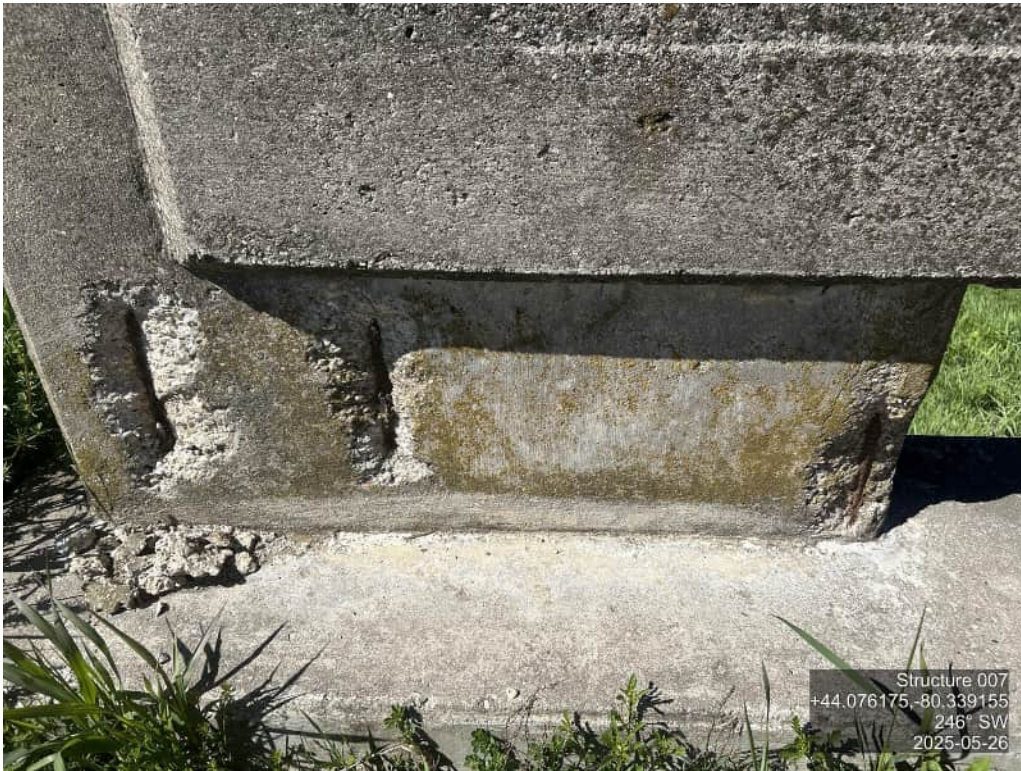
**BARRIER POSTS – WEST – SPALLING WITH EXPOSED CORRODED REBAR**

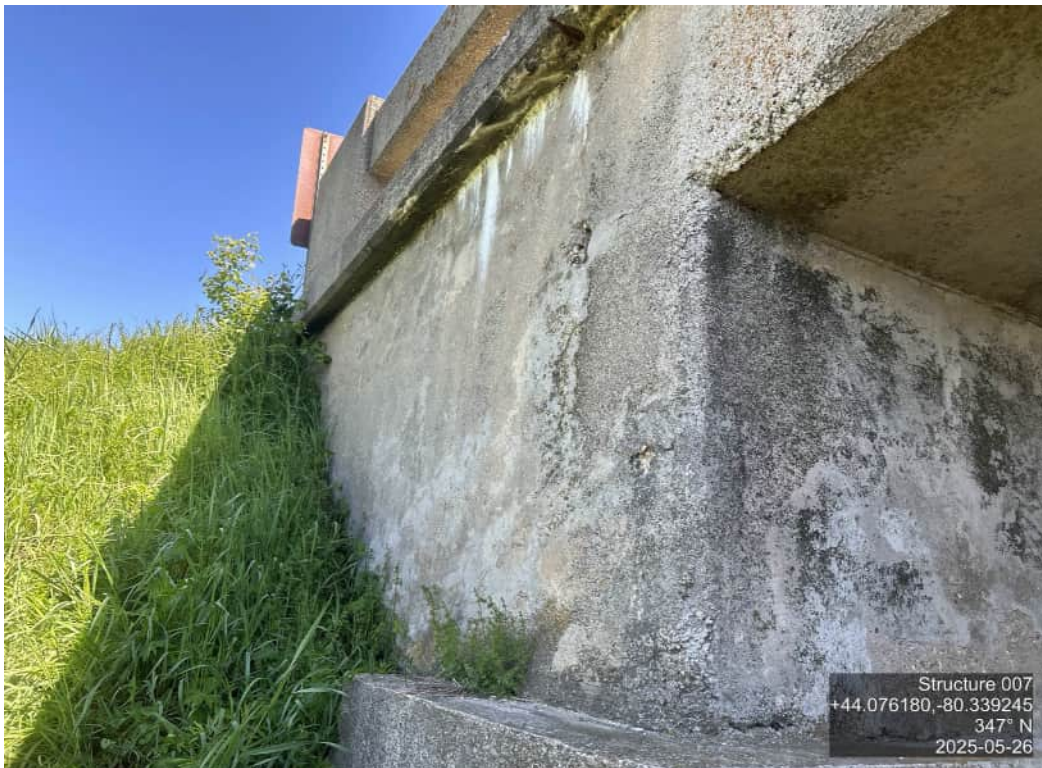
**WINGWALLS – NORTHWEST – LIGHT HONEYCOMBING, DISSINTEGRATION AND EFFLORESCENCE STAINING**

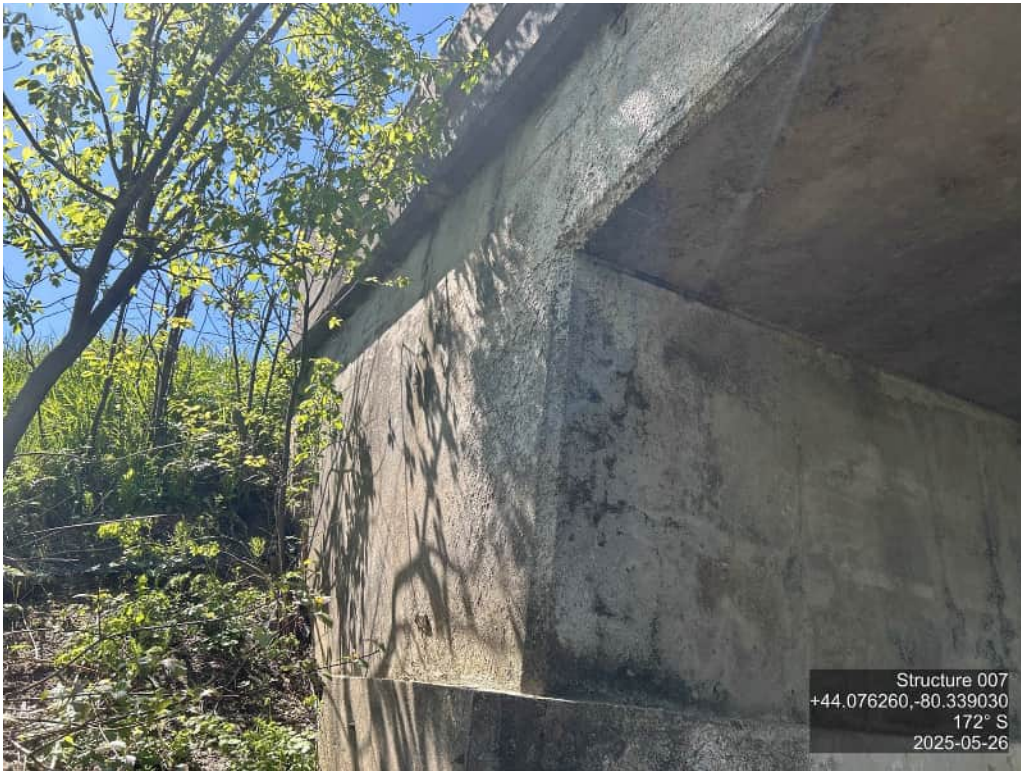
**SOFFIT EXTERIOR – EAST – HONEYCOMBING AND EFFLORESCENCE STAINING**

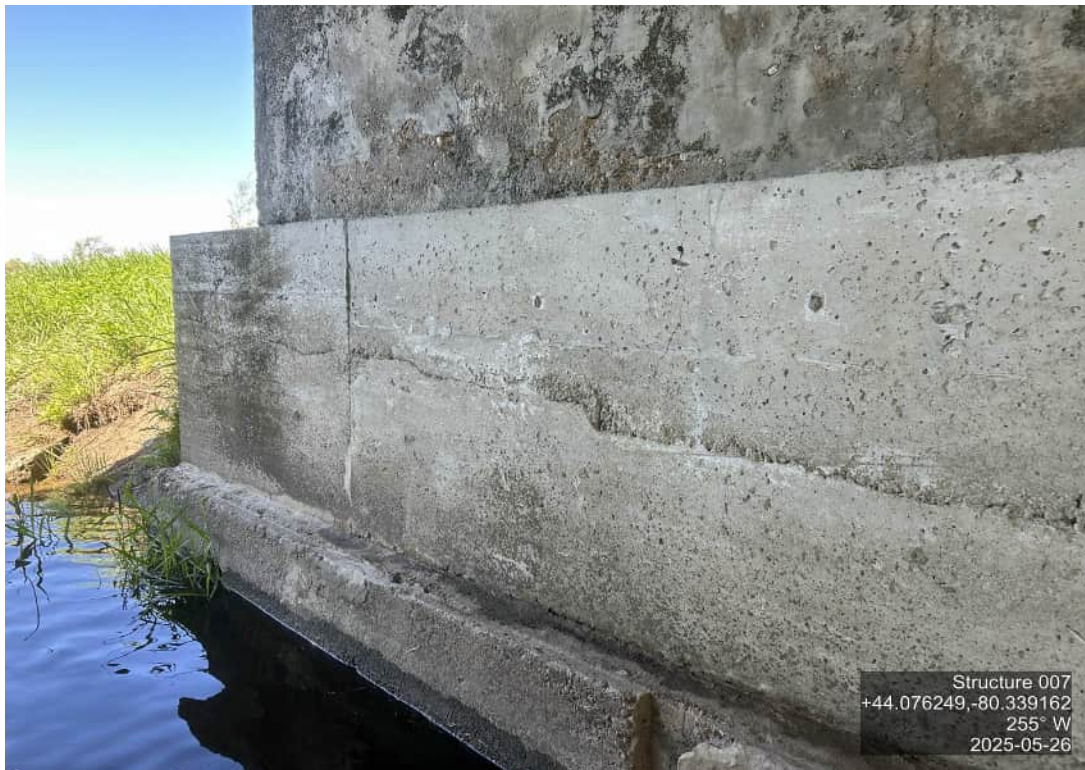
**ABUTMENT WALLS – NORTH – COLD JOINTS, HONEYCOMBING AND SEVERAL VERTICAL CRACKS**
