**BURNSIDE**

## **2025 OSIM Bridge Inspections Report**

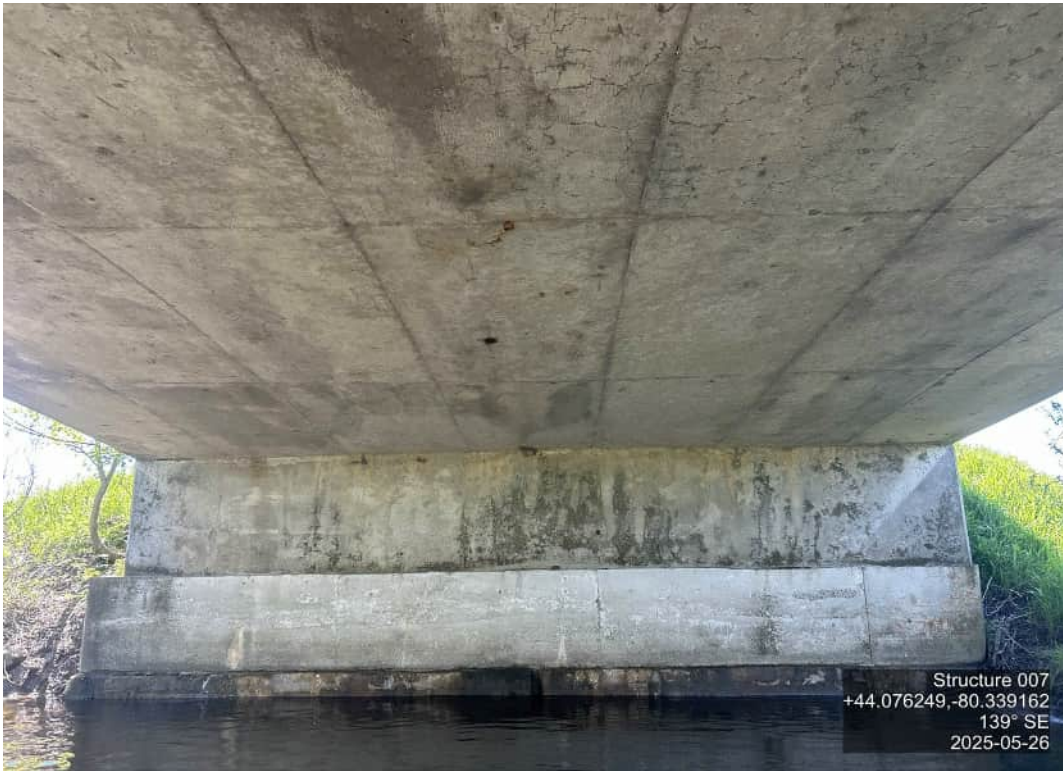
**SOFFIT INTERIOR – INTERIOR – PATTERN CRACKING AND FULL SPAN WIDE CRACK IN CENTER**

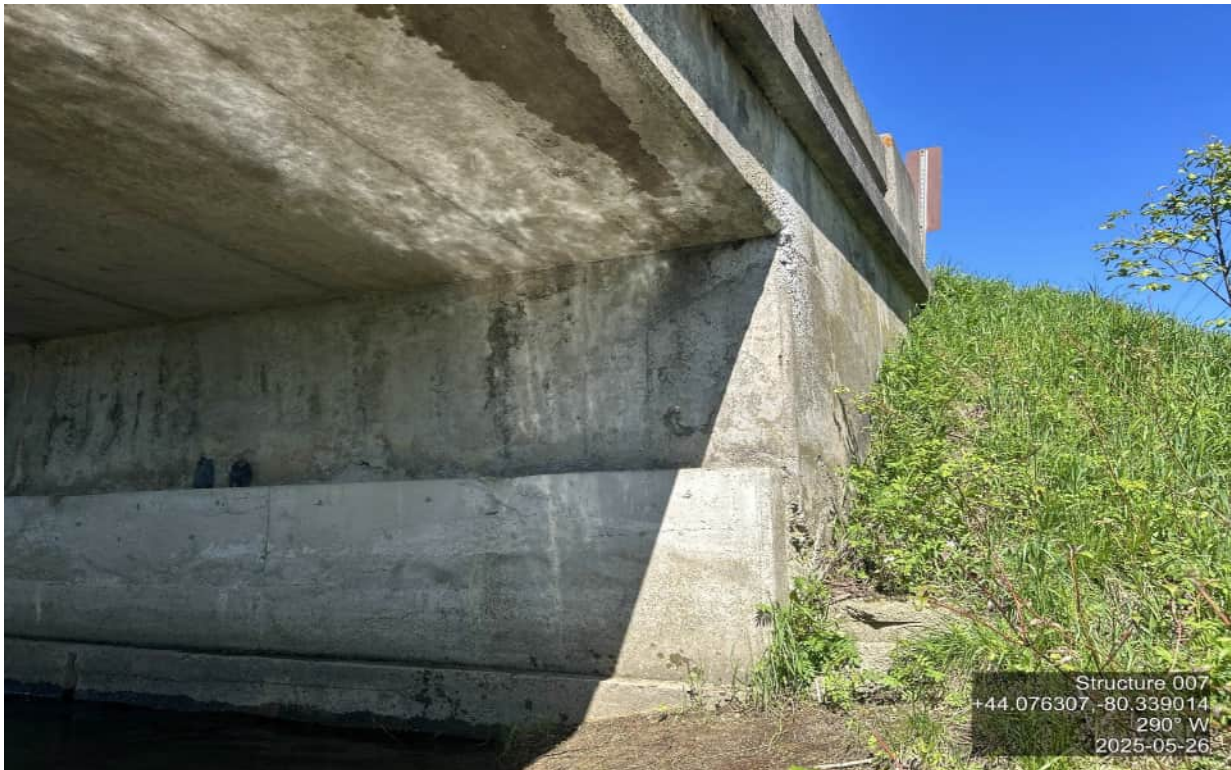
**EMBANKMENTS – NORTHWEST – WELL VEGETATED AND STABLE**

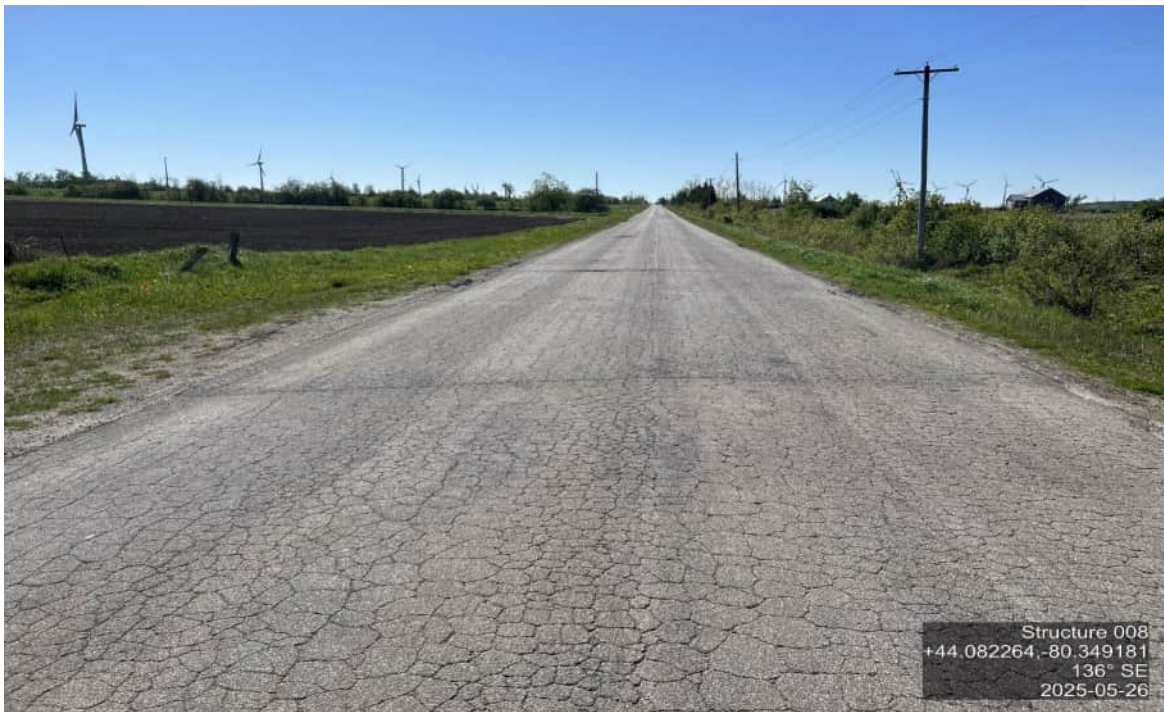
Structure 008  
+44.082264, -80.349181  
136° SE  
2025-05-26

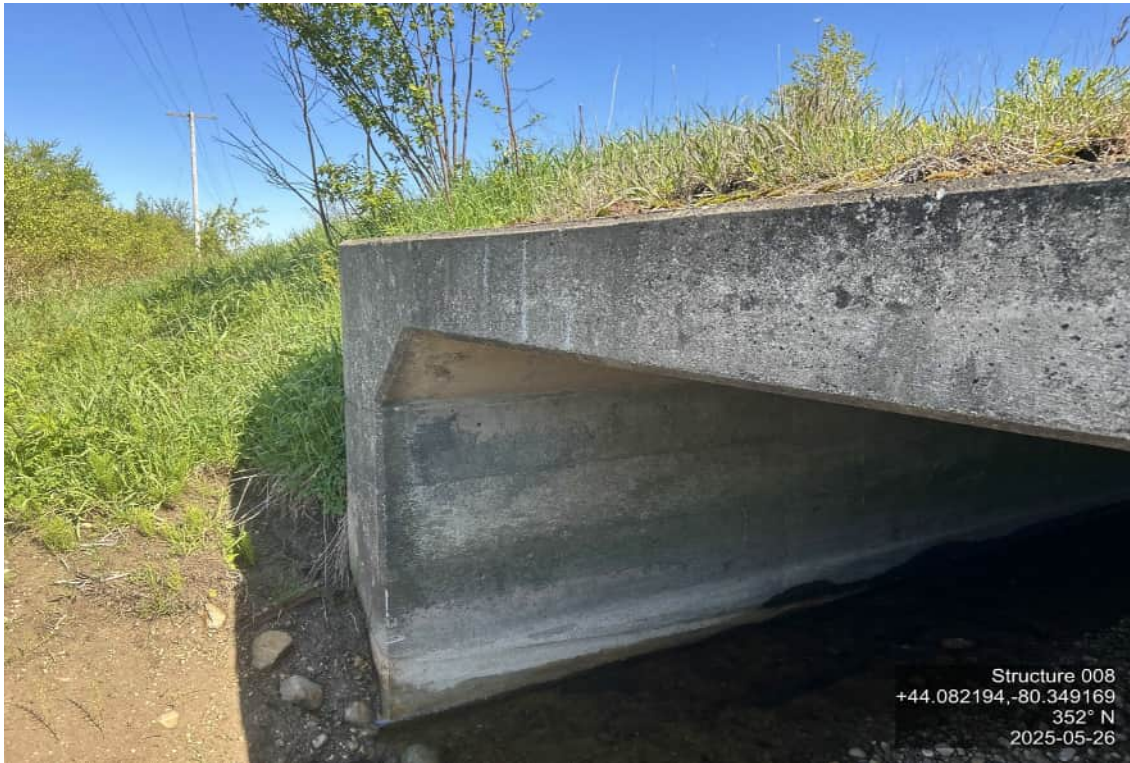
**DECK WEARING SURFACE – OVER DECK TOP – SEVERE ALLIGATOR CRACKING**

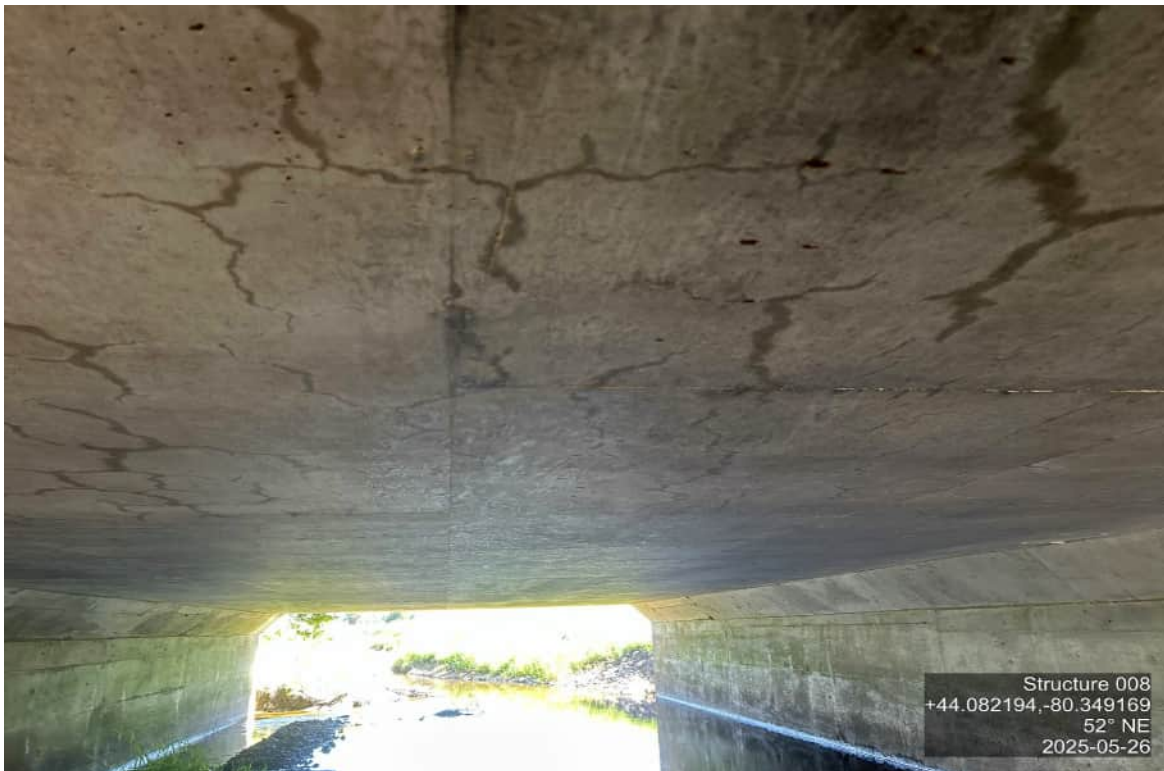
**BARREL – INTERIOR – MOISTURE PENETRATION CRACKING**

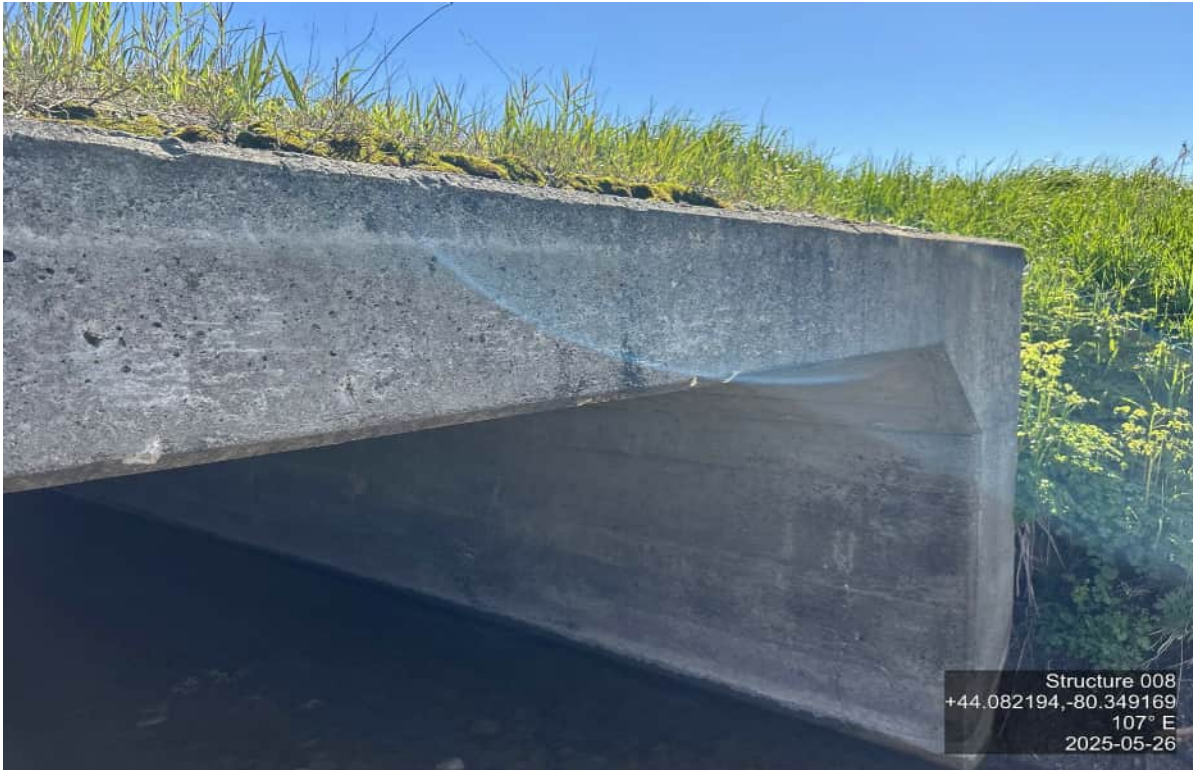
**OUTLET – WEST – LIGHT SCALING AND POPOUTS**

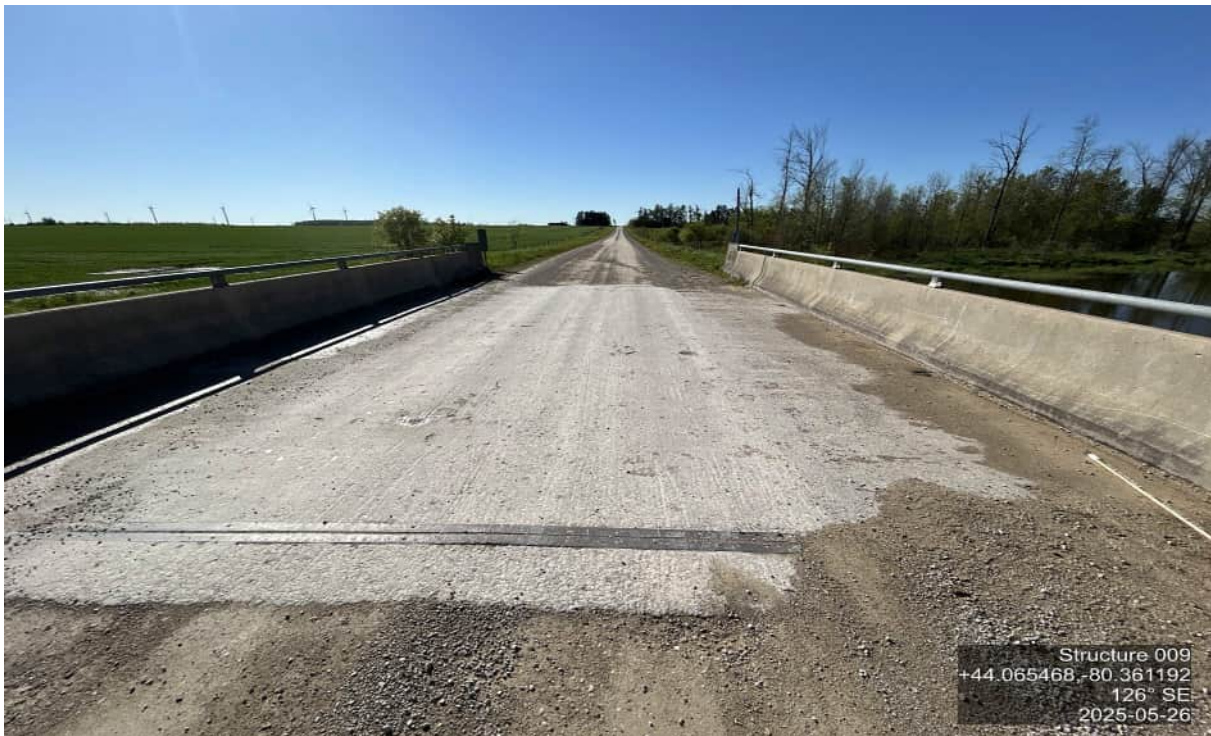
**DECK TOP – NORTH – MEDIUM LONGITUDINAL CRACK IN CENTER WITH DELAMINATIONS PRESENT**

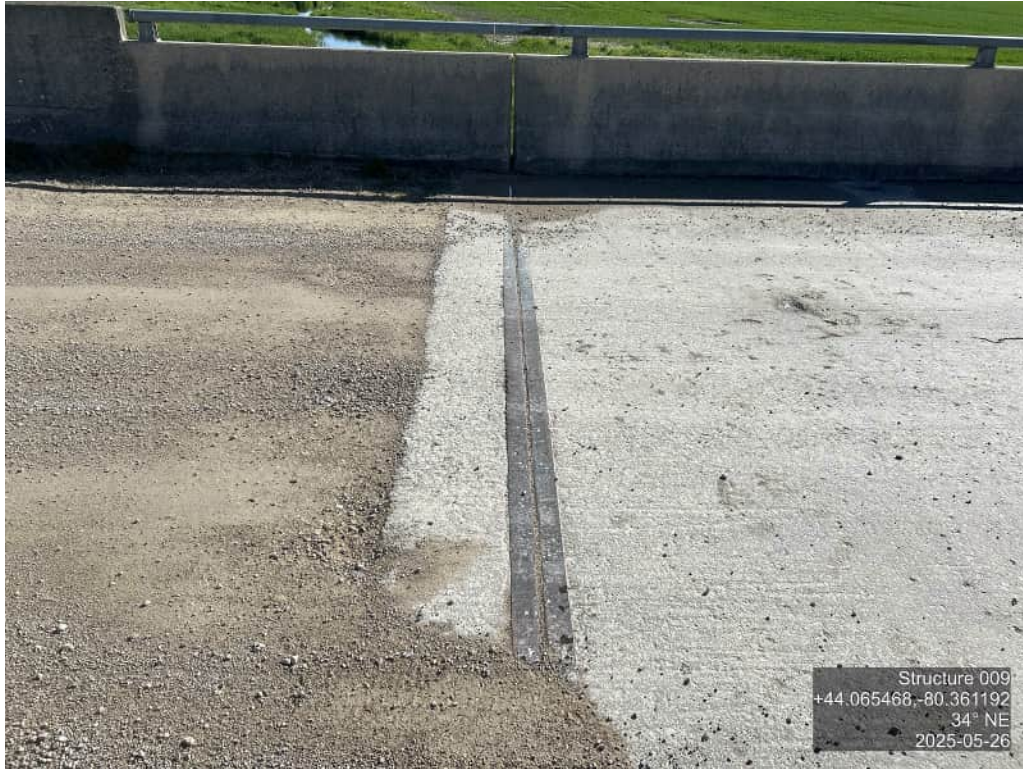
**ARMOURING – NORTH – APPEARS TO BE SEIZED**

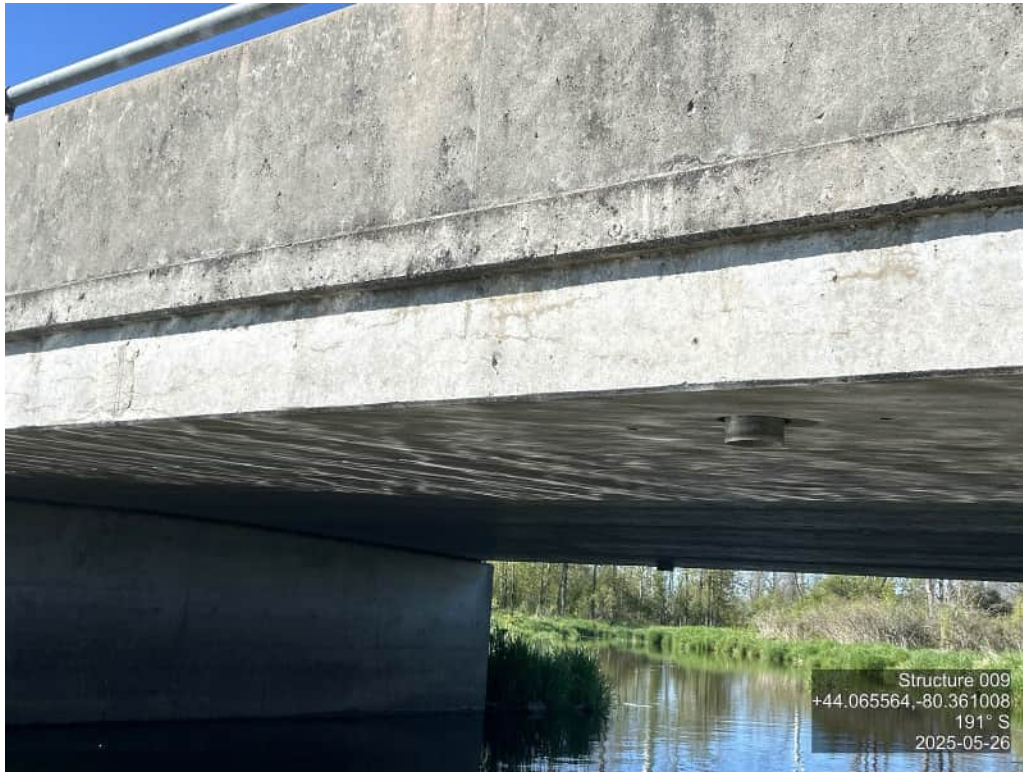
**BARRIER WALL EXTERIOR – WEST – NARROW STAINED CRACKS**

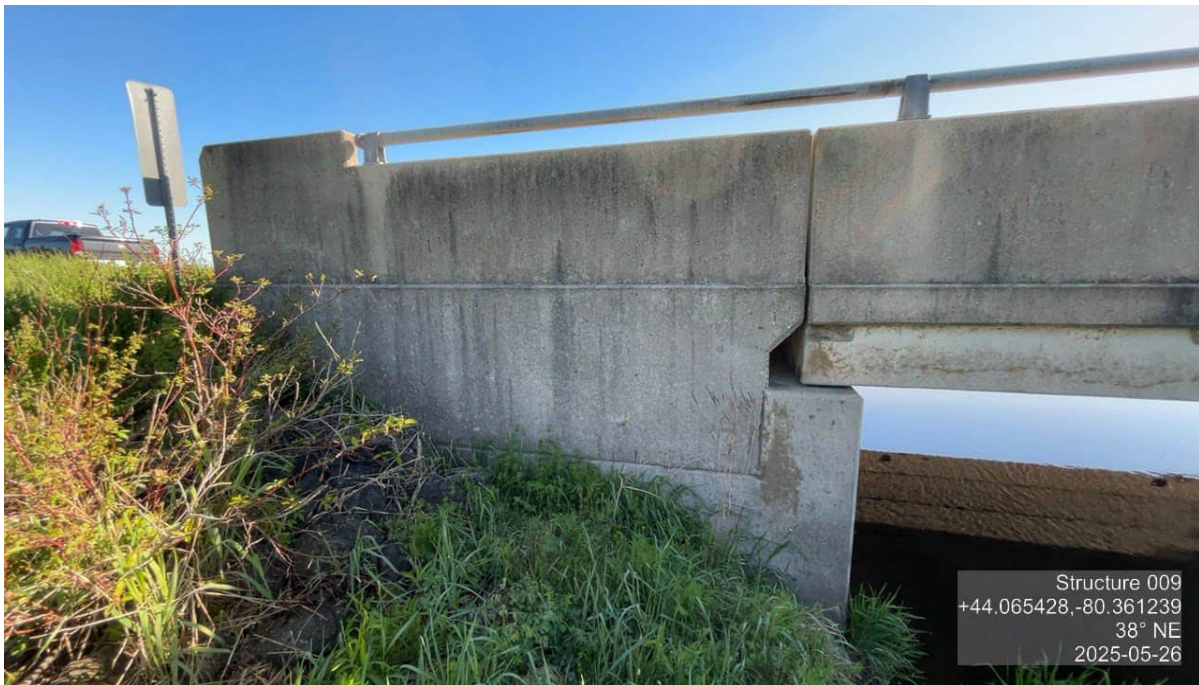
**WINGWALL – NORTHEAST – NARROW STAINED CRACKS**

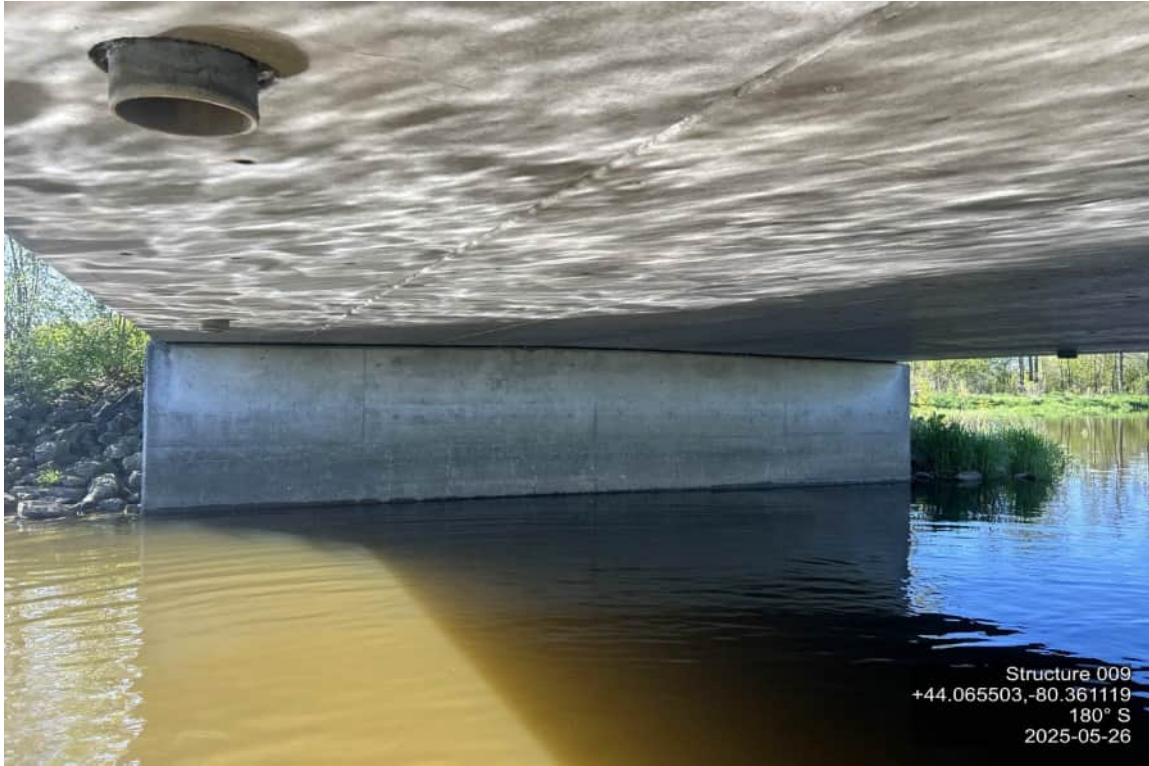
**ABUTMENT WALLS – SOUTH – LIGHT HONEYCOMBING**

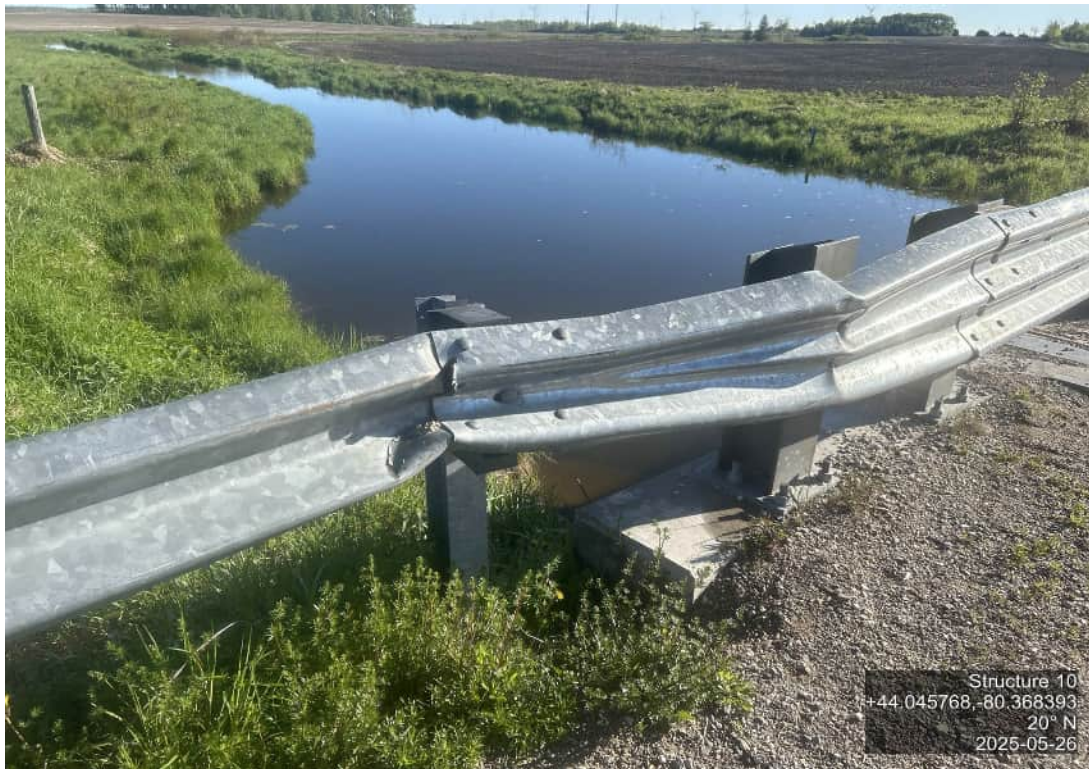
**APPROACH GUIDERAIL – NORTH – IMPACT DAMAGE THROUGHOUT**

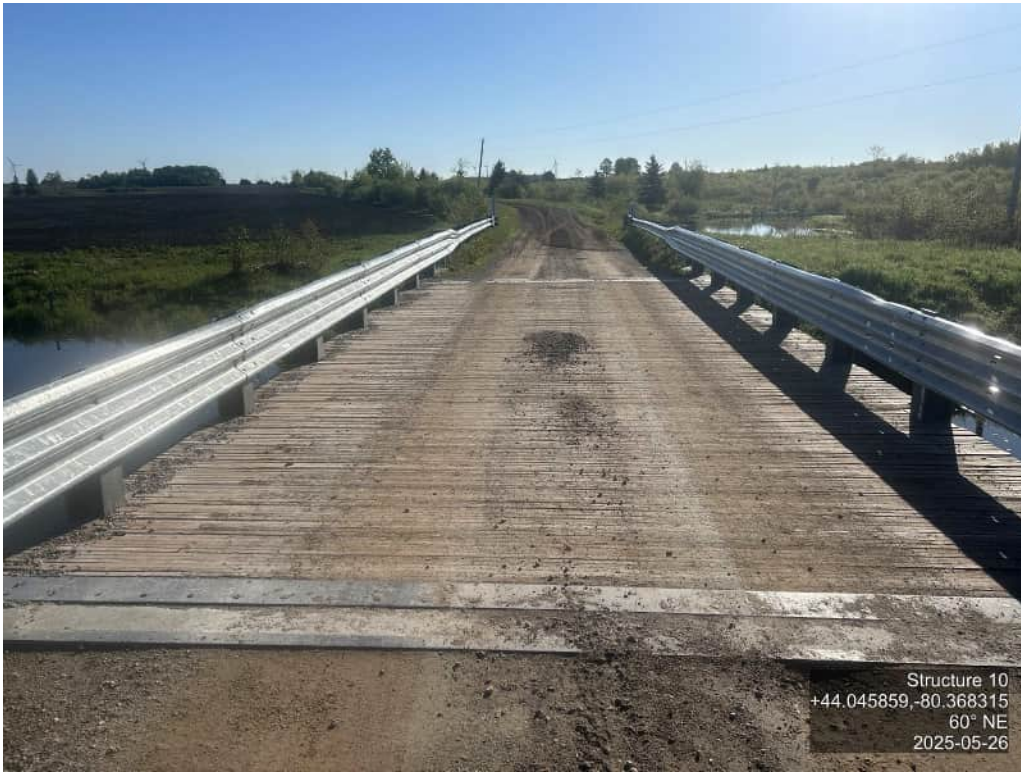
**DECK TOP – EAST – LIGHT SPLITS AND WEATHERING**

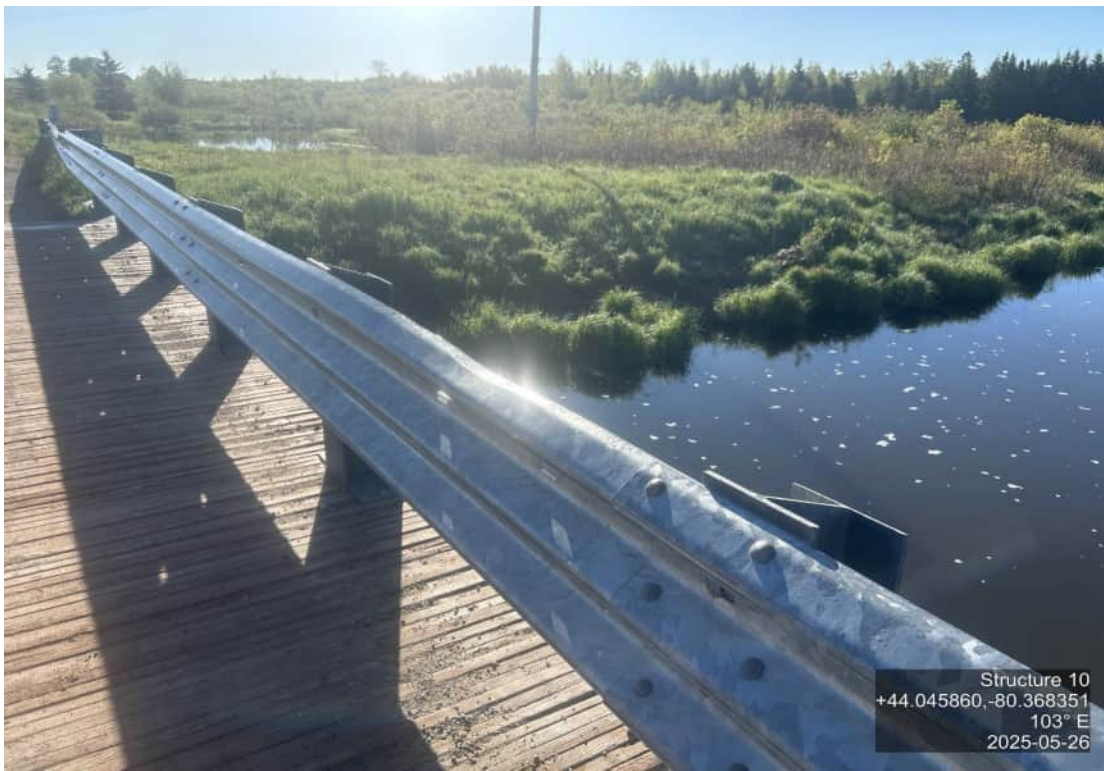
**RAILING SYSTEM – SOUTH – LIGHT IMPACT DAMAGE**

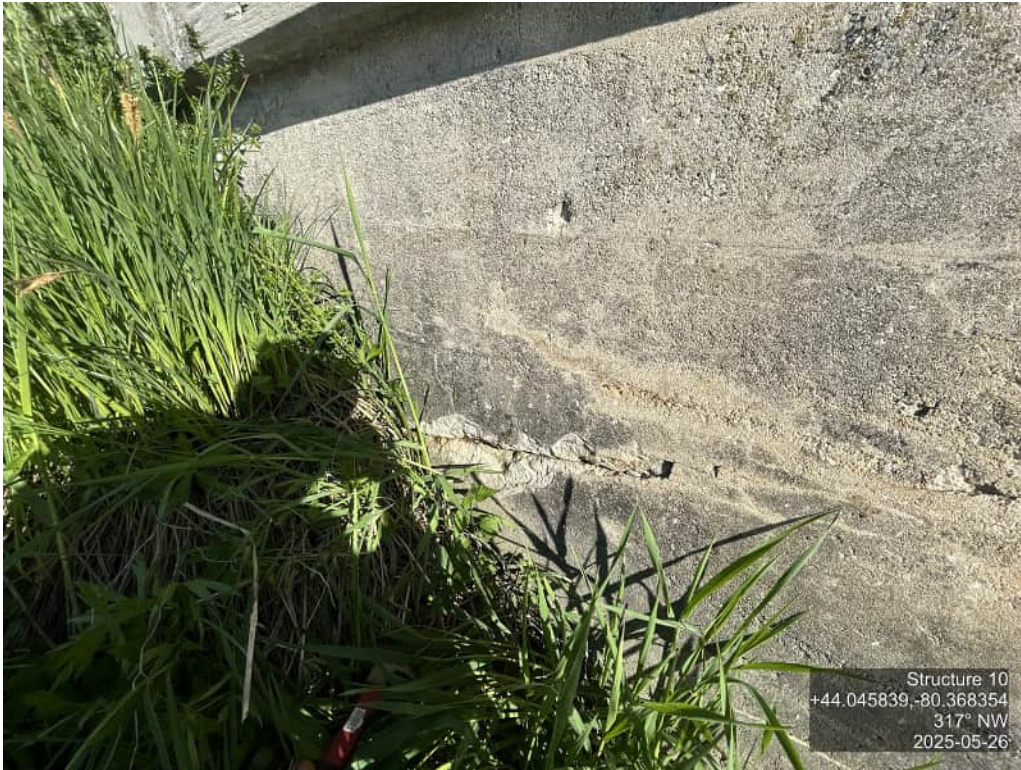
**WINGWALL – SOUTHEAST – MEDIUM CRACK**

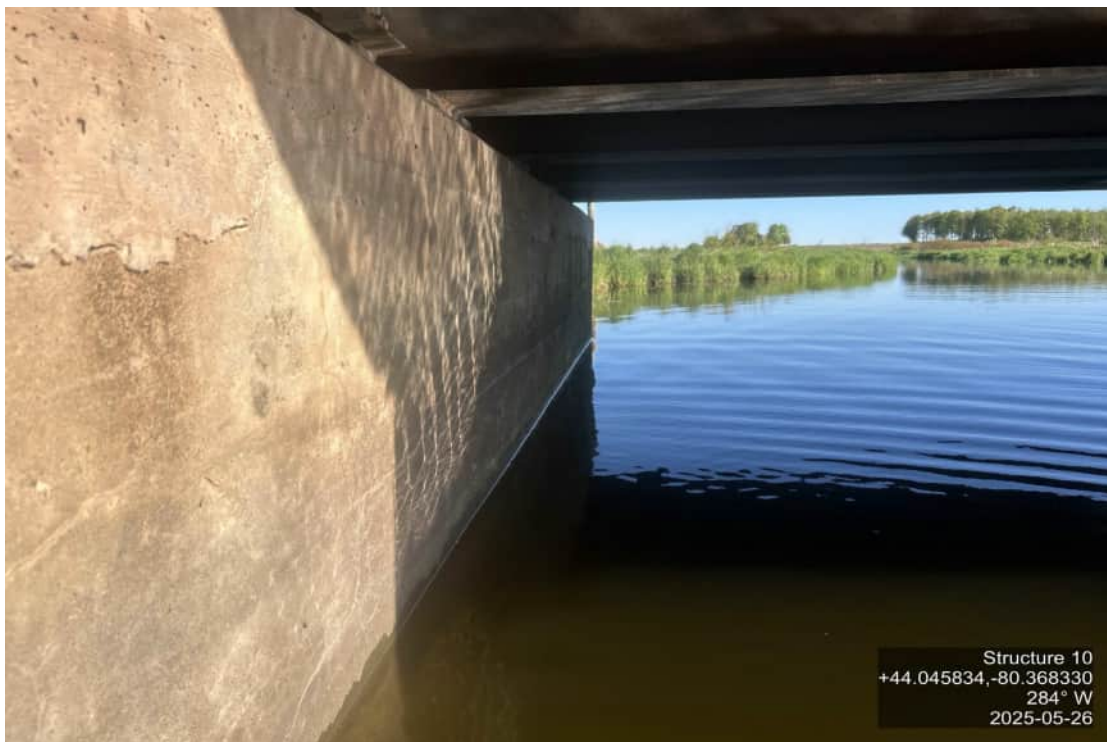
**ABUTMENT WALLS – WEST – HAIRLINE TO MEDIUM CRACKING THROUGHOUT**

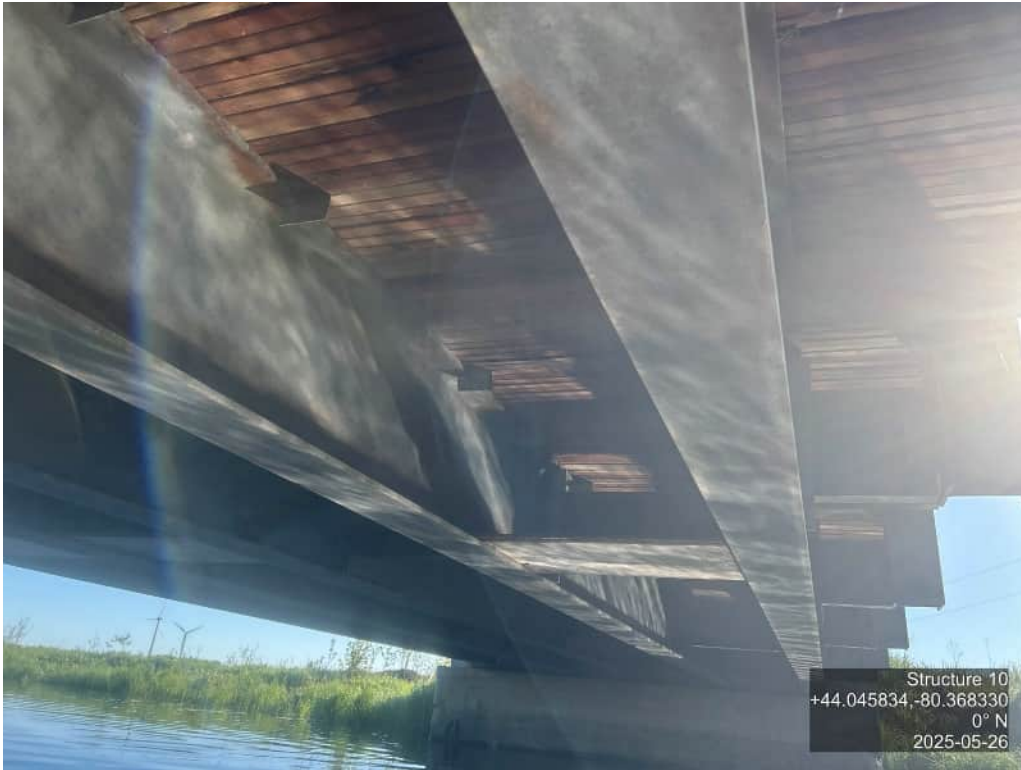
**GIRDERS – MIDDLE**

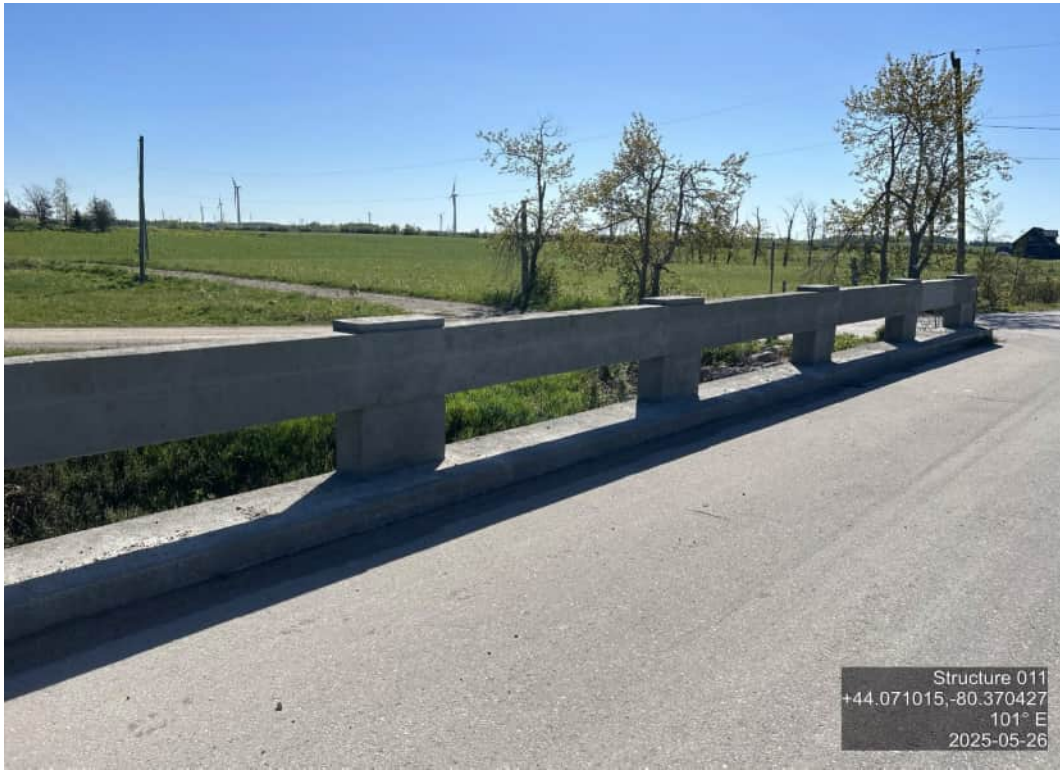
**RAILING SYSTEM – SOUTH – REPAIRED DURING 2022 REHAB**

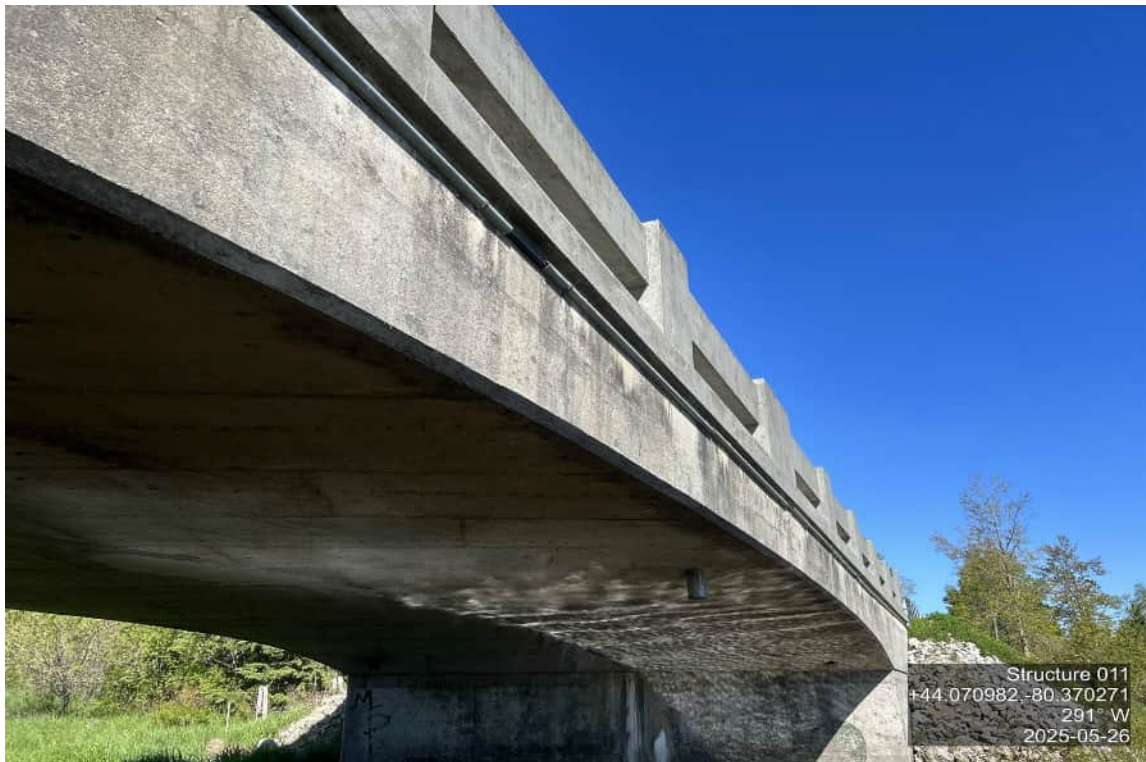
**SOFFIT EXTERIOR – WEST – DAMPNESS NOTED**

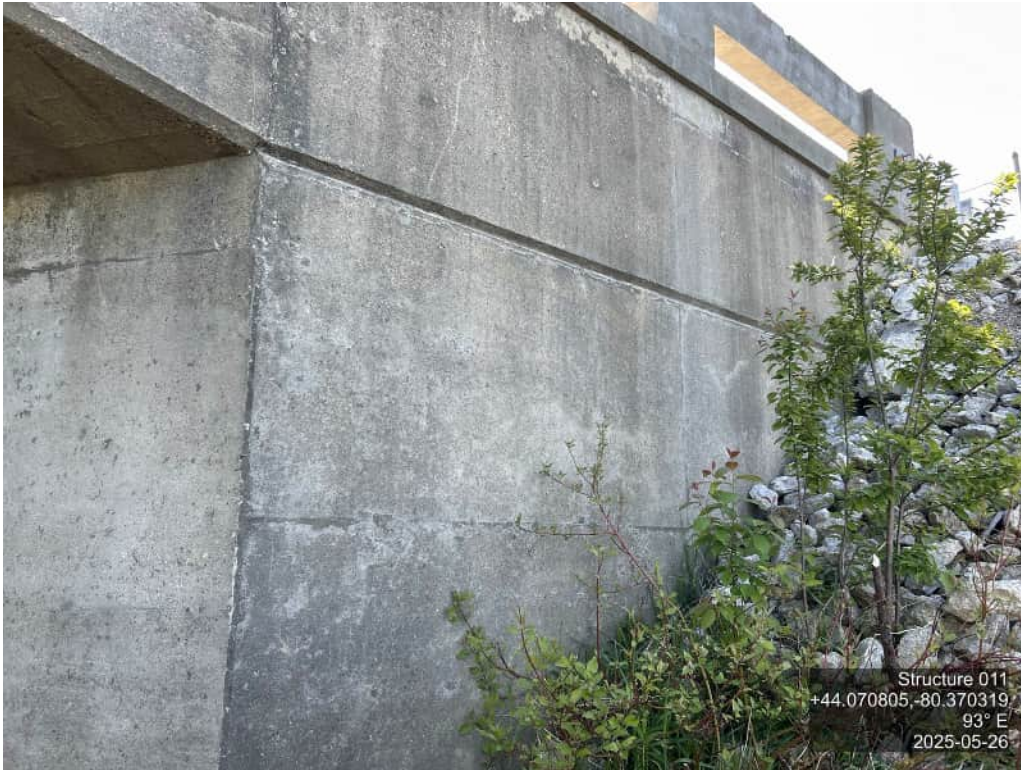
**WINGWALL – SOUTHWEST – EFFLORESCENCE STAINING**

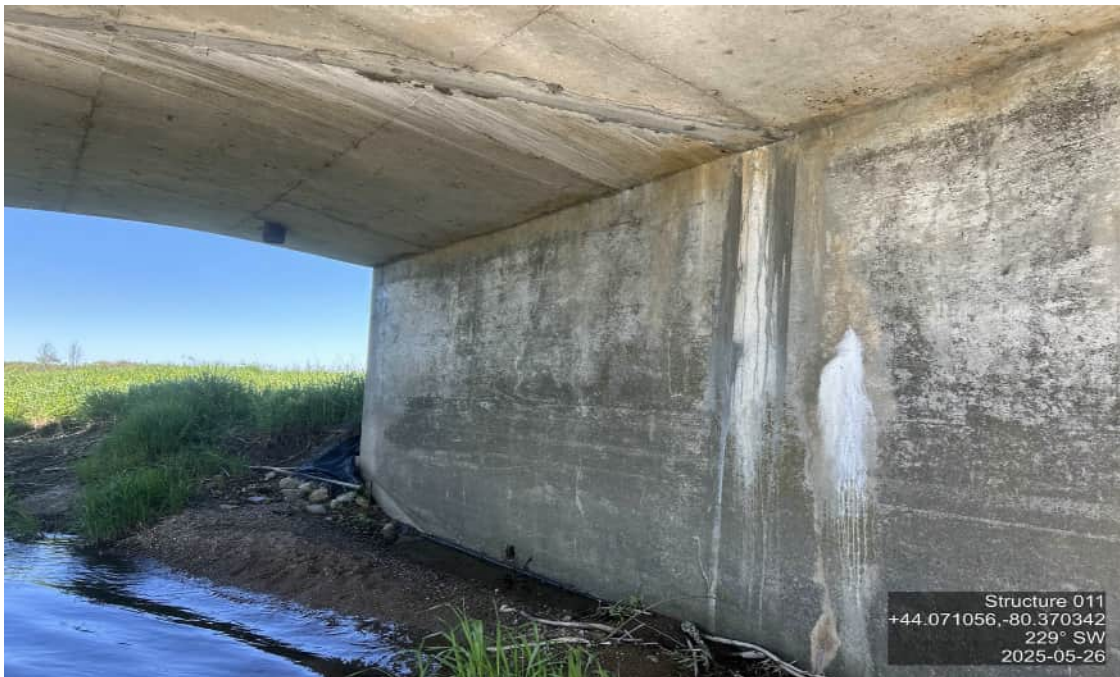
**ABUTMENT WALLS – SOUTHWEST – WIDE VERTICAL FULL HEIGHT CRACK AT CENTER**

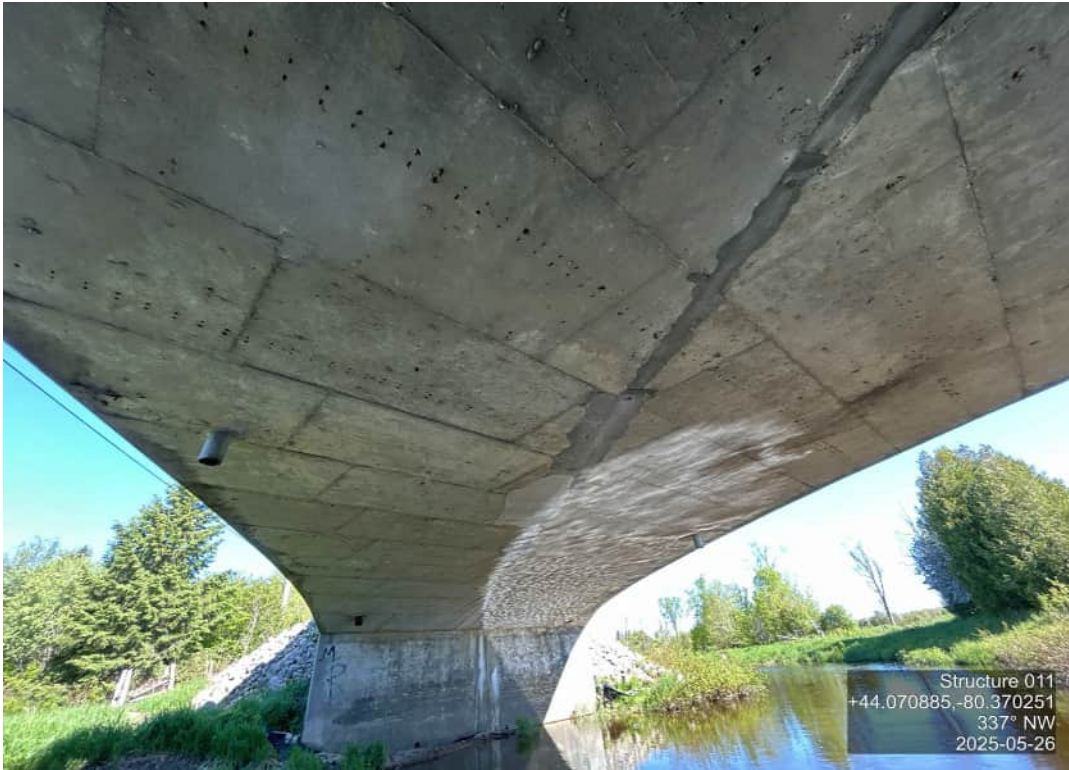
**SOFFIT INTERIOR – NORTHWEST – WIDE CRACK PATCHED IN 2022 REHAB**

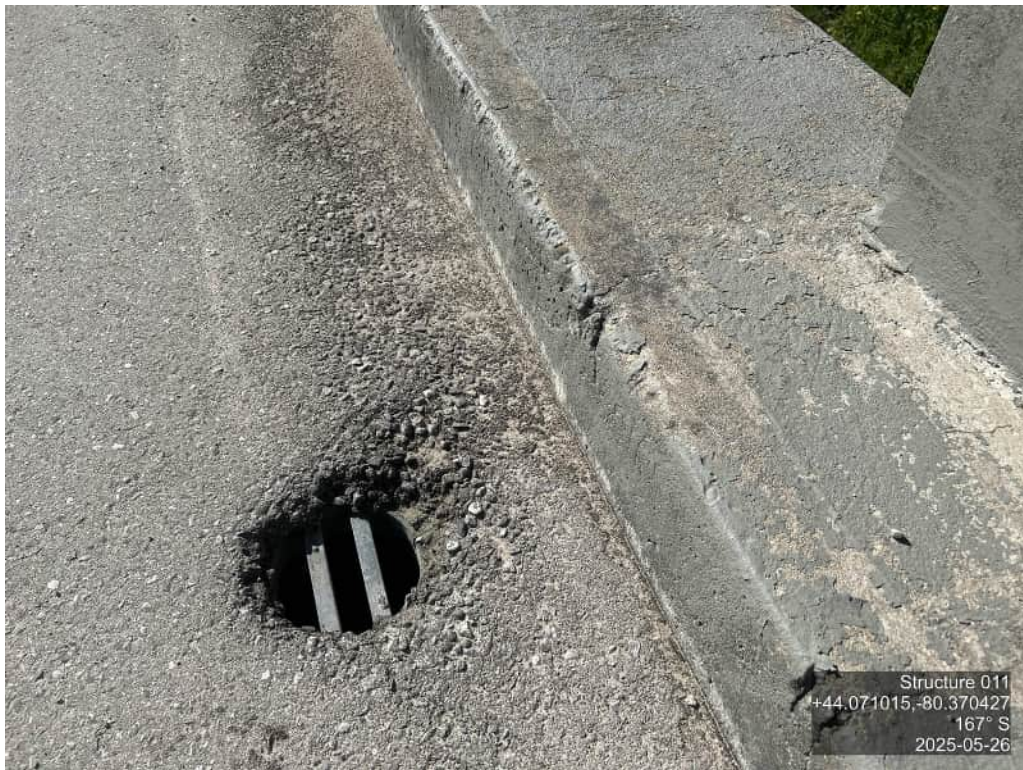
**DECK DRAINS – EAST – ALL APPEAR FUNCTIONAL**

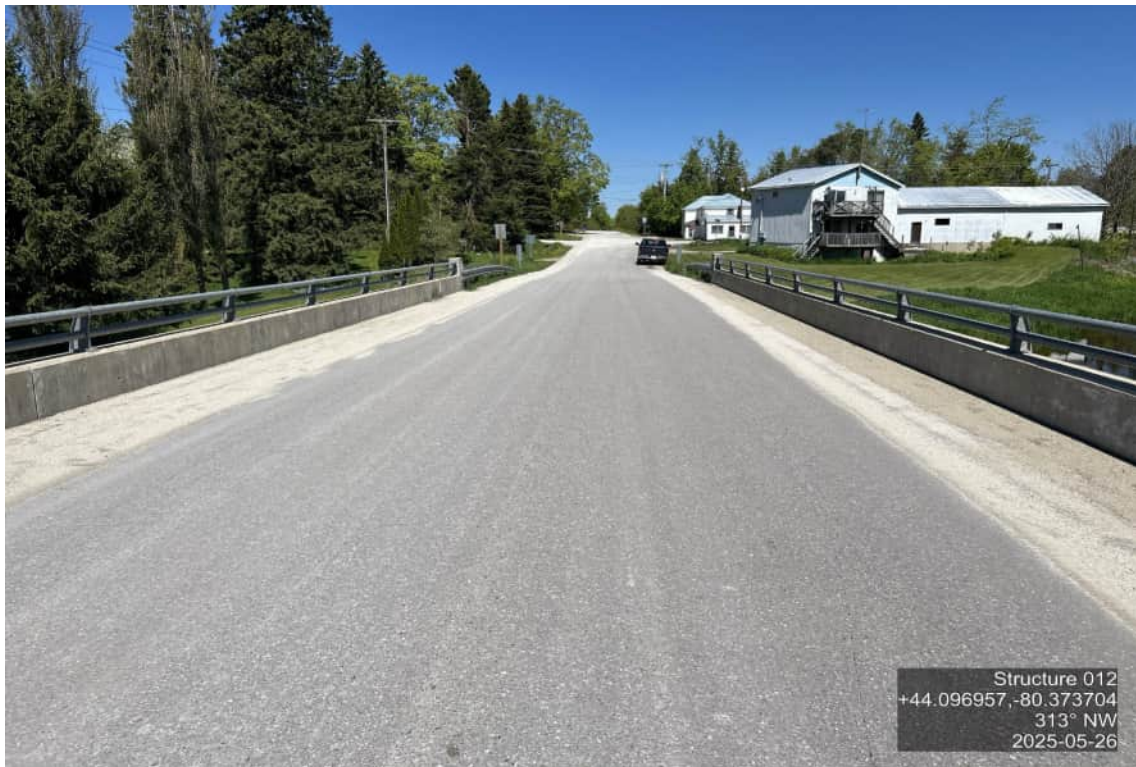
**DECK WEARING SURFACE – WEST – GRANULAR ON SHOULDERS**

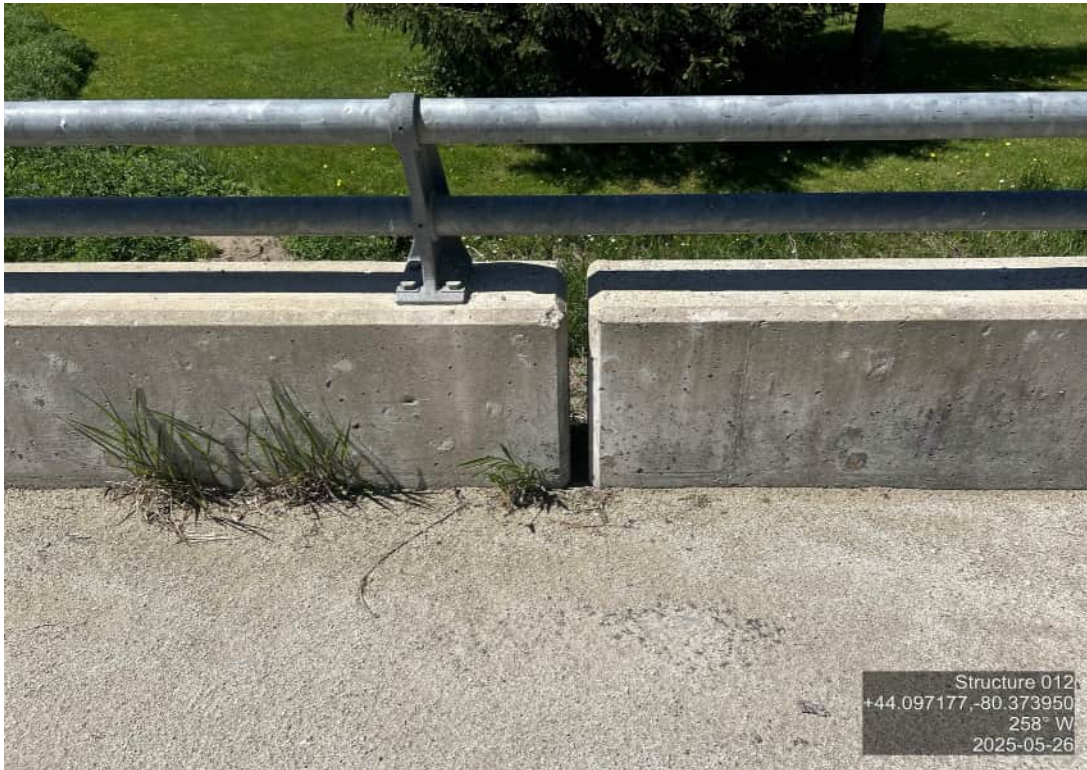
**BARRIER WALLS INTERIOR – NORTH – MISSING JOINT SEAL**

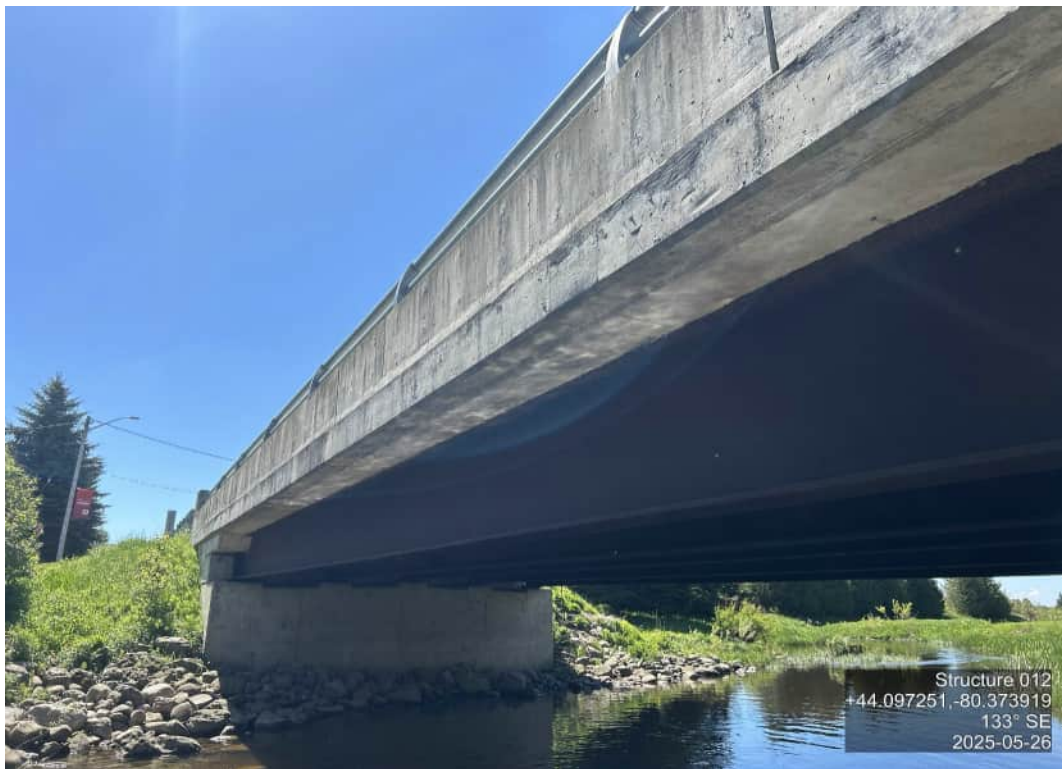
**BARRIER WALLS EXTERIOR – SOUTHWEST**

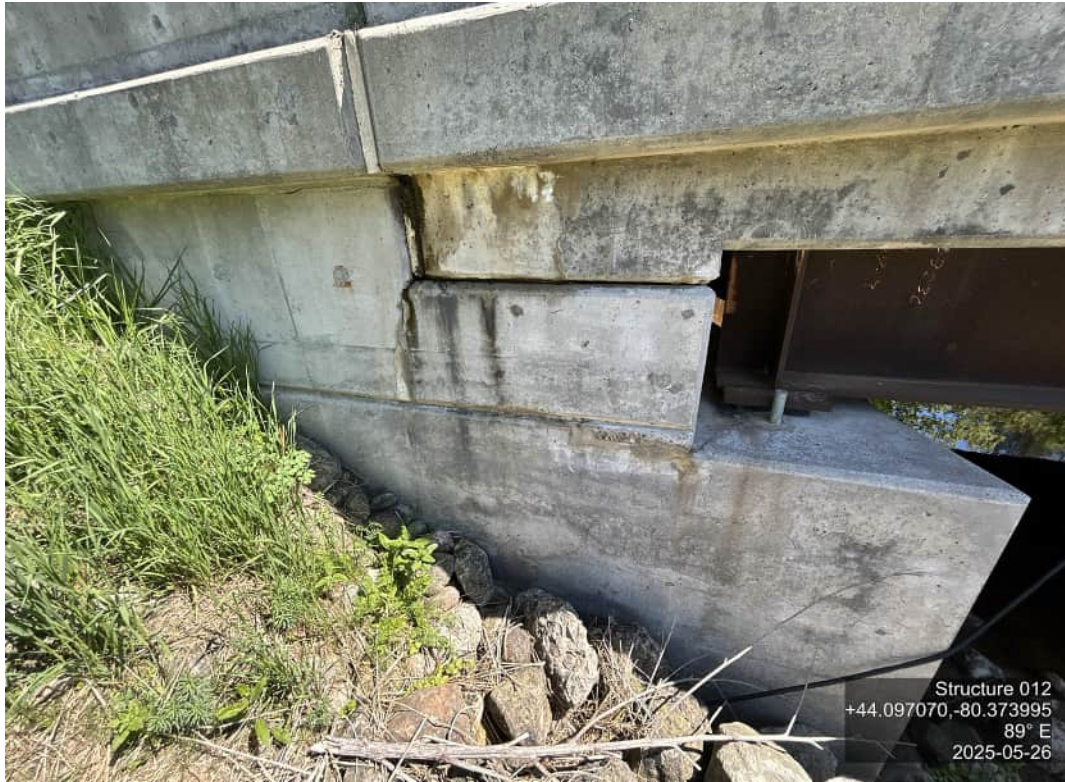
**WINGWALLS – WEST – EFFLORESCENCE STAINED CRACK BELOW JOINT**
