**BURNSIDE**

## **2025 OSIM Bridge Inspections Report**

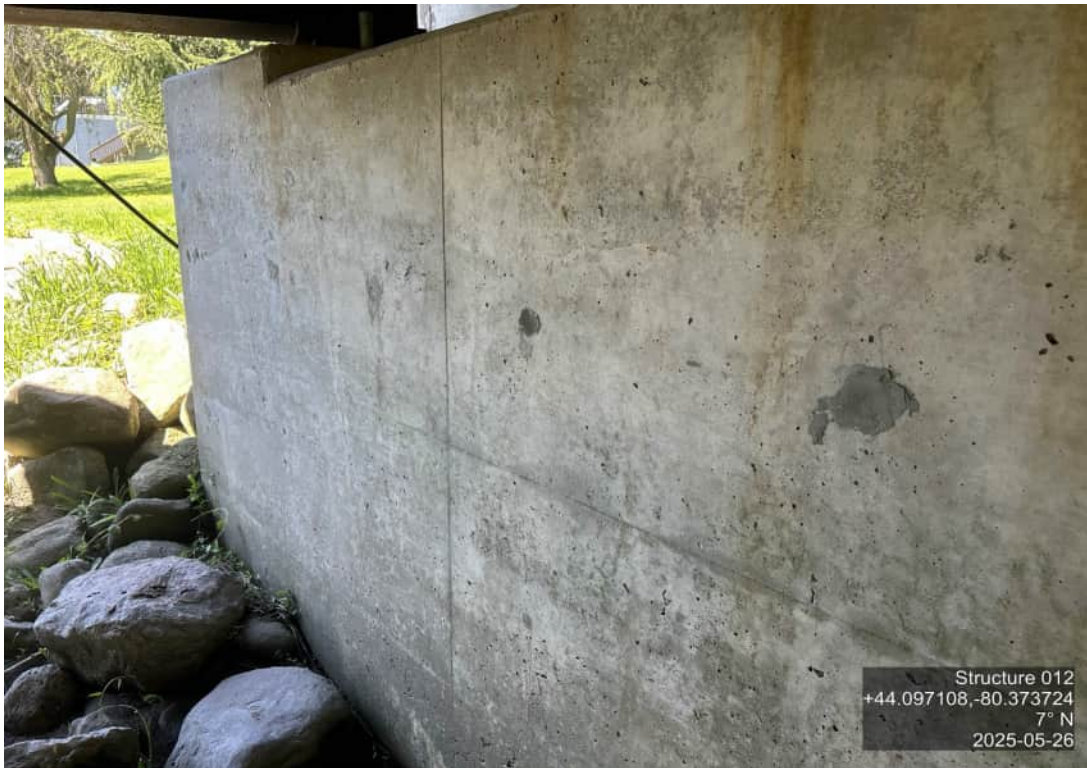
**ABUTMENT WALLS – LOCATION – MEDIUM VERTICAL CRACK ON EACH WALL**

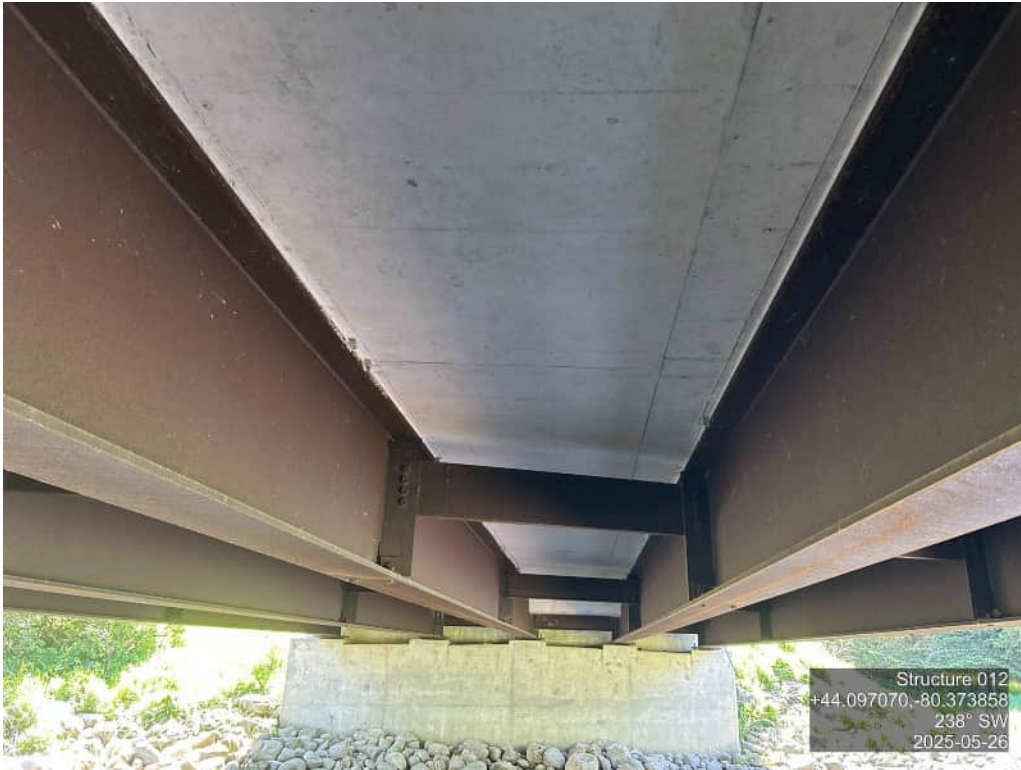
**GIRDERS – MIDDLE**

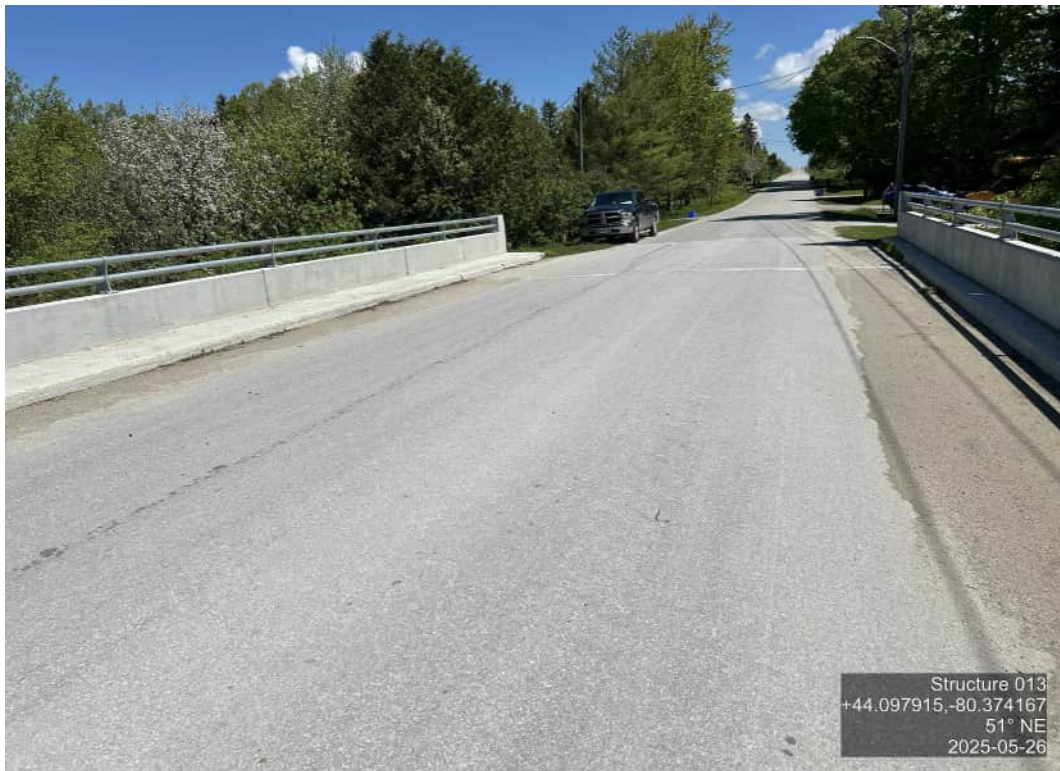
**DECK WEARING SURFACE – NORTHWEST – REPLACED IN 2021**

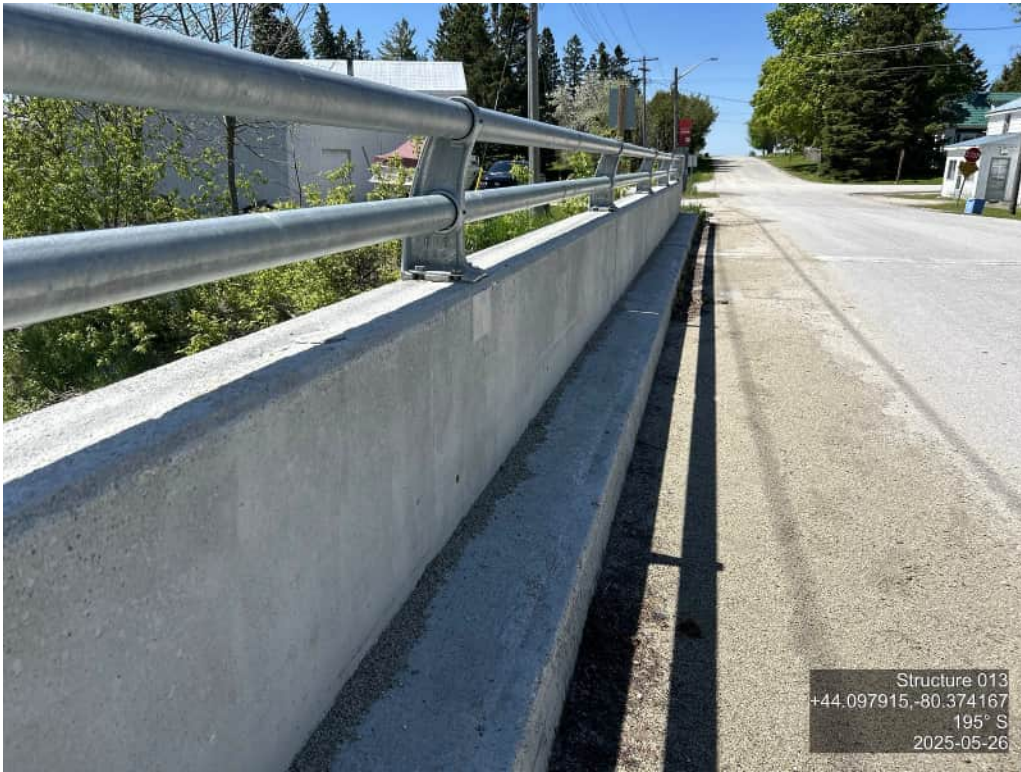
Structure 013  
+44.097915, -80.374167  
195° S  
2025-05-26

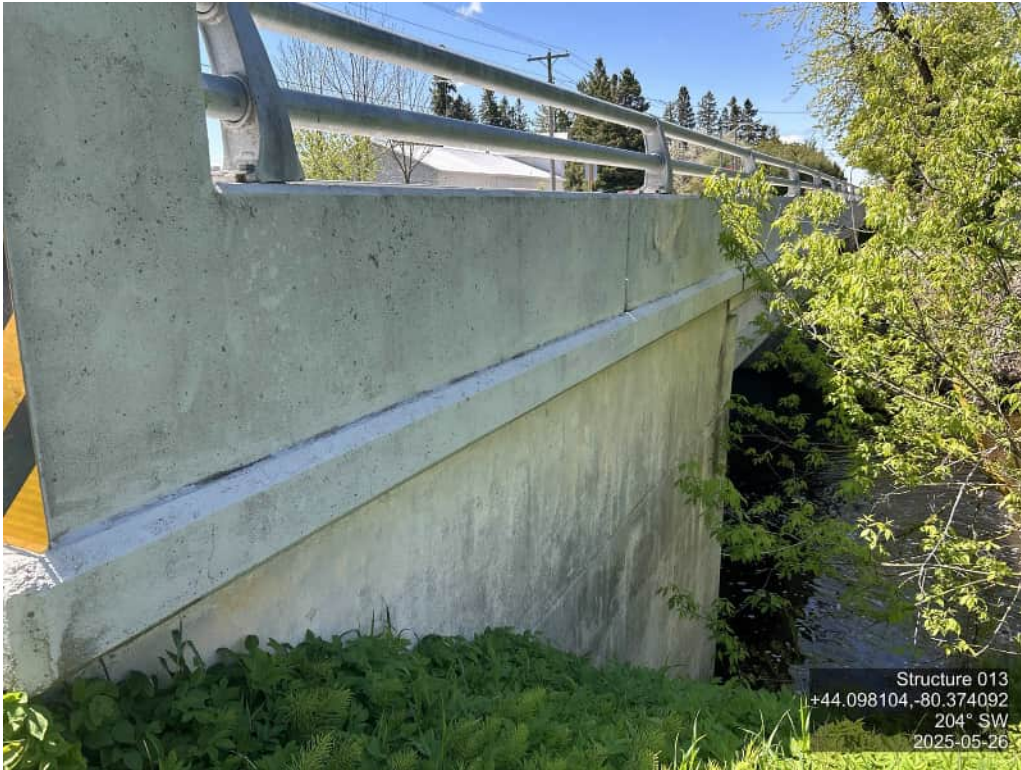
**WINGWALL – SOUTHEAST – NARROW CRACKS THROUGHOUT**

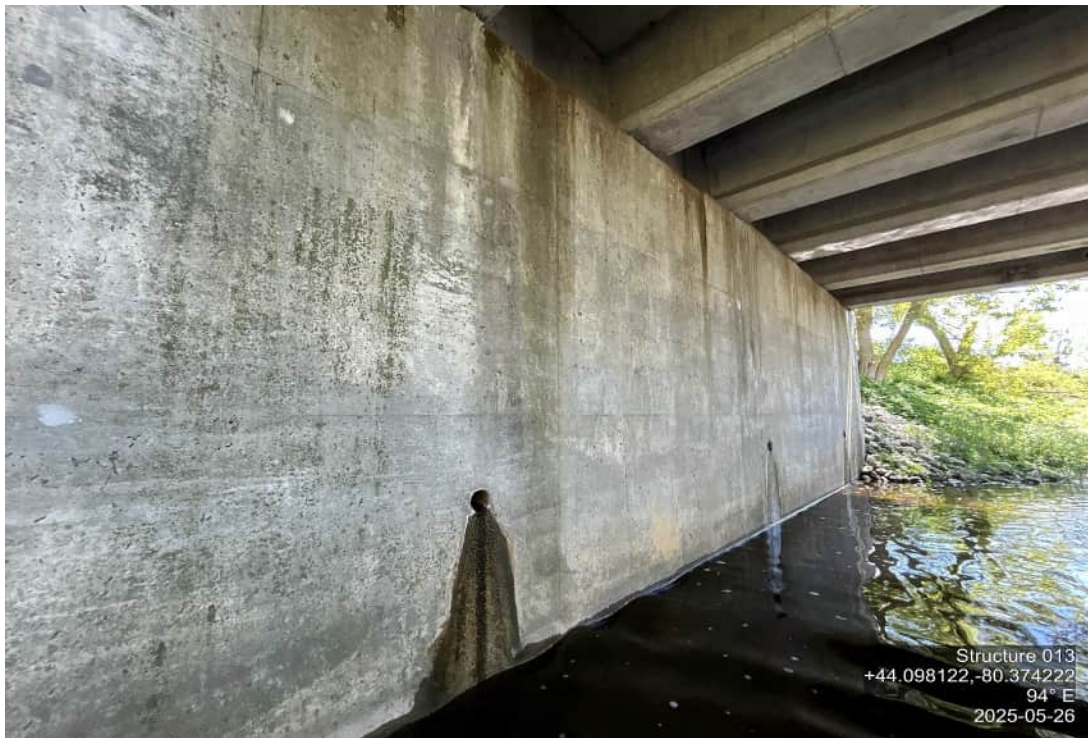
**ABUTMENT WALLS – EAST – WIDE VERTICAL CRACK IN CENTER**

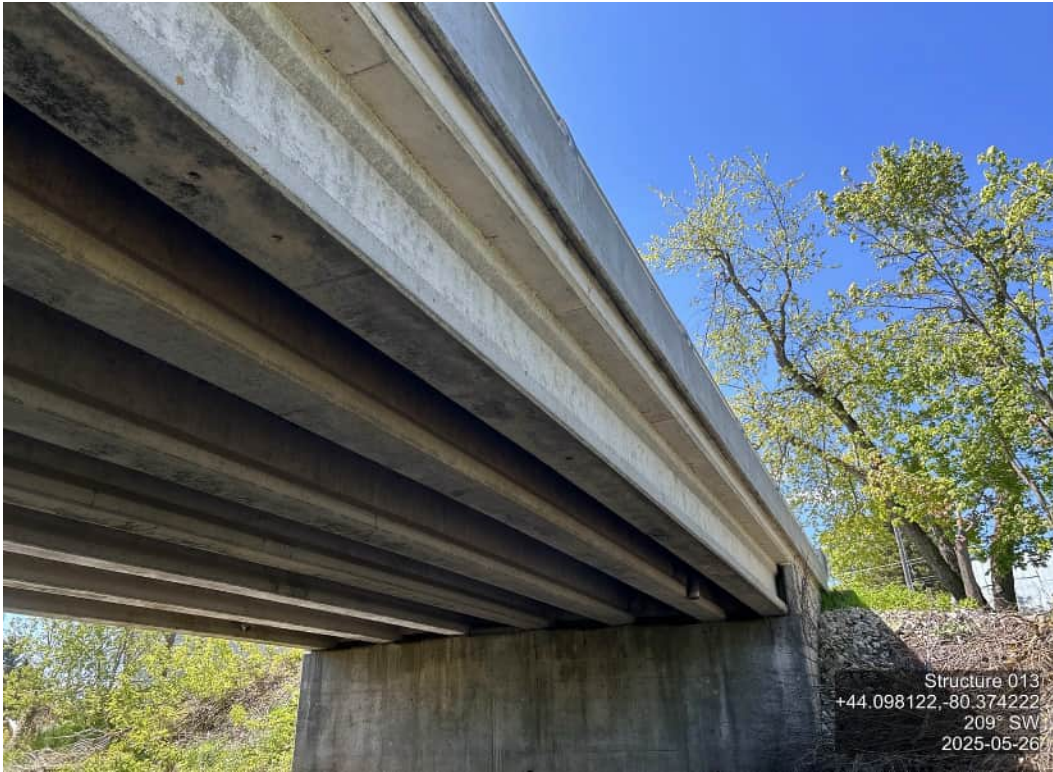
**GIRDERS – MIDDLE – NARROW CRACKS THROUGHOUT**

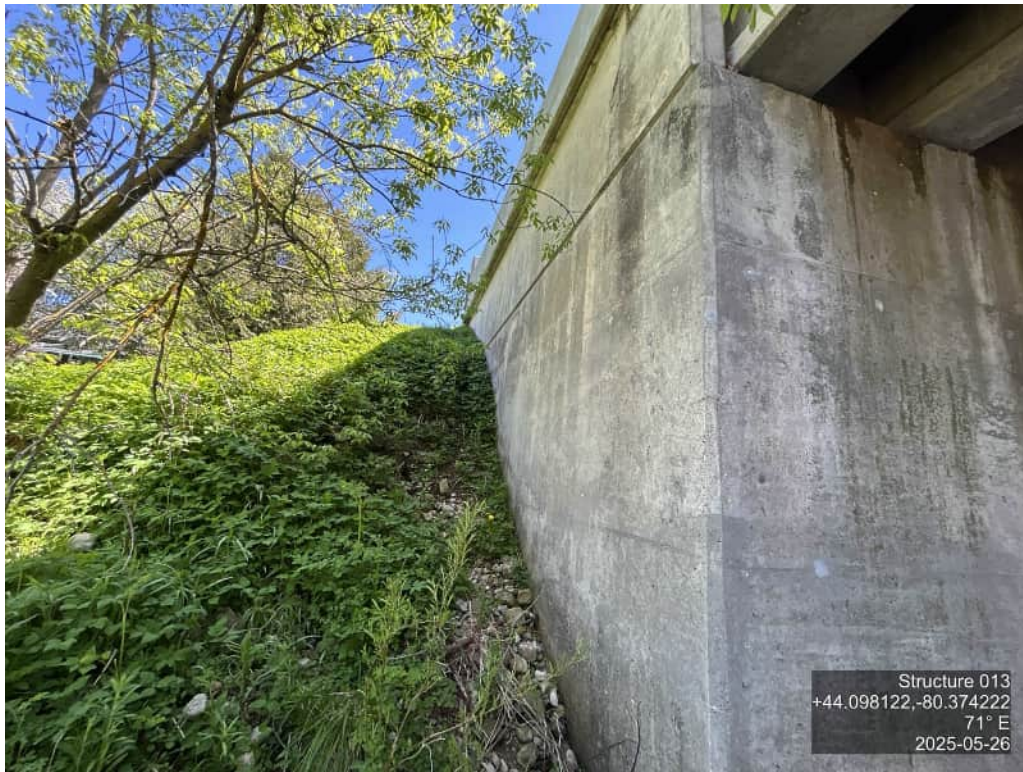
**EMBANKMENT – EAST**

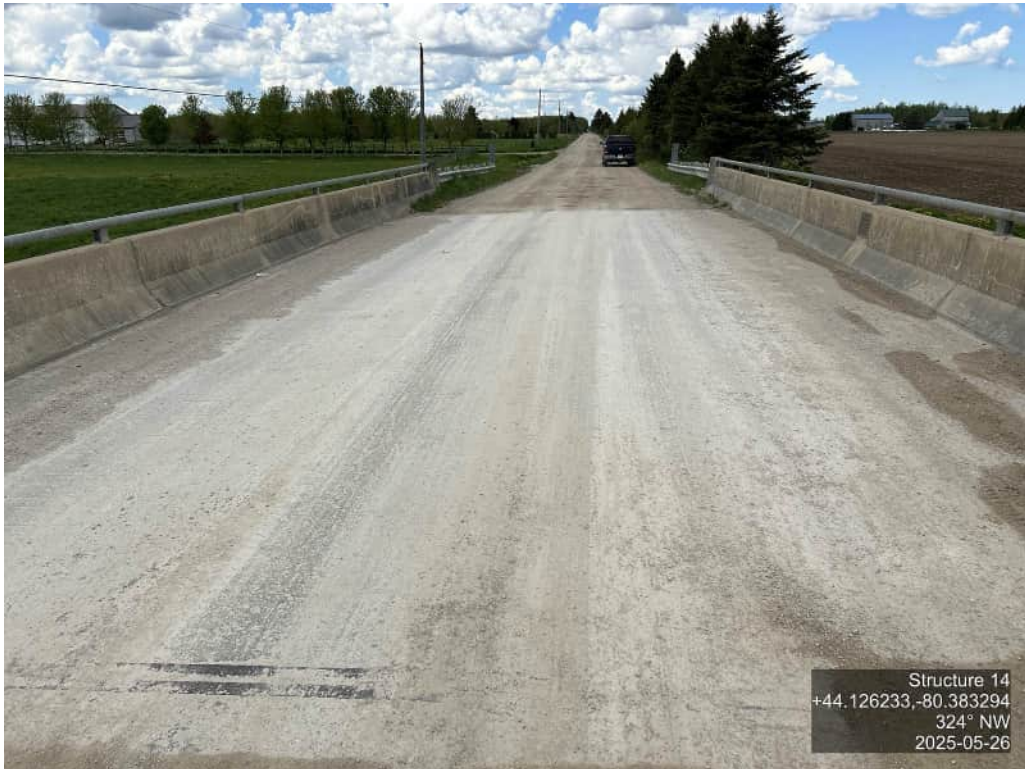
Structure 14  
+44.126233,-80.383294  
324° NW  
2025-05-26

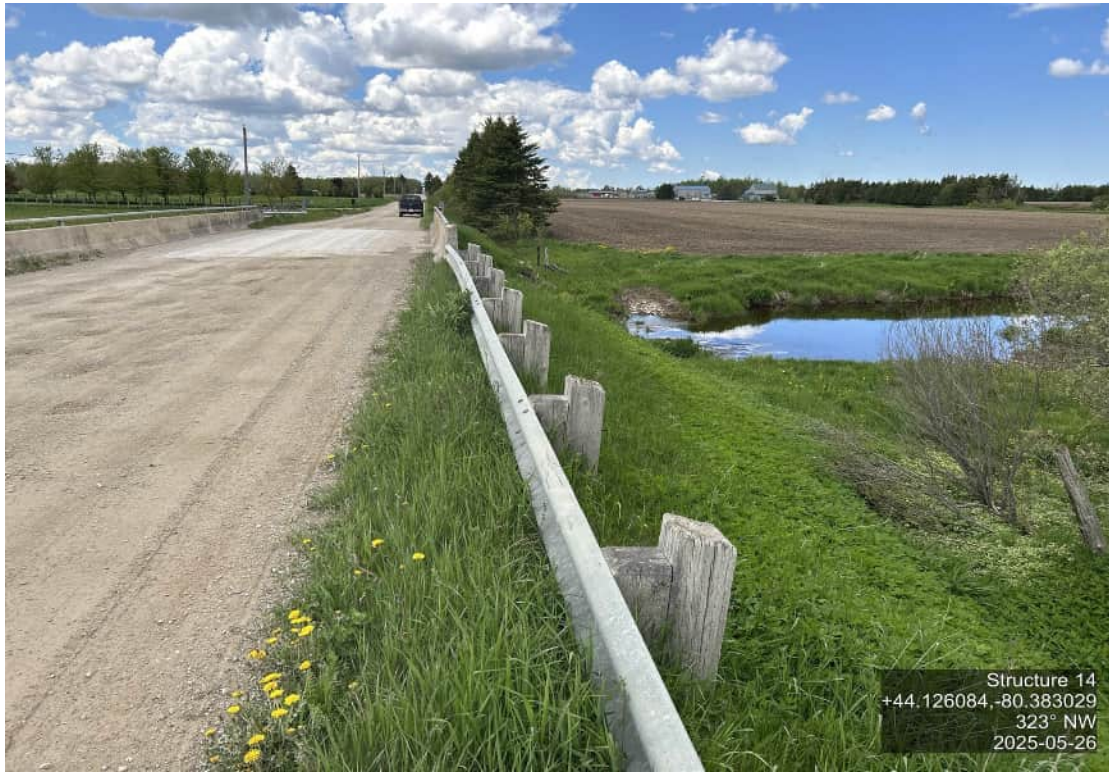
Structure 14  
+44.126084,-80.383029  
323° NW  
2025-05-26

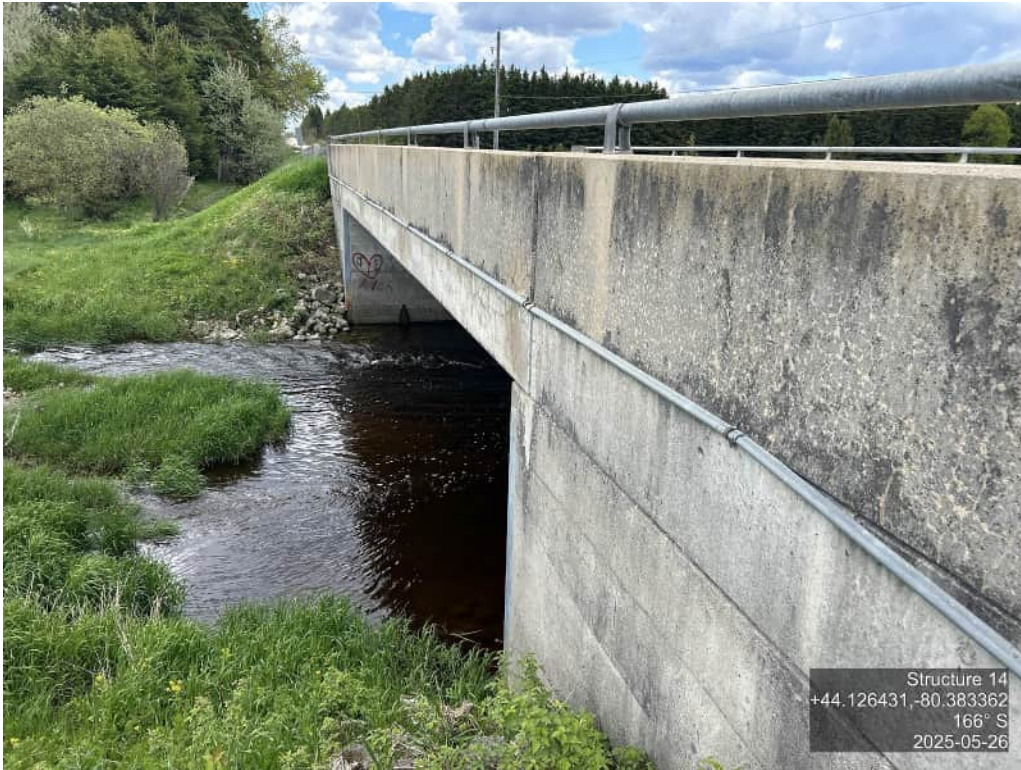
**BARRIER WALLS EXTERIOR – EAST – NARROW STAINED CRACKS**

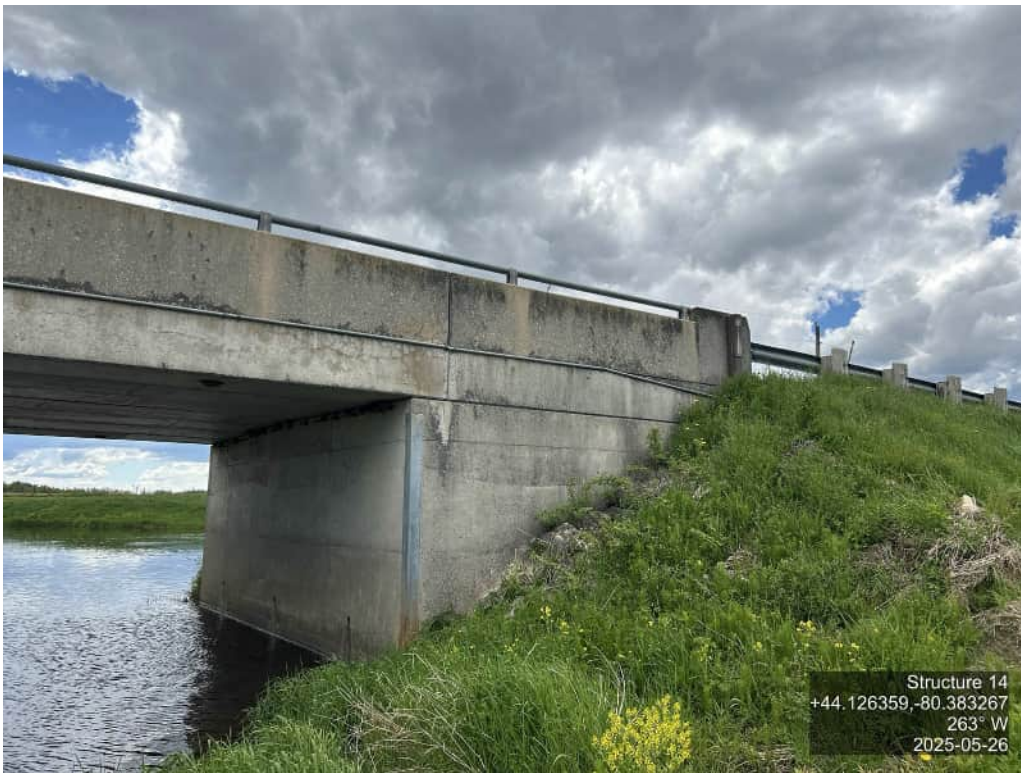
**WINGWALL – EAST – NARROW STAINED CRACKS**

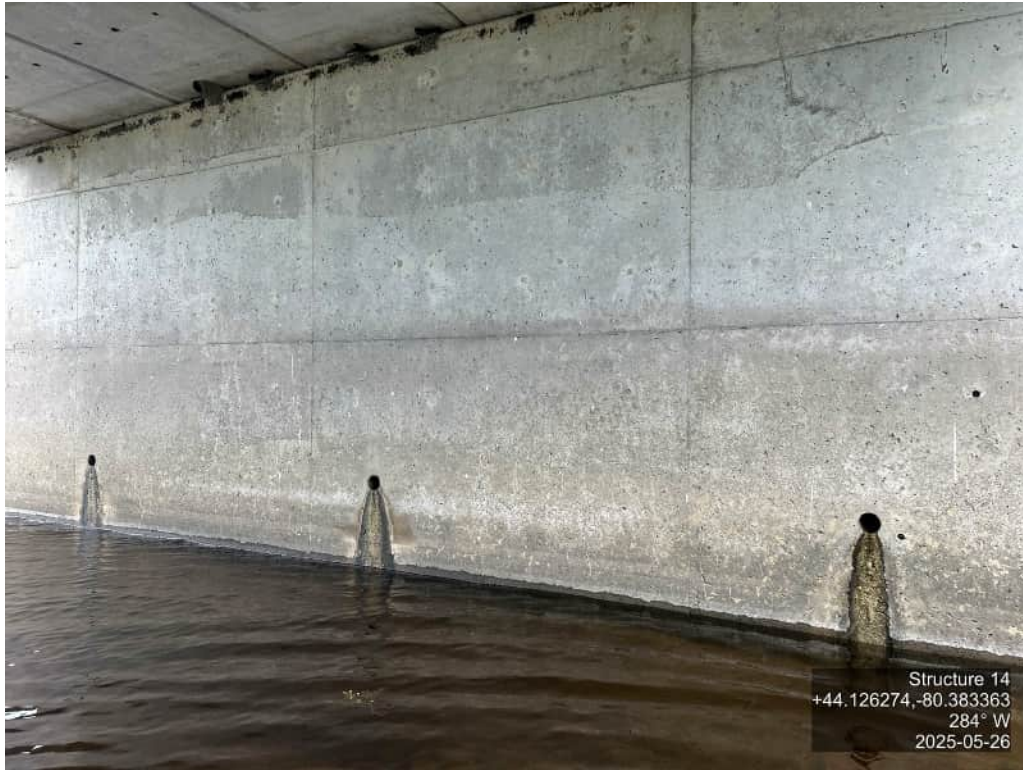
**ABUTMENT WALLS – SOUTH – COLD JOINT**

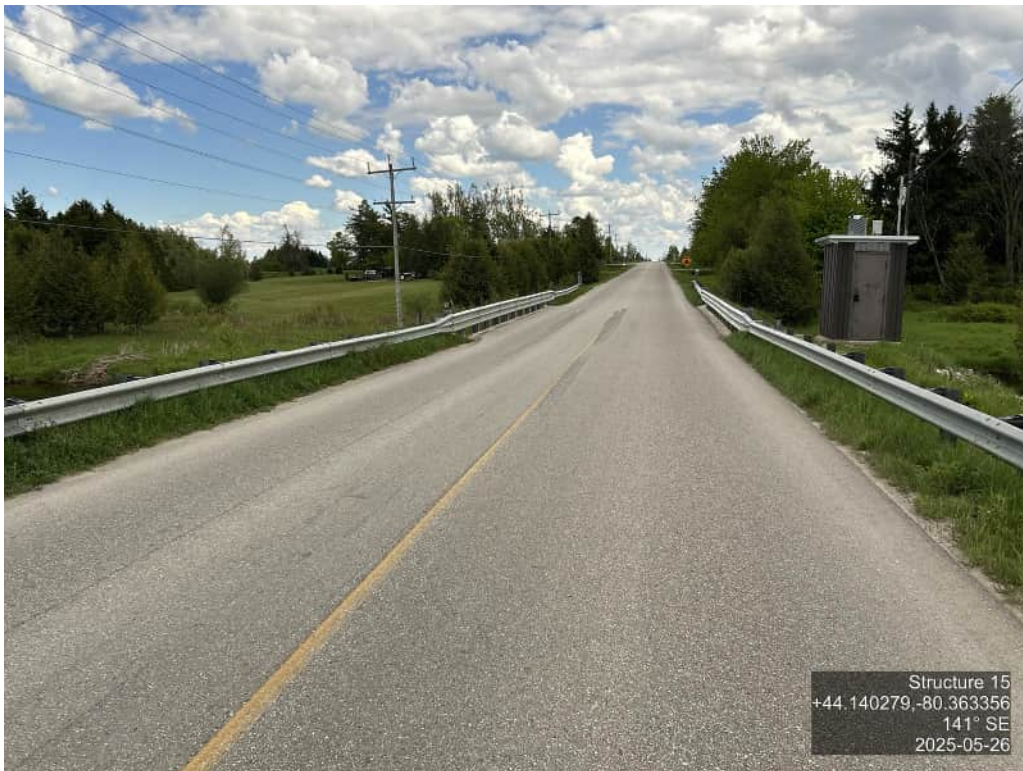
APPROACH WEARING SURFACE – SOUTH

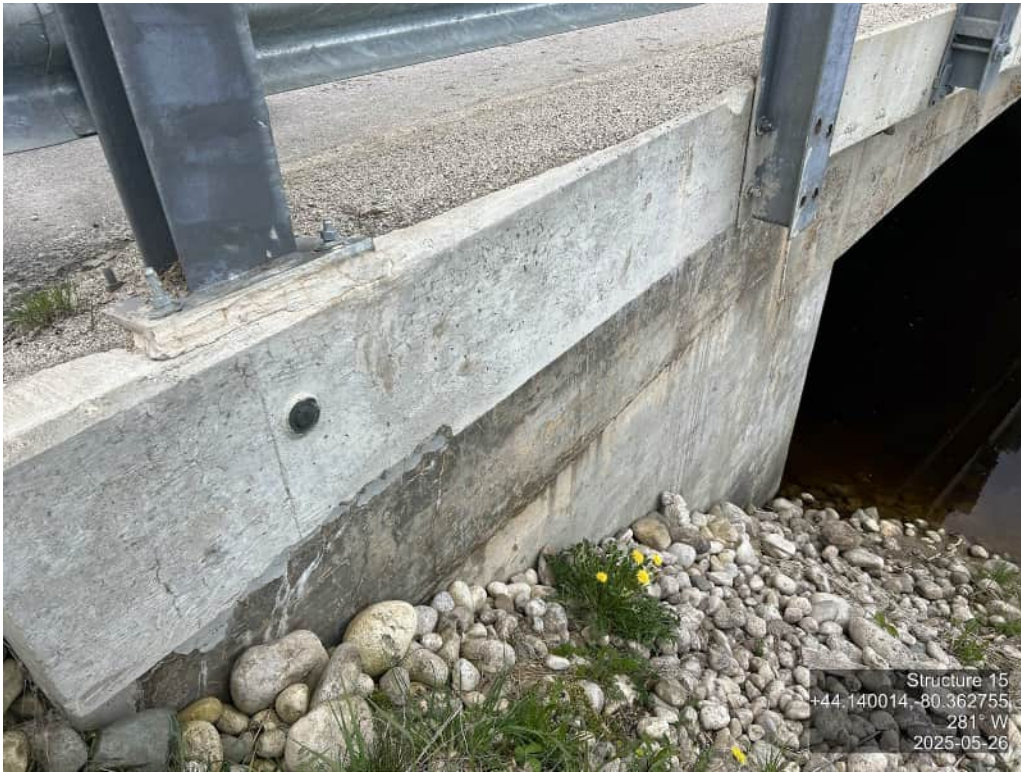
**CURB – NORTHEAST – LIGHT SCALING**

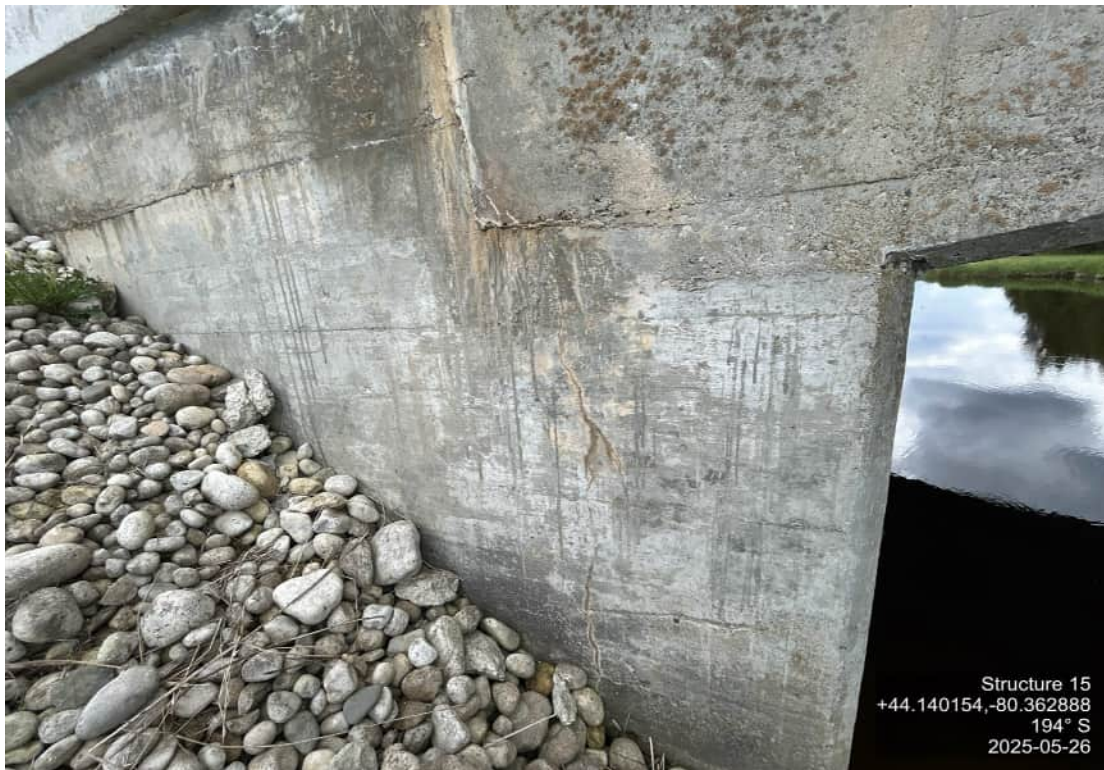
**WINGWALL – SOUTHWEST – DELAMINATIONS AND STAINED CRACKS**

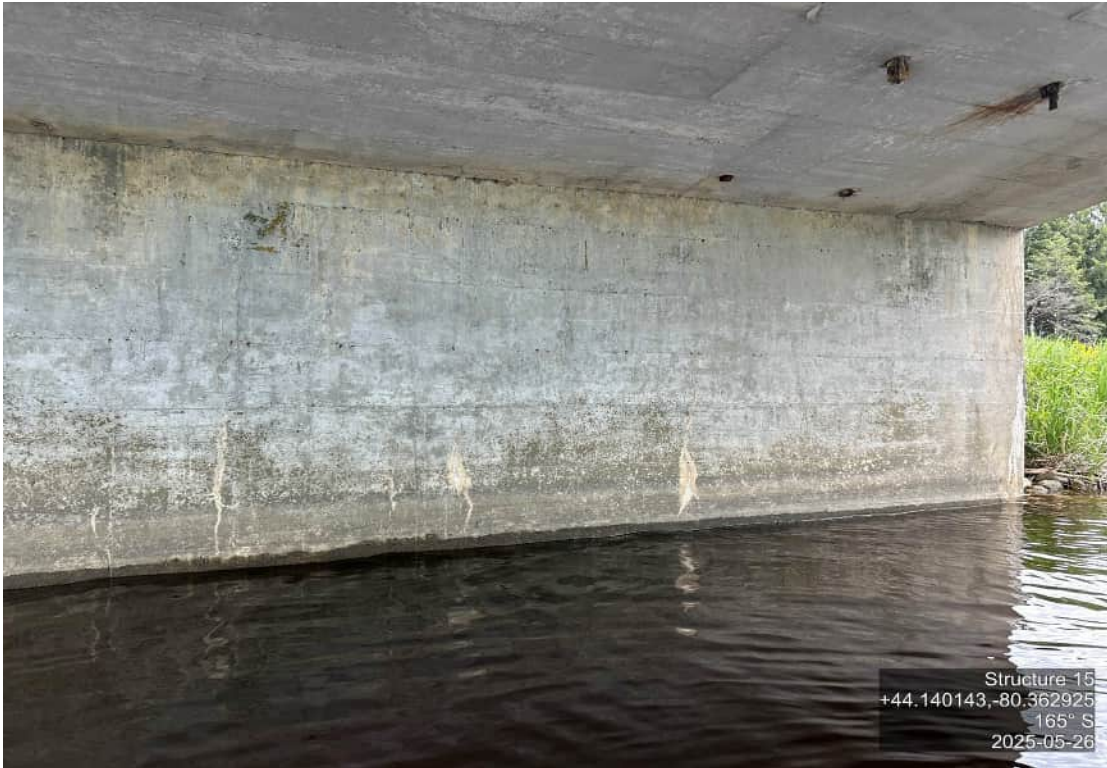
**ABUTMENT WALLS – SOUTHWEST – DELAMINATIONS AND STAINED CRACKING**

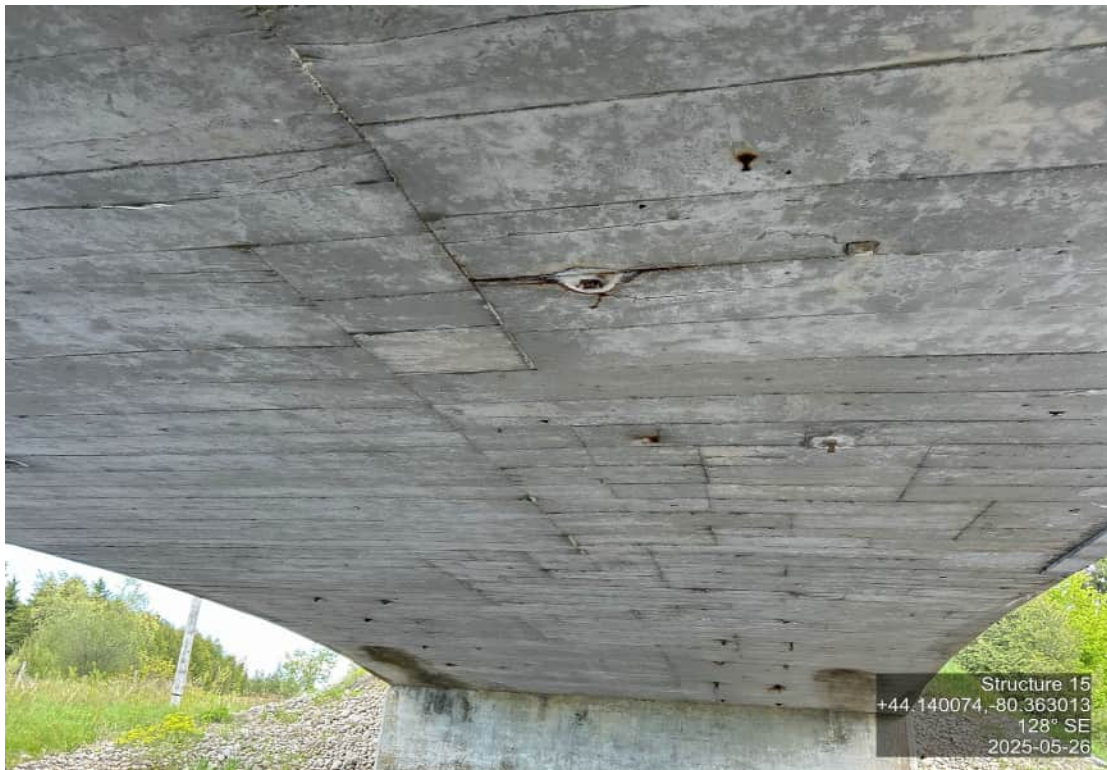
**SOFFIT- INTERIOR - LIGHT DELAMINATIONS**

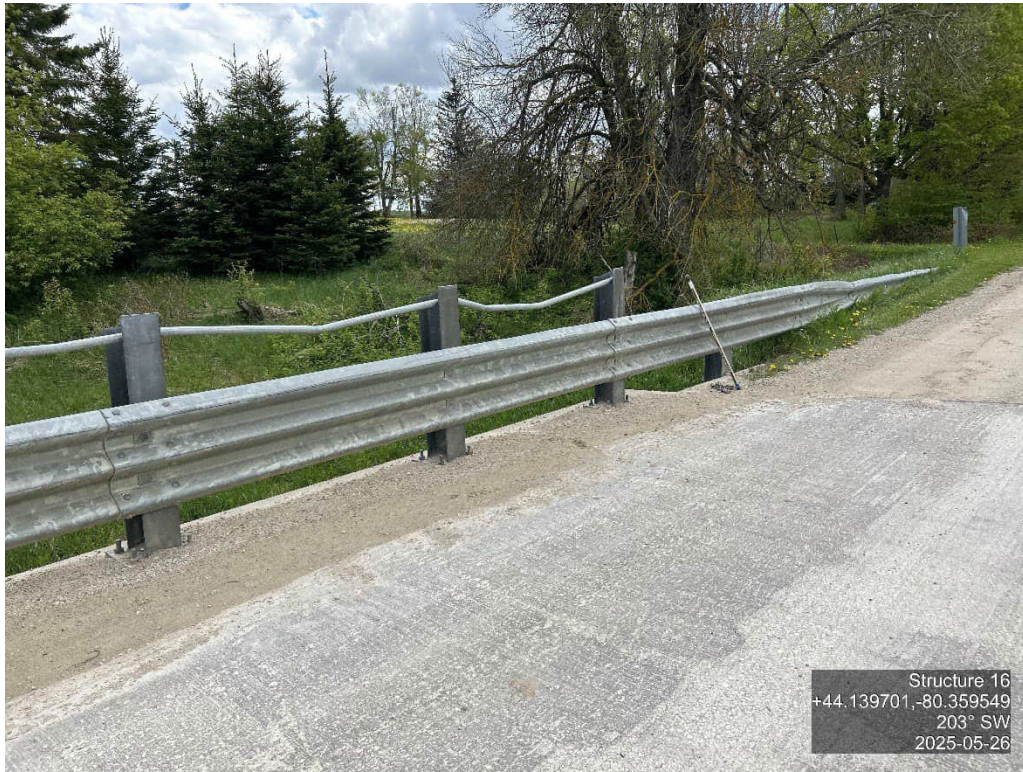
Structure 16  
+44.139701,-80.359549  
203° SW  
2025-05-26

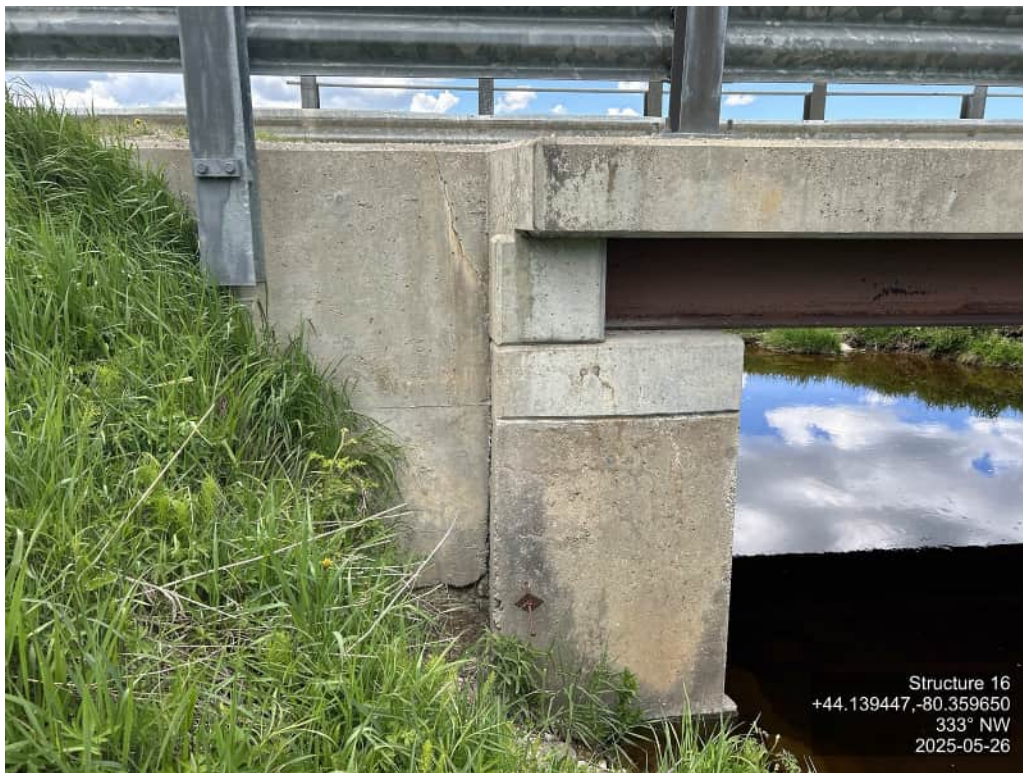
Structure 16  
+44.139447,-80.359650  
333° NW  
2025-05-26

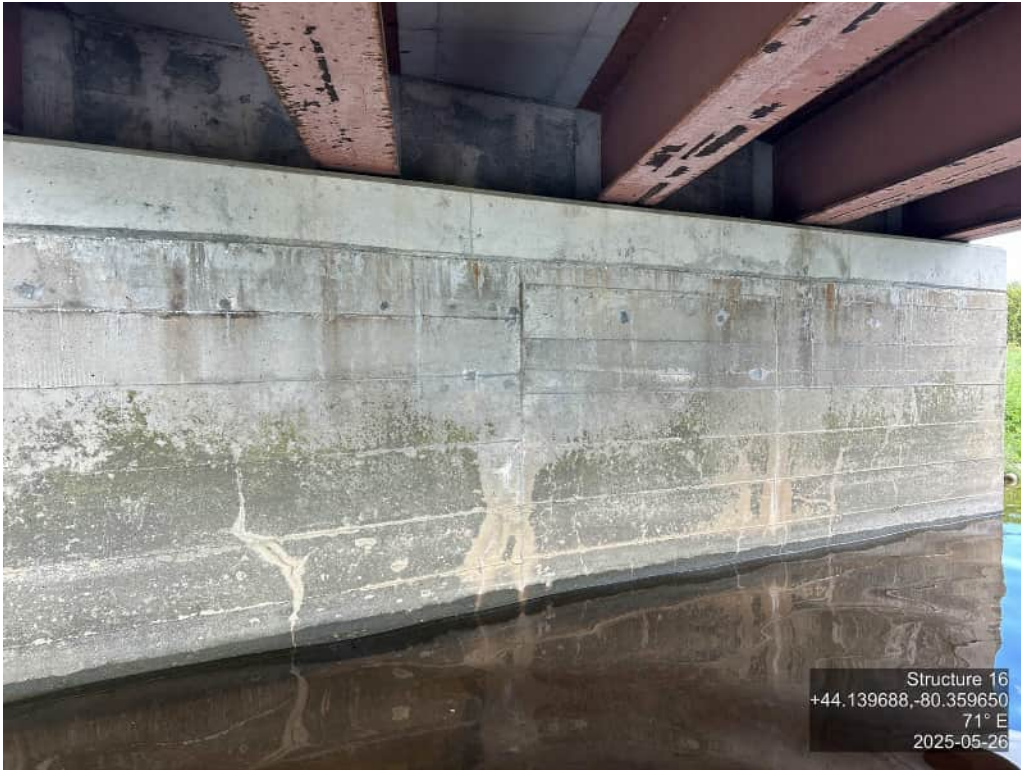
**ABUTMENT WALLS – EAST – WIDE VERTICAL CRACKS AND LIGHT HONEYCOMBING**

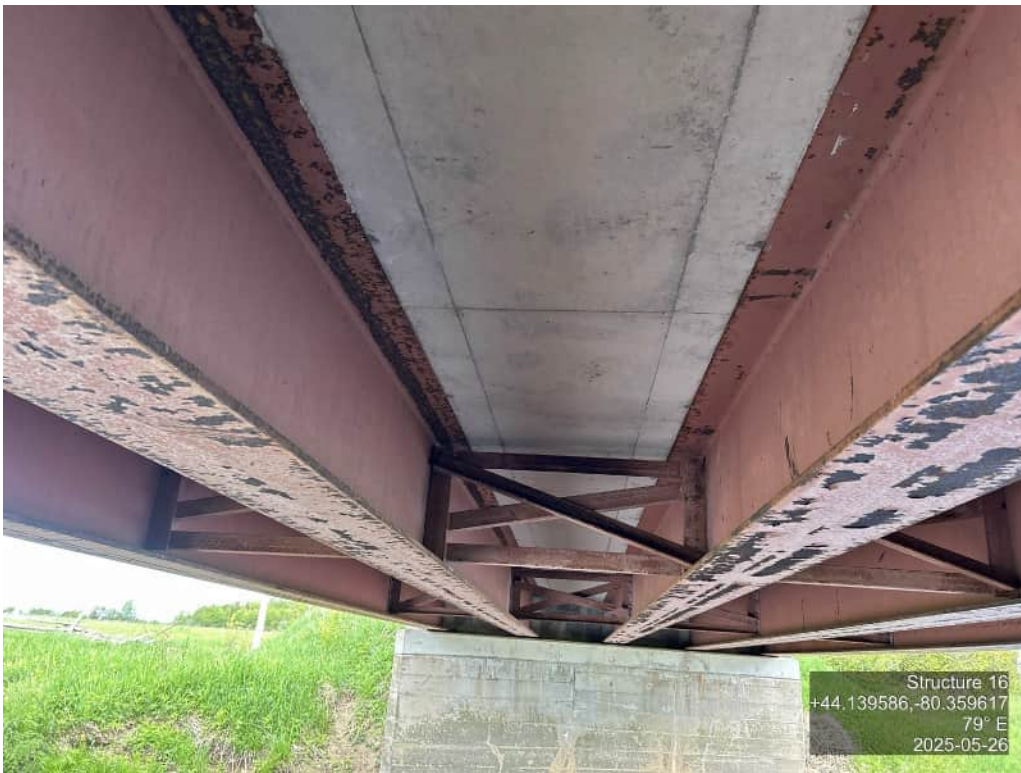
**SOFFIT- INTERIOR**

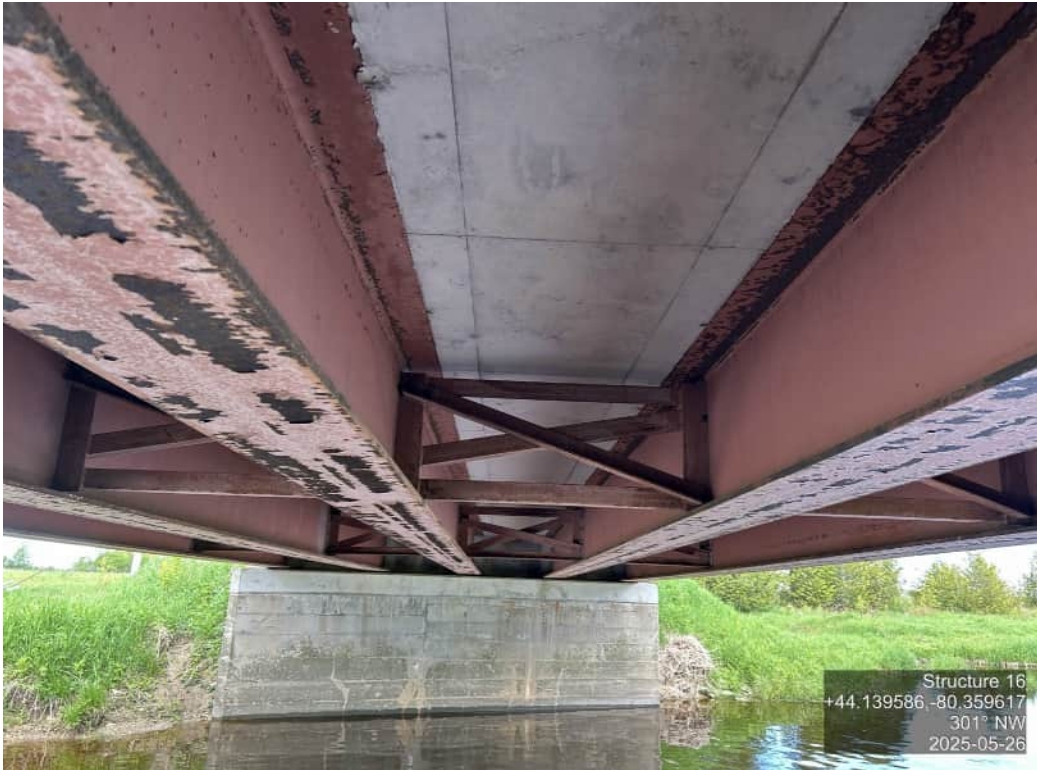
**GIRDERS – MIDDLE – MODERATE SURFACE CORROSION**

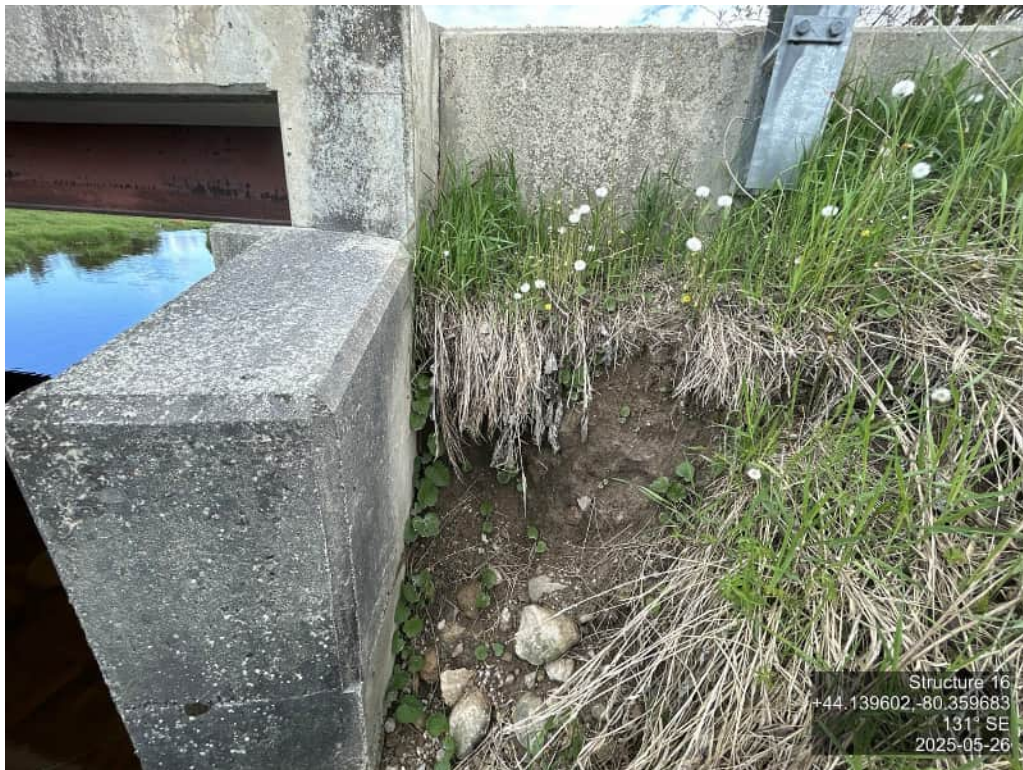
**EMBANKMENT – SOUTHWEST – SEVERE ERROSION**

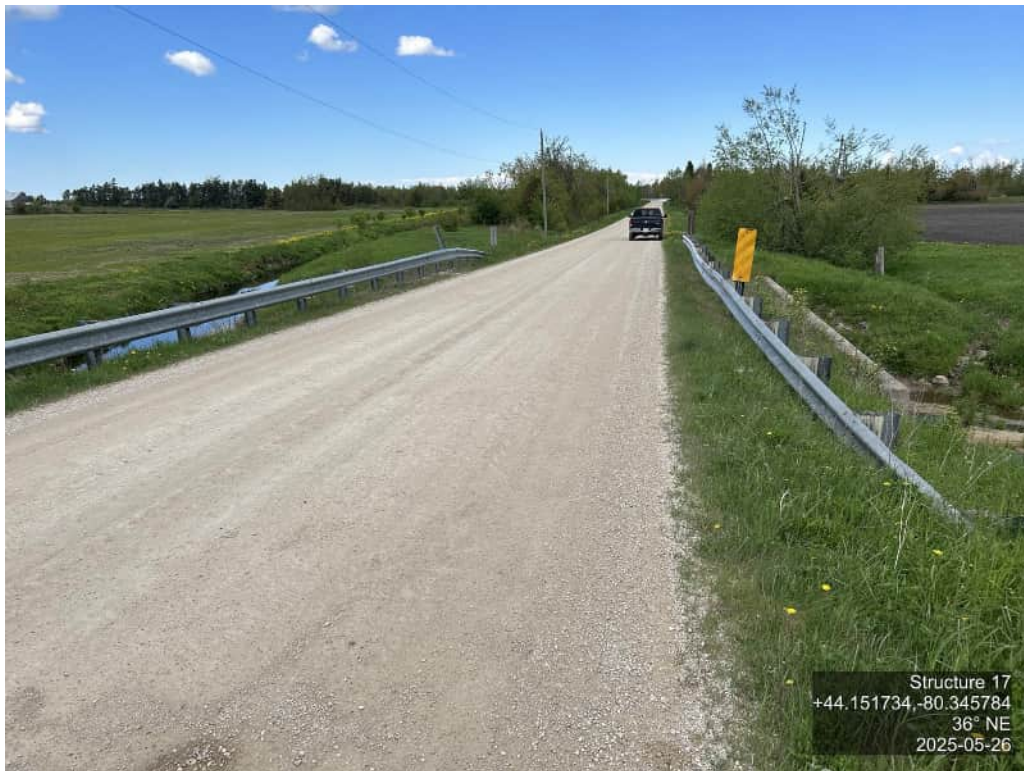
Structure 17  
+44.151734,-80.345784  
36° NE  
2025-05-26

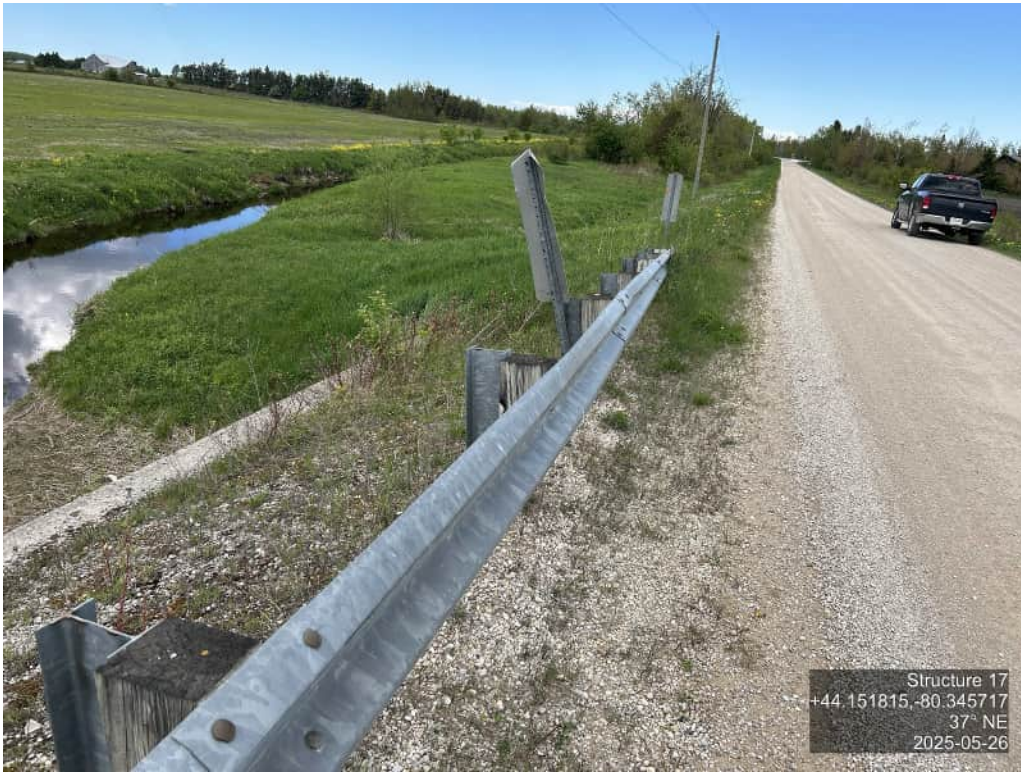
**GUIDE RAIL – WEST – ROTTING OFFSET BLOCKS**

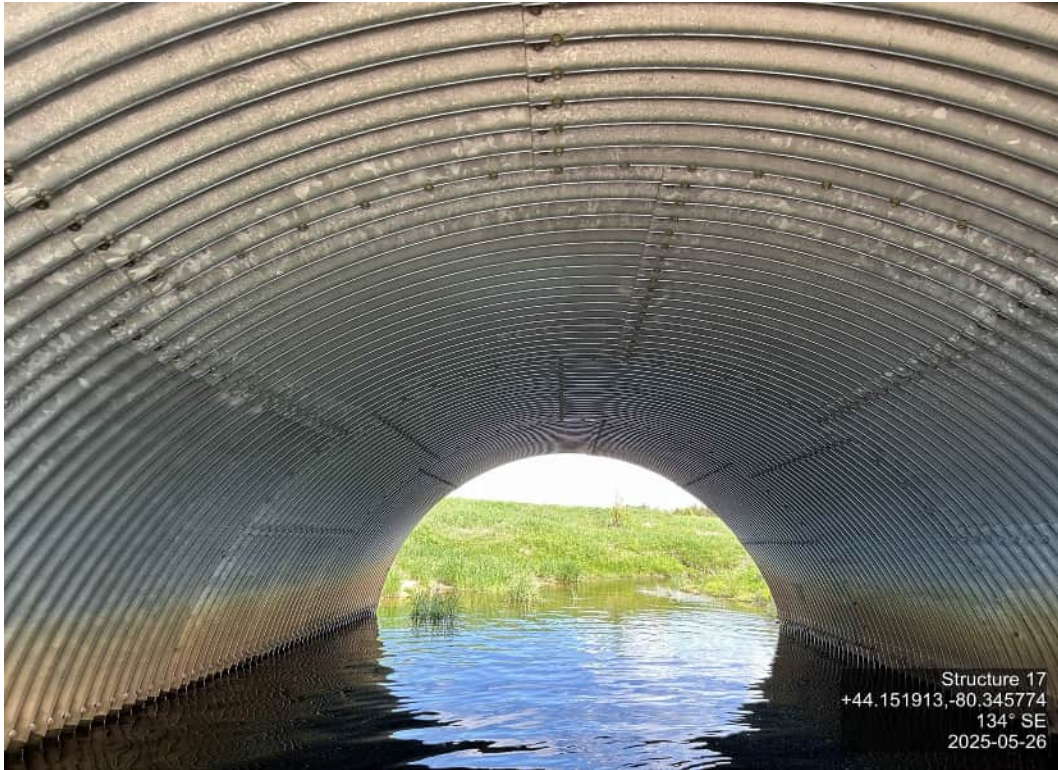
Structure 17  
+44.151913,-80.345774  
134° SE  
2025-05-26

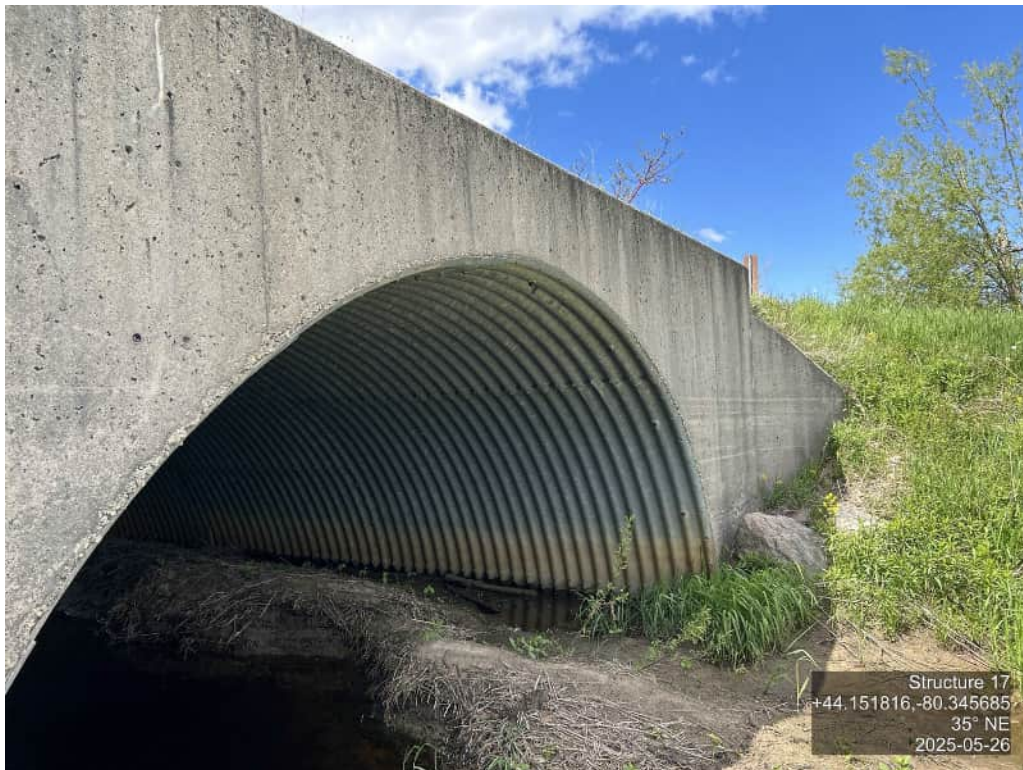
Structure 17  
+44.151816,-80.345685  
35° NE  
2025-05-26
