**BURNSIDE**

## **2025 OSIM Bridge Inspections Report**

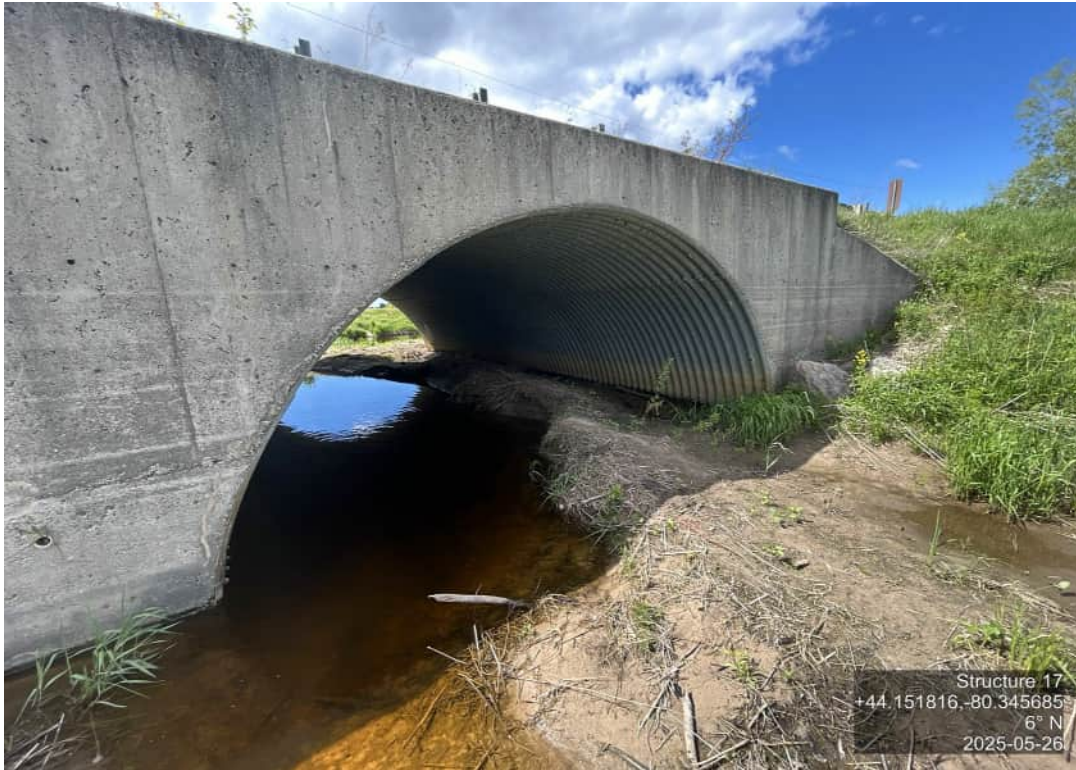
**STREAM – EAST – AGGRADATION IN BARREL**

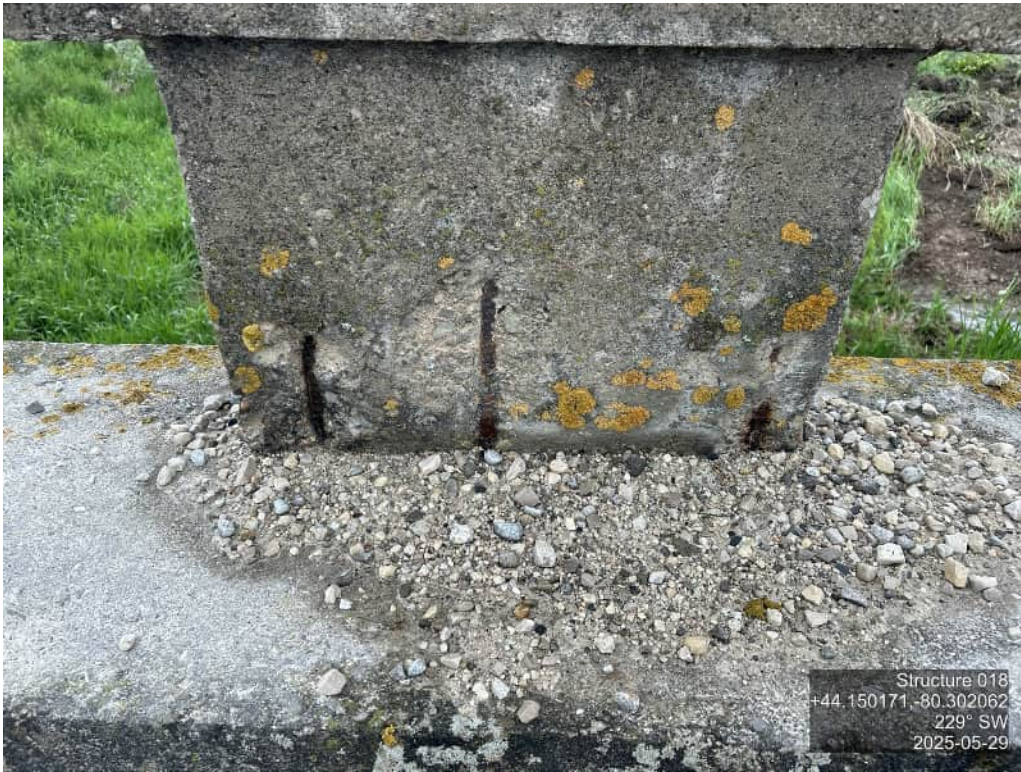
**POSTS – INTERIOR – SPALLS WITH EXPOSED CORRODED REBAR**

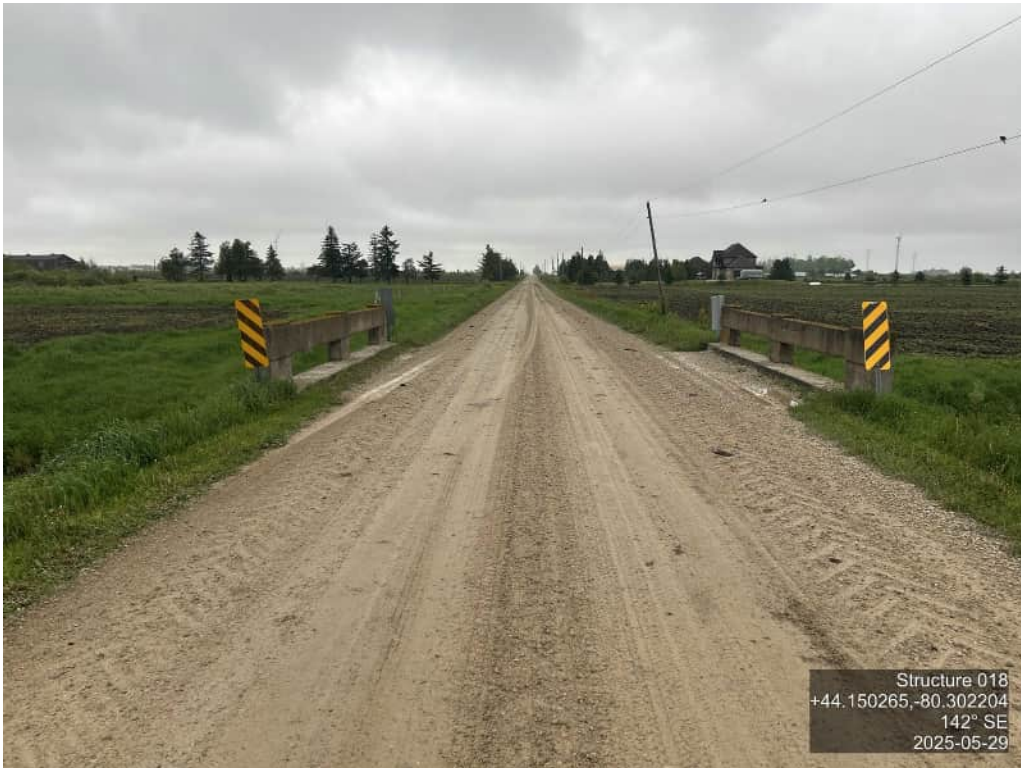
**DECK WEARING SURFACE – SOUTHEAST**

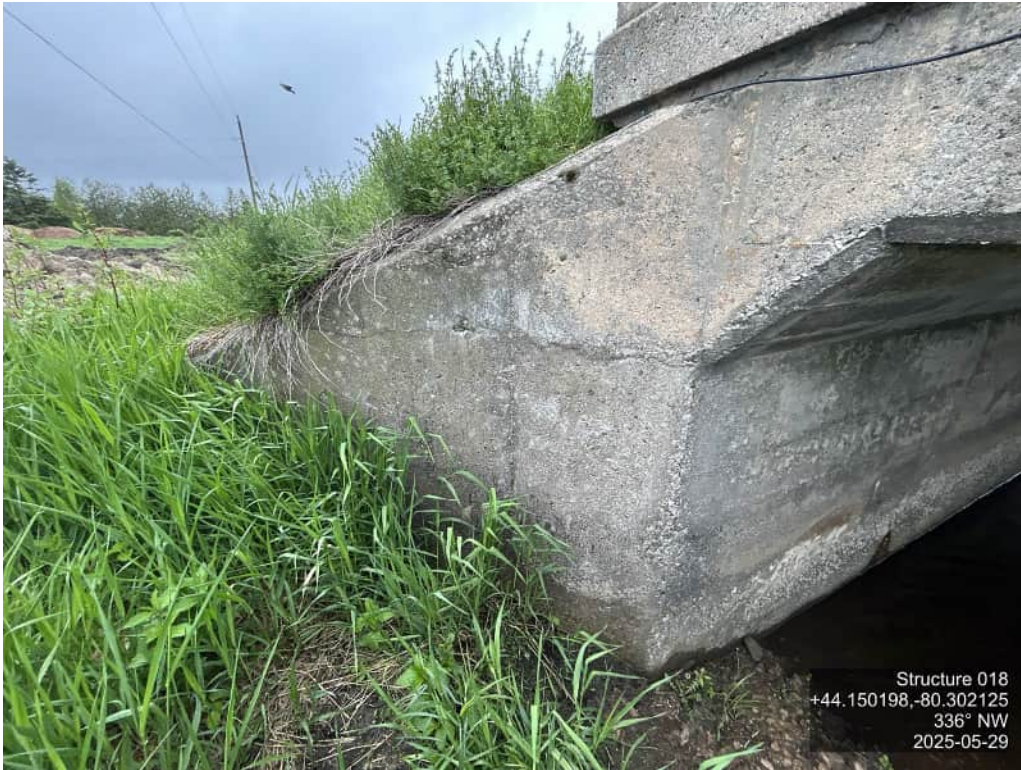
Structure 018  
+44.150198,-80.302125  
336° NW  
2025-05-29

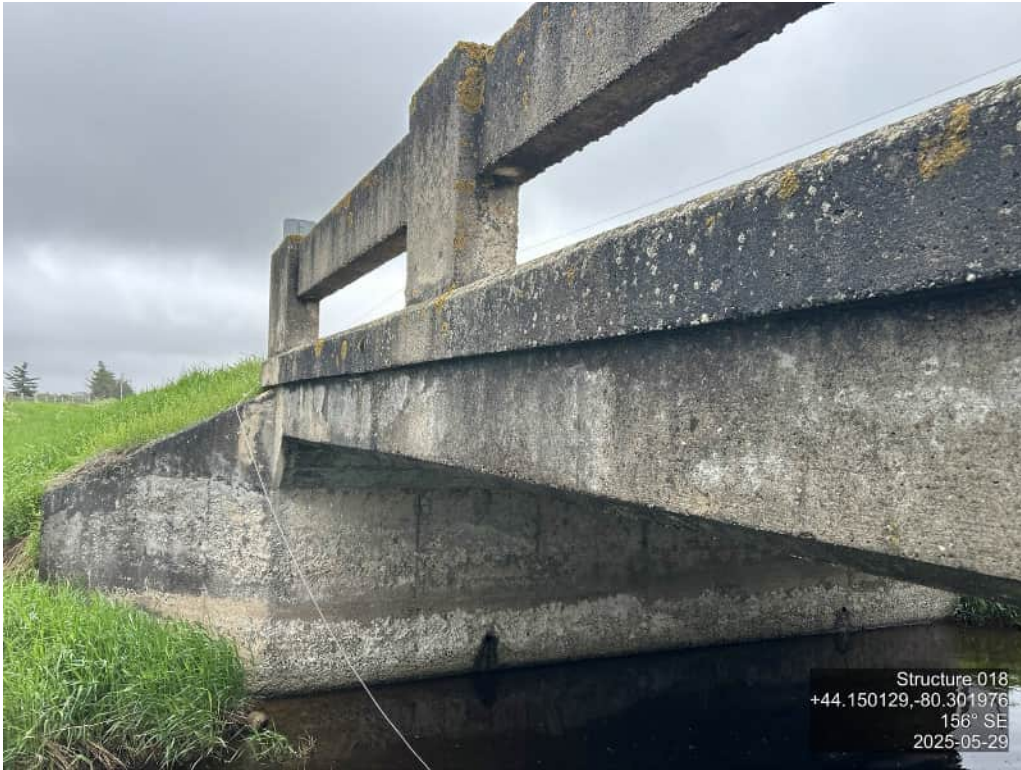
Structure 018  
+44.150129,-80.301976  
156° SE  
2025-05-29

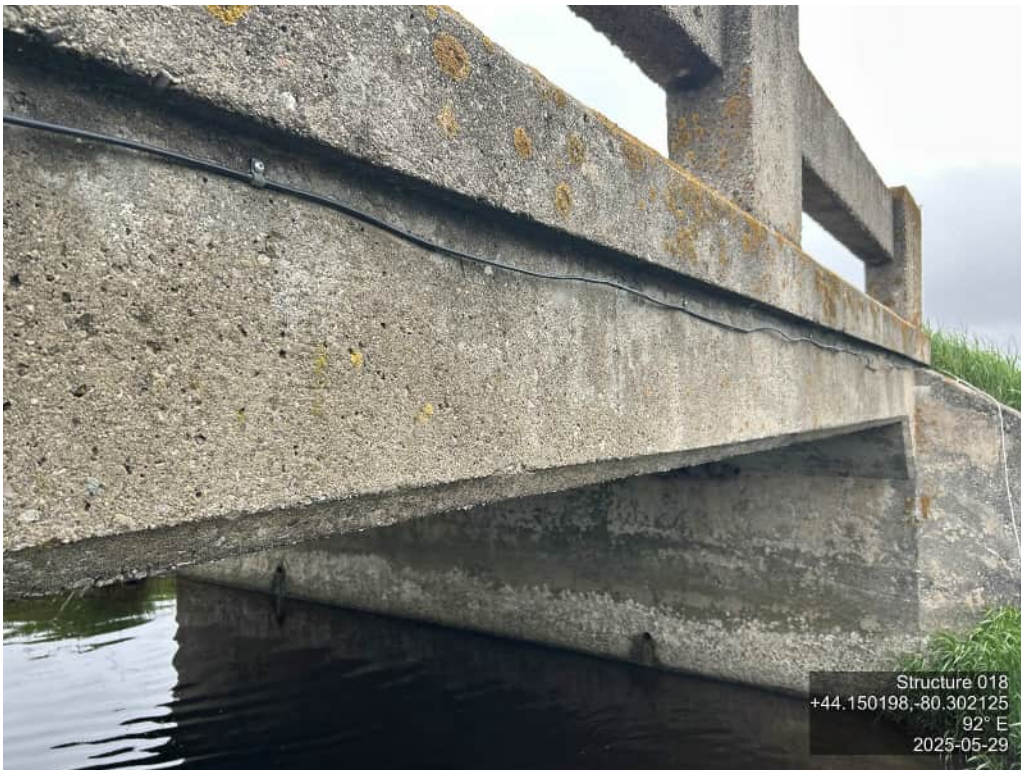
Structure 018  
+44.150198,-80.302125  
92° E  
2025-05-29

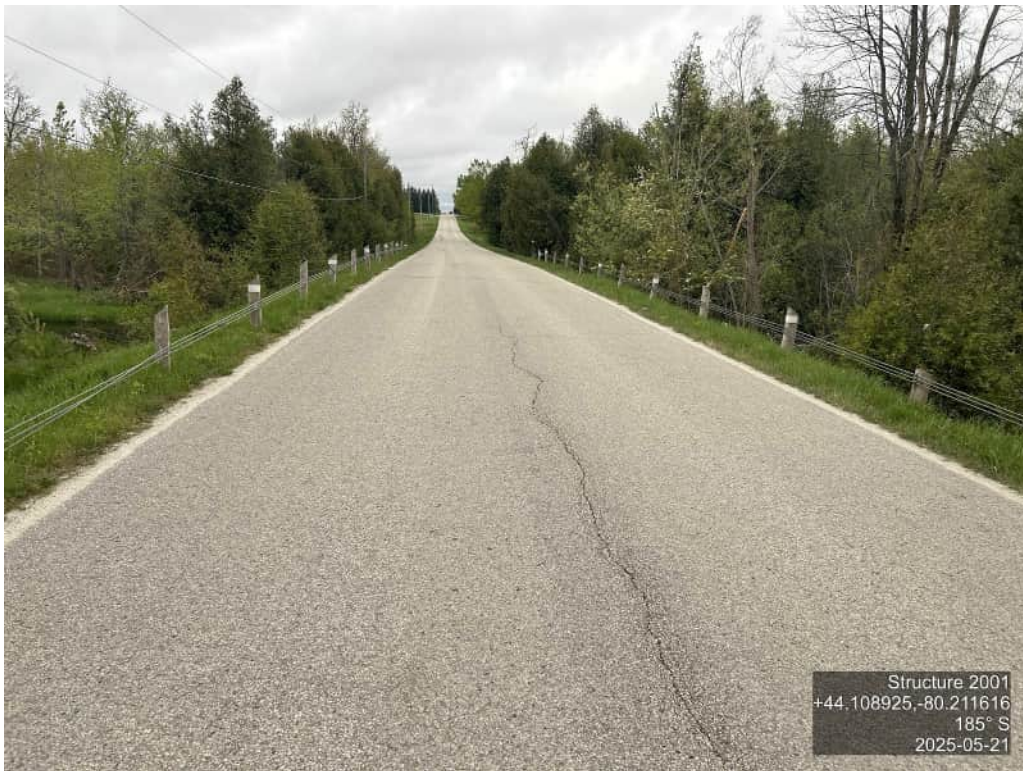
**DECK WEARING SURFACE – SOUTH – WIDE TRANSVERSE CRACKS**

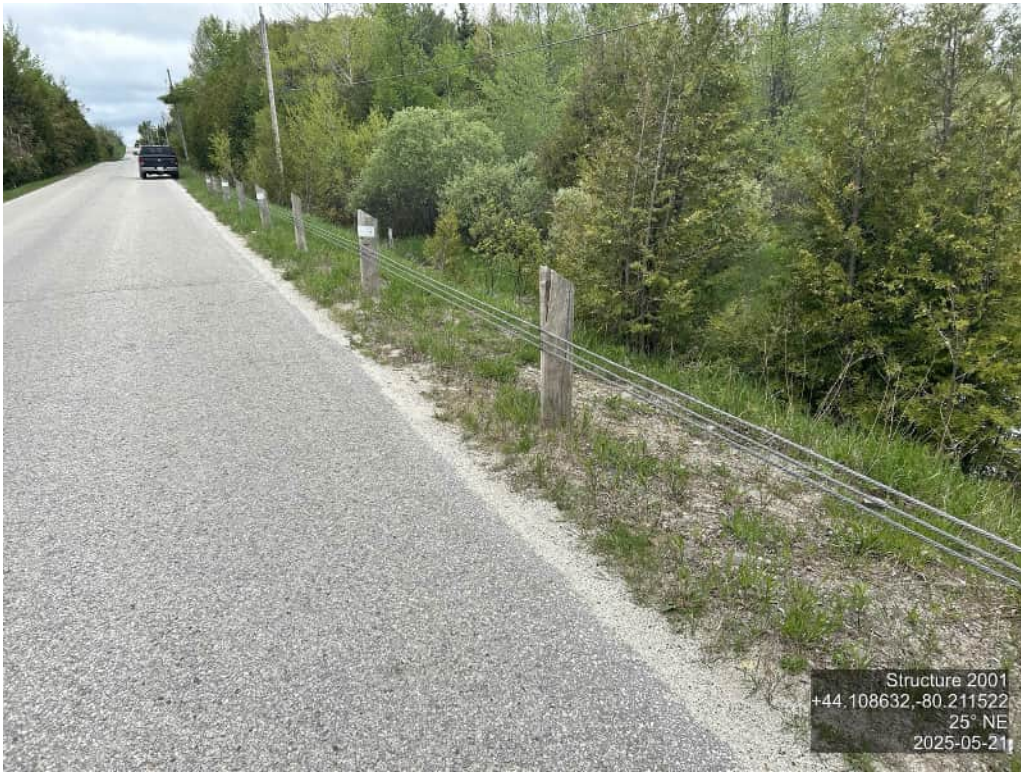
**GUIDE RAIL – WEST – ROTTED POSTS AND LOW CABLES**

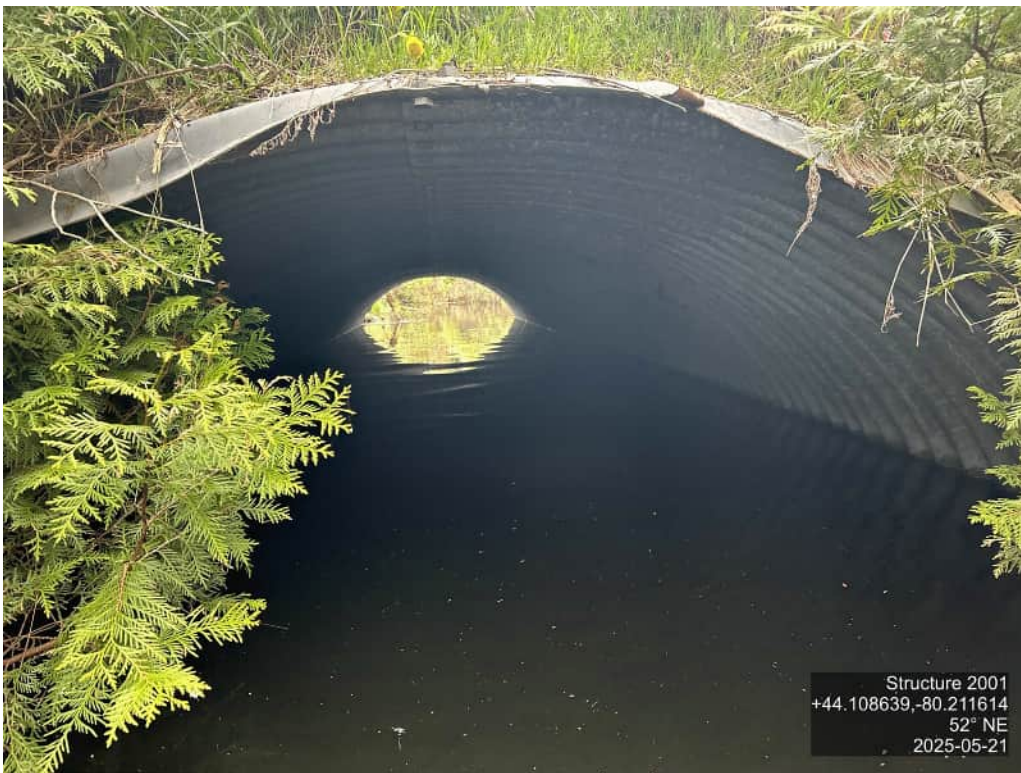
**BARREL – INSIDE WALLS – LIGHT CORROSION, FLAKING AND LIGHT BULGING**

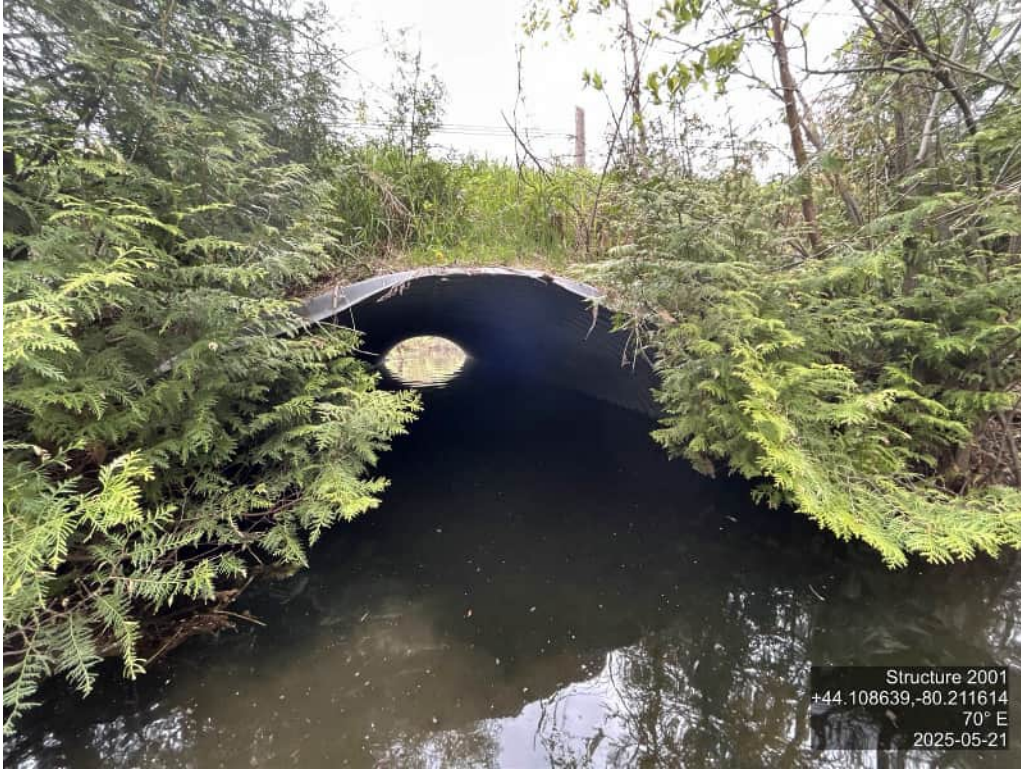
**EMBANKMENT – EAST – OVERGROWN VEGETATION**

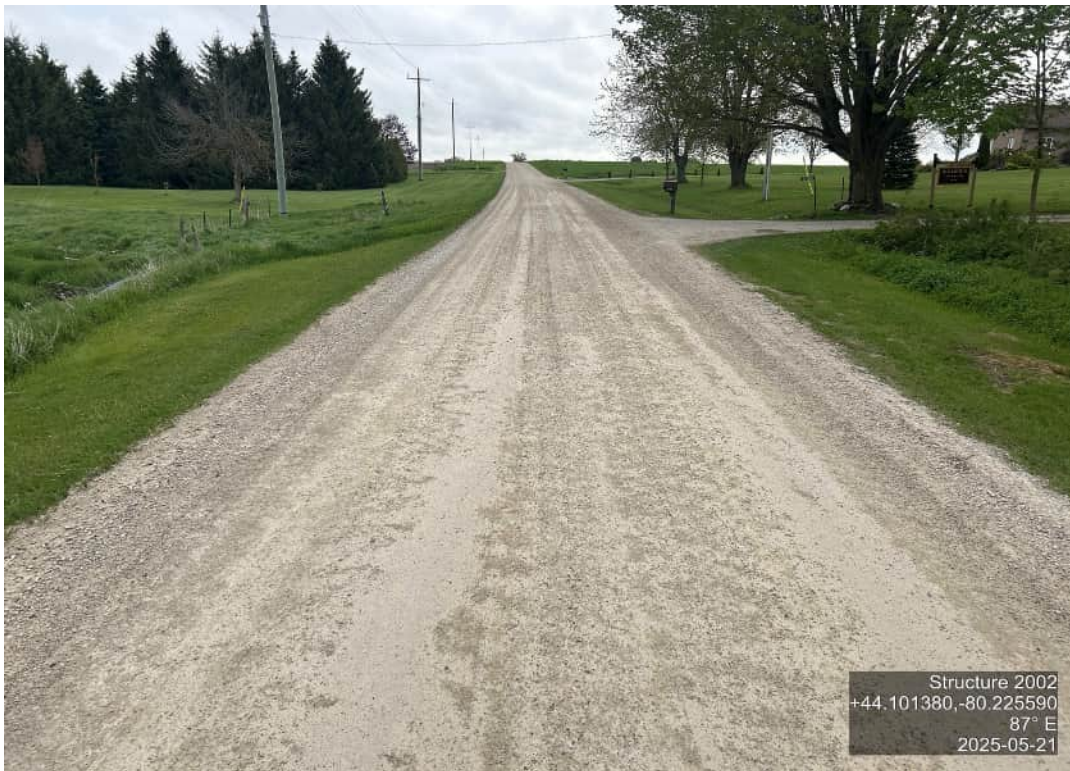
**DECK WEARING SURFACE – WEST**

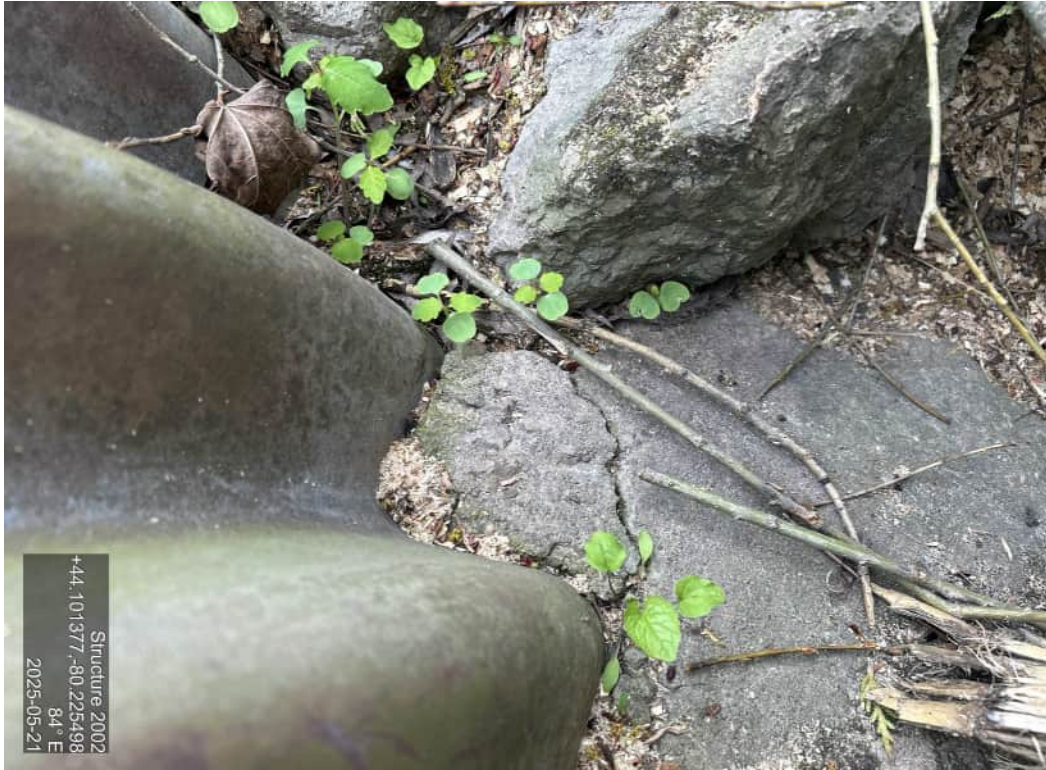
**INLET – SOUTHEAST – SPALL**

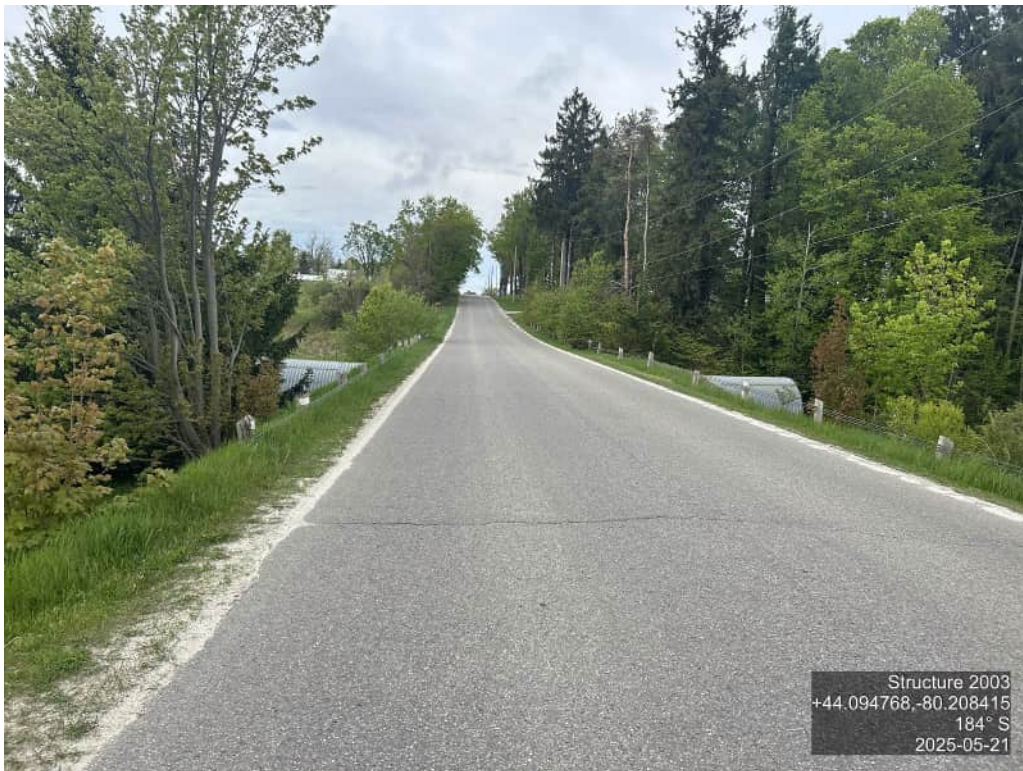
**DECK WEARING SURFACE – NORTH – NARROW FULL WIDTH TRANSVERSE CRACK**

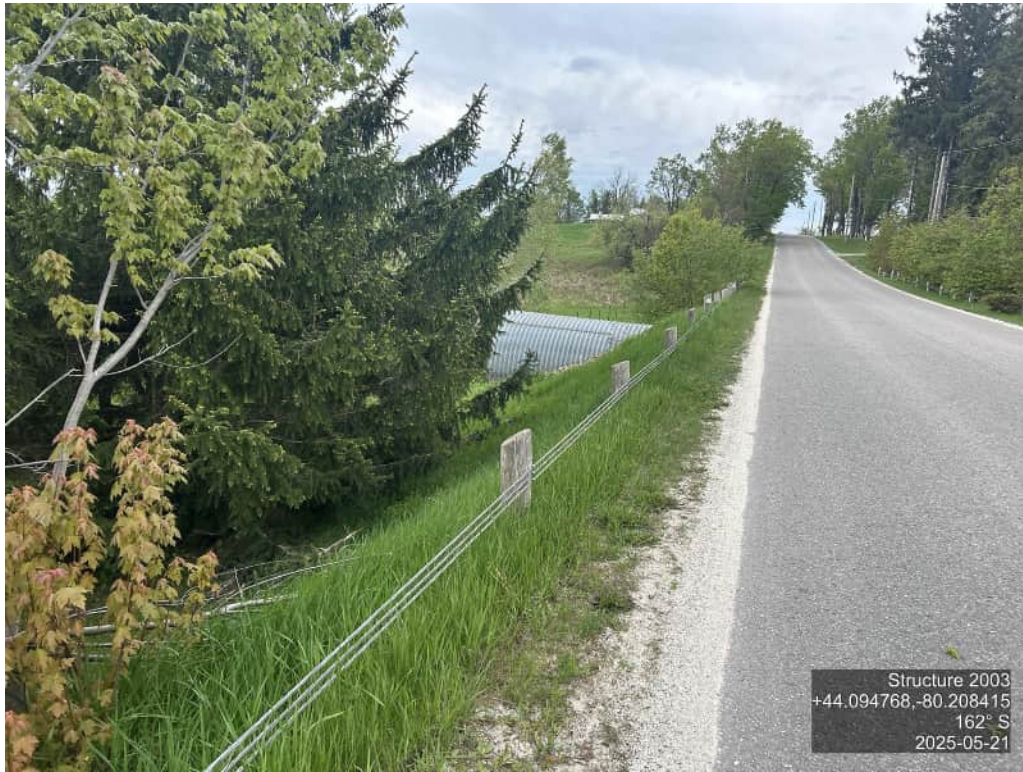
**GUIDE RAIL – WEST – ROTTED POSTS**

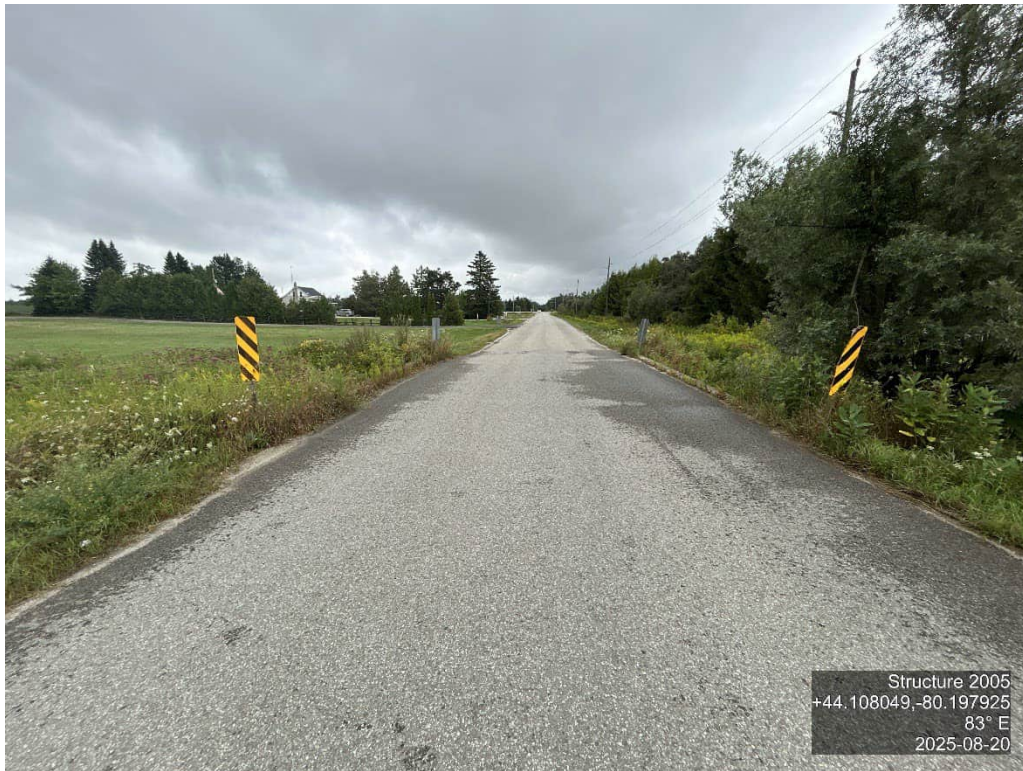
Structure 2005  
+44.108049,-80.197925  
83° E  
2025-08-20

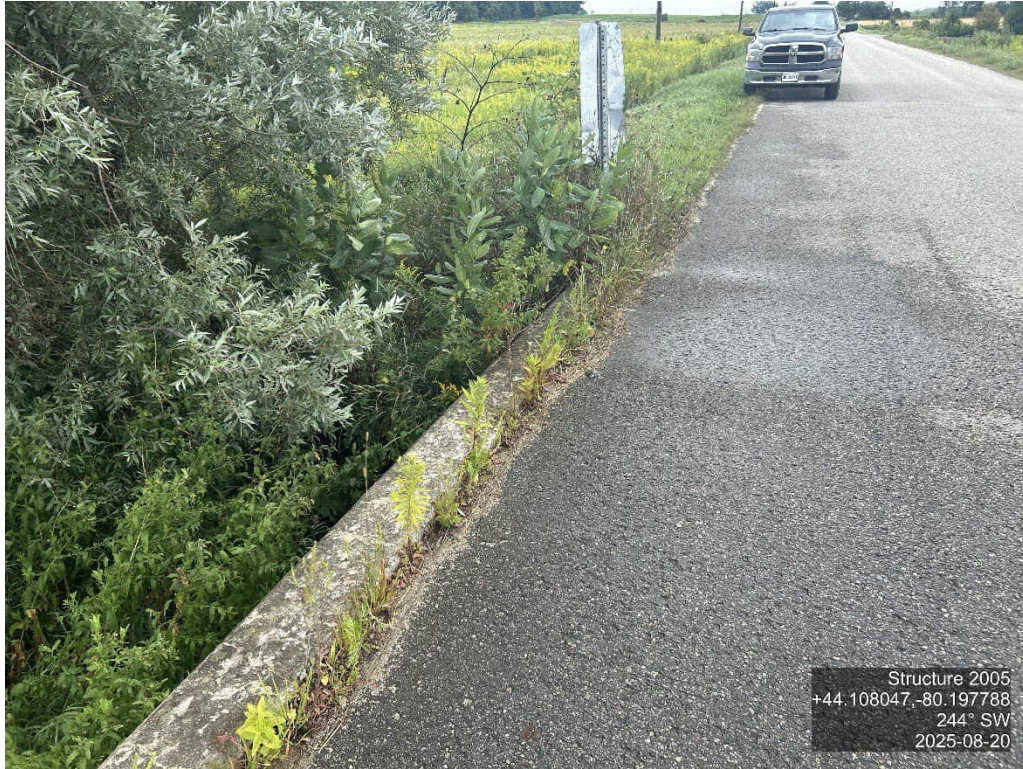
**CURB – WEST – VEGETATION GROWTH**

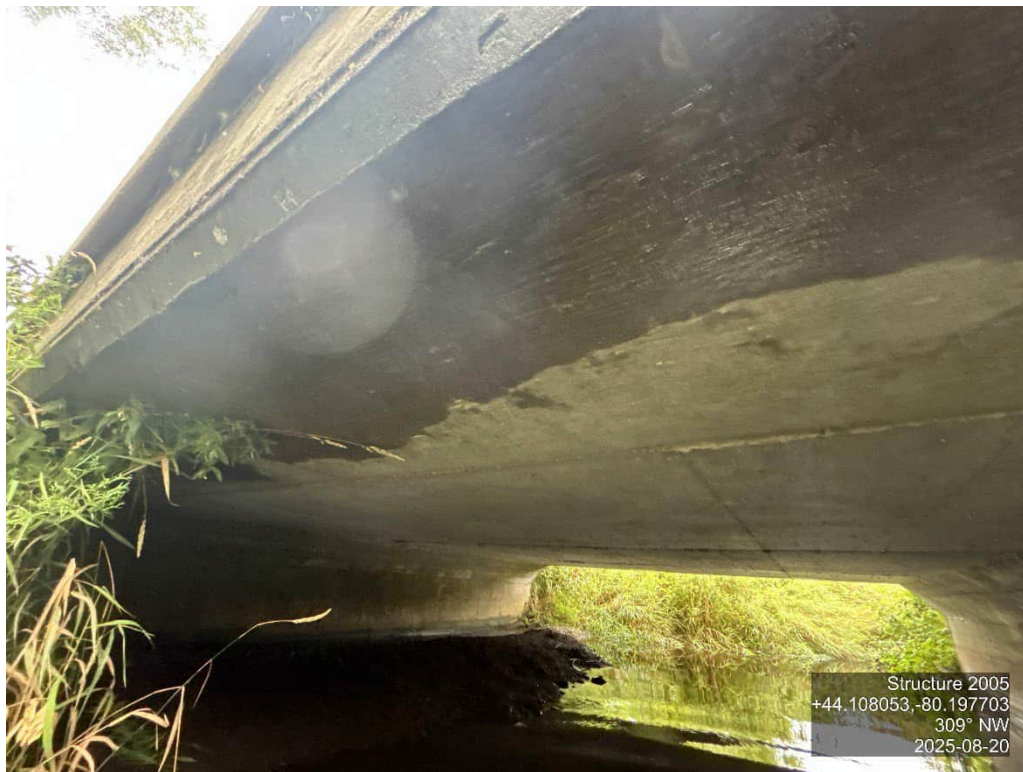
**SOFFIT EXTERIOR – EAST – DAMPNESS NOTED**

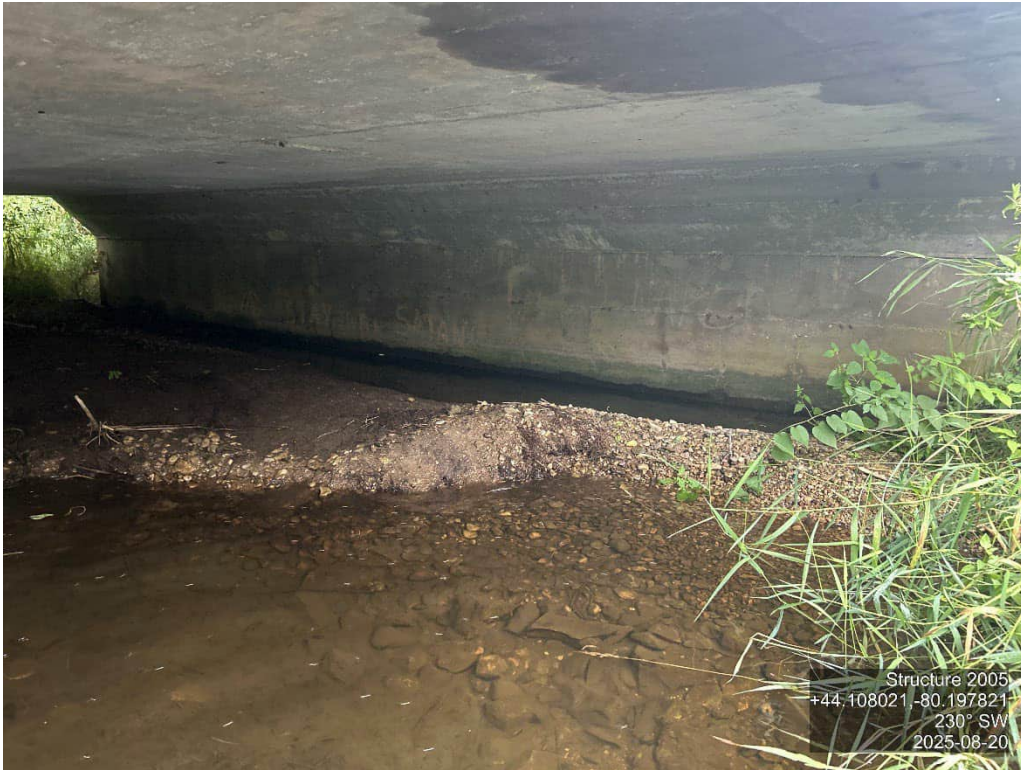
**WATERCOURSE – SEDIMENT BUILDUP**

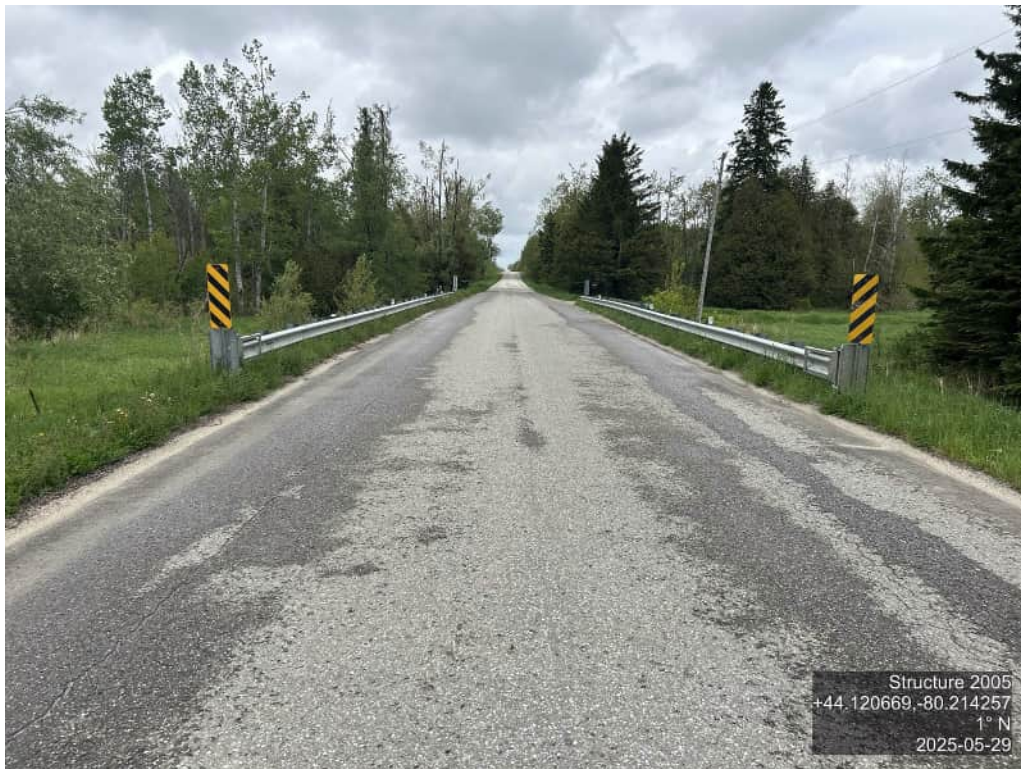
**DECK WEARING SURFACE – NORTH**

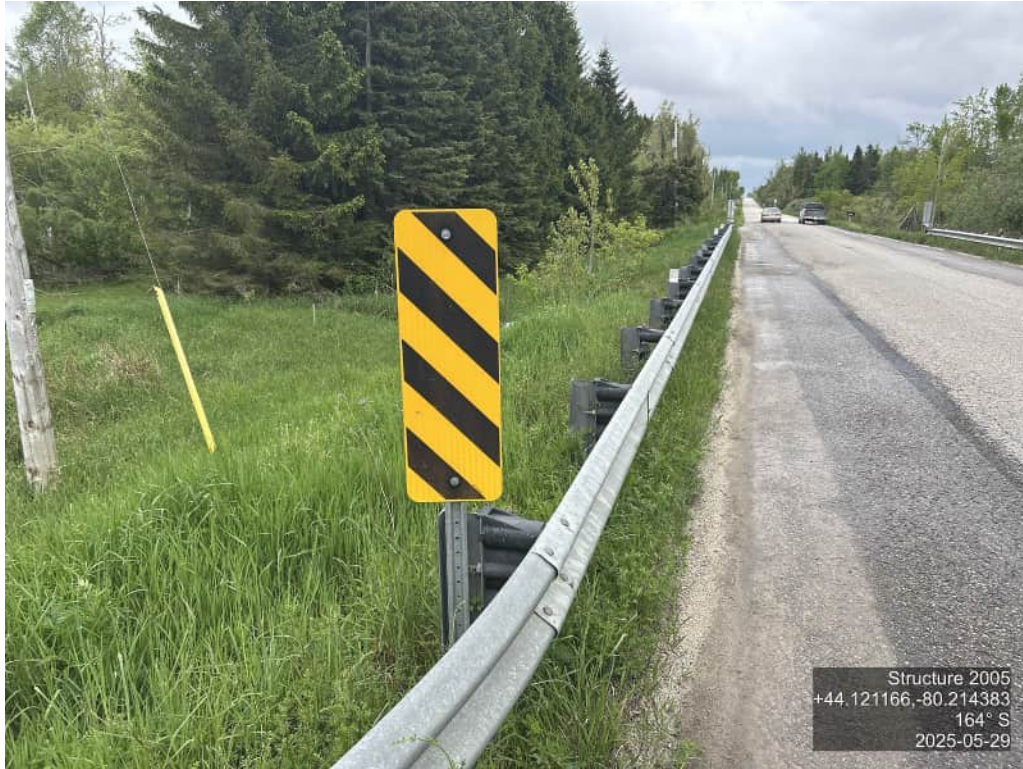
**GUIDE RAIL – SOUTH**

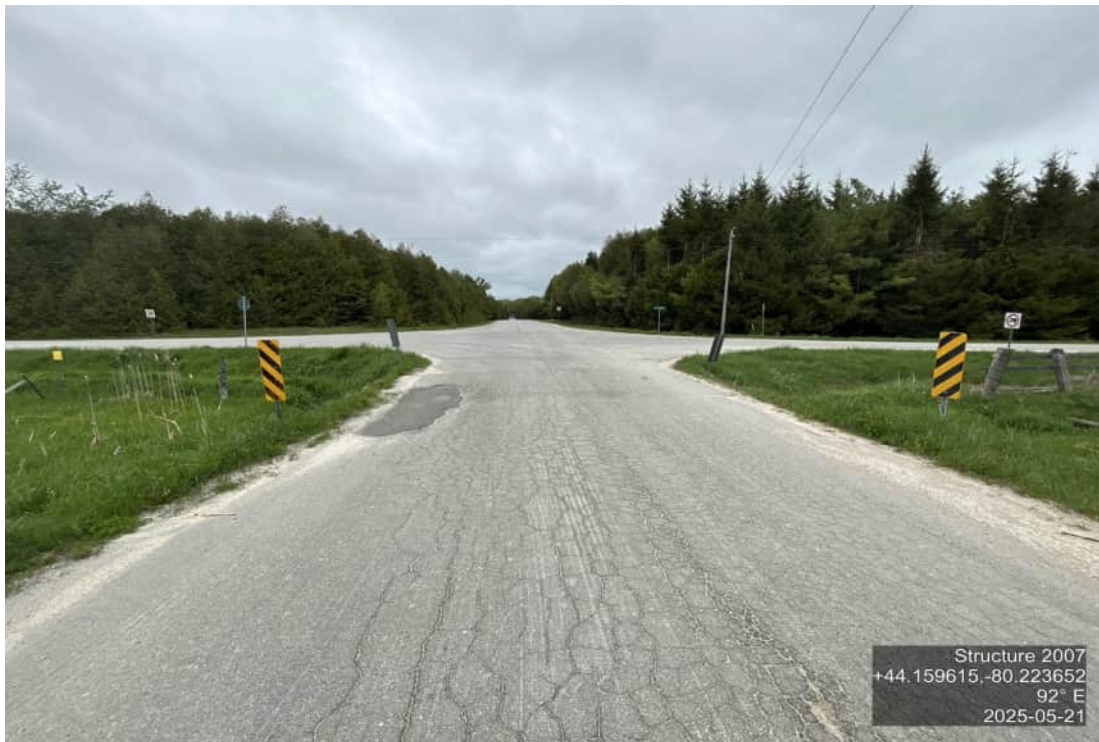
DECK WEARING SURFACE– NORTH – LONGITUDINAL CRACKING THROUGHOUT

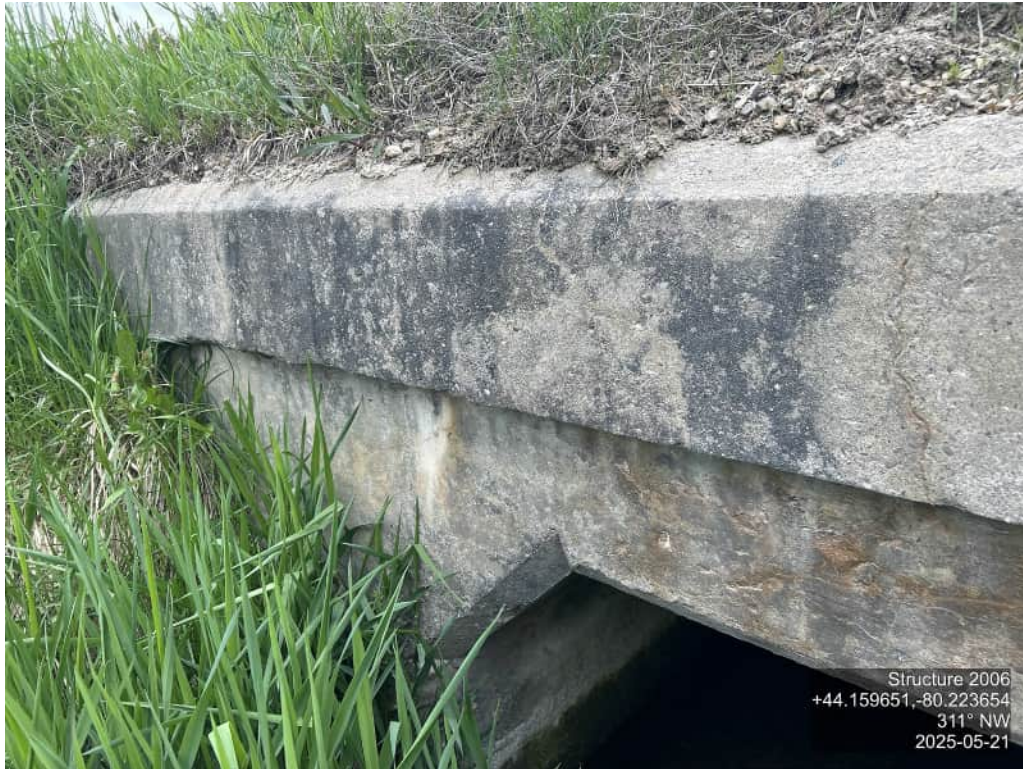
**CURB – WEST – IMPACT DAMAGE SPALLS ON ENDS**

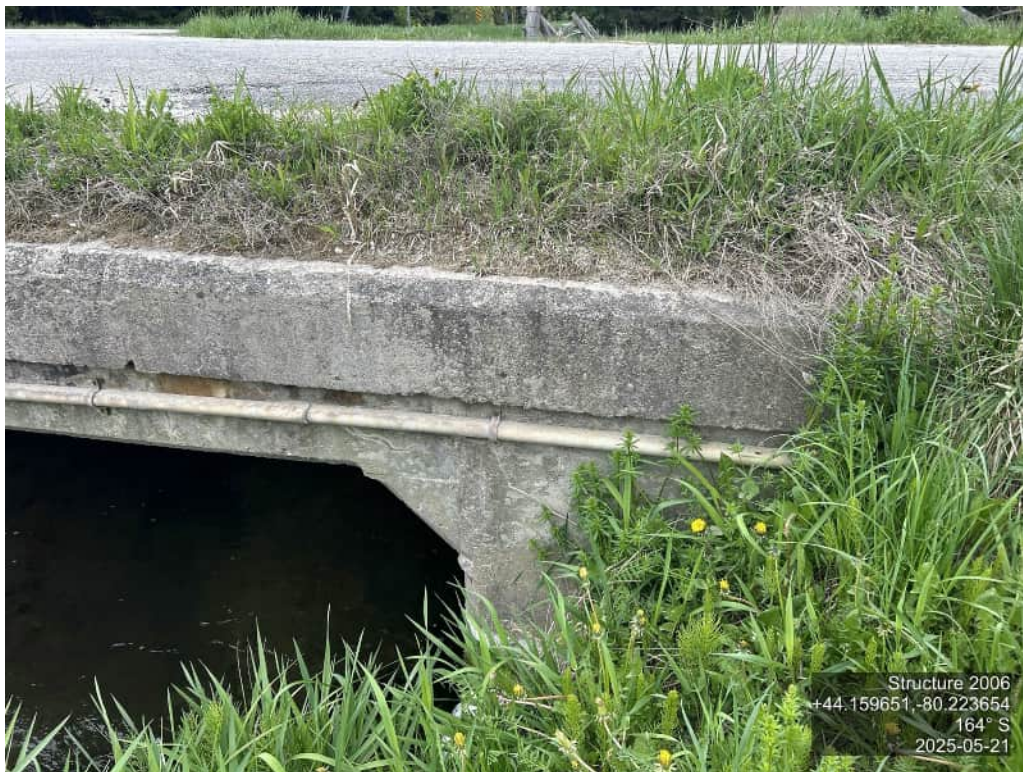
**WINGWALL – SOUTH – NARROW STAINED CRACKS**

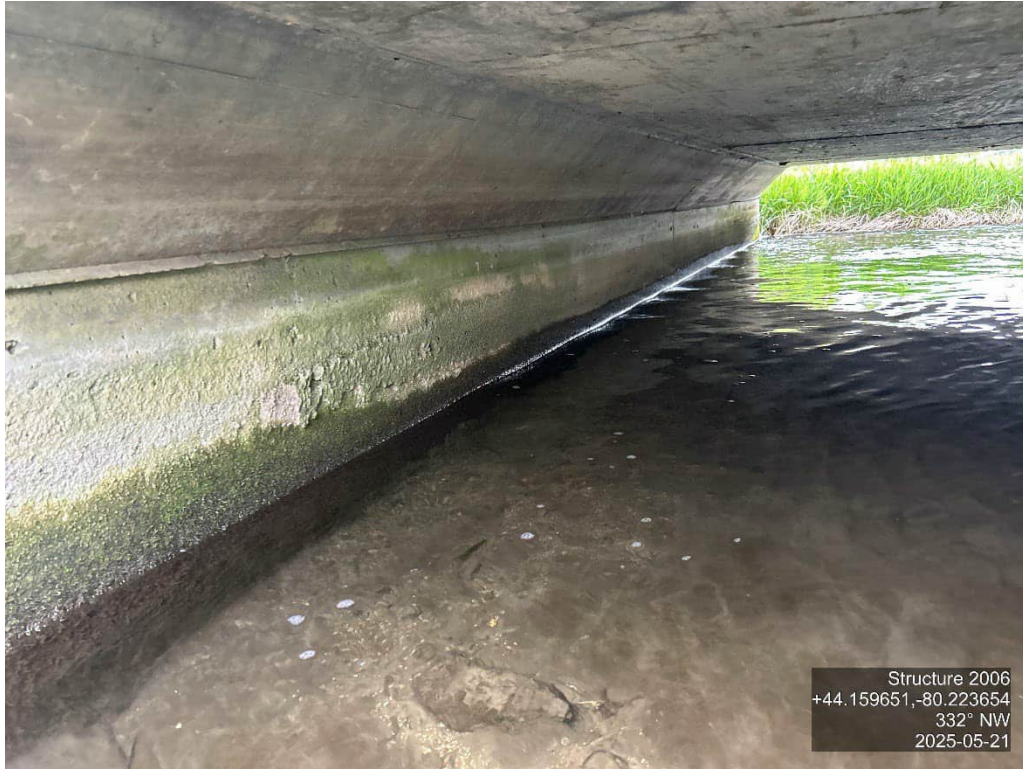
**ABUTMENT WALLS – NORTH**

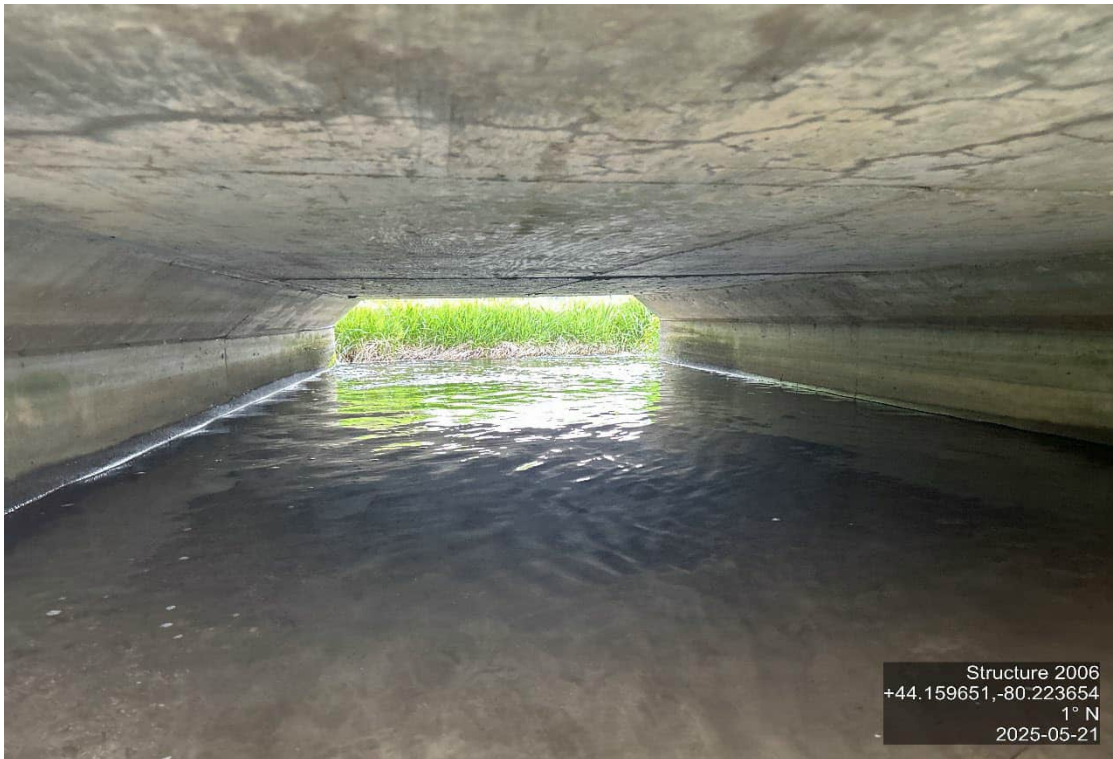
**SOFFIT – INTERIOR – SPALLS WITH EXPOSED CORRODED REBAR**

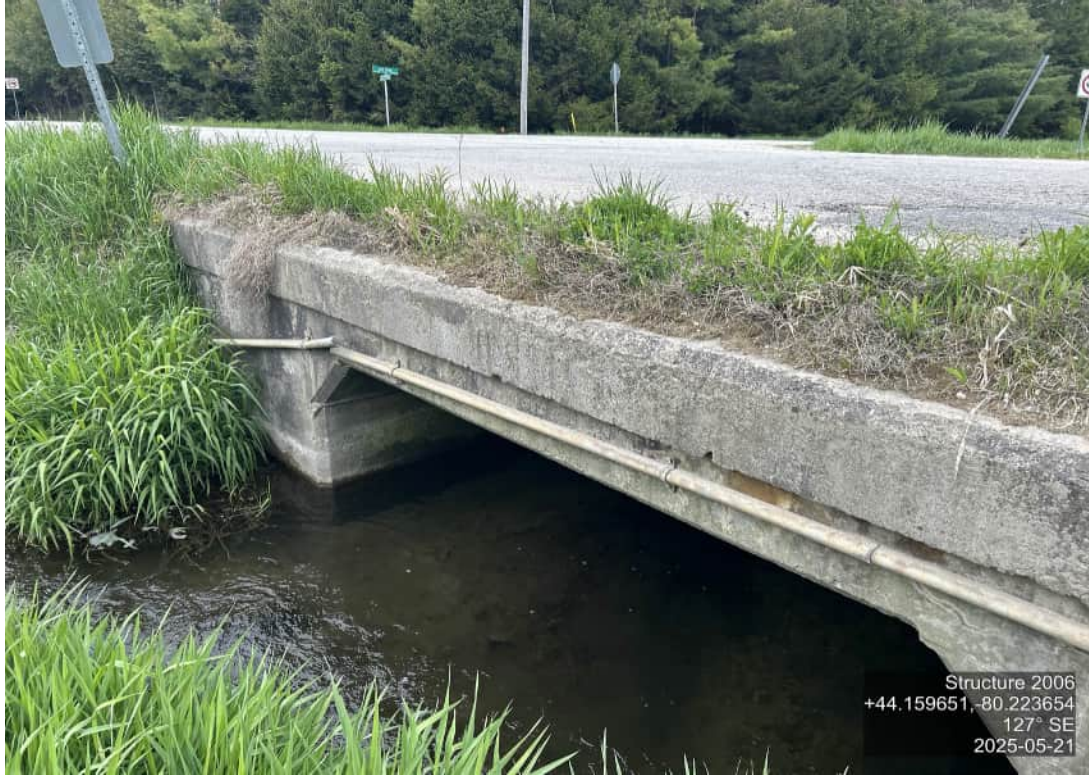
**STREAM – SOUTH FOOTING EXPOSED**

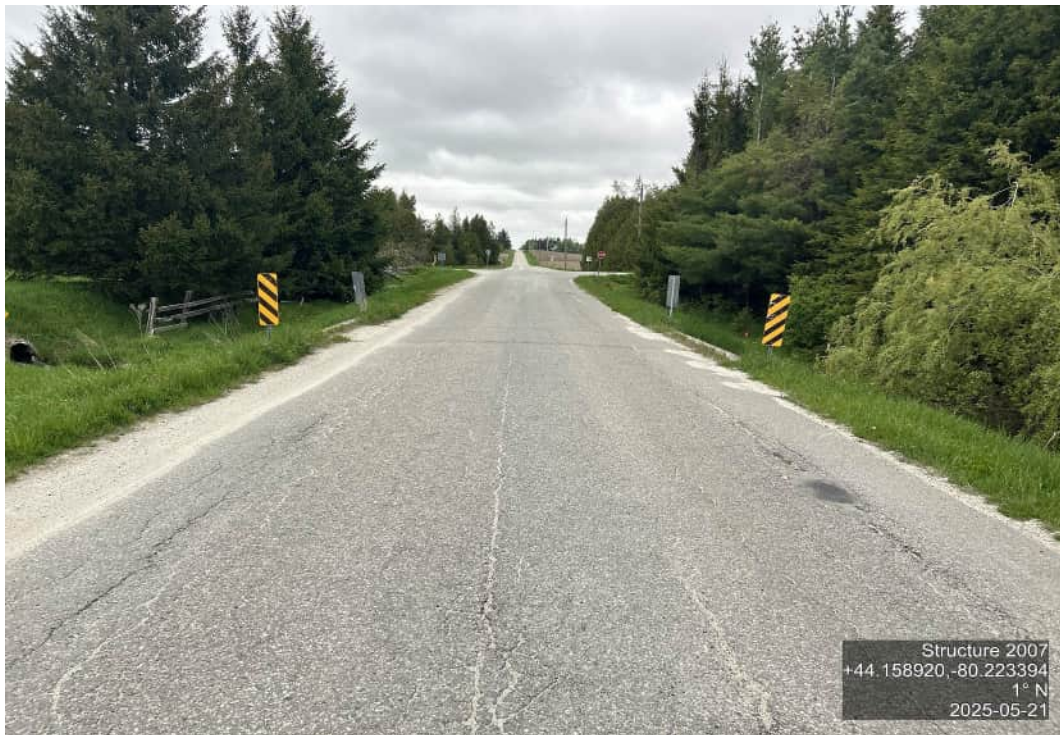
**DECK WEARING SURFACE – NORTH – SEVERE ALLIGATOR CRACKING**

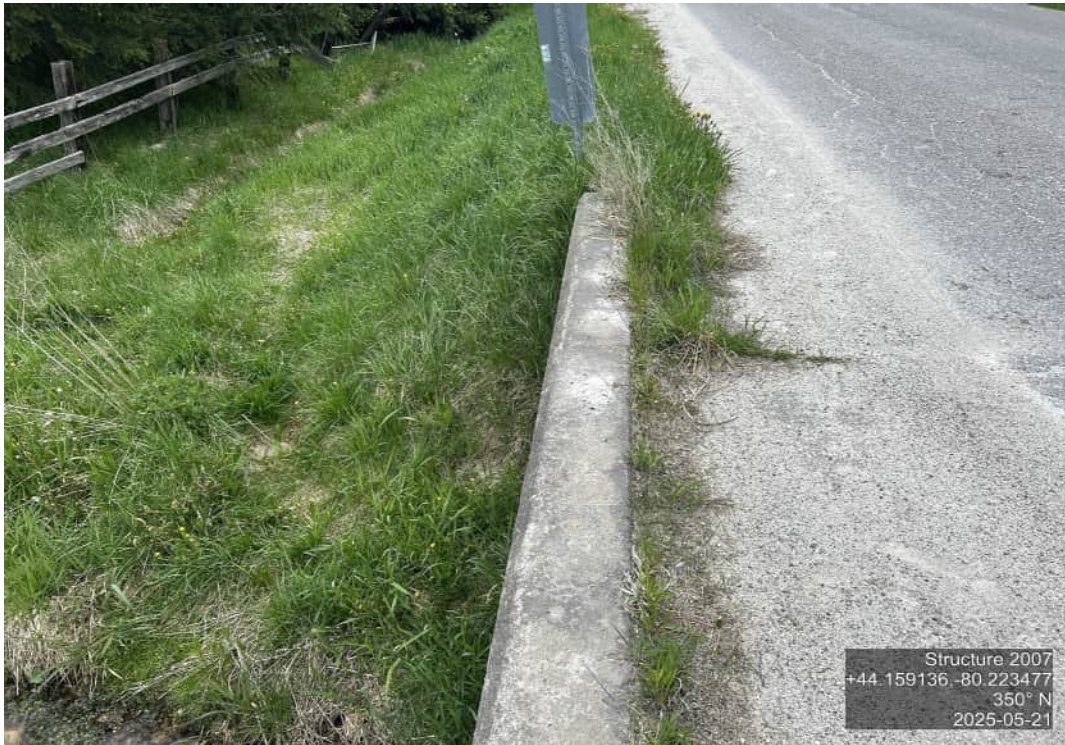
**CURB – WEST – SMALL SPALLS**
