**BURNSIDE**

## **2025 OSIM Bridge Inspections Report**

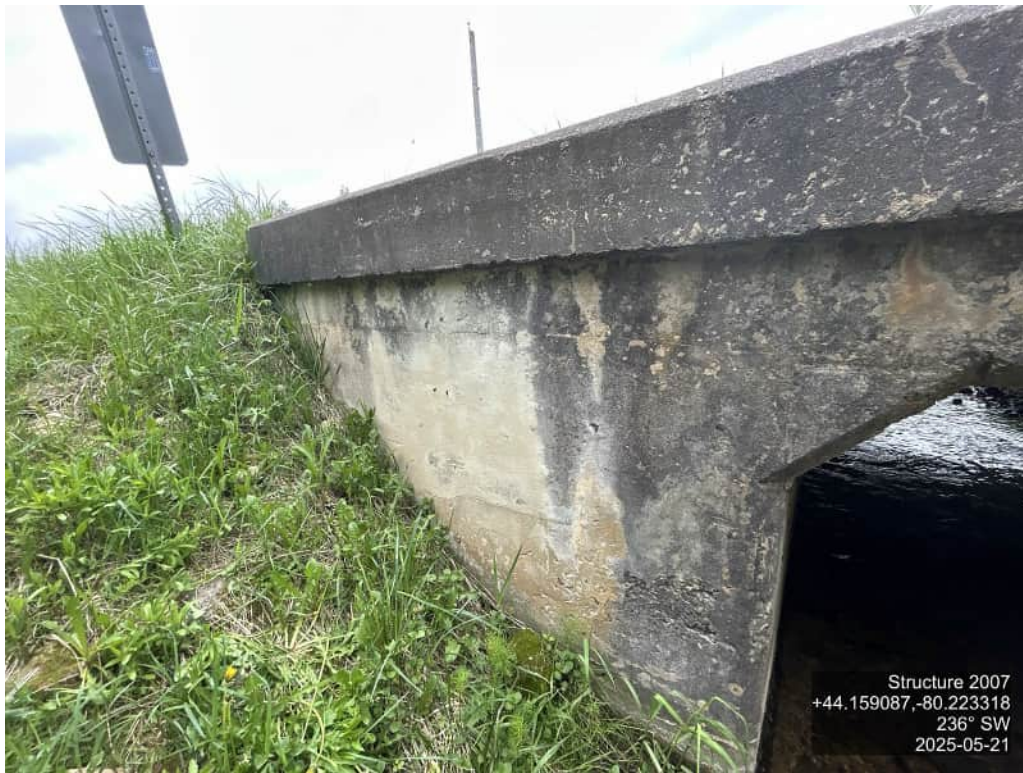
**WINGWALL – NORTHWEST – NARROW STAINED CRACKS**

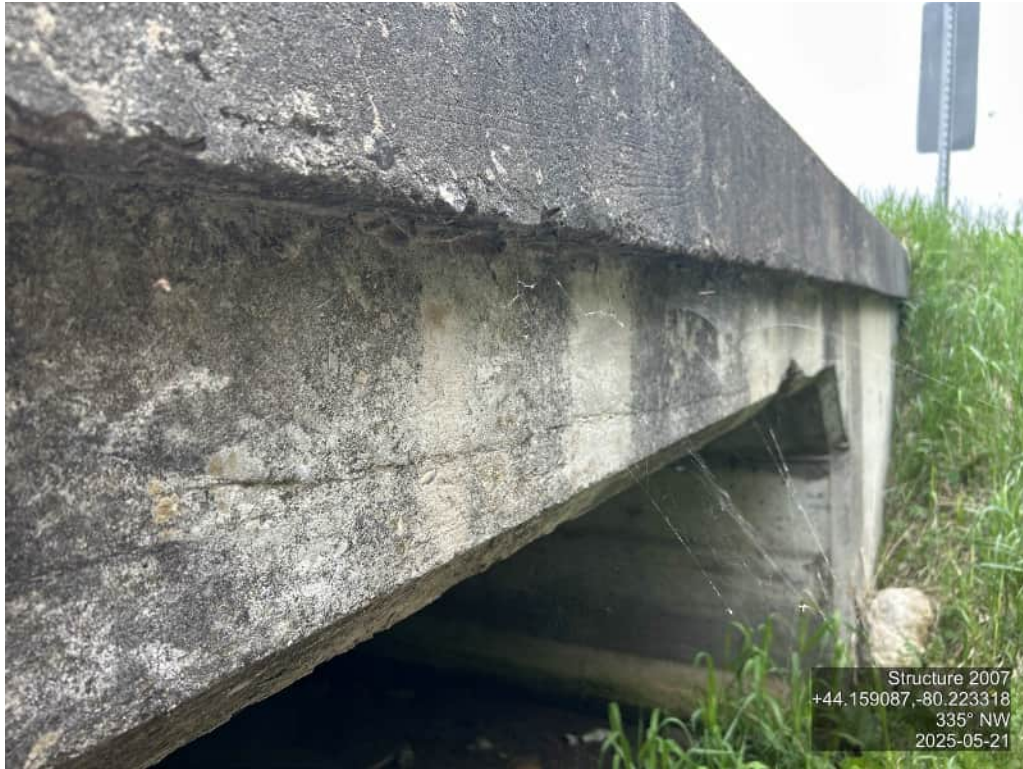
**SOFFIT EXTERIOR – SOUTH - DELAMINATIONS**

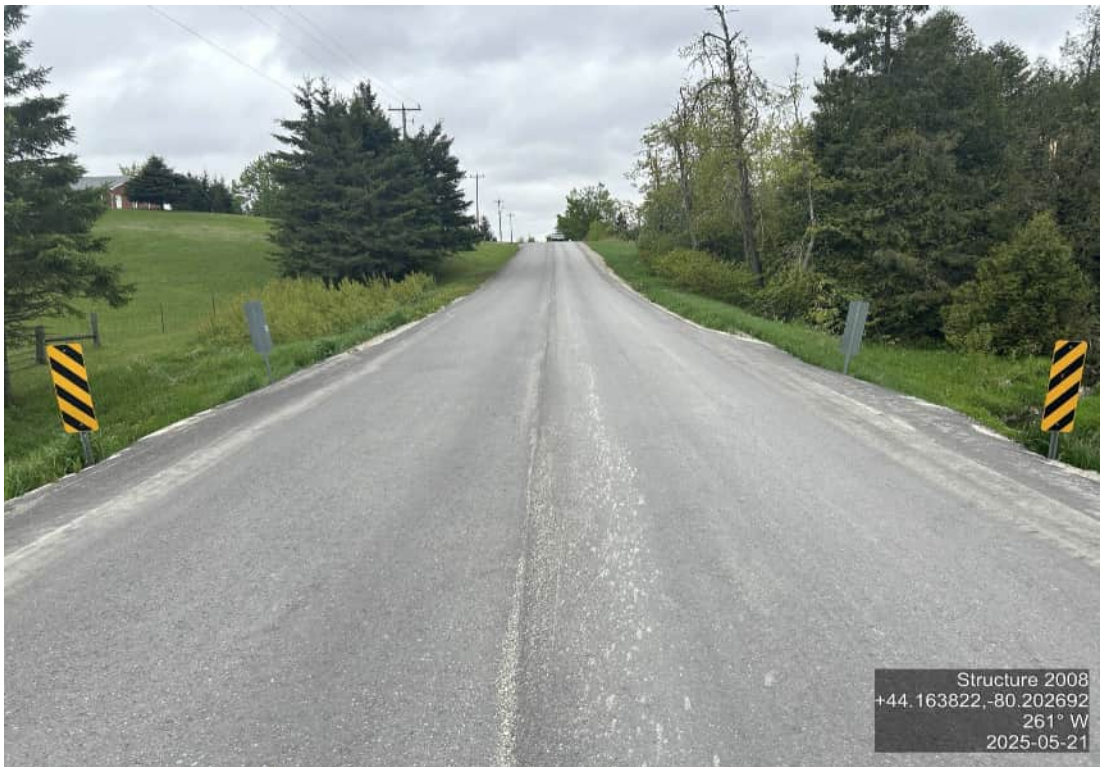
**DECK WEARING SURFACE – EAST – LONGITUDINAL CRACKS**

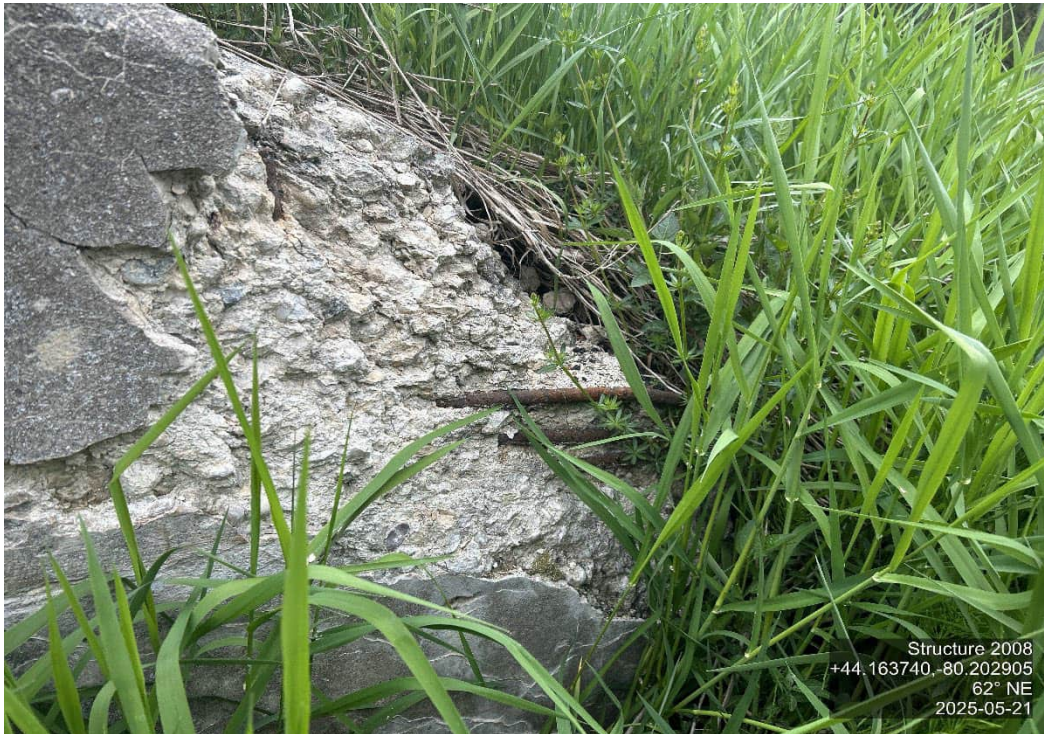
**WINGWALL – SOUTHWEST – DISINTEGRATION AND SPALLS WITH EXPOSED CORRODED REBAR**

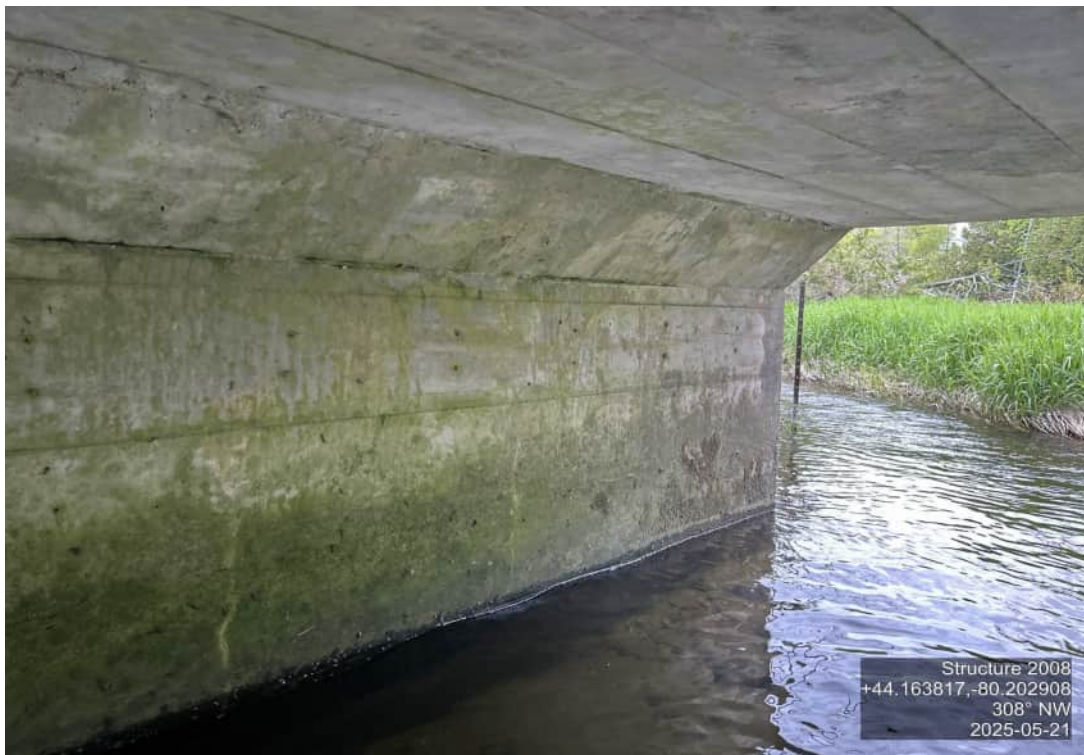
**ABUTMENT WALLS – NORTHWEST – VERTICAL CRACKS**

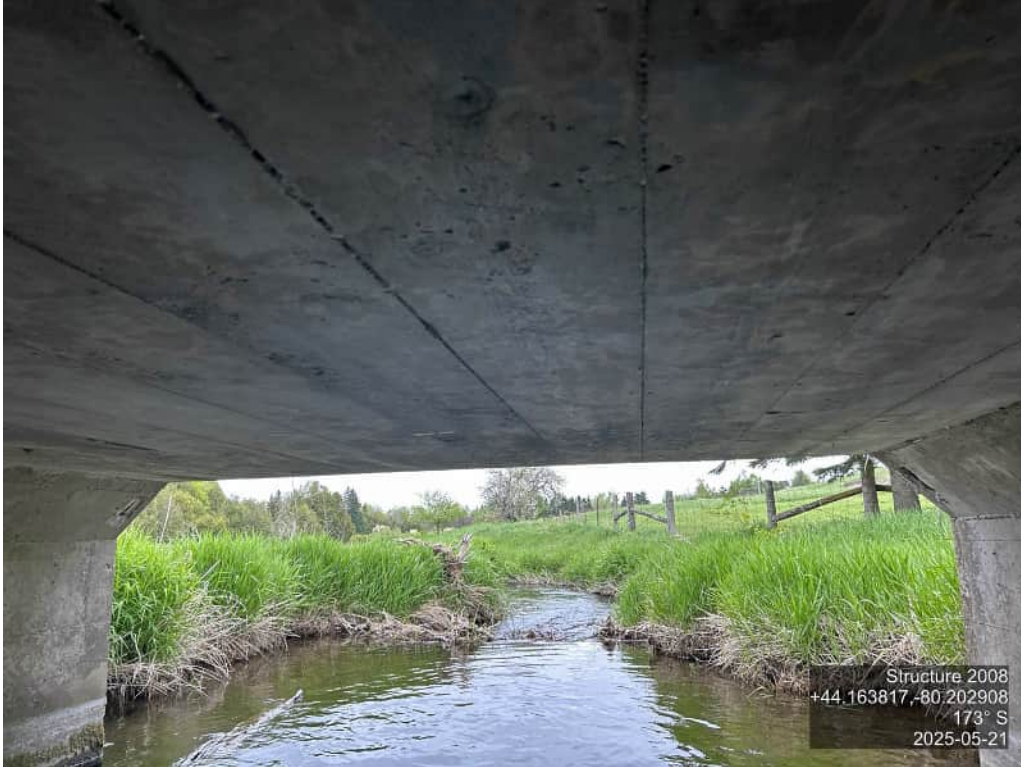
**SOFFIT INTERIOR – SOUTH – LIGHT HONEYCOMBING AND DELAMINATIONS**

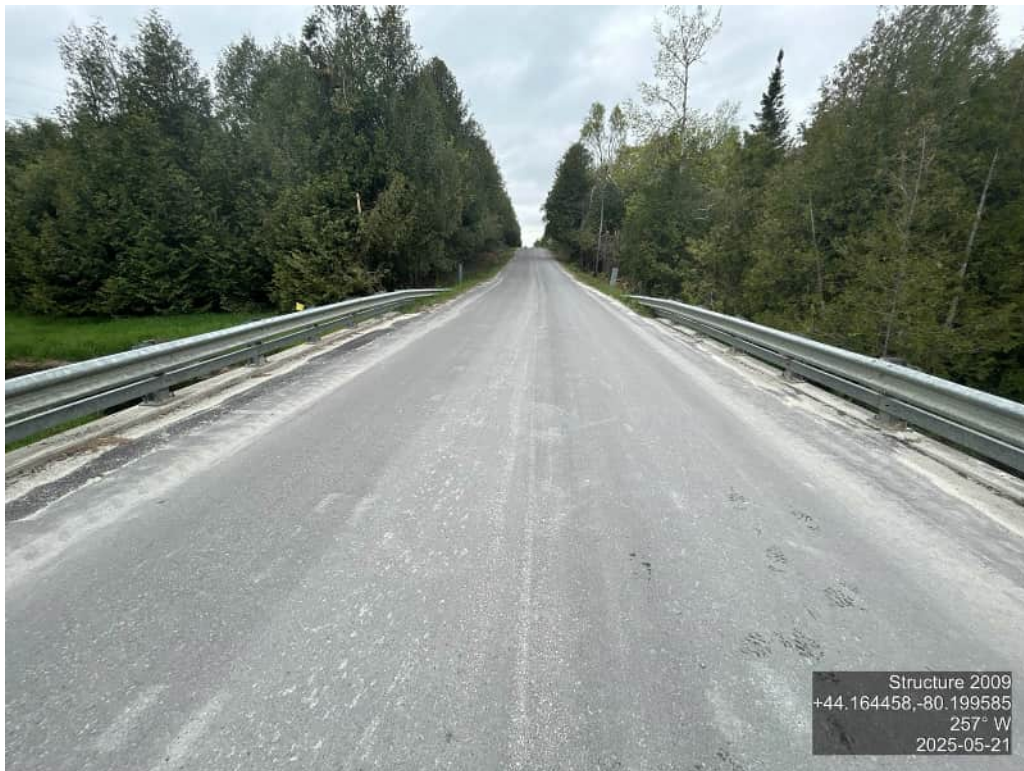
**DECK WEARING SURFACE – WEST**

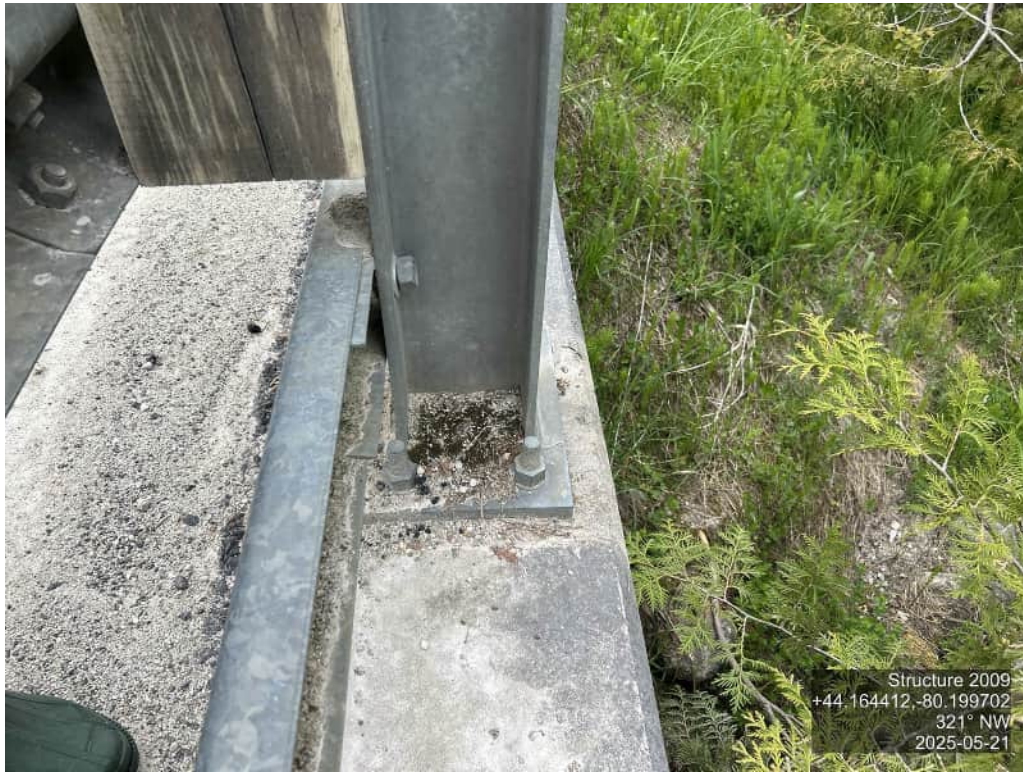
**CURB – NORTHWEST – POUR VIBRATION AROUND BASE PLATES**

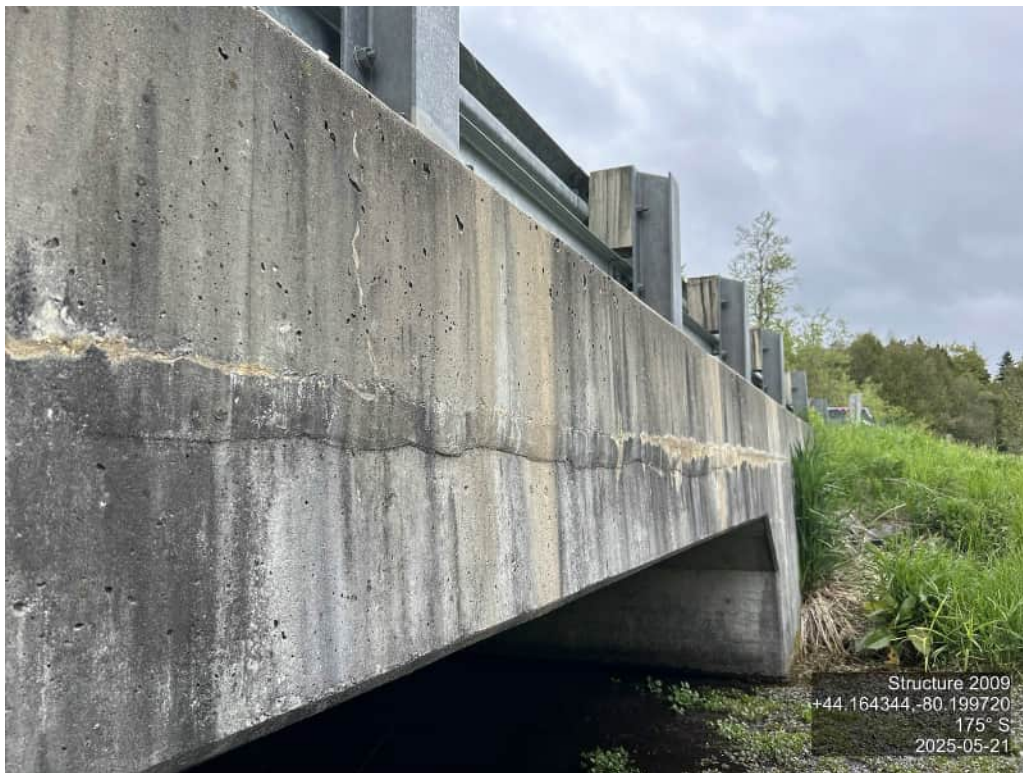
**INLET – NORTH – EFFLORESCENCE STAINED CRACKS**

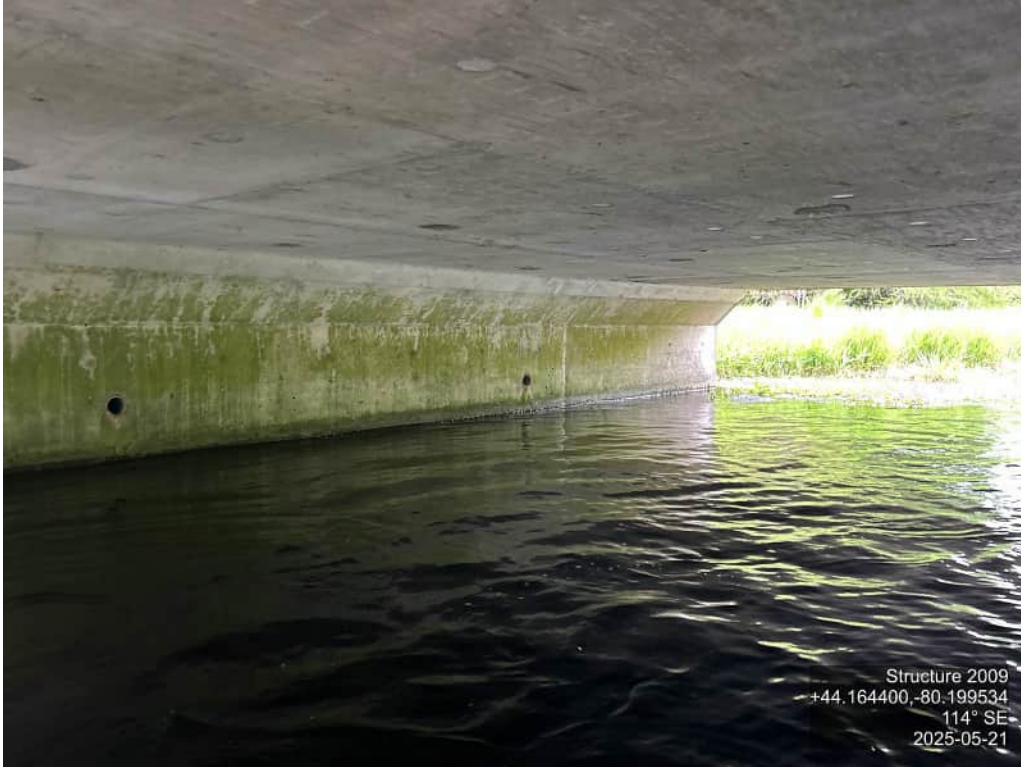
**BARREL – INTERIOR – DAMPNESS NOTED**

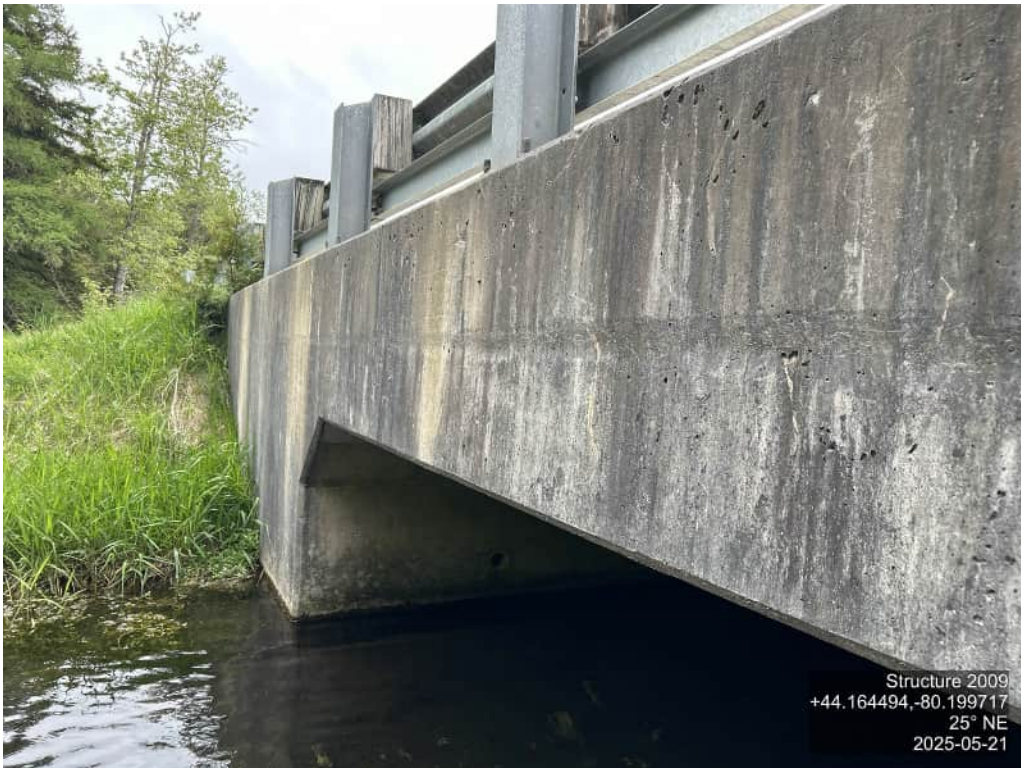
**OUTLET – SOUTH – EFFLORESCENCE STAINED CRACKS THROUGHOUT**

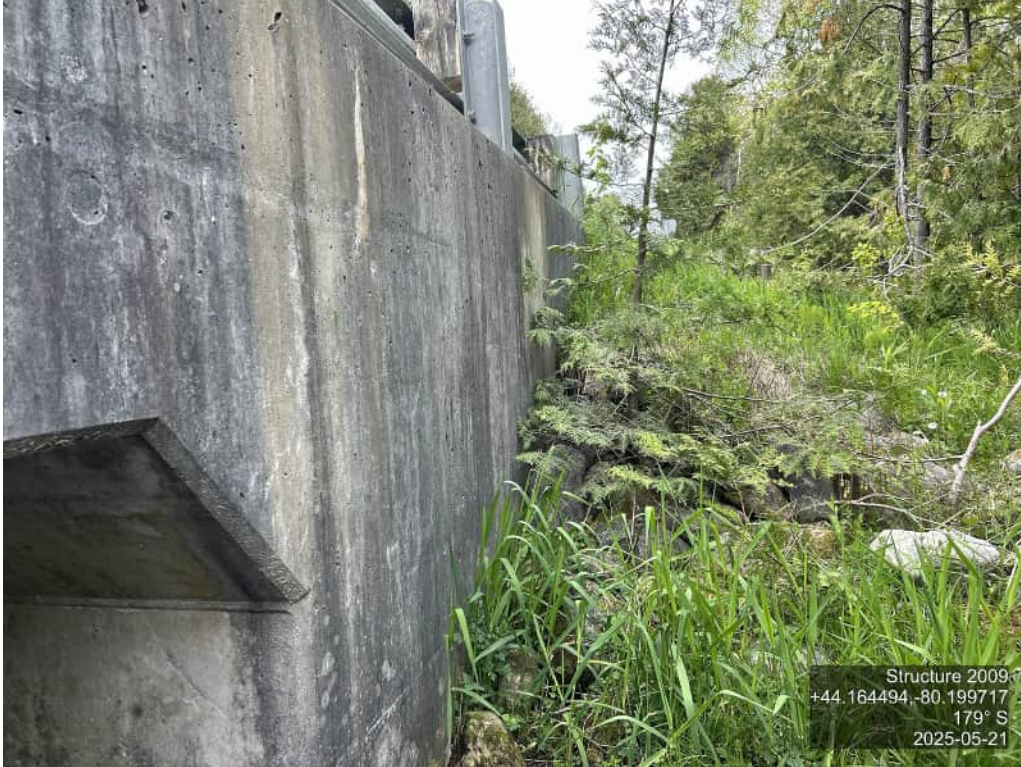
**EMBANKMENT – NORTHEAST – ROCK PROTECTION**

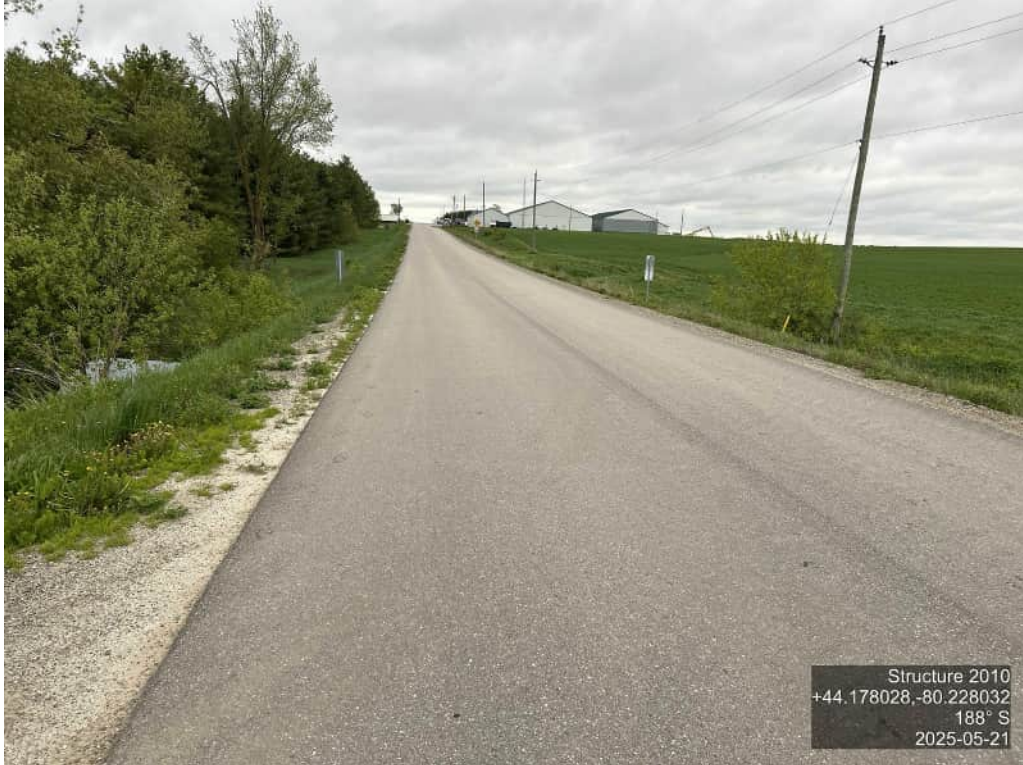
Structure 2010  
+44.178028,-80.228032  
188° S  
2025-05-21

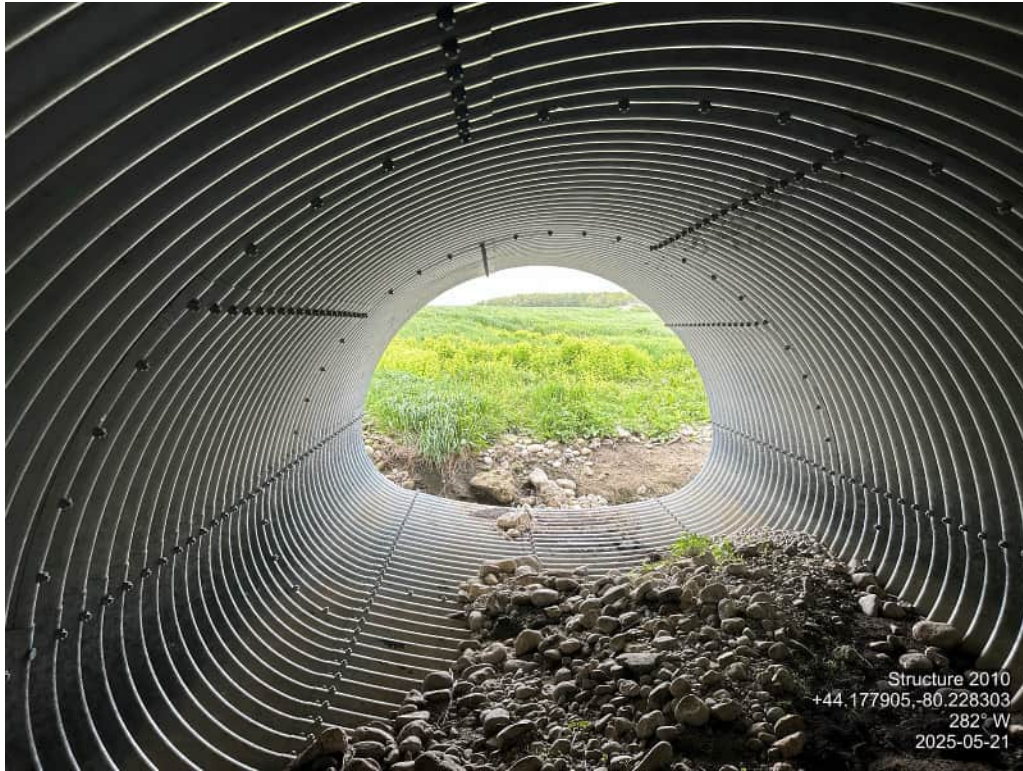
Structure 2010  
+44.177905,-80.228303  
282° W  
2025-05-21

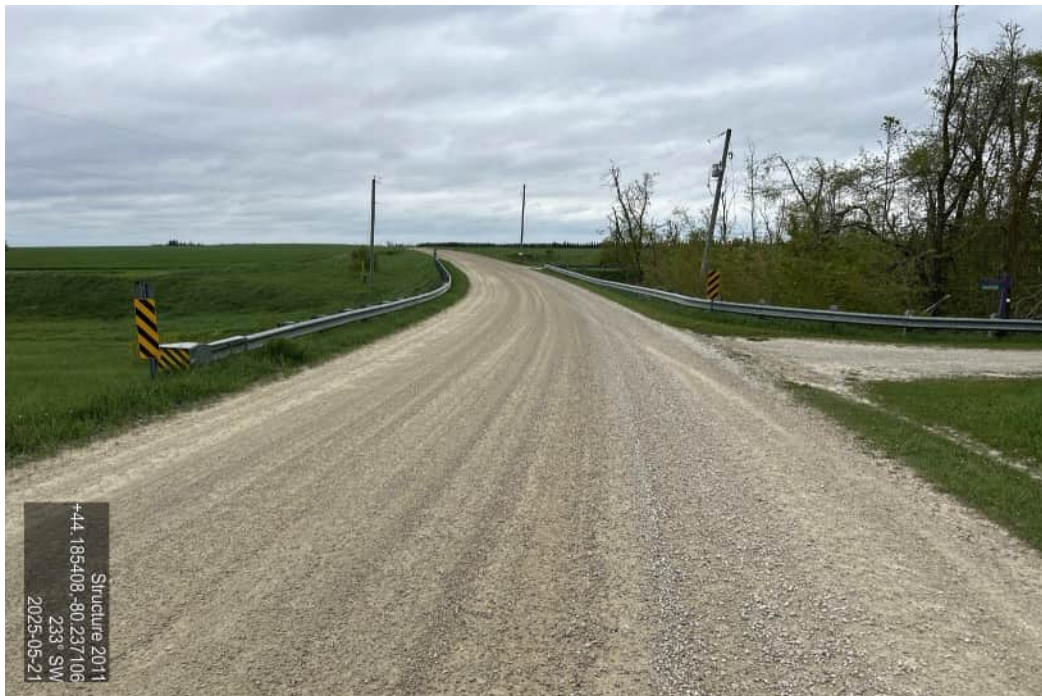
**APPROACH WEARING SURFACE – EAST**

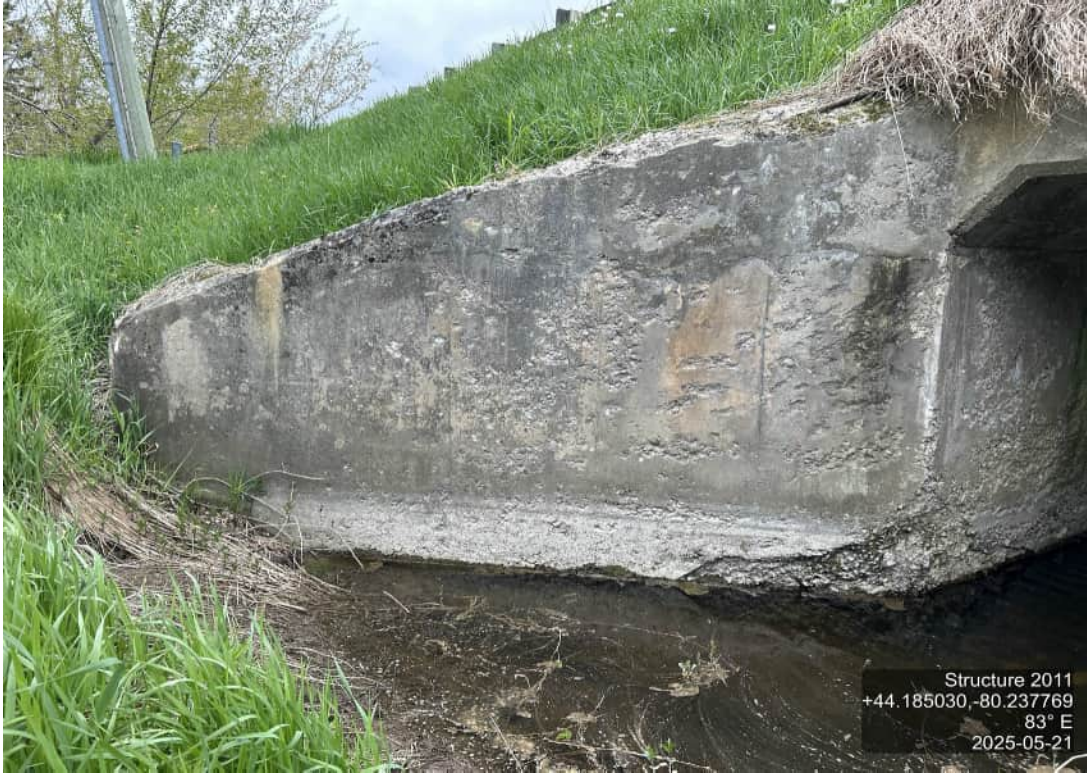
**WINGWALL – SOUTHEAST – SEVERE SCALING, DELAMINATIONS AND SPALL WITH EXPOSED CORRODED REBAR**

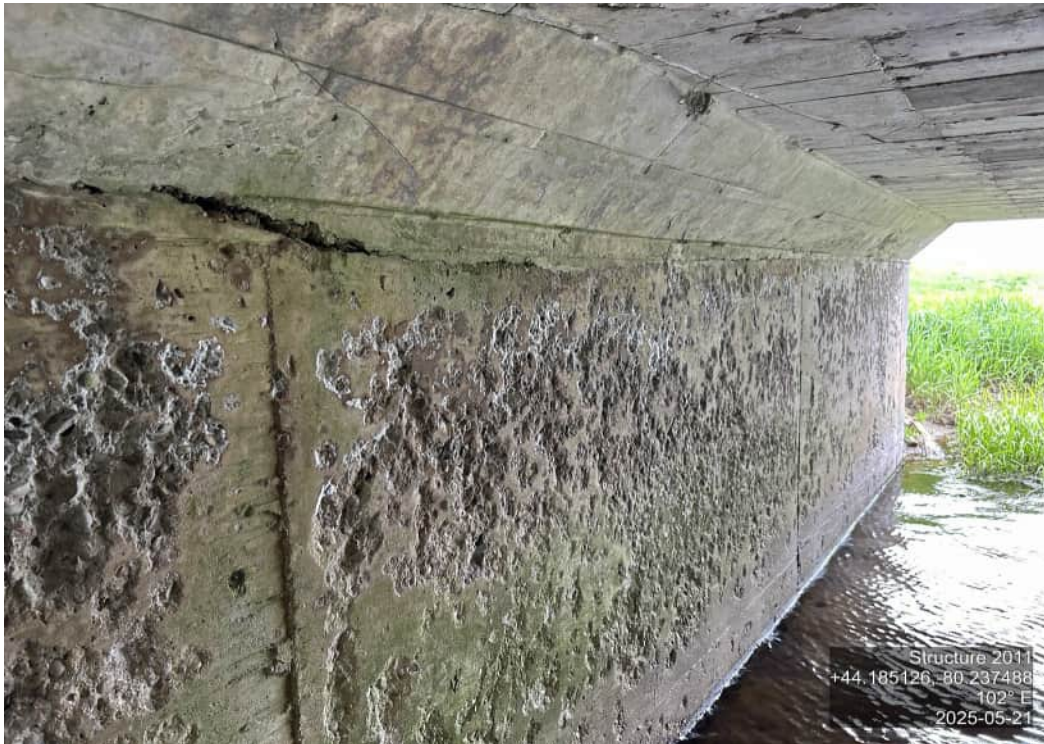
**ABUTMENT WALLS – EAST – SEVERE SCALING WITH HONEYCOMBING AND DELAMINATIONS**

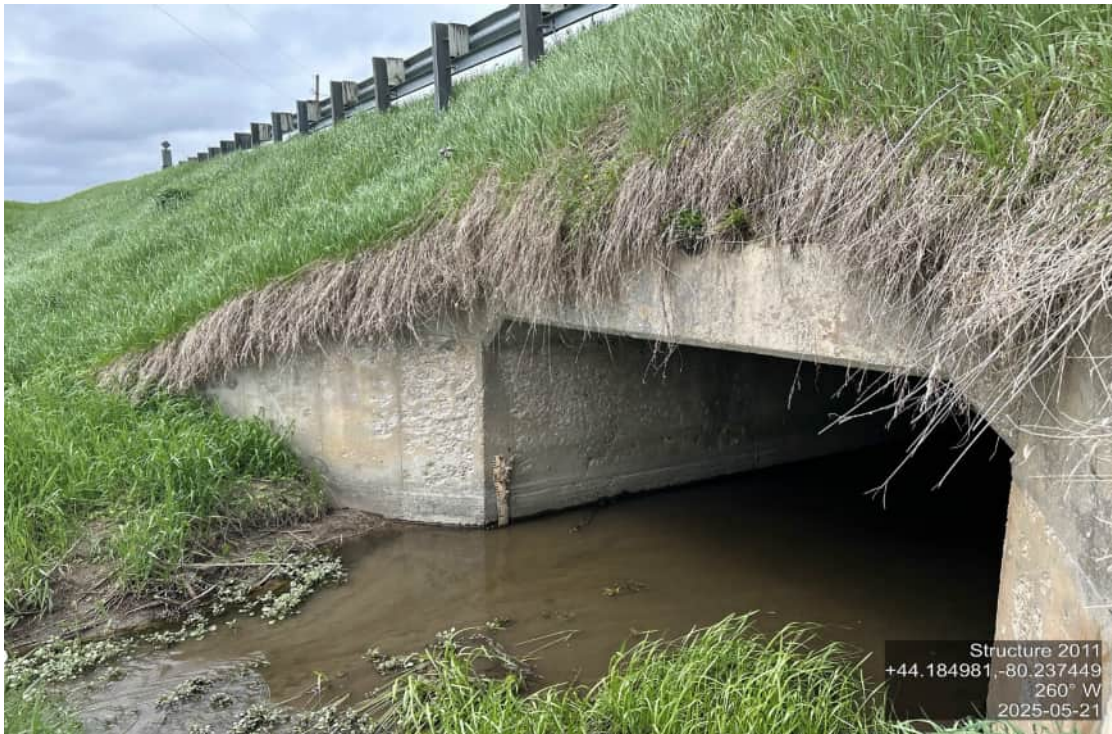
**SOFFIT – EXTERIOR – SPALLING WITH EXPOSED CORRODED REBAR AND DELAMINATIONS**

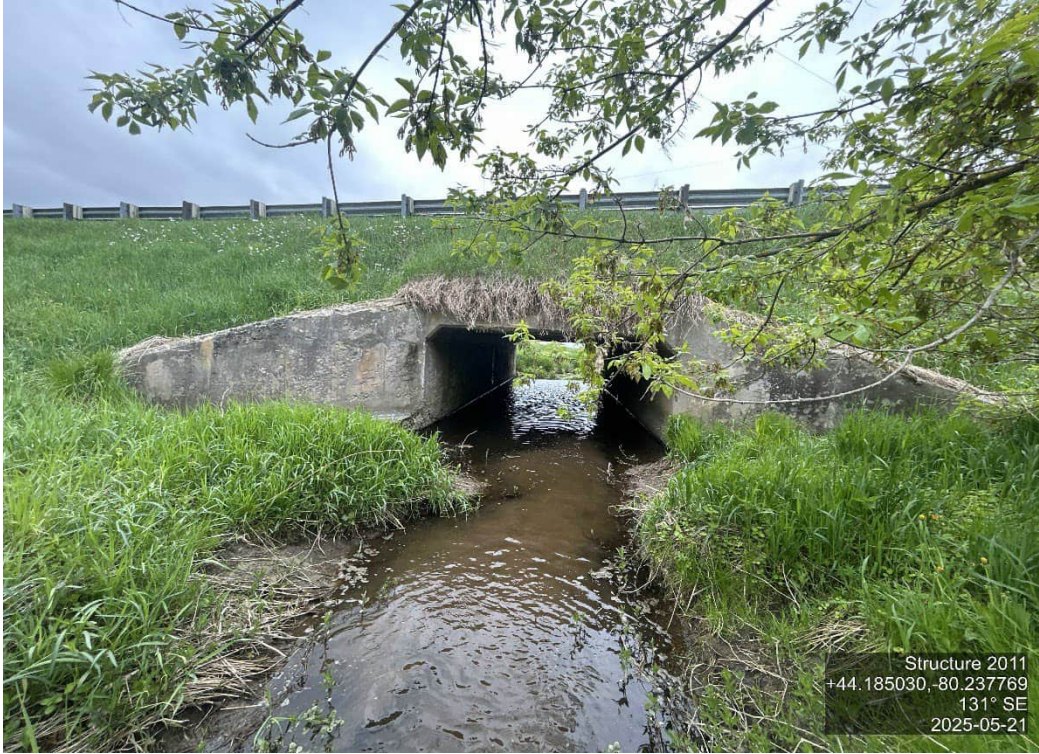
**STREAM – SOUTH – FLOWS NORTH TO SOUTH**

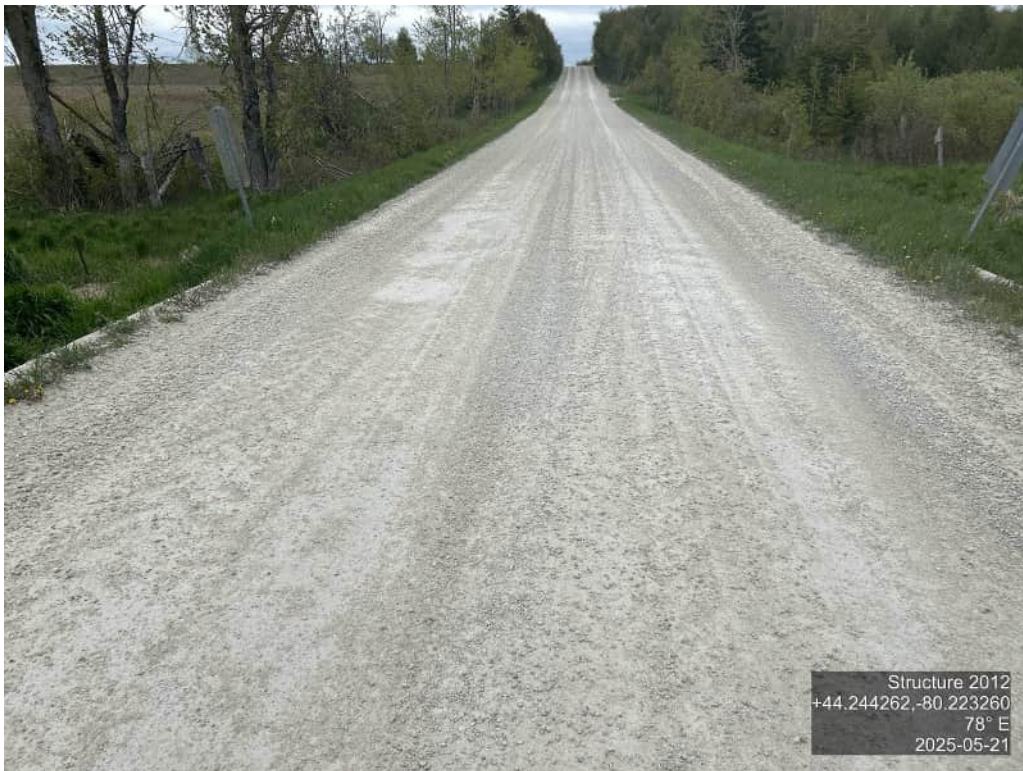
**DECK WEARING SURFACE – EAST – MODERATE POTHOLES**

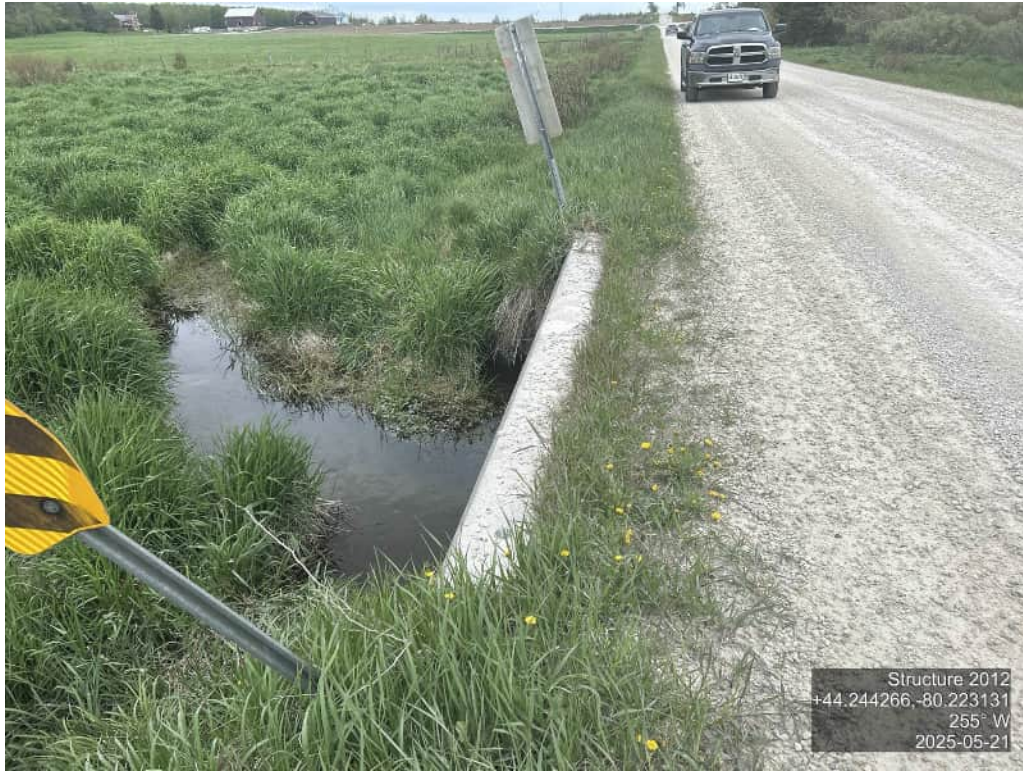
**CURB – SOUTH – IMPACT DAMAGE ON SW SIDE**

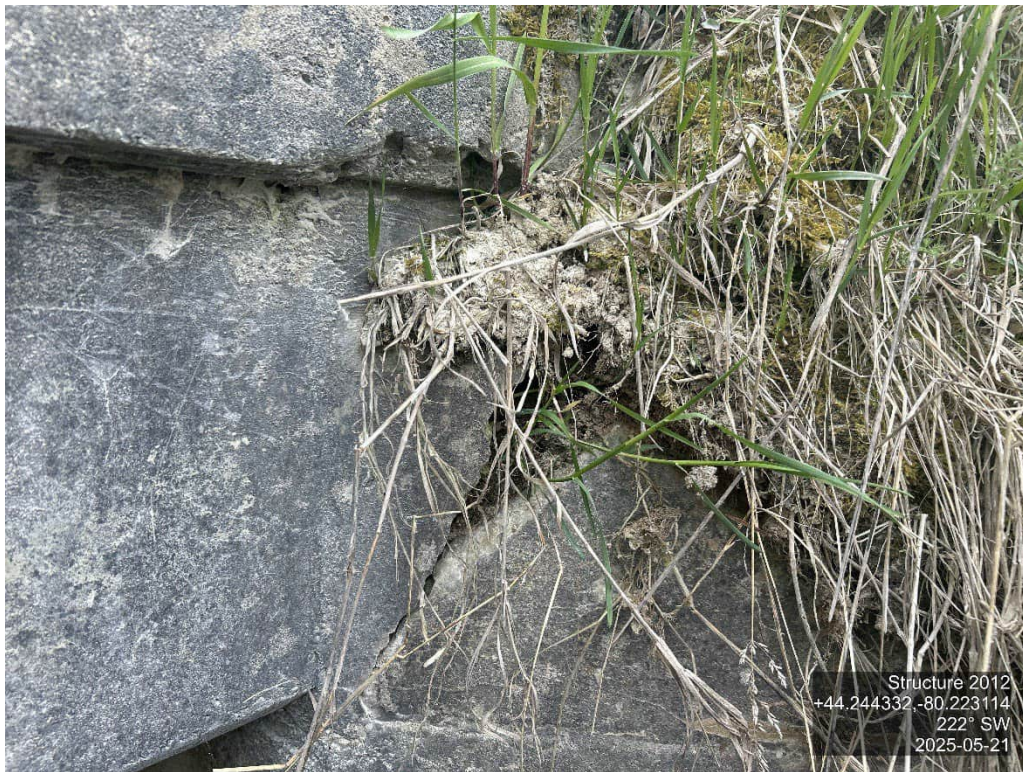
**WINGWALL – SOUTHWEST – WIDE CRACK AT CONNECTION**

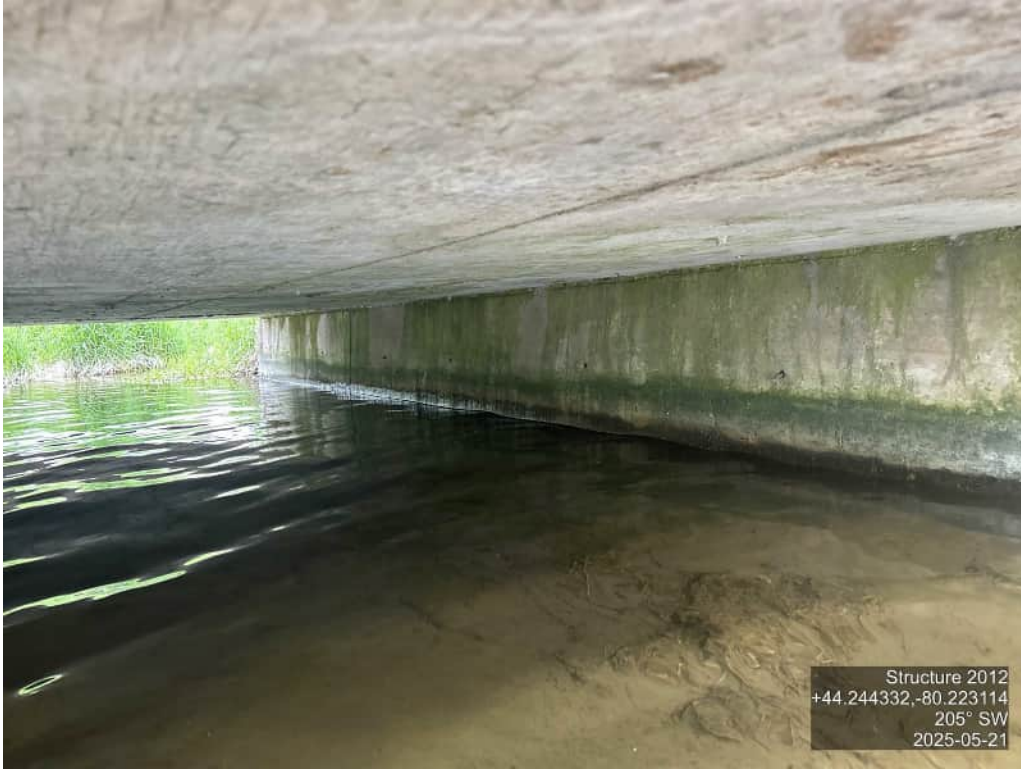
**ABUTMENT WALLS – INTERIOR – STAINING AT WATERLINE**

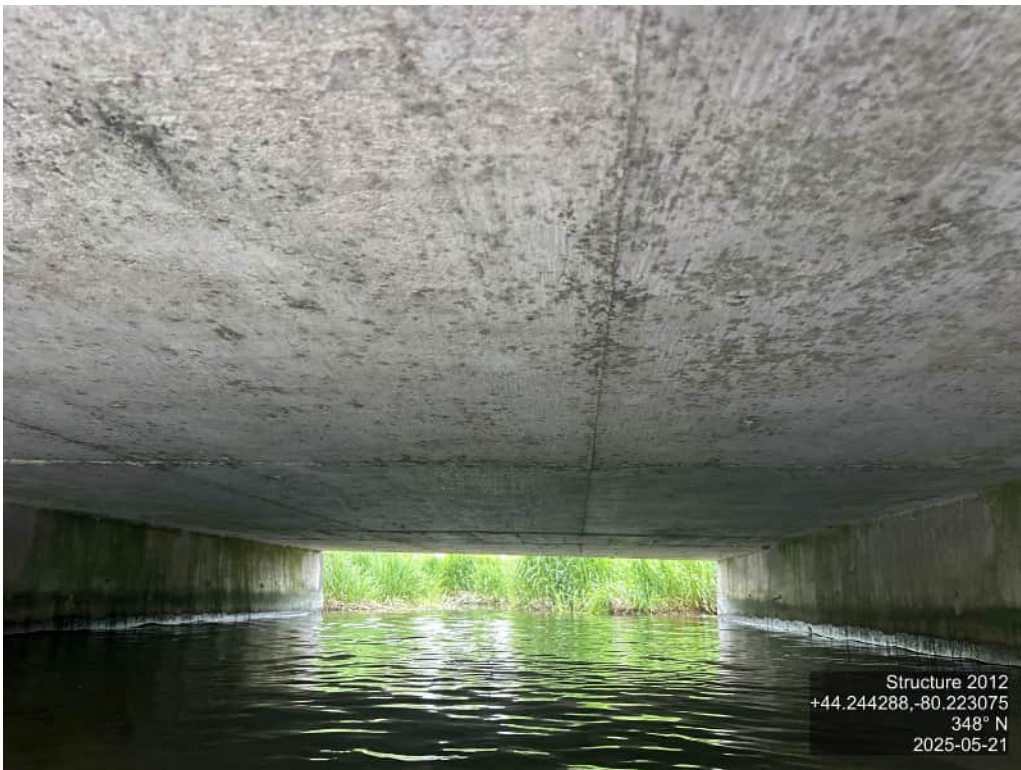
**SOFFIT- INTERIOR – LIGHT TO MODERATE HONEYCOMBING**

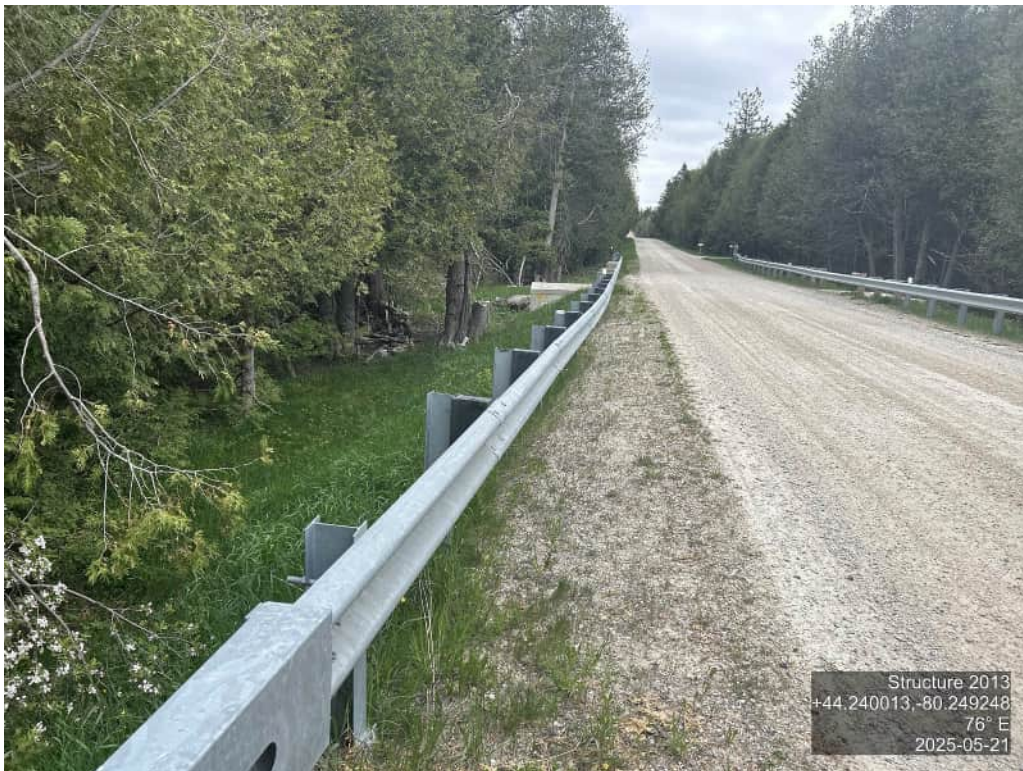
**APPROACH WEARING SURFACE – EAST**

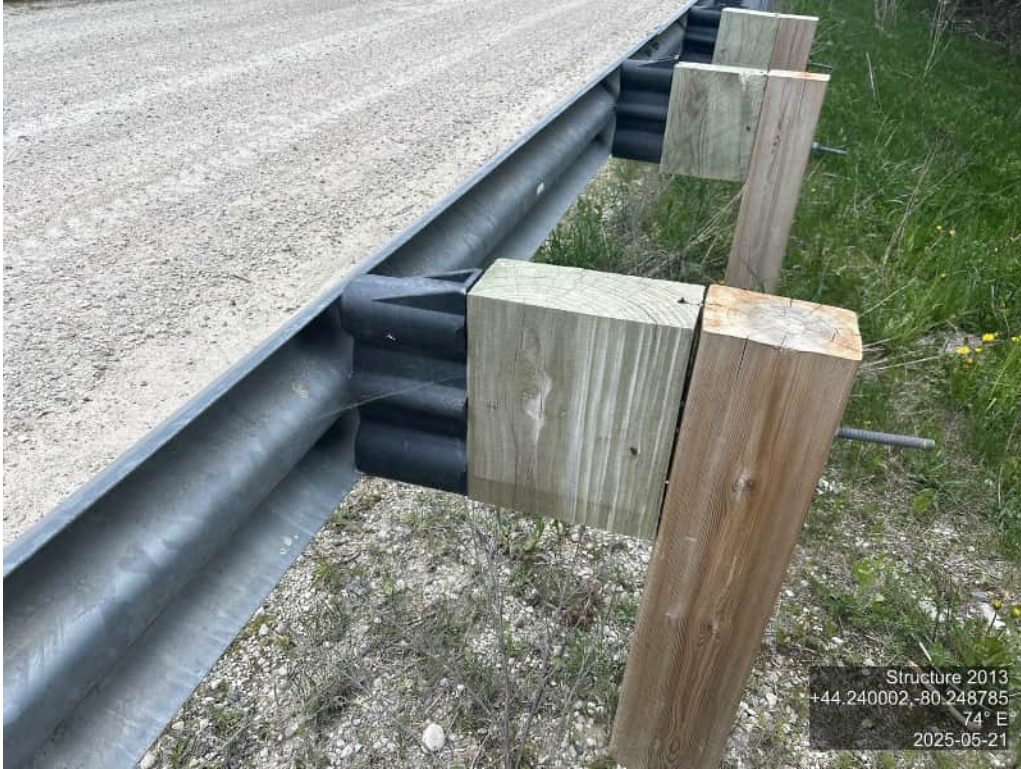
Structure 2013  
+44.240002,-80.248785  
74° E  
2025-05-21

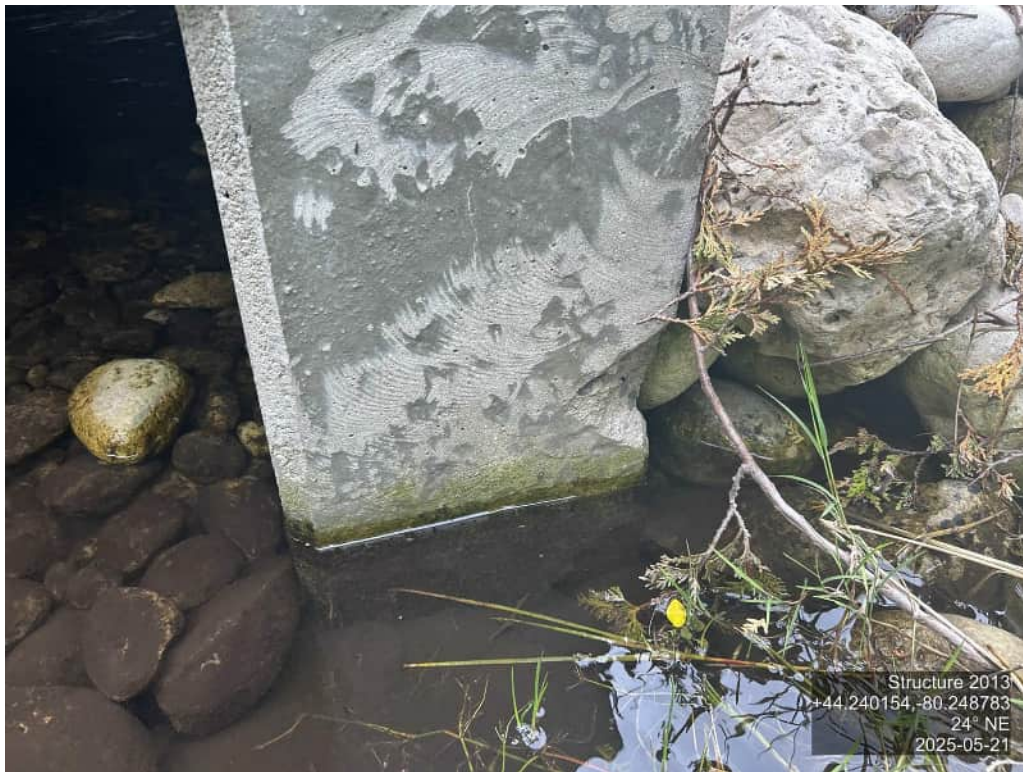
**OUTLET – NORTH – SMALL SPALL**

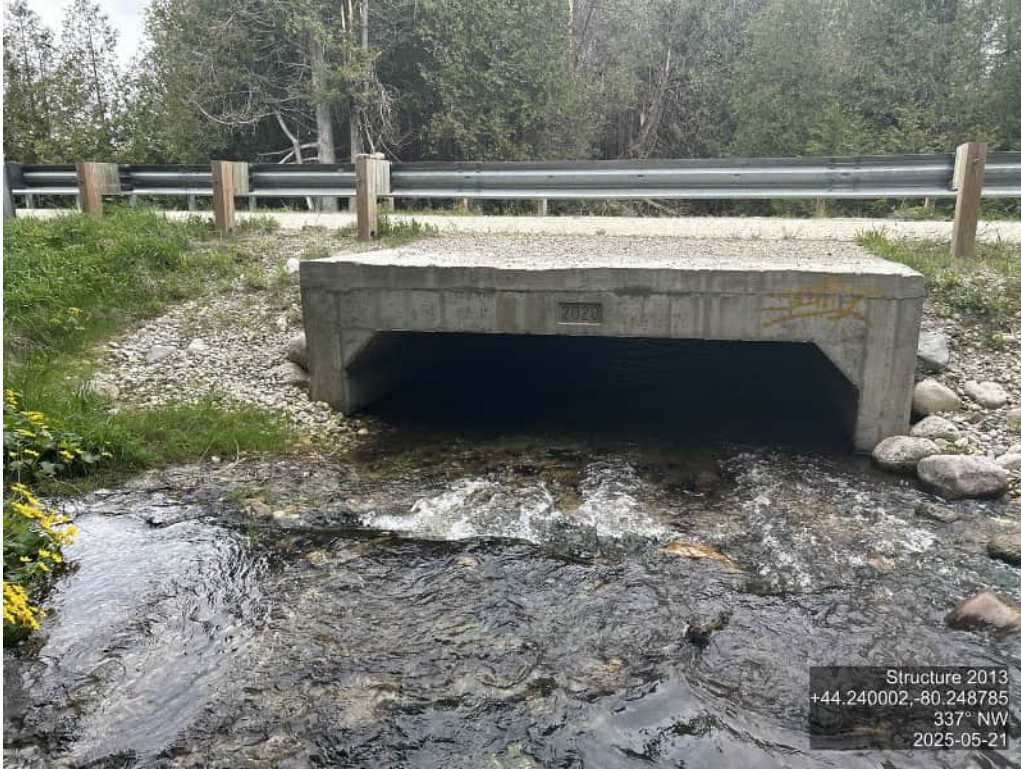
**EMBANKMENT – SOUTH – ROCK PROTECTION PRESENT**

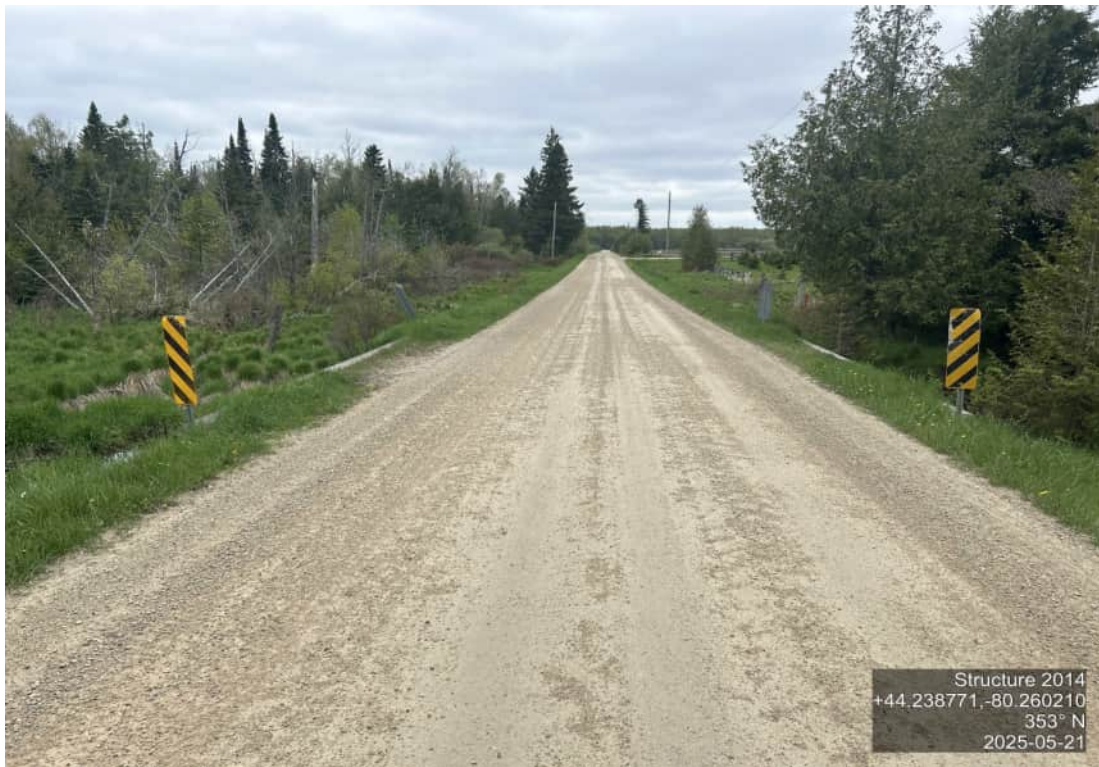
**DECK WEARING SURFACE – NORTH – SMALL POTHOLES**
