**BURNSIDE**

## **2025 OSIM Bridge Inspections Report**

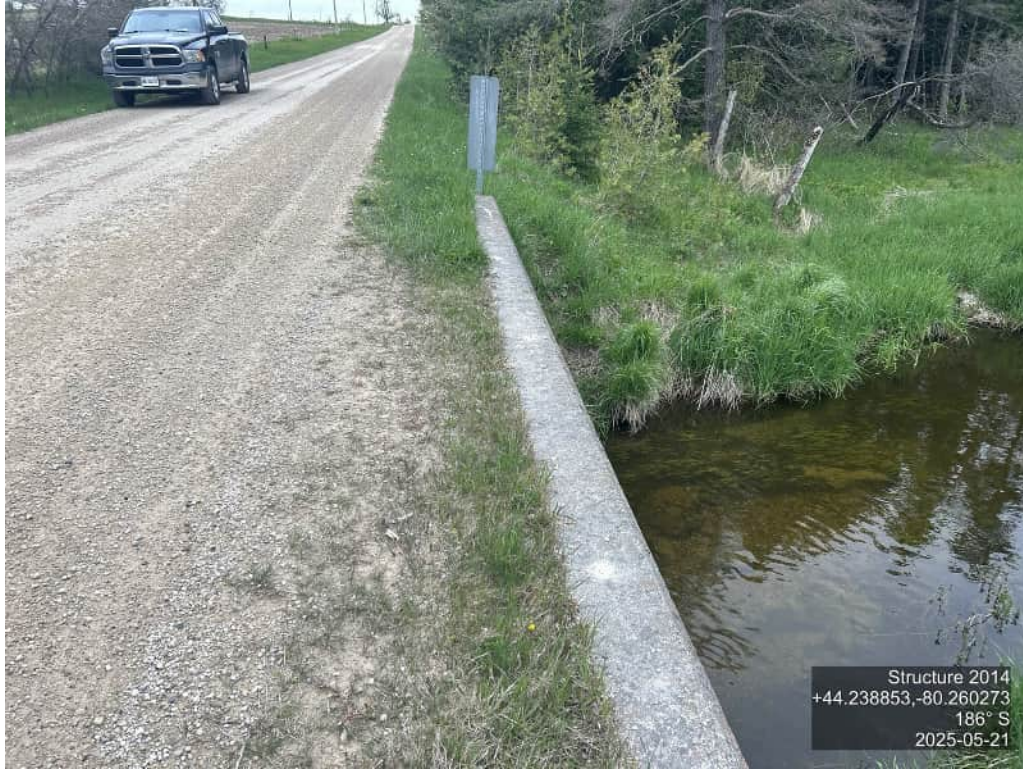
**CURB – SOUTHEAST – MEDIUM CRACKS THROUGHOUT**

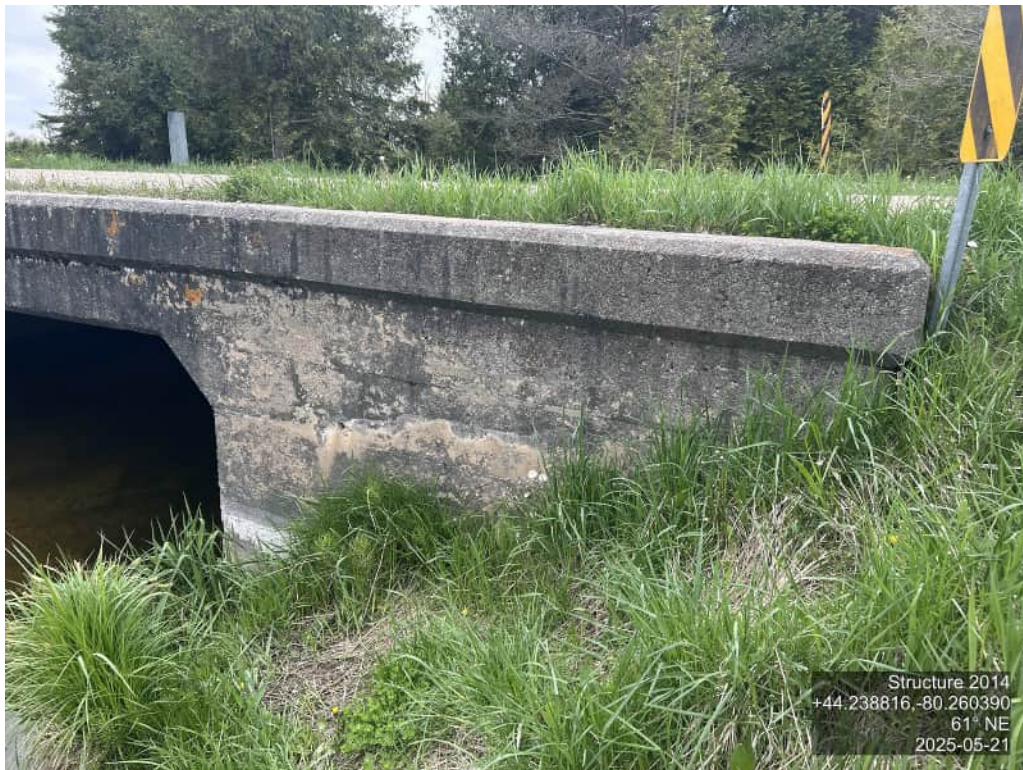
**WINGWALL – NORTHWEST – SCALING AND STAINING PRESENT**

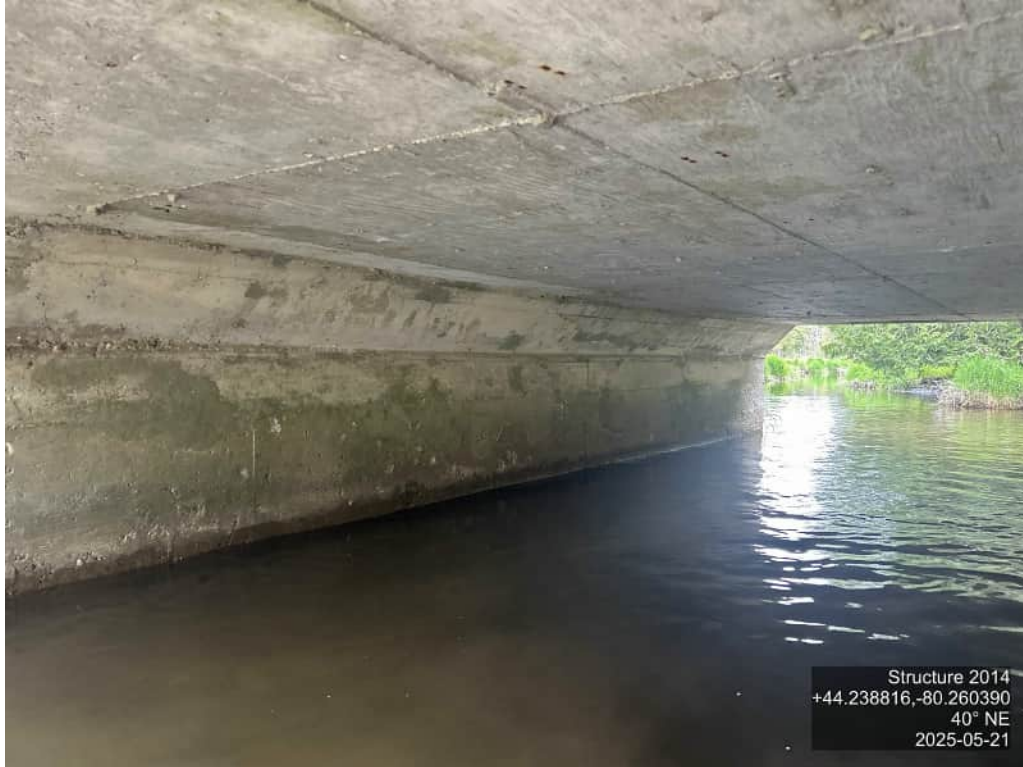
**ABUTMENT WALLS – INTERIOR – SEVERE SCALING AND HONEYCOMBING**

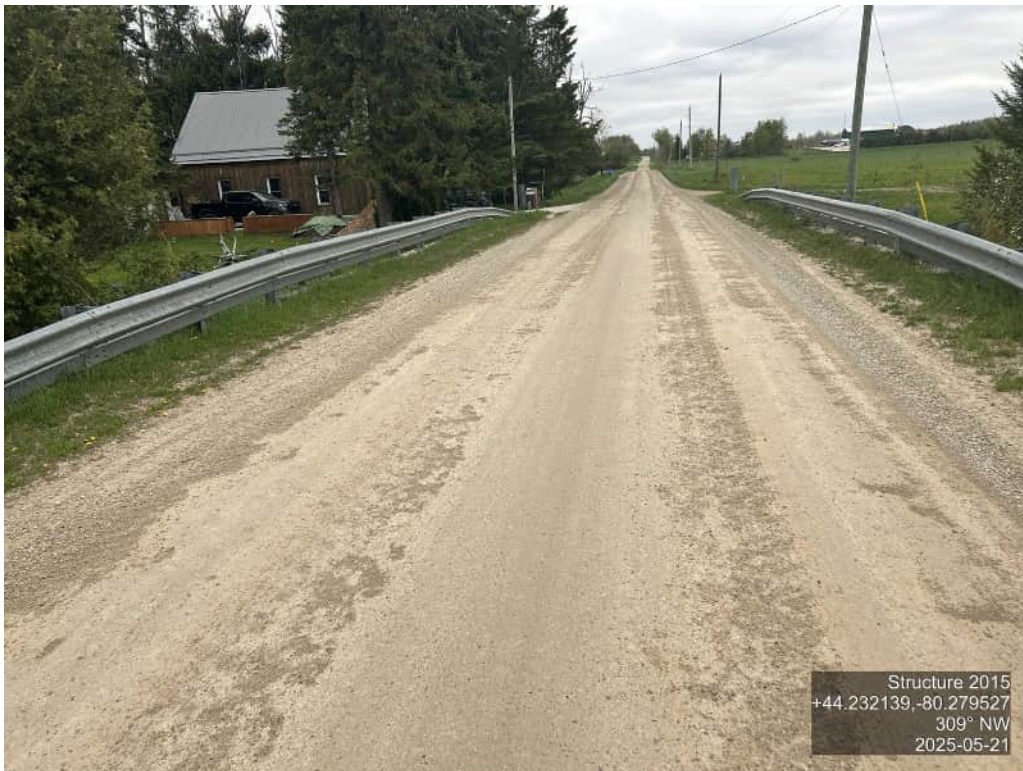
**DECK WEARING SURFACE – NORTH – VEGETATION ALONG SHOULDERS**

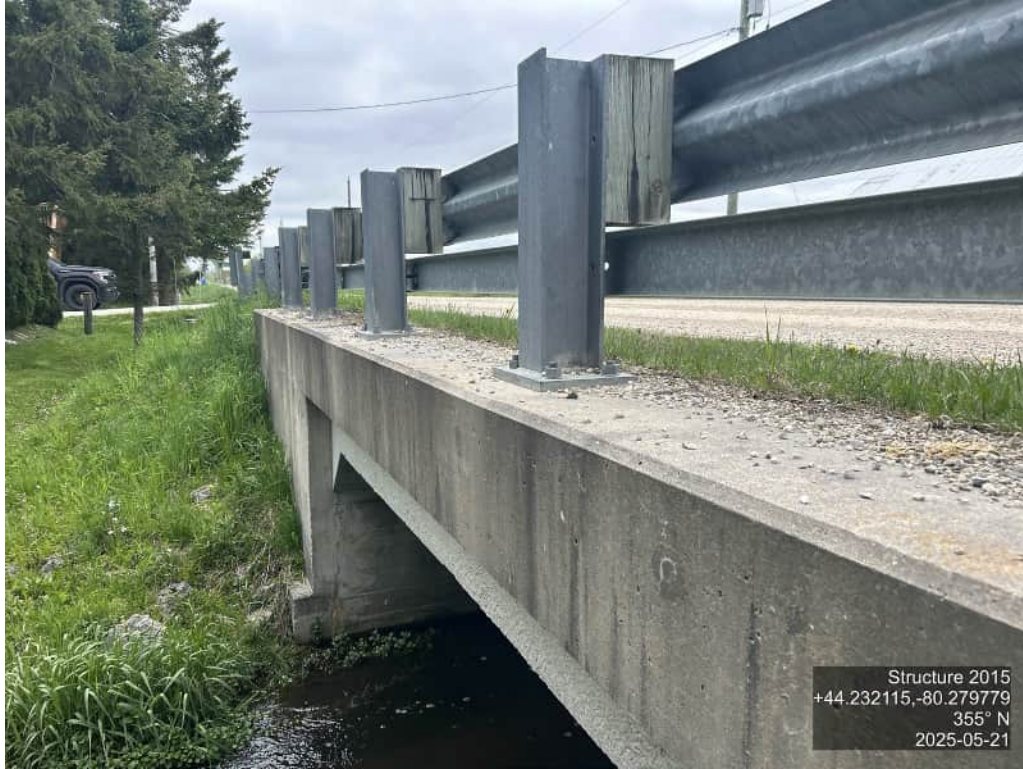
**CURB – NORTHWEST**

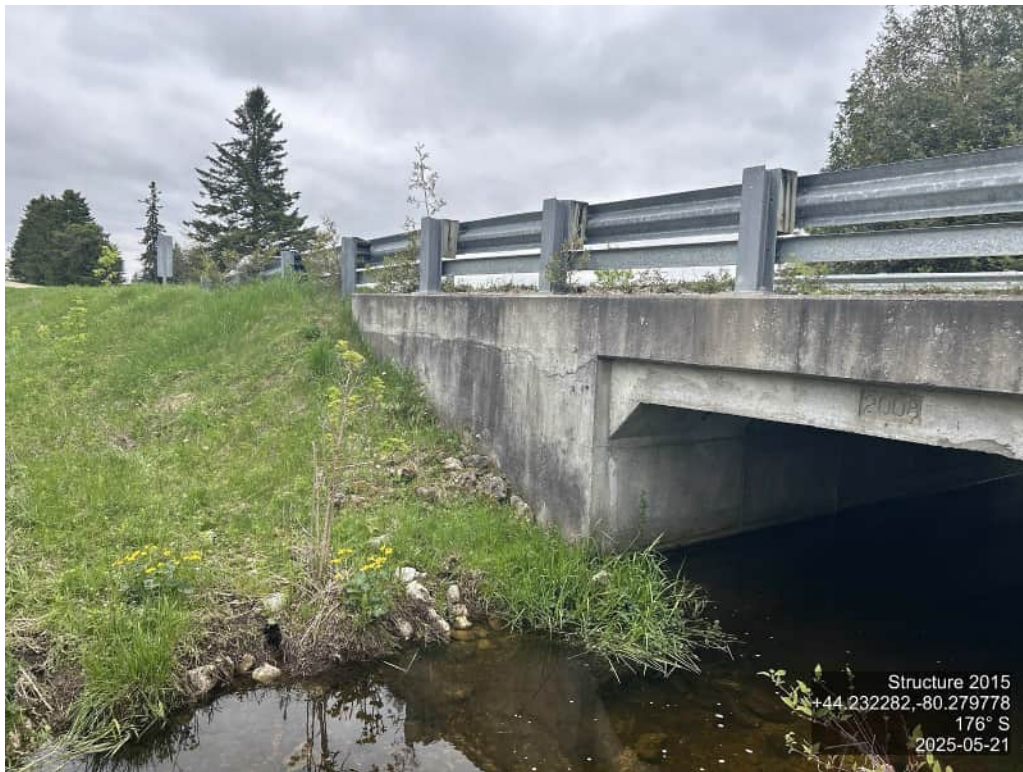
**INLET – NORTH – SMALL GROUT REPAIRS PRESENT**

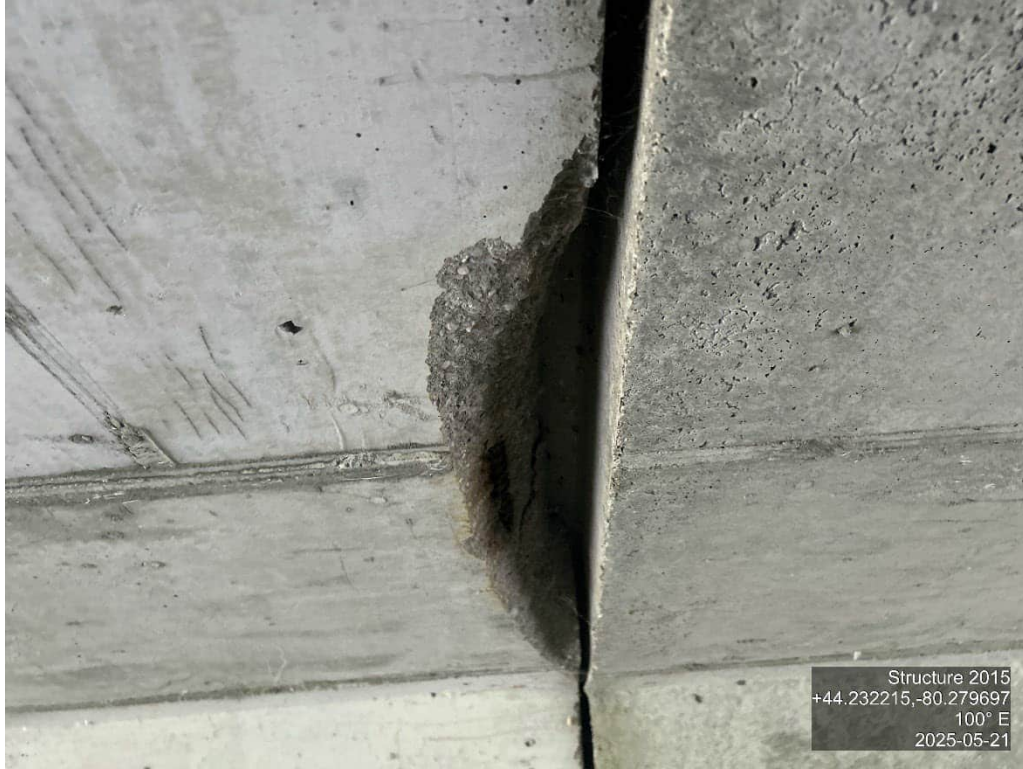
Structure 2015  
+44.232215,-80.279697  
100° E  
2025-05-21

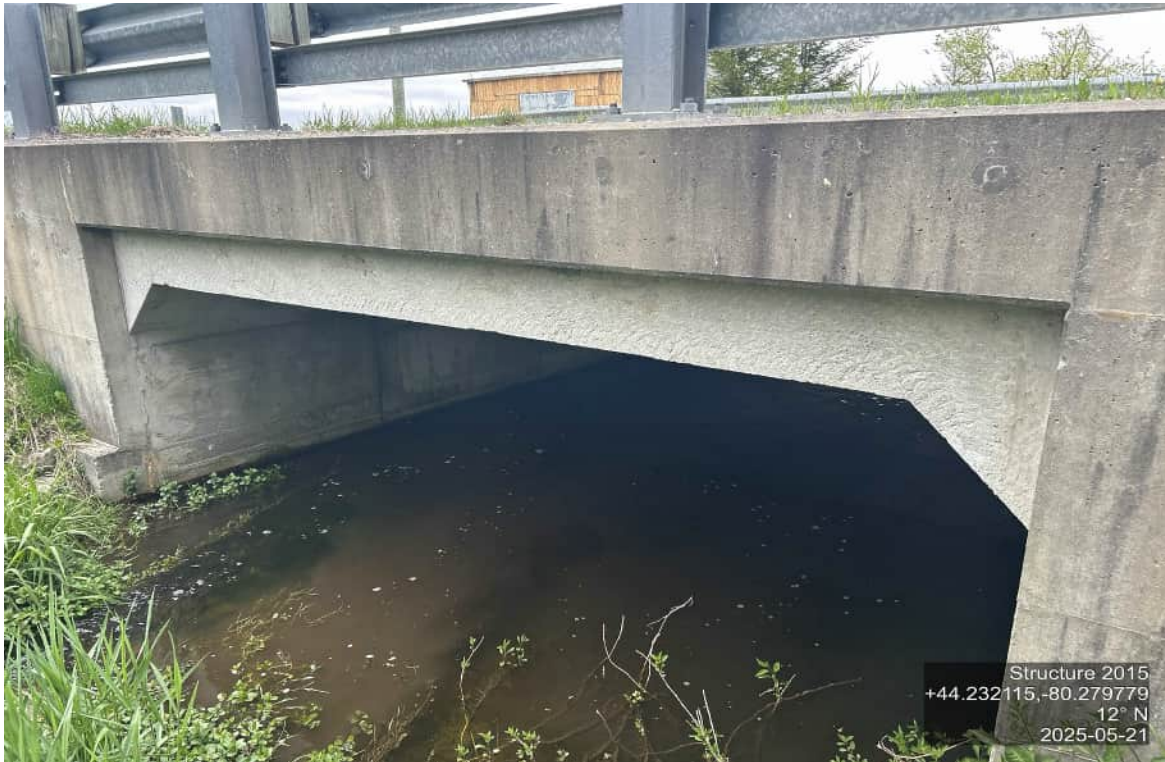
Structure 2015  
+44.232115,-80.279779  
12° N  
2025-05-21

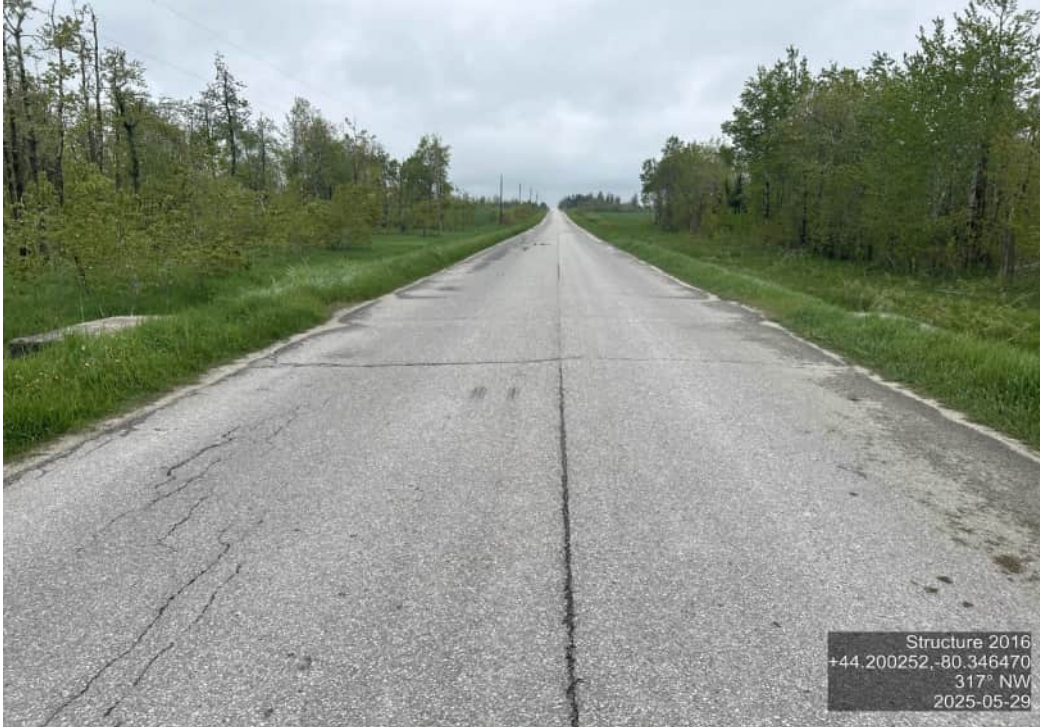
**DECK WEARING SURFACE – NORTH – MODERATE SETTLEMENT AT DECK ENDS AND WIDE TRANSVERSE CRACKS**

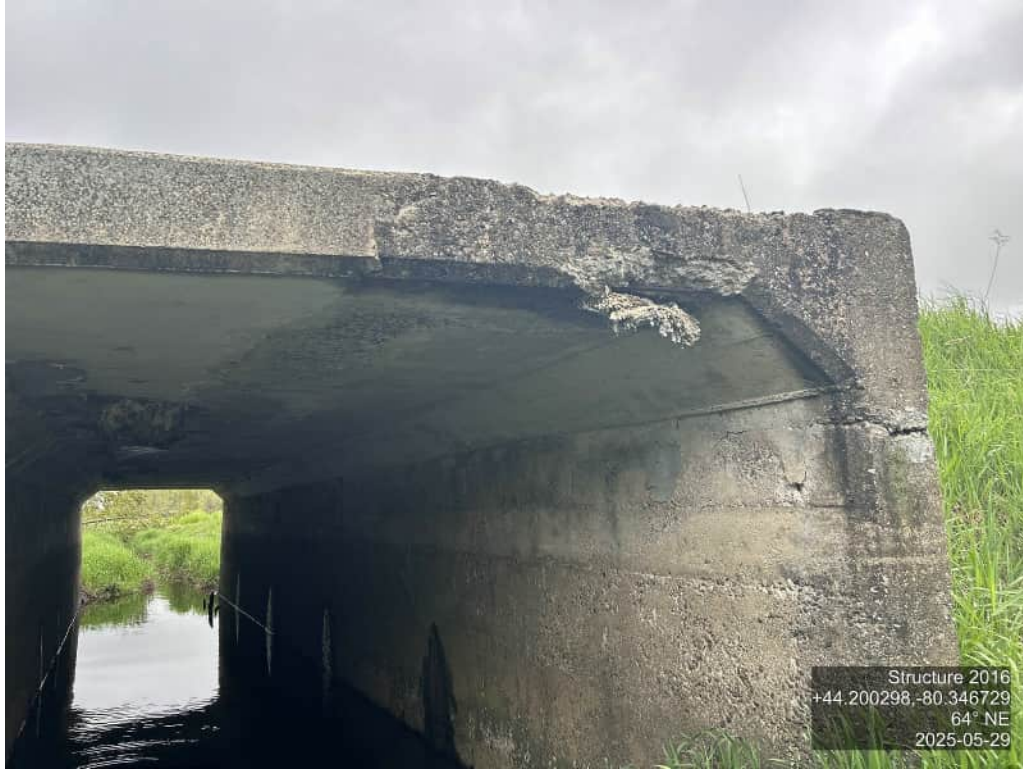
**SOFFIT EXTERIOR – EAST – CRACKS AND SPALLING**

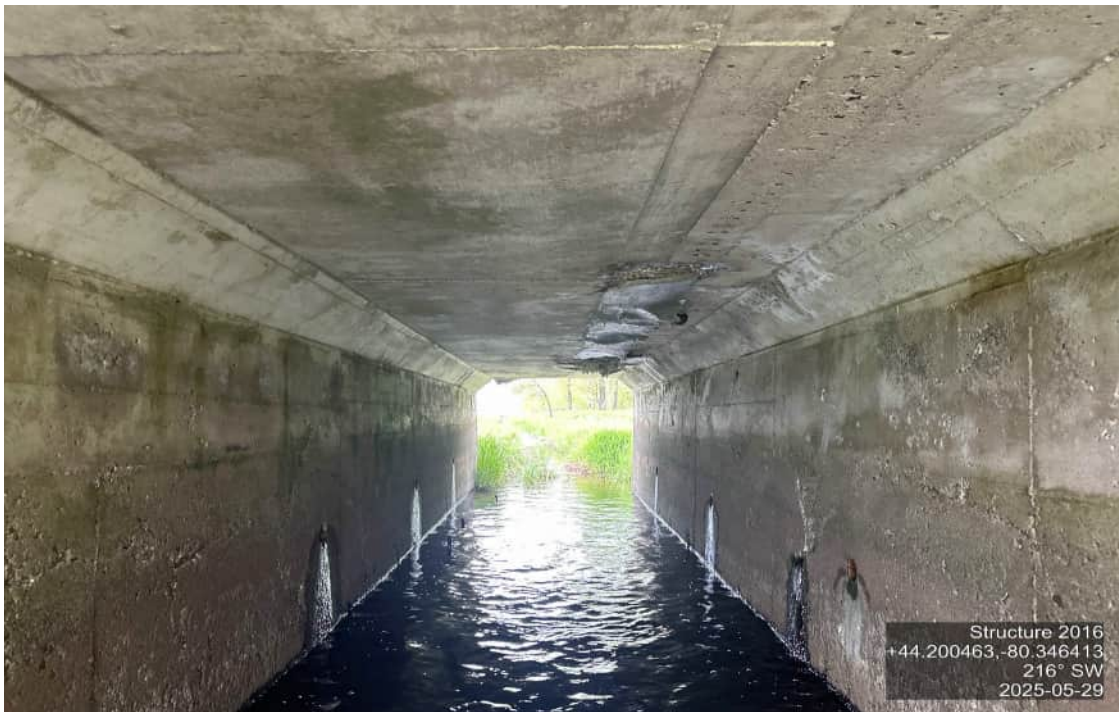
**ABUTMENT WALLS – INTERIOR – SPALLS WITH EXPOSED CORRODED REBAR AND COLD JOINTS ON BOTH WALLS**

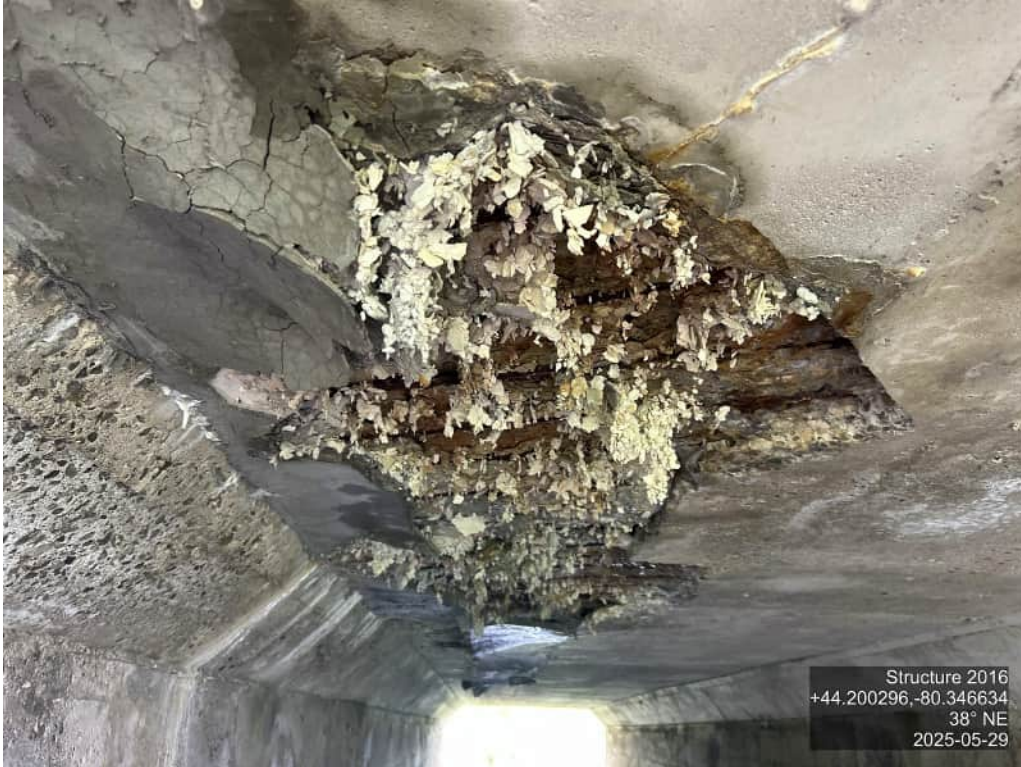
**SOFFIT – INTERIOR – SEVERE SPALLING AND DELAMINATIONS THROUGHOUT**

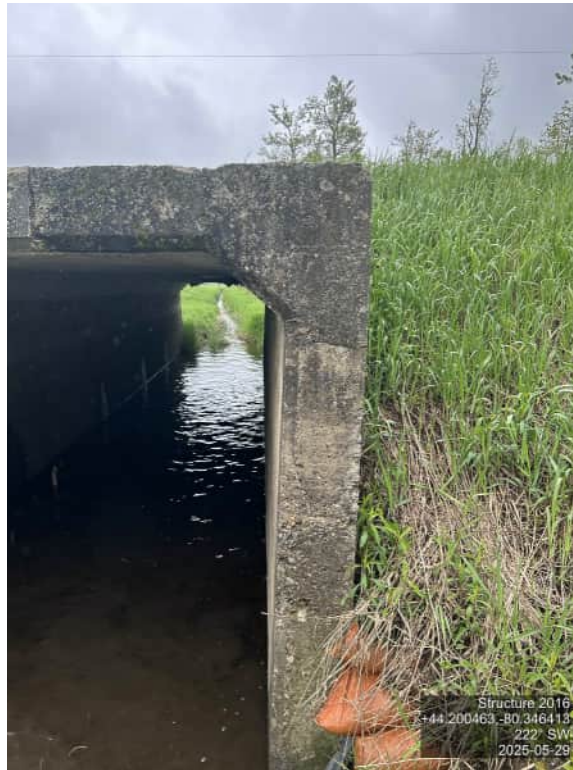
**EMBANKMENT – SOUTHEAST – SANDBAGS PRESENT**

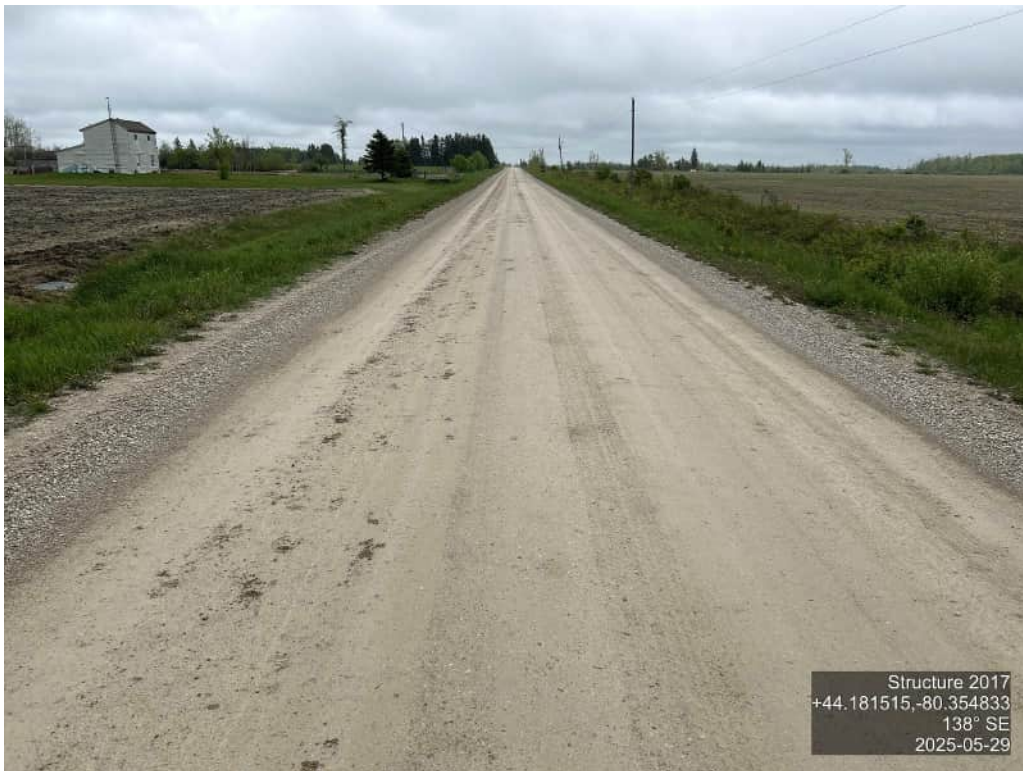
**DECK WEARING SURFACE – SOUTHWEST – GRAVEL ON SHOULDERS**

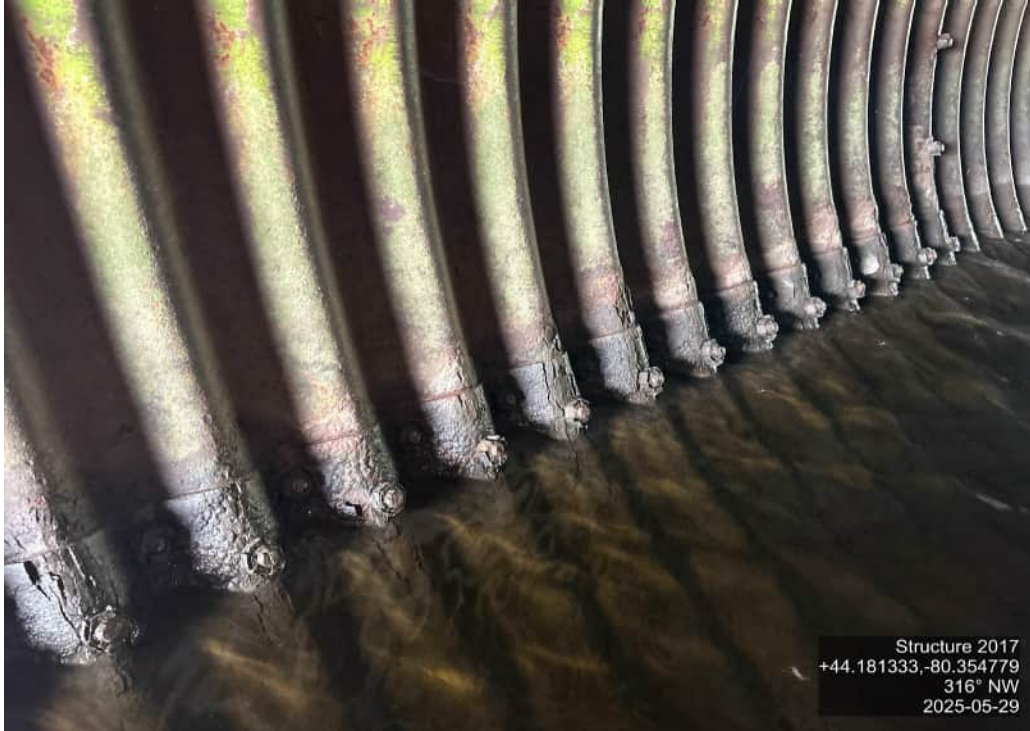
**BARREL – NORTHWEST – SEVERE CORROSION, FLAKING AND SECTION LOSS ALONG WATERLINE**

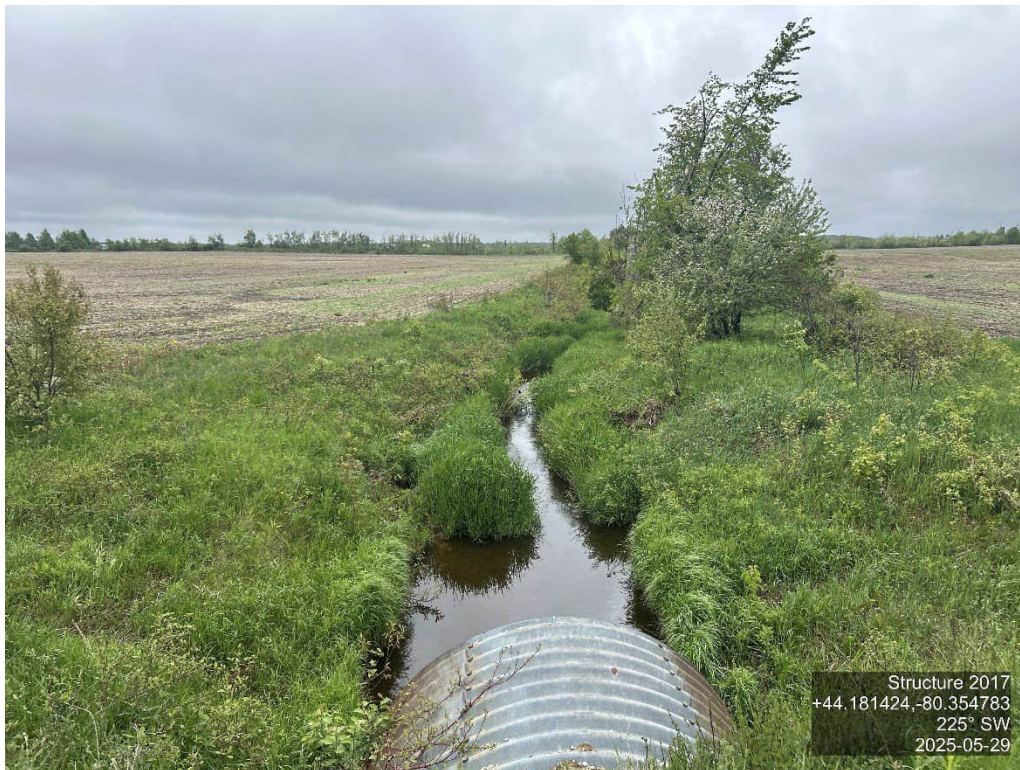
**STREAM – EAST – FLOWS EAST TO WEST**

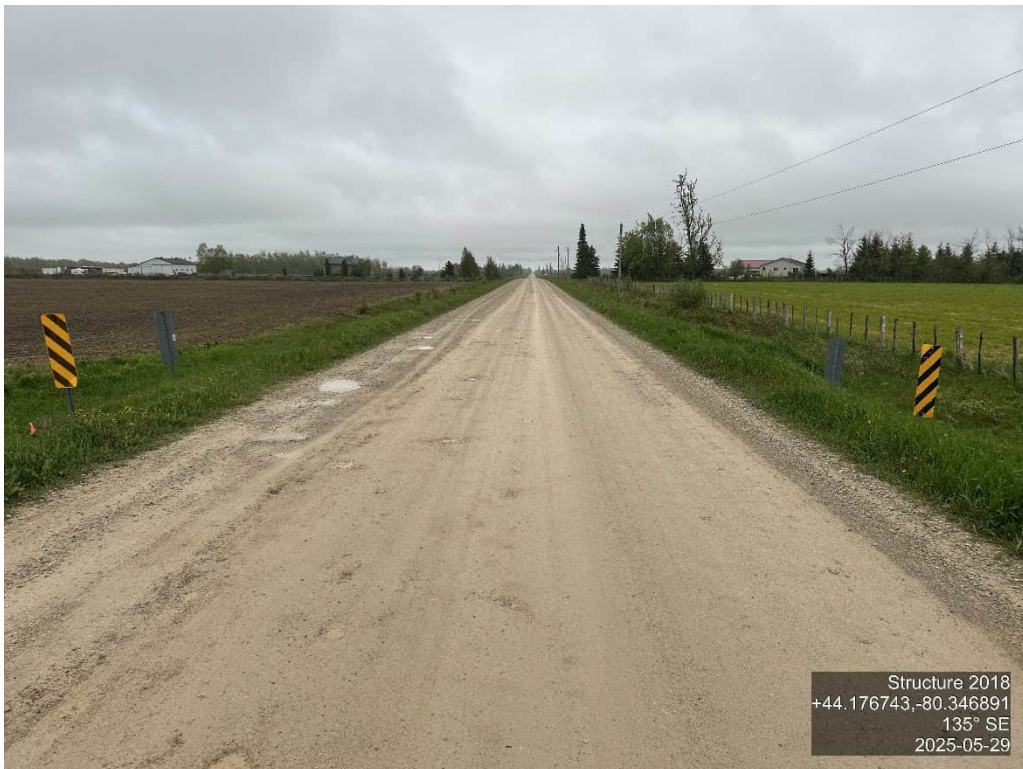
**DECK WEARING SURFACE – WEST – SMALL POTHOLES**

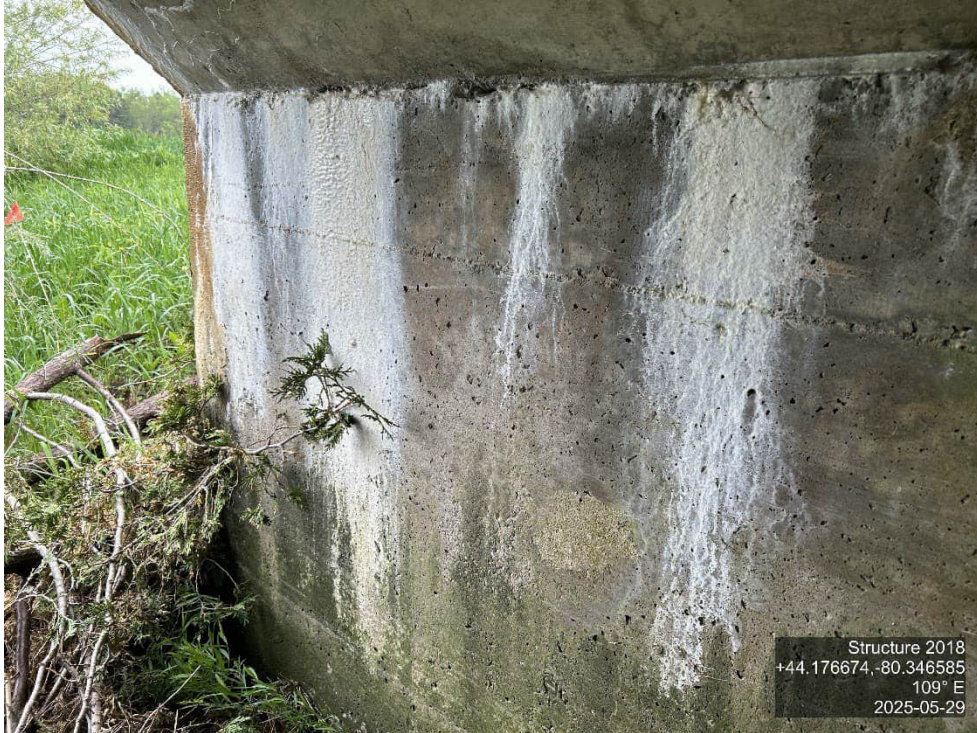
**ABUTMENT – EAST – EFFLOURESCENCE**

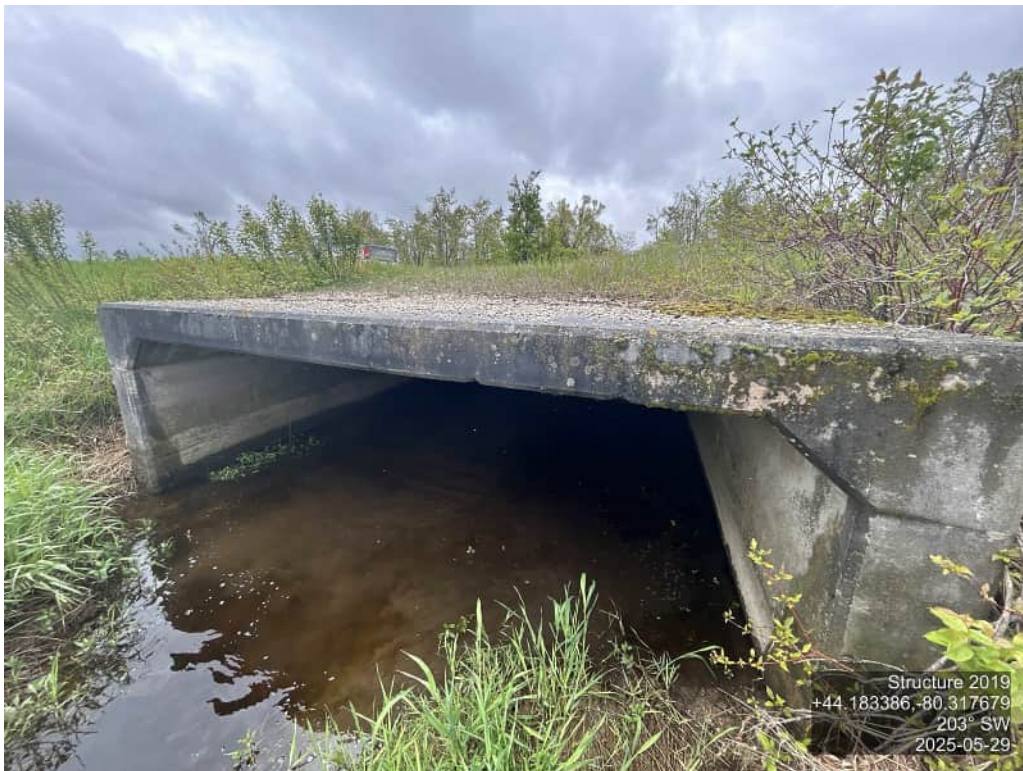
**INLET – NORTH – SMALL SPALL AND WATER STAINING**

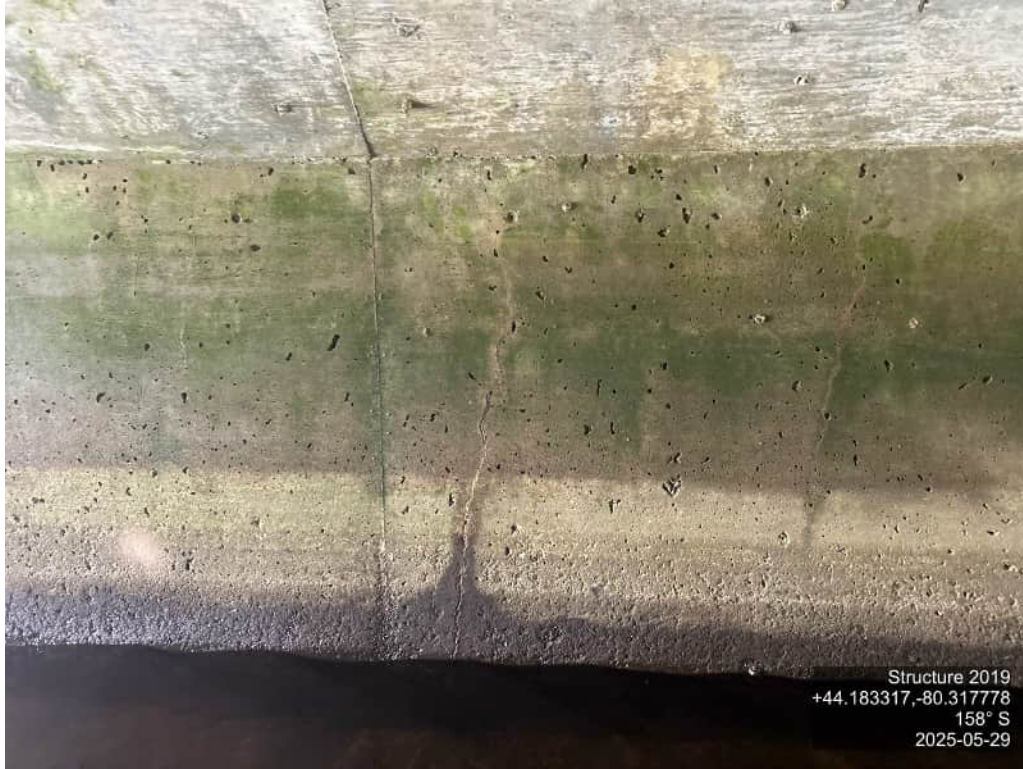
Structure 2019  
+44.183317,-80.317778  
158° S  
2025-05-29

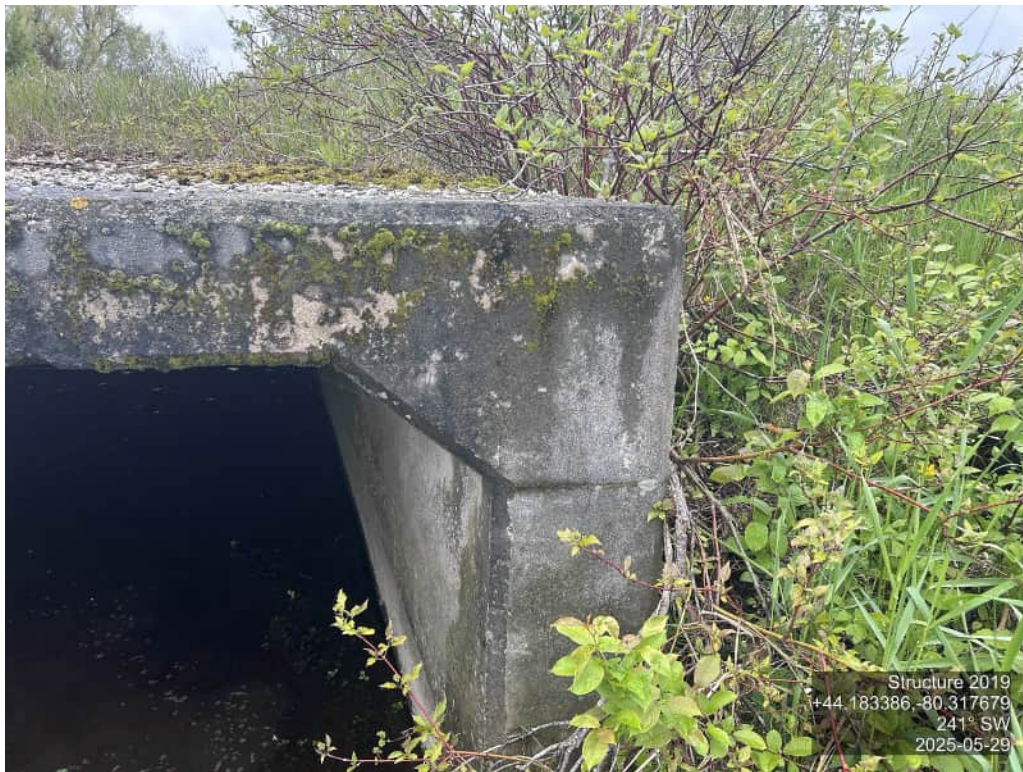
Structure 2019  
+44.183386,-80.317679  
241° SW  
2025-05-29

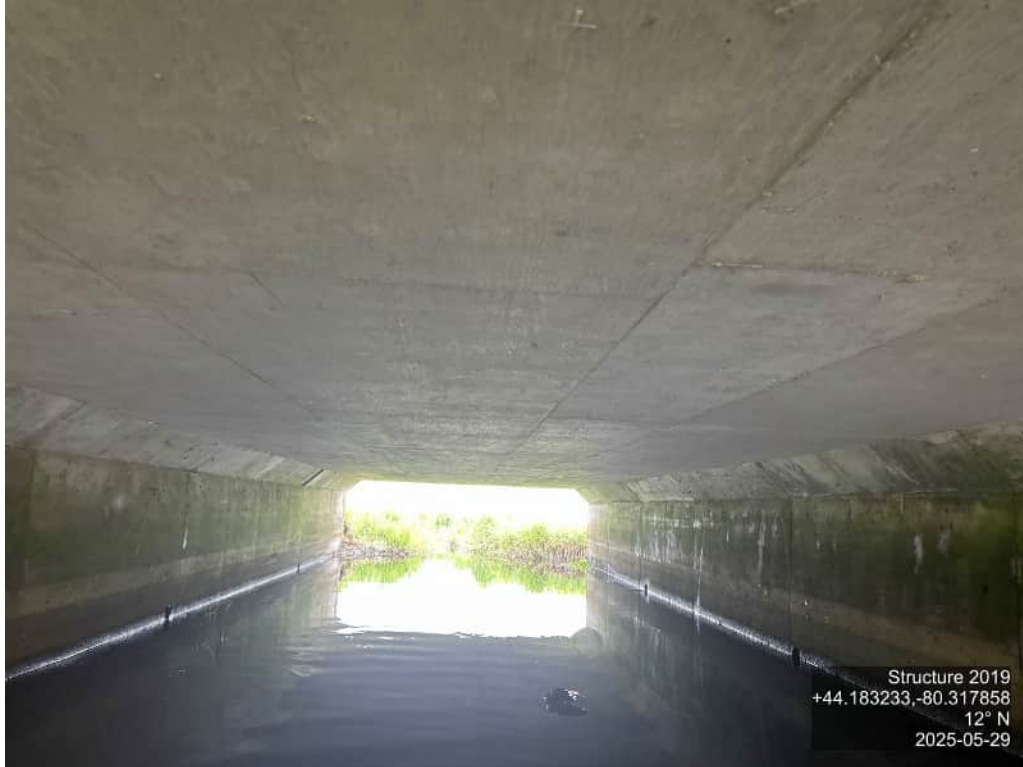
**STREAM – NORTH – VEGETATION PARTIALLY OBSTRUCTING WATECOURSE**

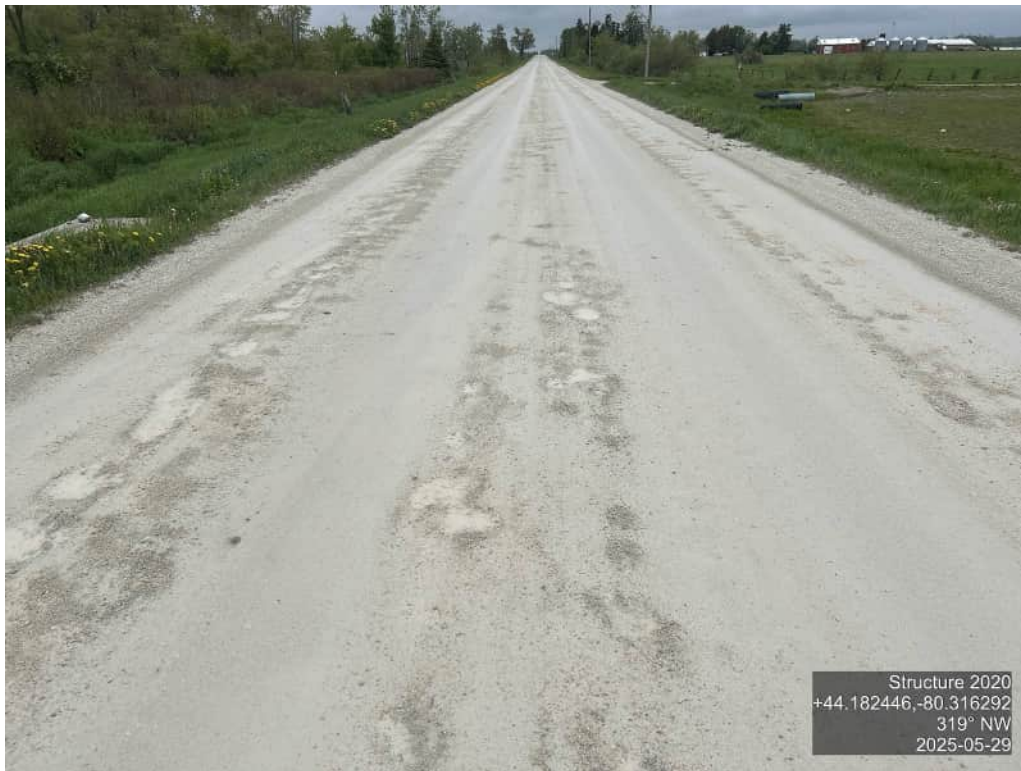
**DECK WEARING SURFACE – OVER DECK TOP – SMALL POTHoles**

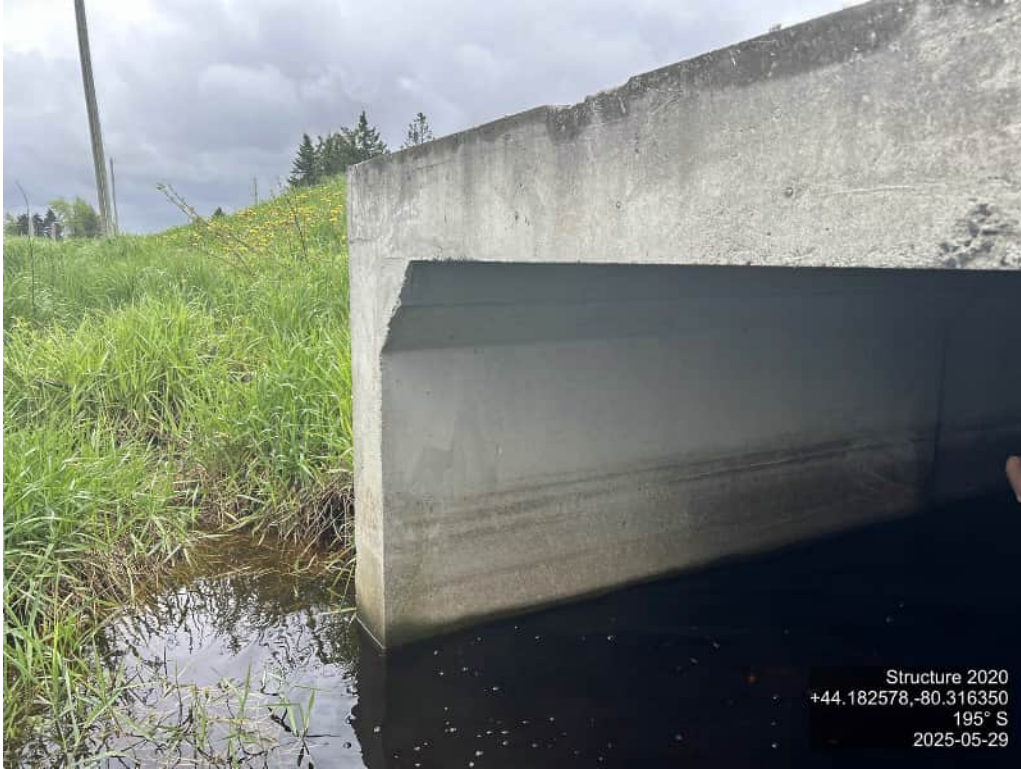
Structure 2020  
+44.182578,-80.316350  
195° S  
2025-05-29

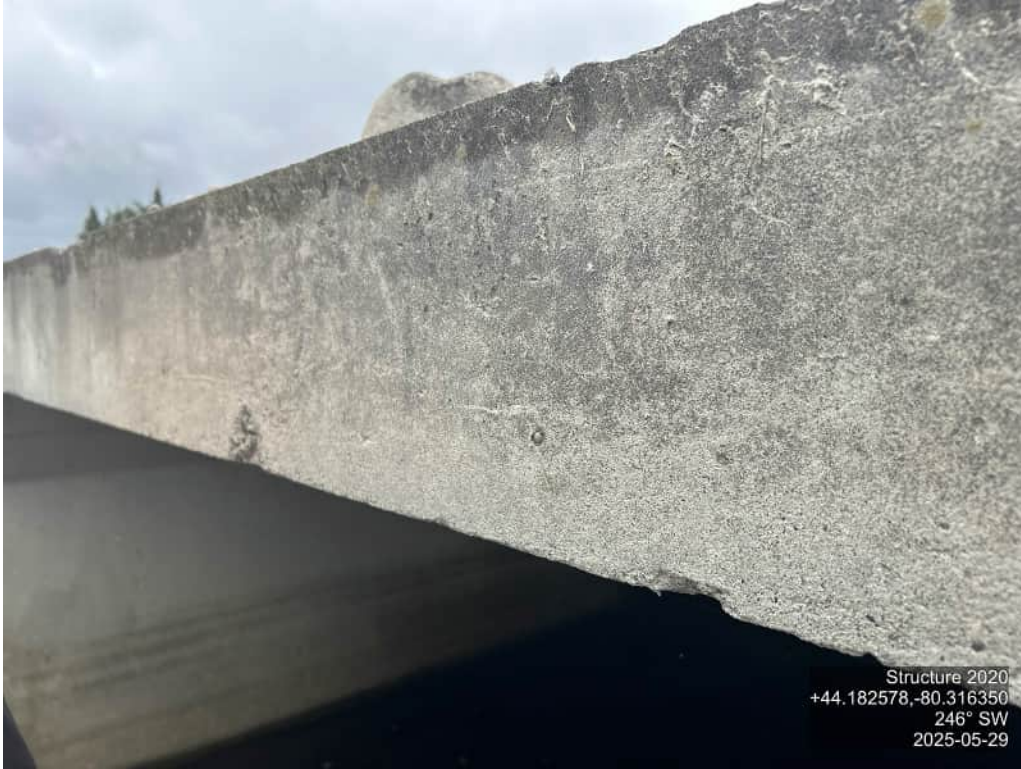
Structure 2020  
+44.182578,-80.316350  
246° SW  
2025-05-29

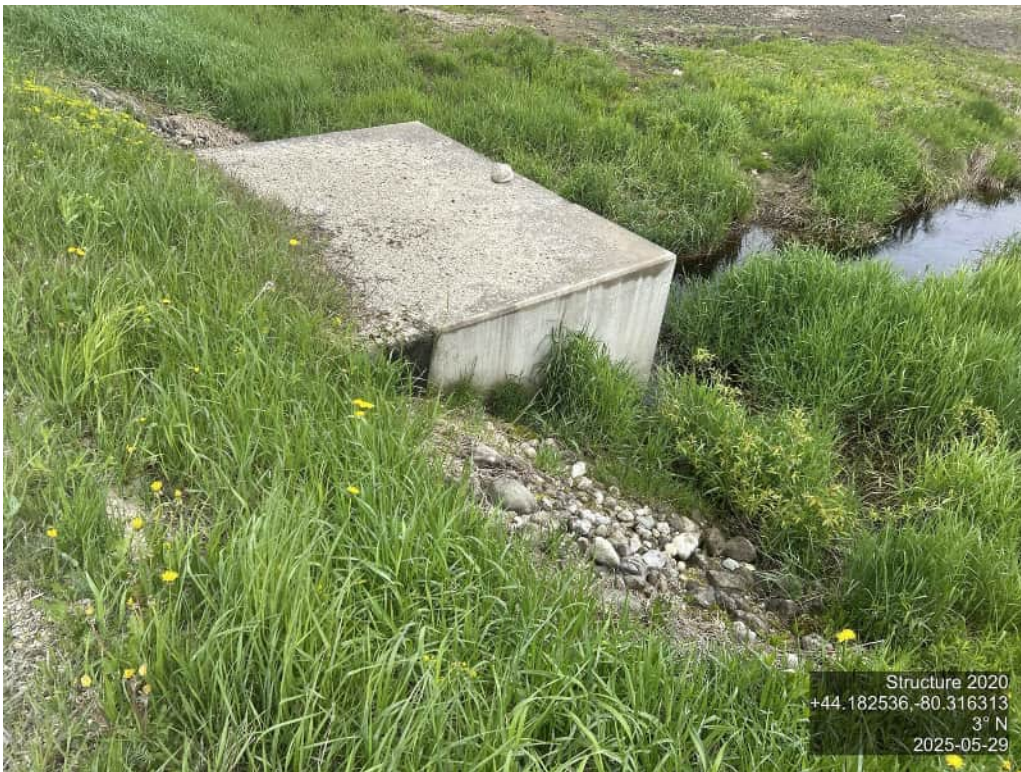
Structure 2020  
+44.182536,-80.316313  
3° N  
2025-05-29

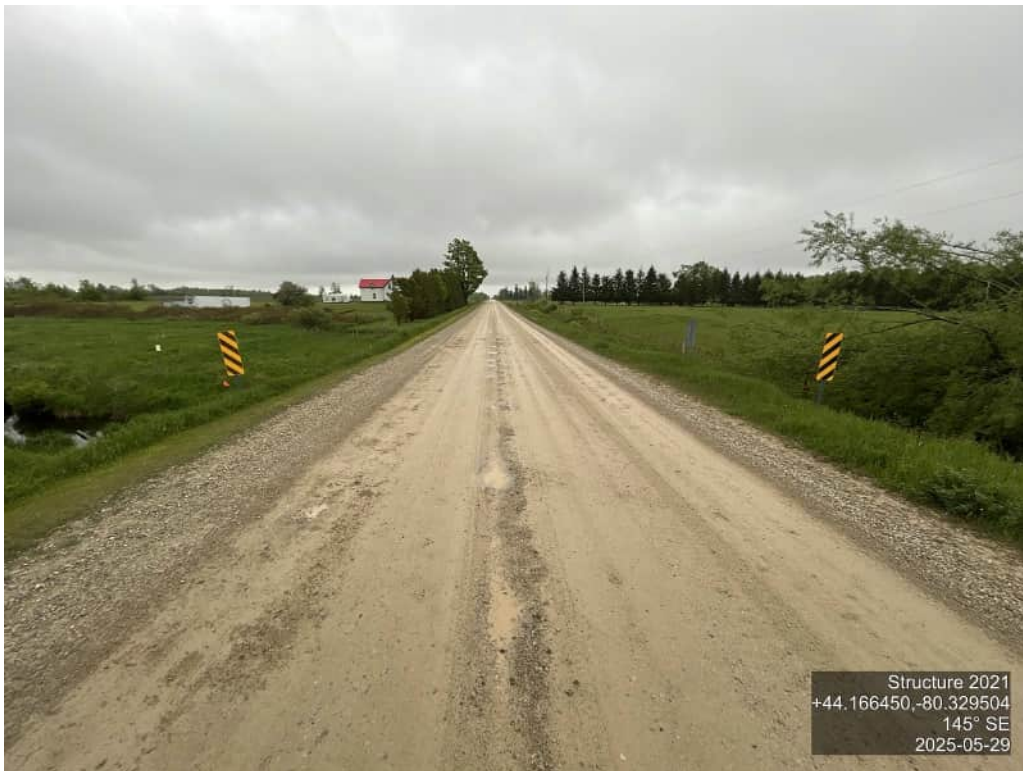
**DECK WEARING SURFACE – NORTH – SMALL POTHoles AND MINOR RUTTING**

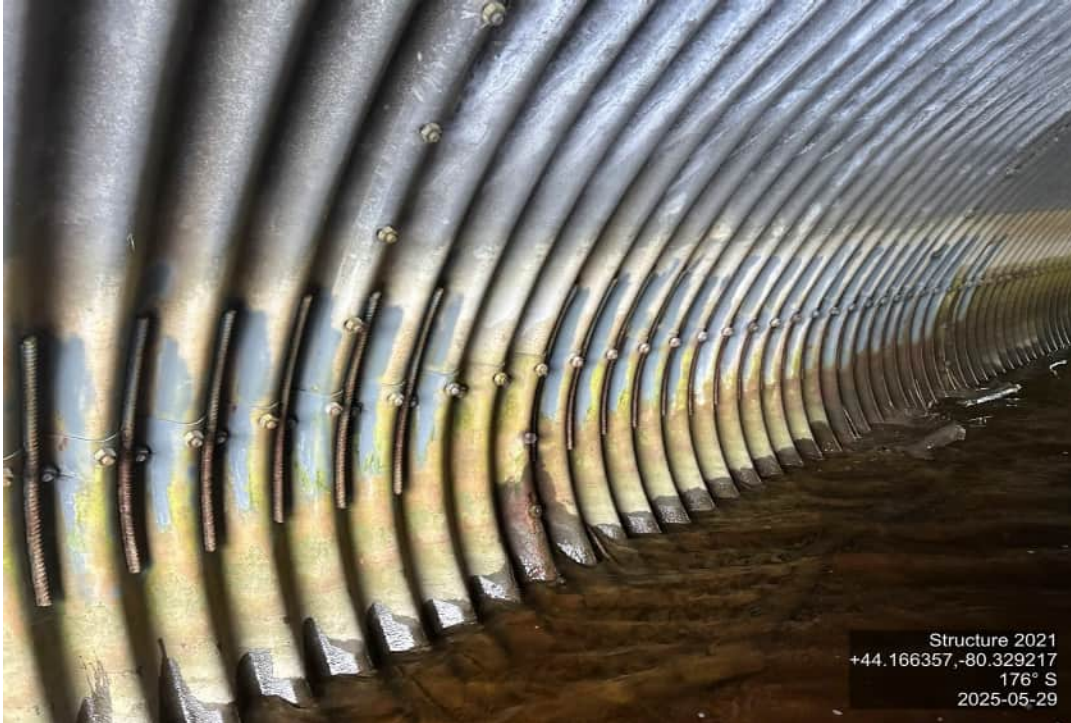
**BARREL – SOUTH – FLAKING AND PERFORATIONS UP TO SPRING LINE**

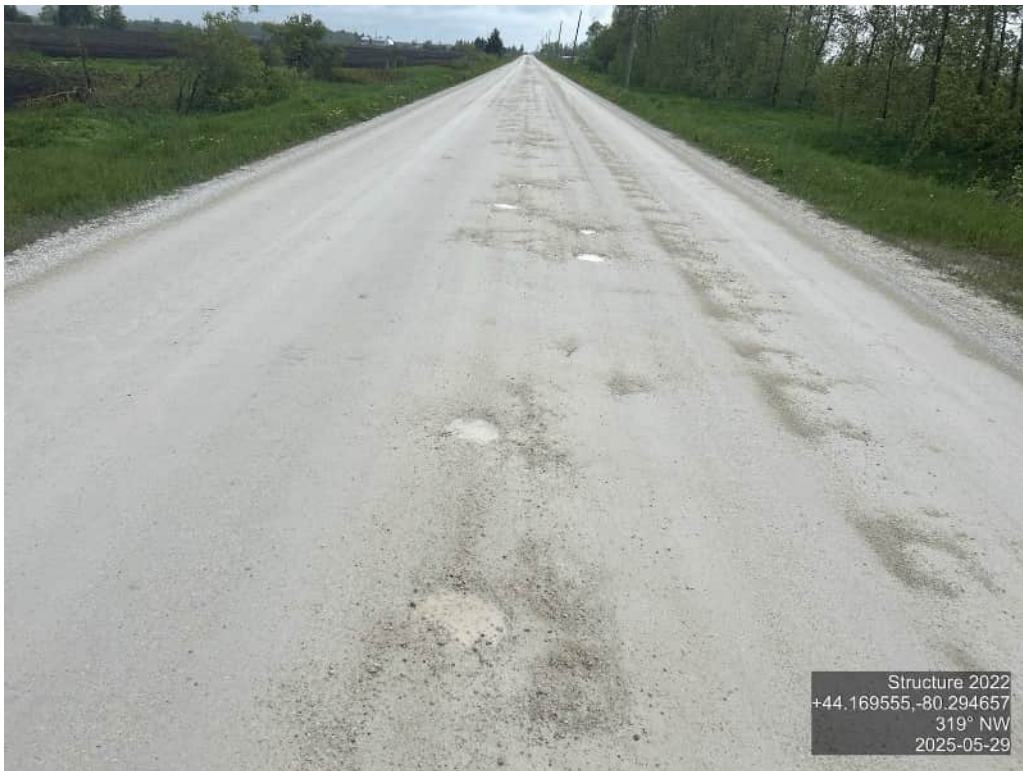
**DECK WEARING SURFACE – NORTH – SMALL POTHoles**
