**BURNSIDE**

## **2025 OSIM Bridge Inspections Report**

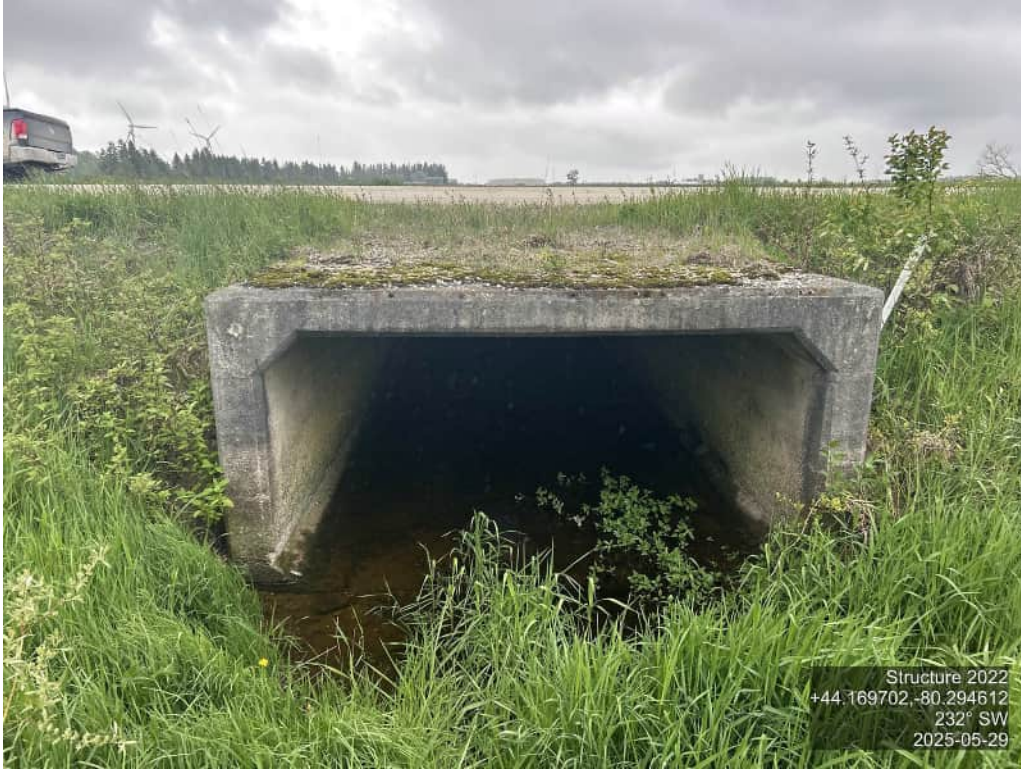
**DECK WEARING SURFACE – NORTH – SMALL POTHoles**

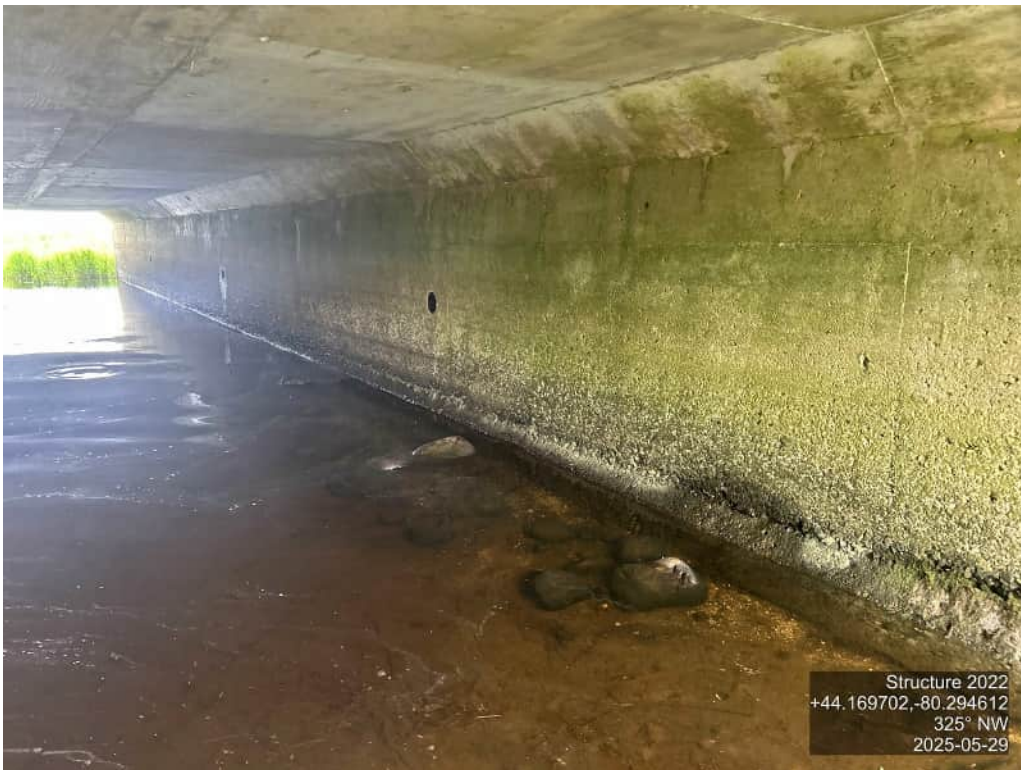
**BARREL – EAST – HONEYCOMBING, SCALING AND WIDE CRACKS AT HAUNCH**

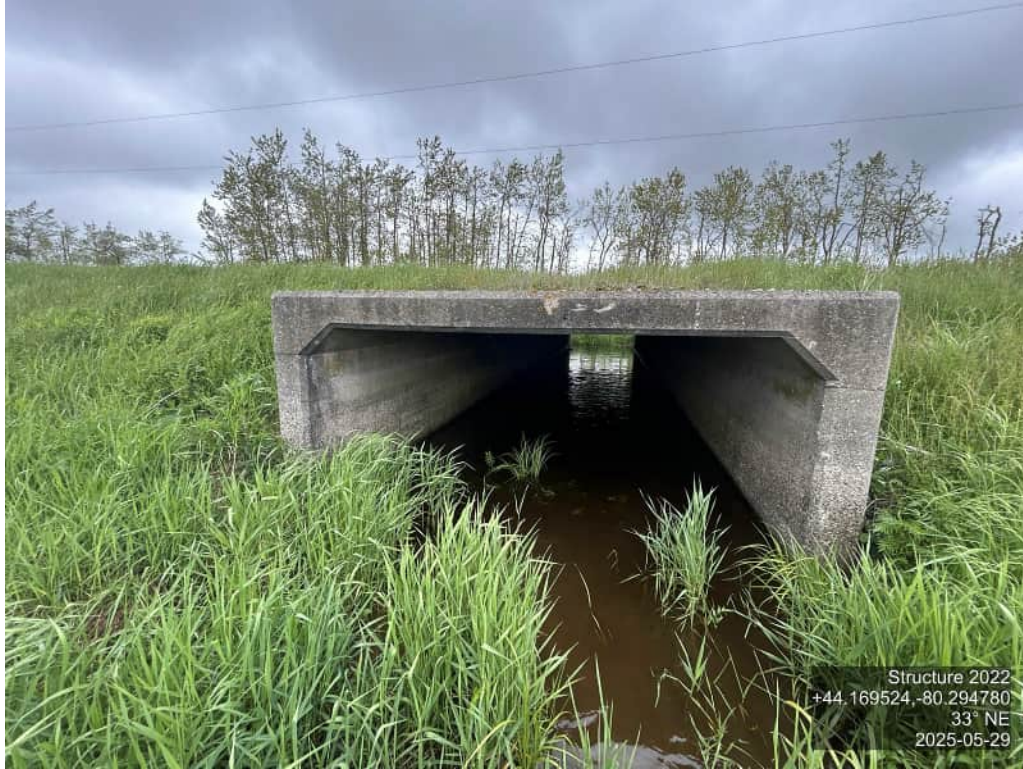
**OUTLET – SOUTH – SCALING AND HAIRLINE CRACKS**

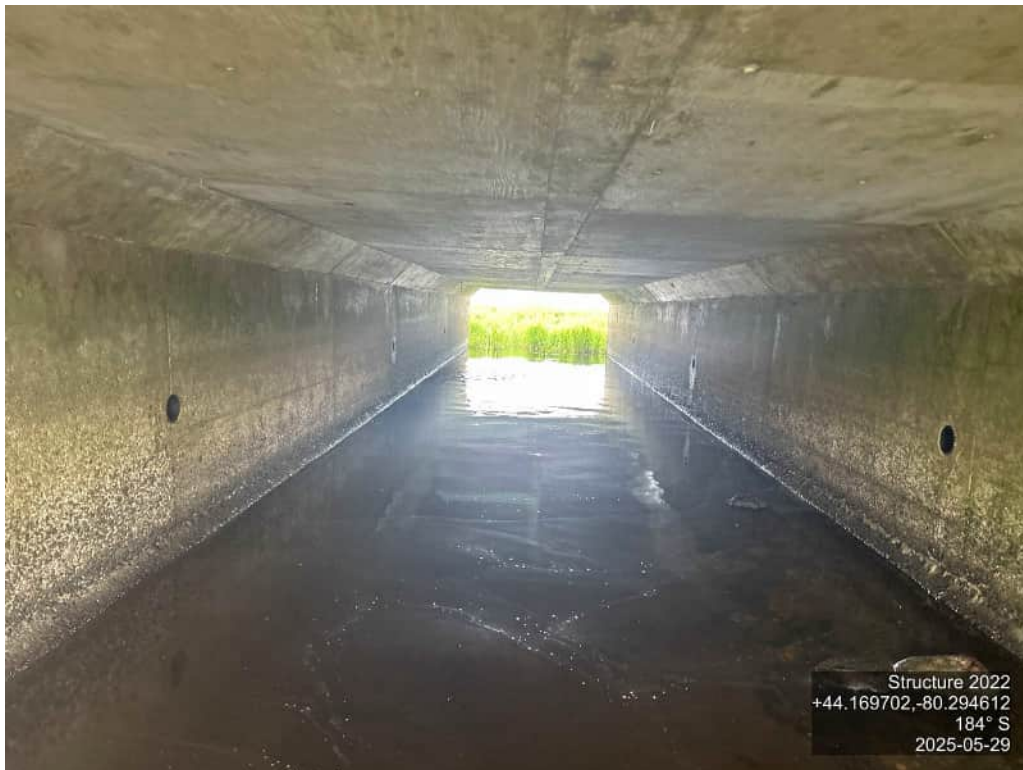
**STREAM – SOUTH – VEGETATION AT INLET**

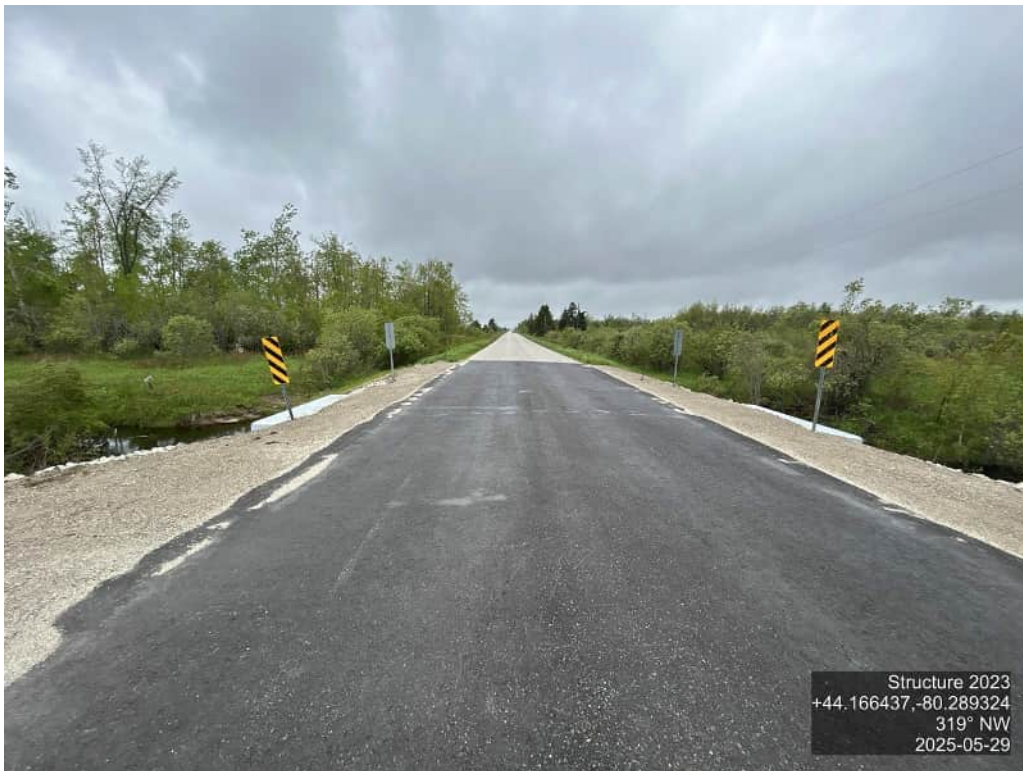
**DECK WEARING SURFACE – SOUTH – REPAVED IN 2024**

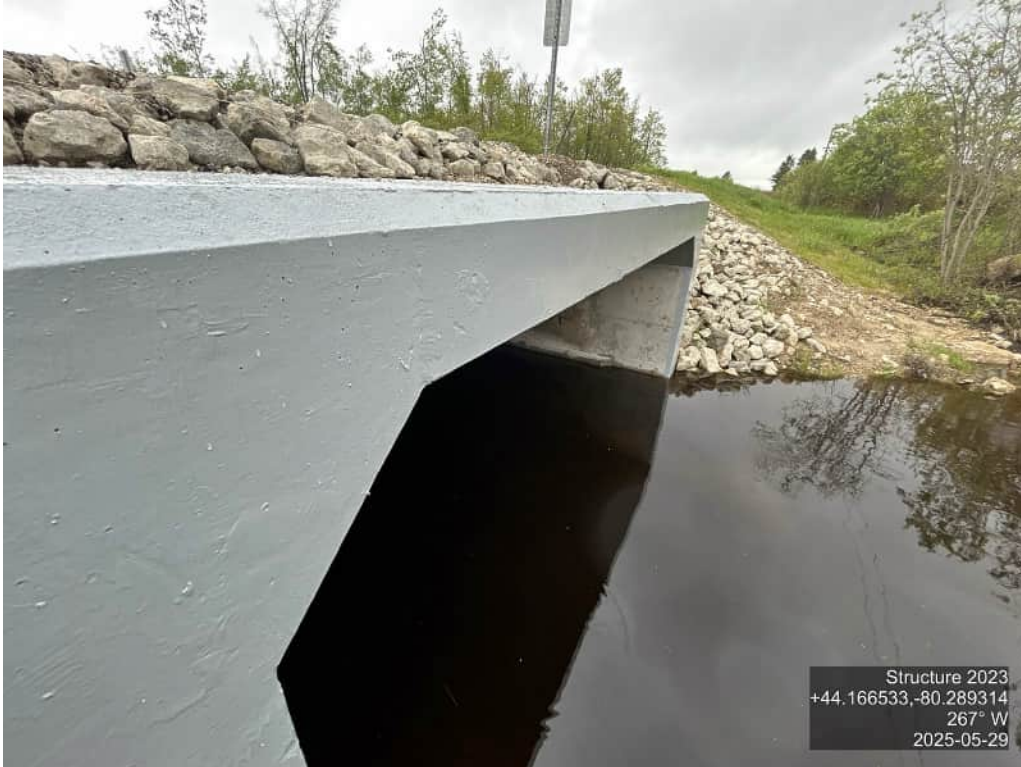
Structure 2023  
+44.166533,-80.289314  
267° W  
2025-05-29

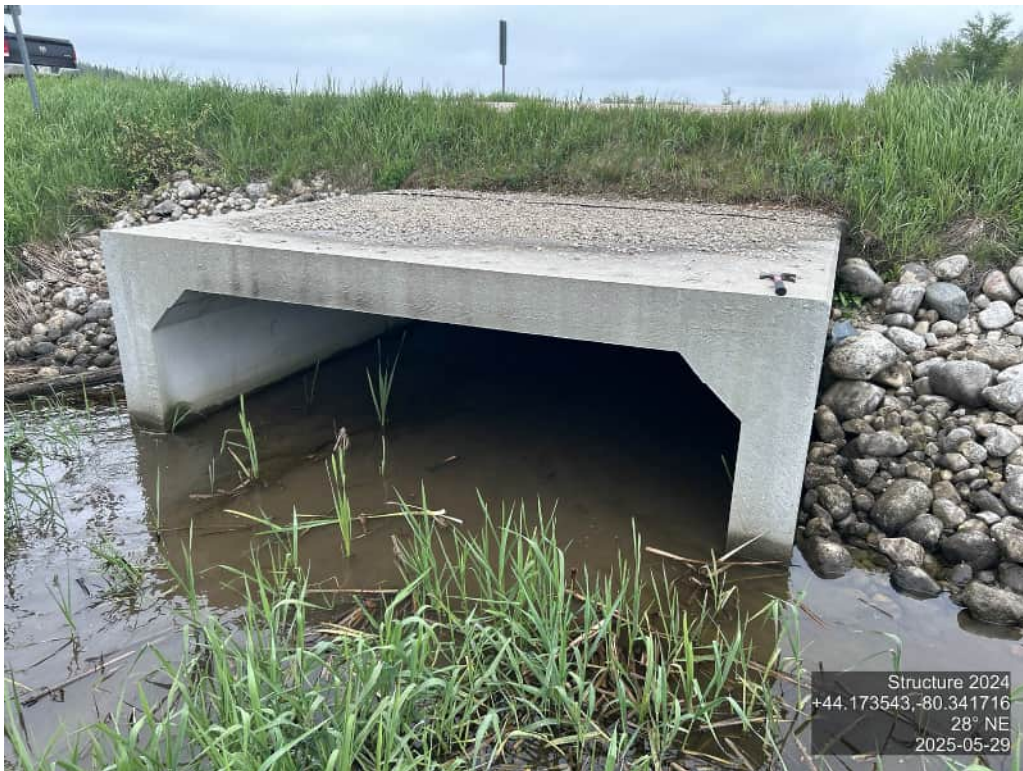
INLET – EAST – HAIRLINE STAINED CRACKS

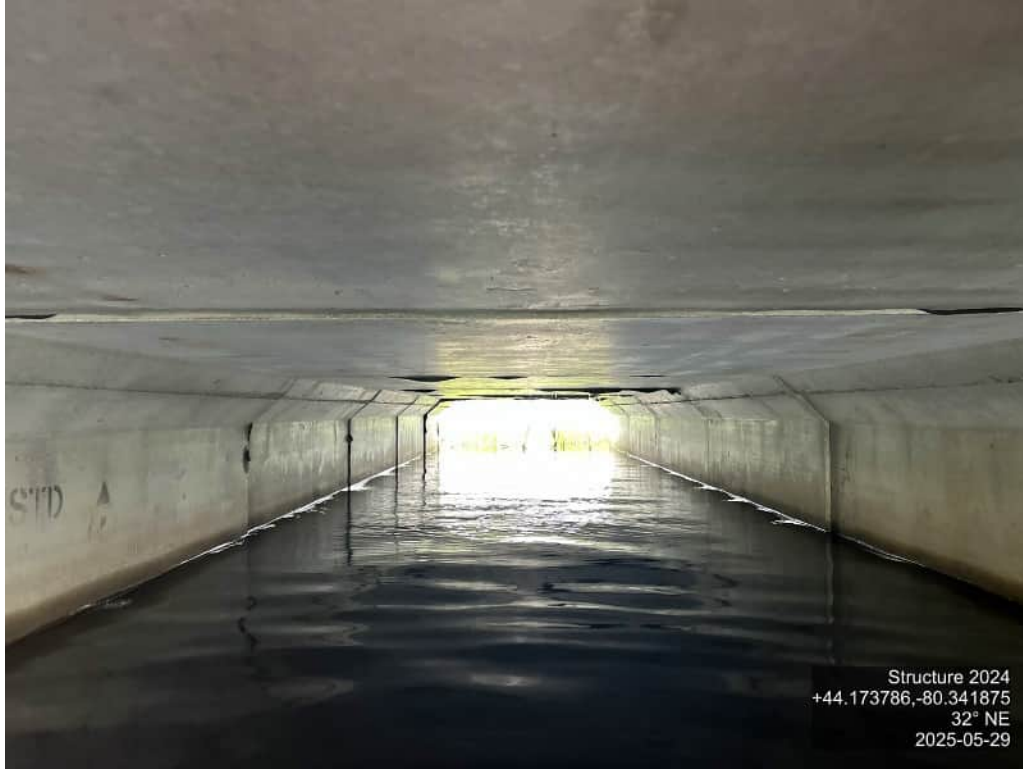
**BARREL – INTERIOR – GAP BETWEEN JOINTS**

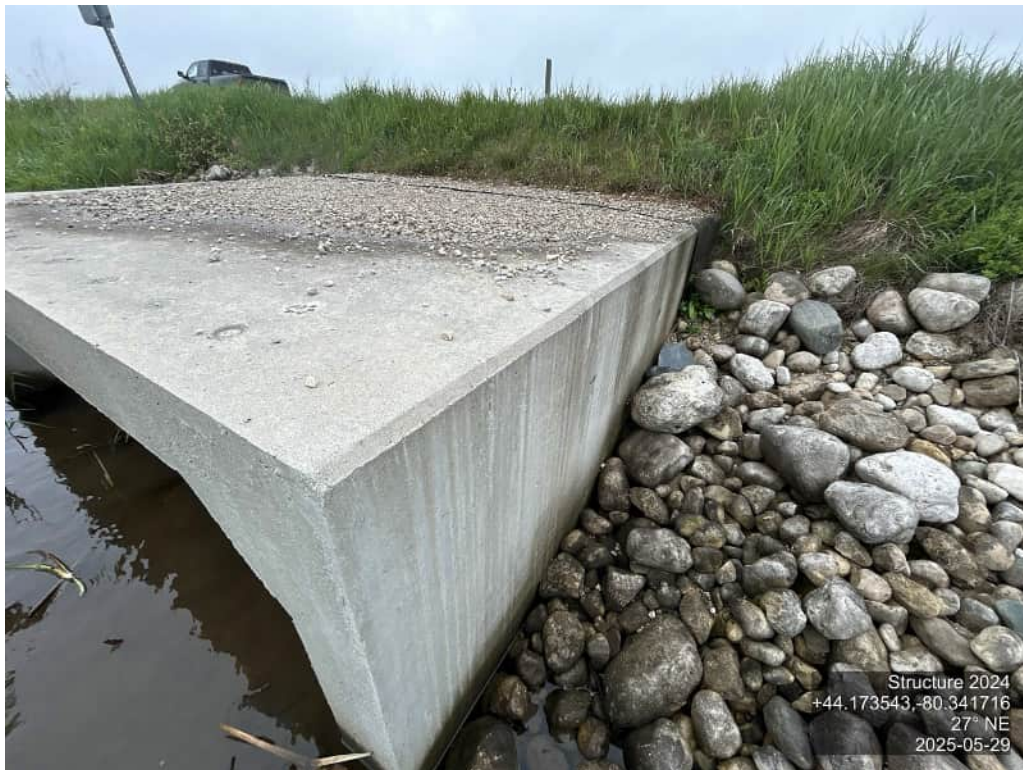
**OUTLET – WEST – HAIRLINE STAINED CRACKS**

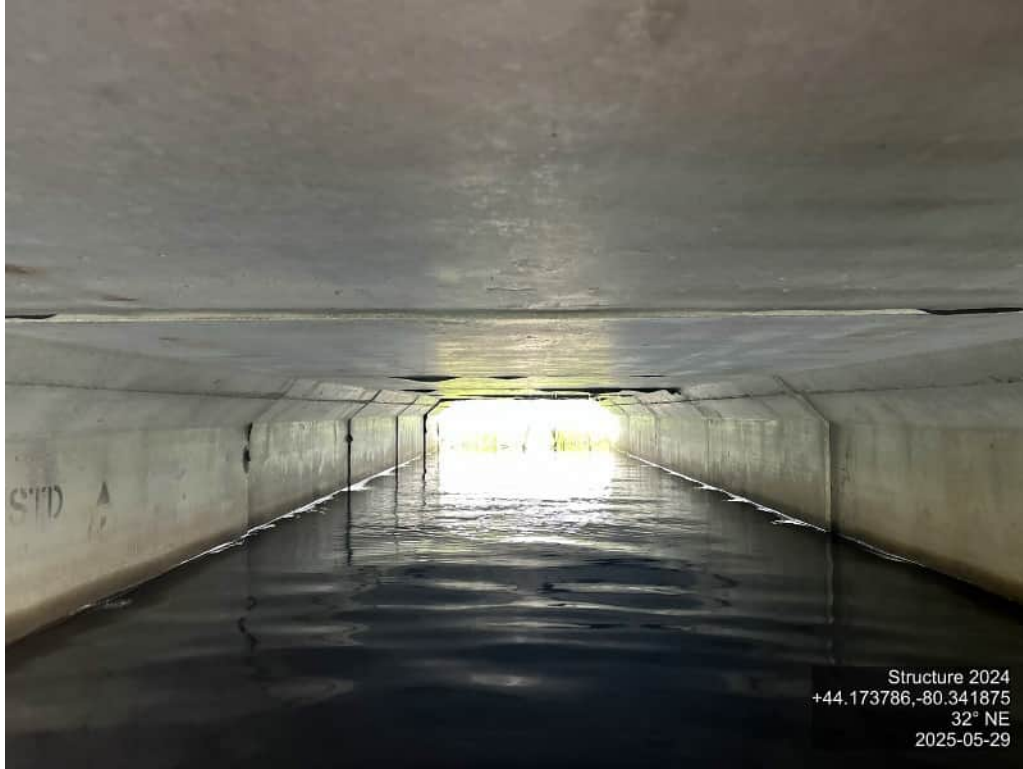
**STREAM – WEST – FLOWS EAST TO WEST**

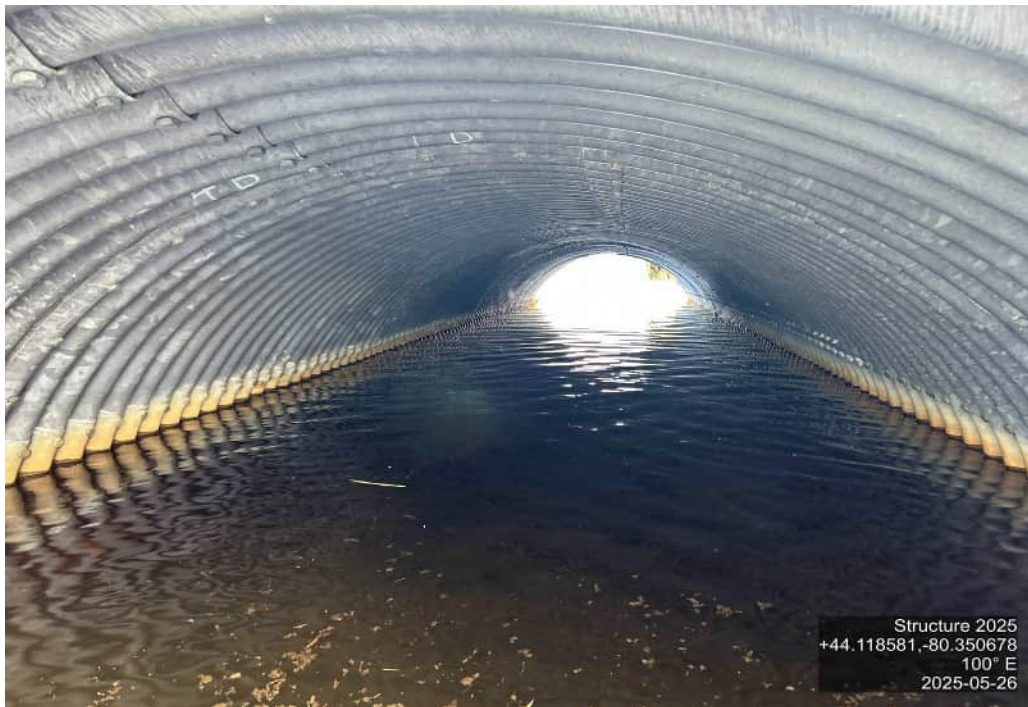
**BARREL – SOUTH – MODERATE TO SEVERE CORROSION UP TO SPRING LINE, PERFORATIONS ON CULVERT FLOOR AND SECTION LOSS ALONG ENTIRE FLOOR**

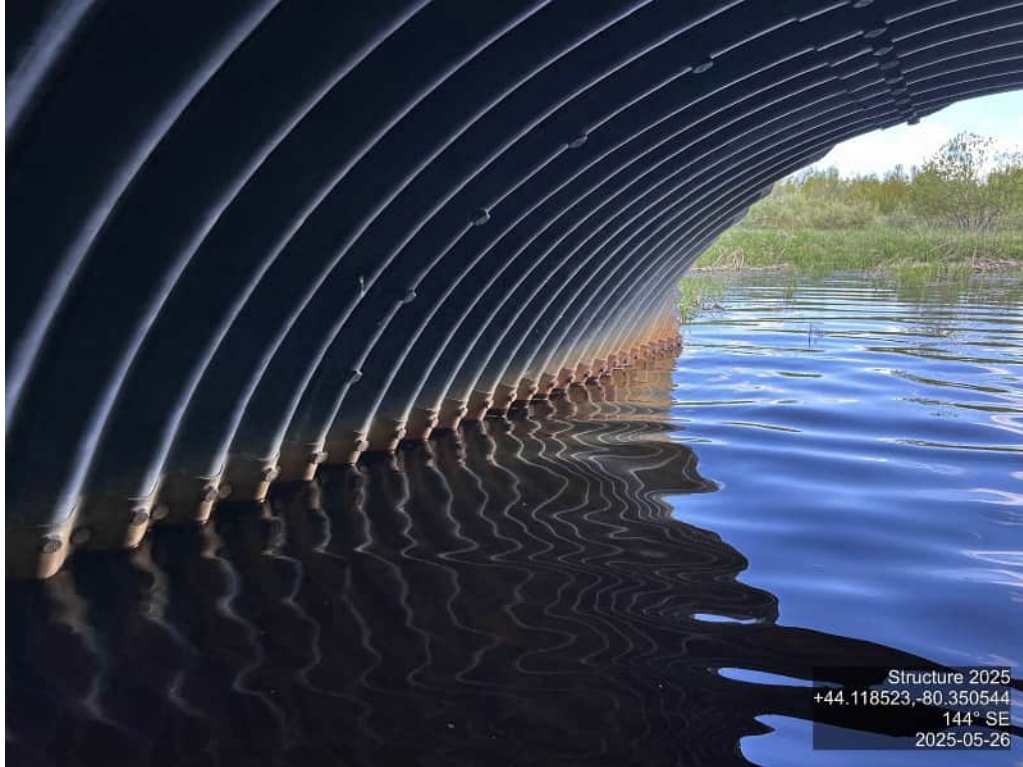
Structure 2025  
+44.118523,-80.350544  
144° SE  
2025-05-26

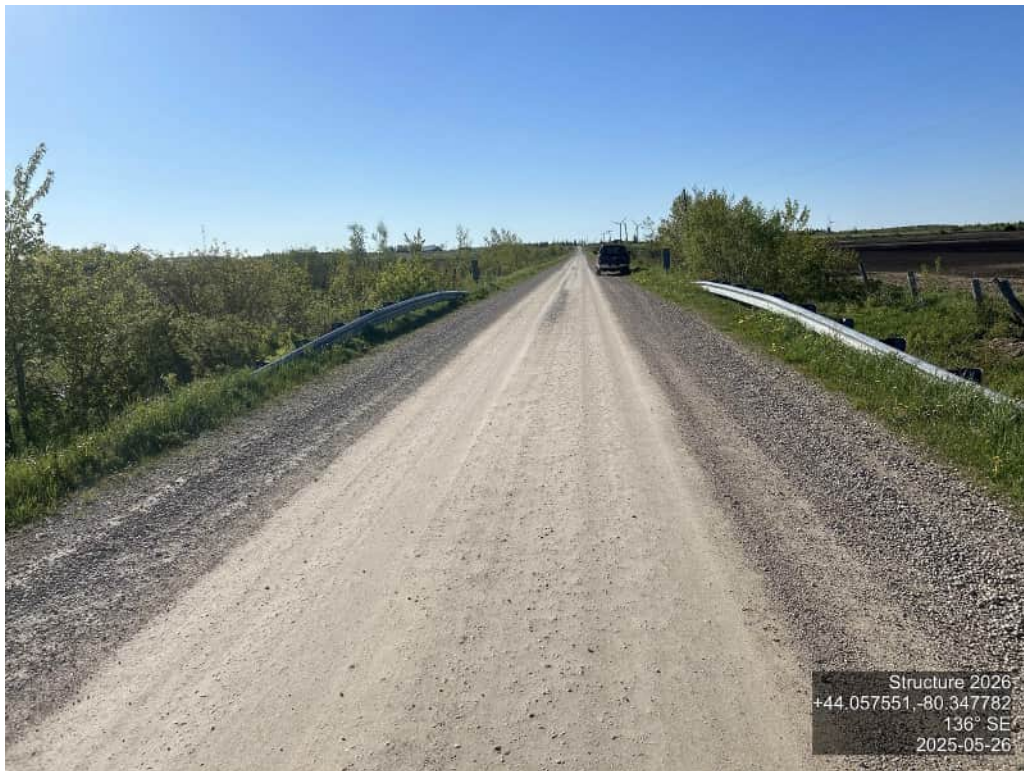
**DECK WEARING SURFACE – SOUTHEAST – LOOSE GRAVEL ON SHOULDERS**

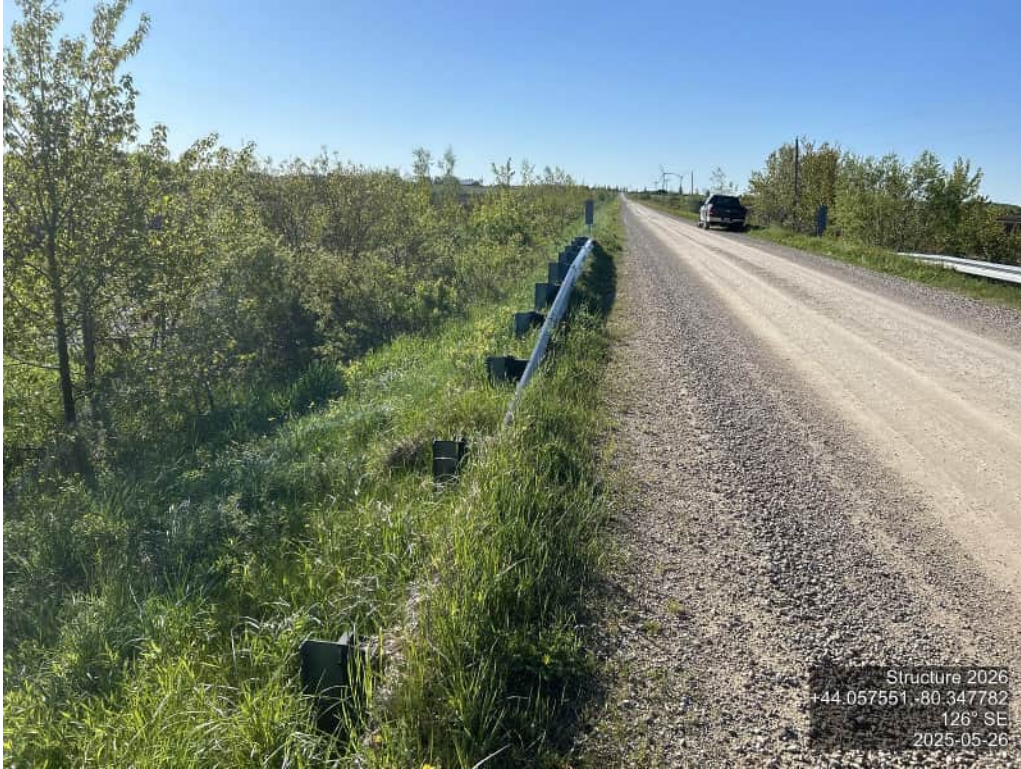
Structure 2026  
+44.057551, -80.347782  
126° SE  
2025-05-26

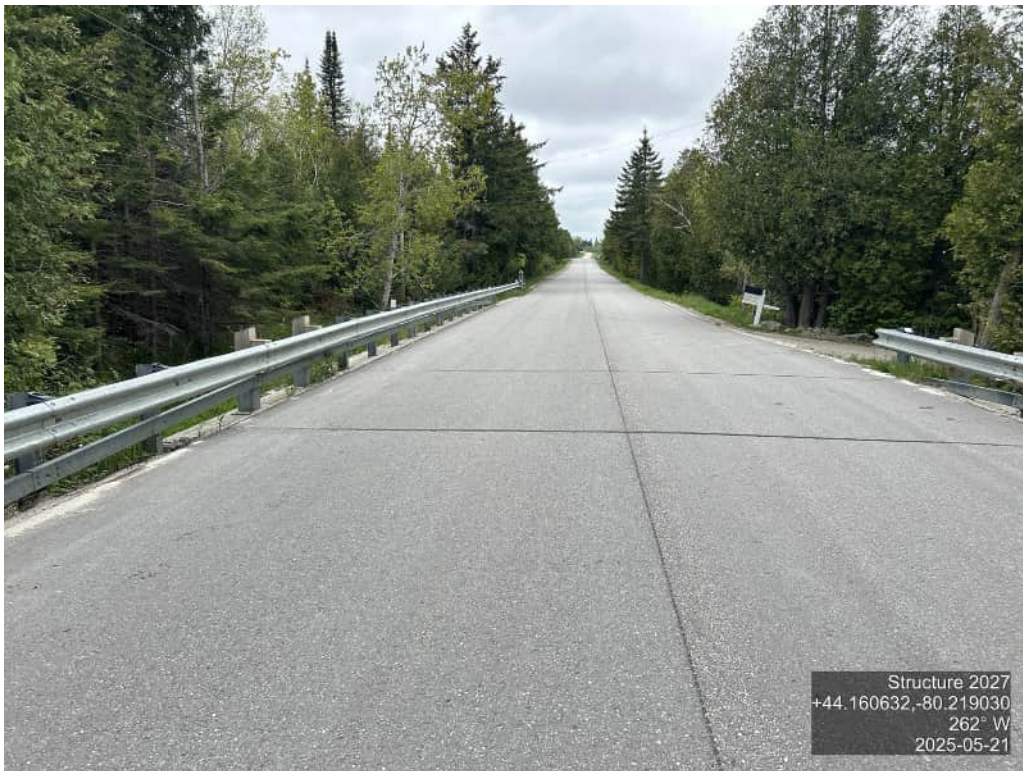
**WEARING SURFACE – WEST – LIGHT EDGE CRACKING**

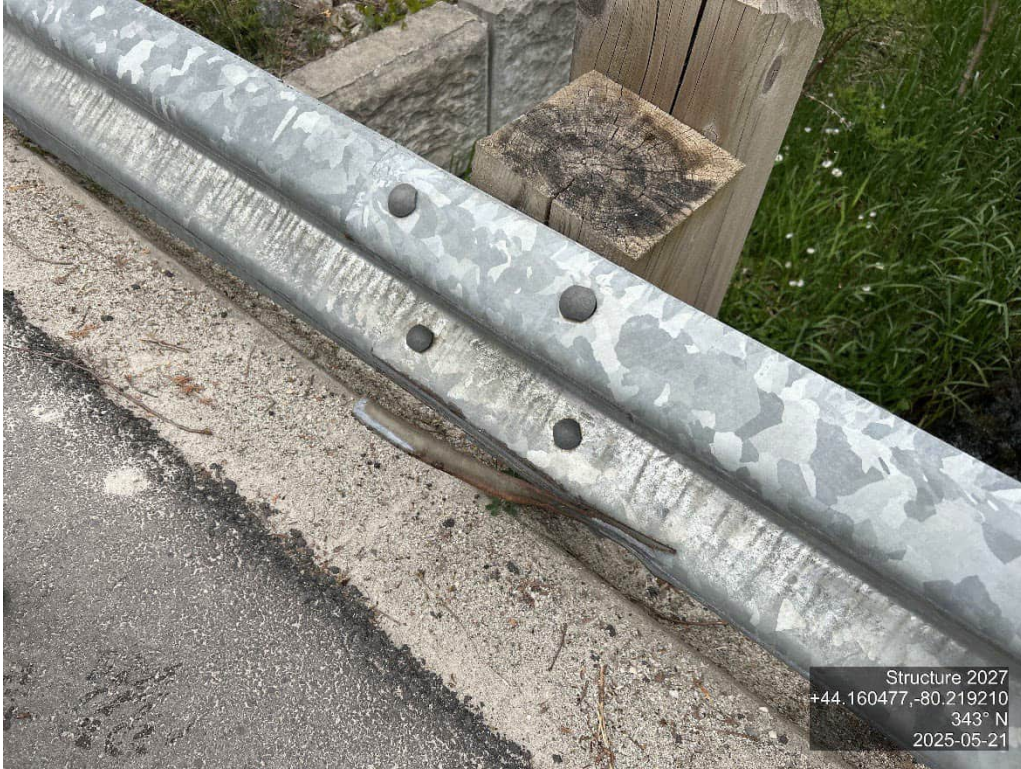
**GUIDERAIL – NORTH – LIGHT IMPACT DAMAGE**

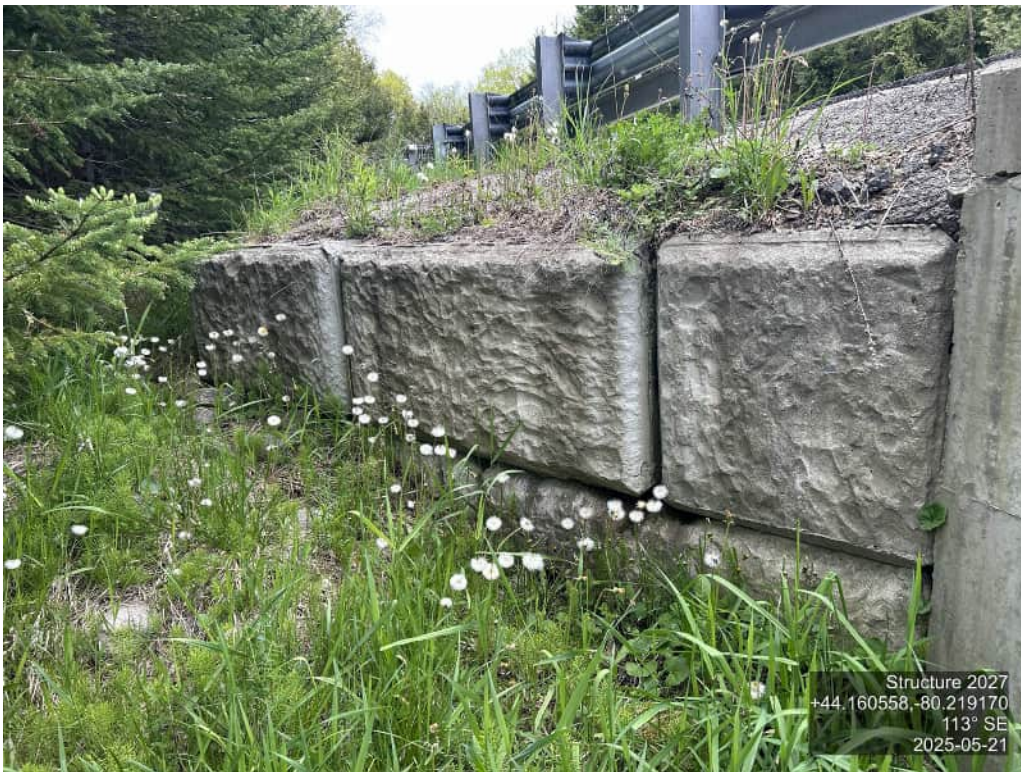
**RETAINING WALL – SOUTHEAST**

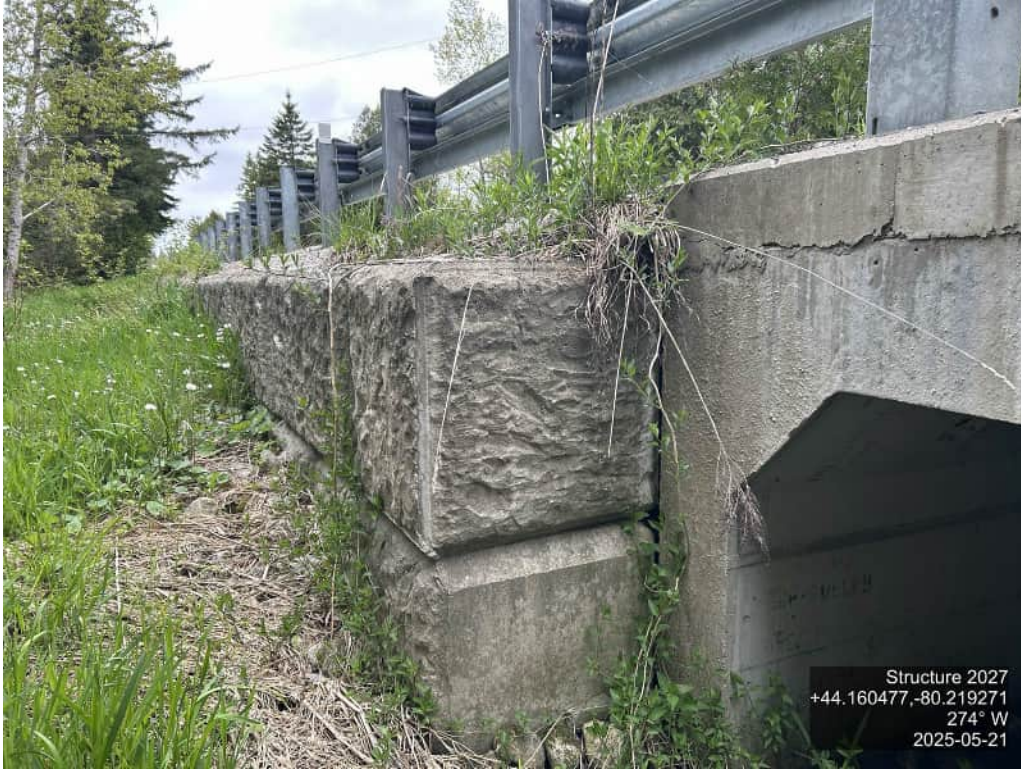
**OUTLET – NORTH – HAIRLINE STAINED CRACKS**

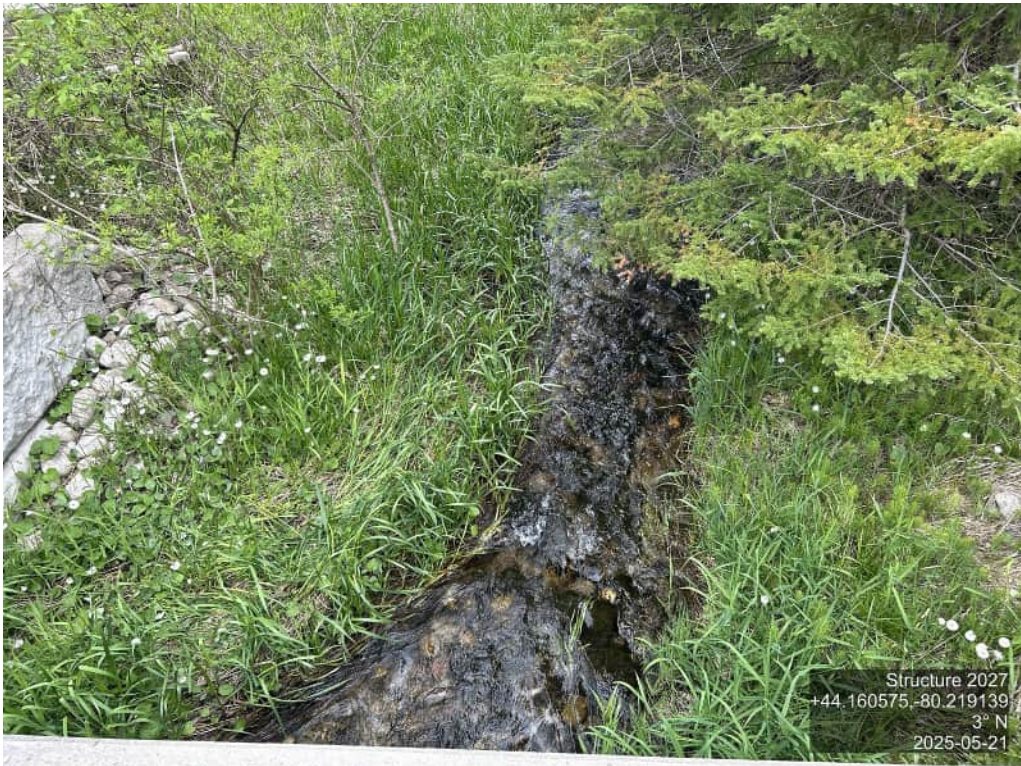
**STREAM – NORTH – FLOWS SOUTH TO NORTH**

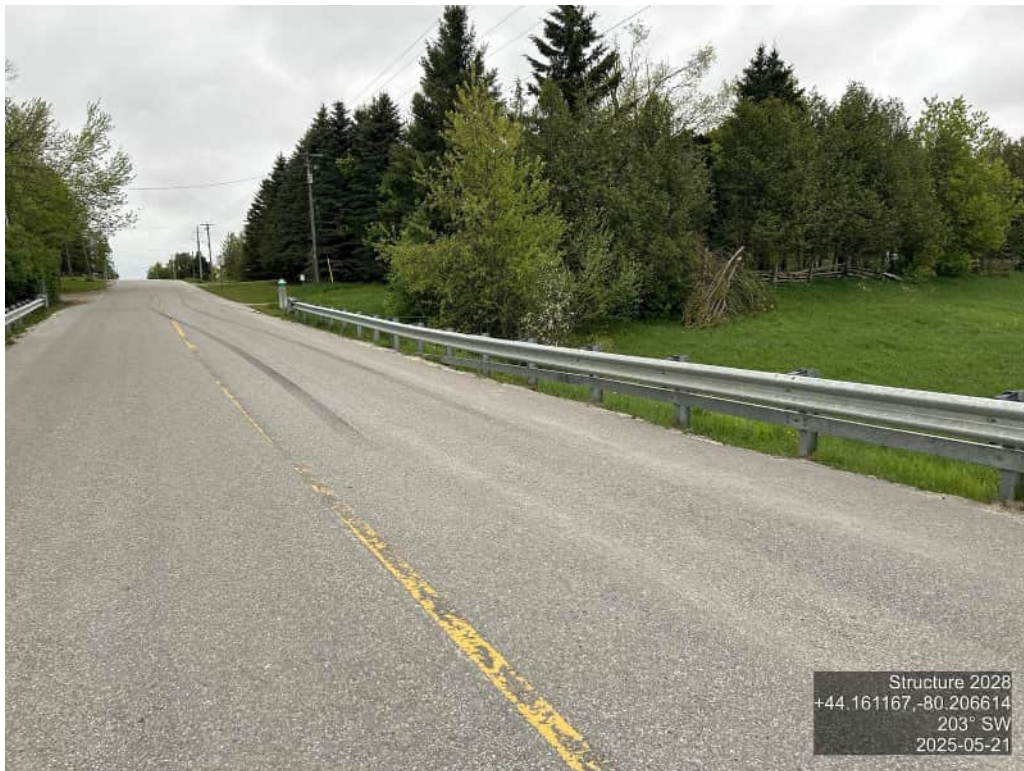
DECK WEARING SURFACE – OVER DECK TOP

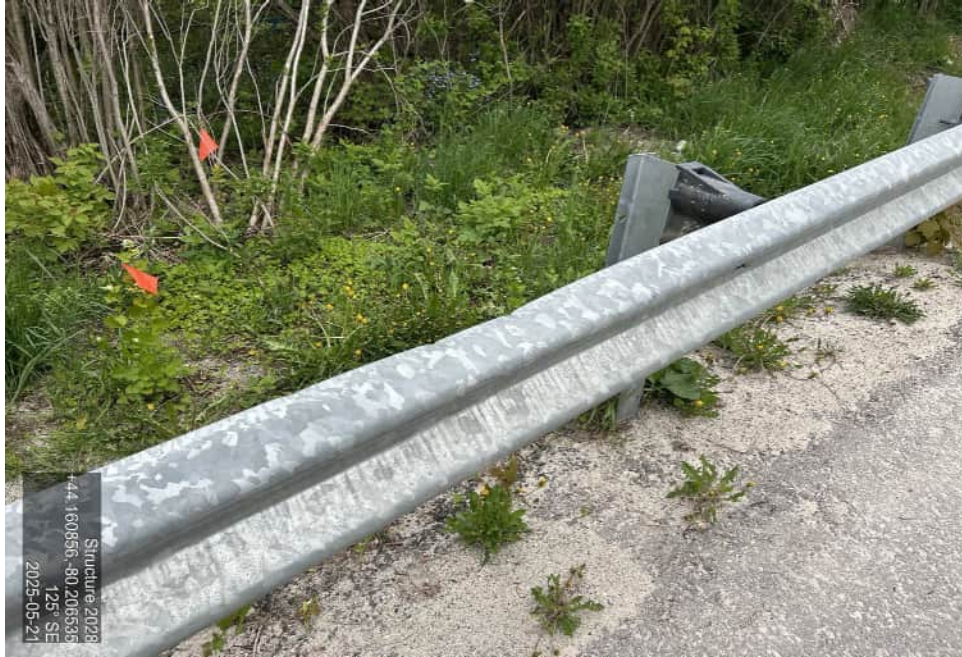
**GUIDERAIL – SOUTHEAST – LIGHT IMPACT DAMAGE AND FALLEN POST**

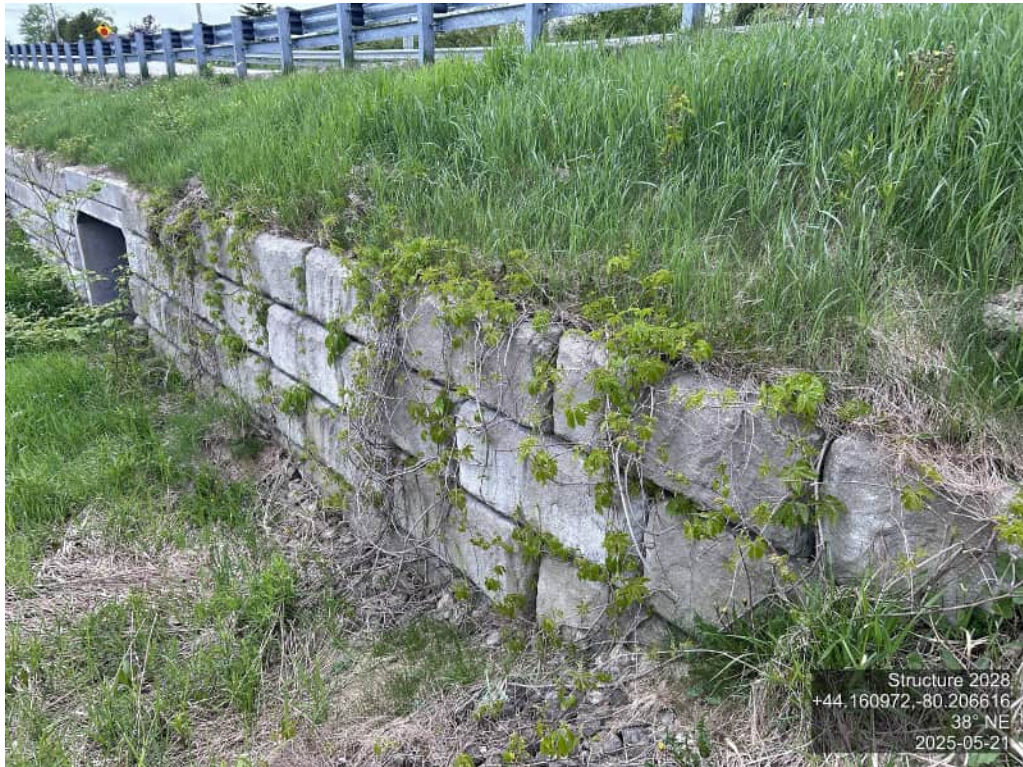
**RETAINING WALLS – NORTHWEST – VEGETATION GROWING OVER WALL**

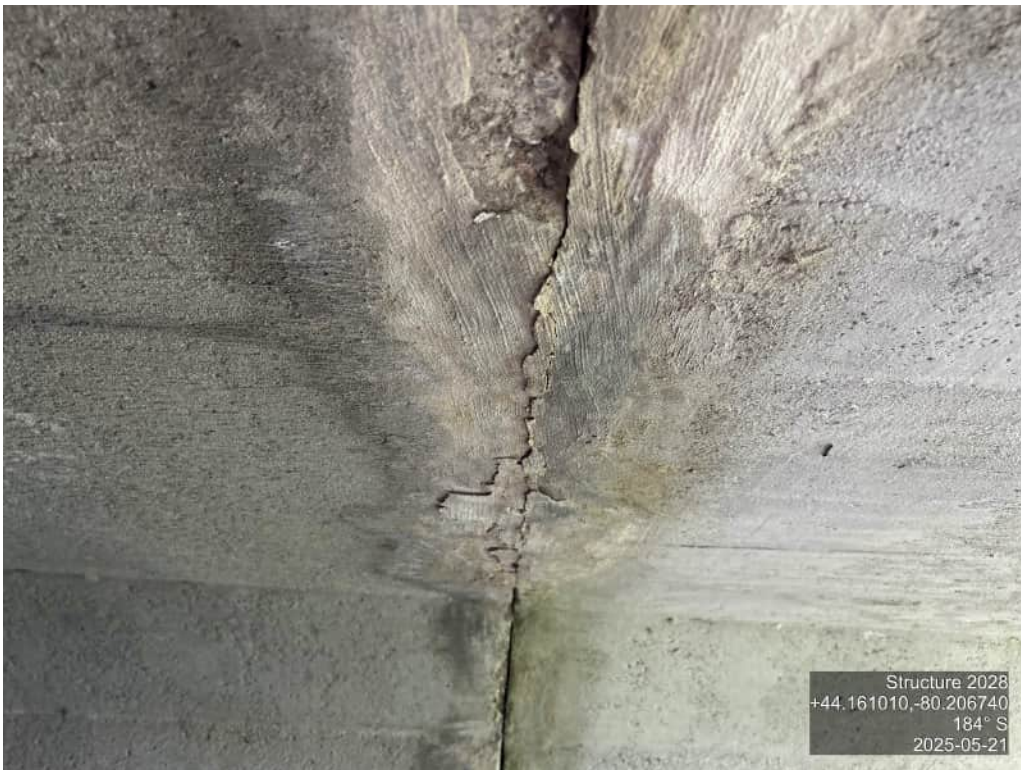
**BARREL – INSIDE WALLS – FAILED PARING AT JOINT WITH WATER PENETRATION**

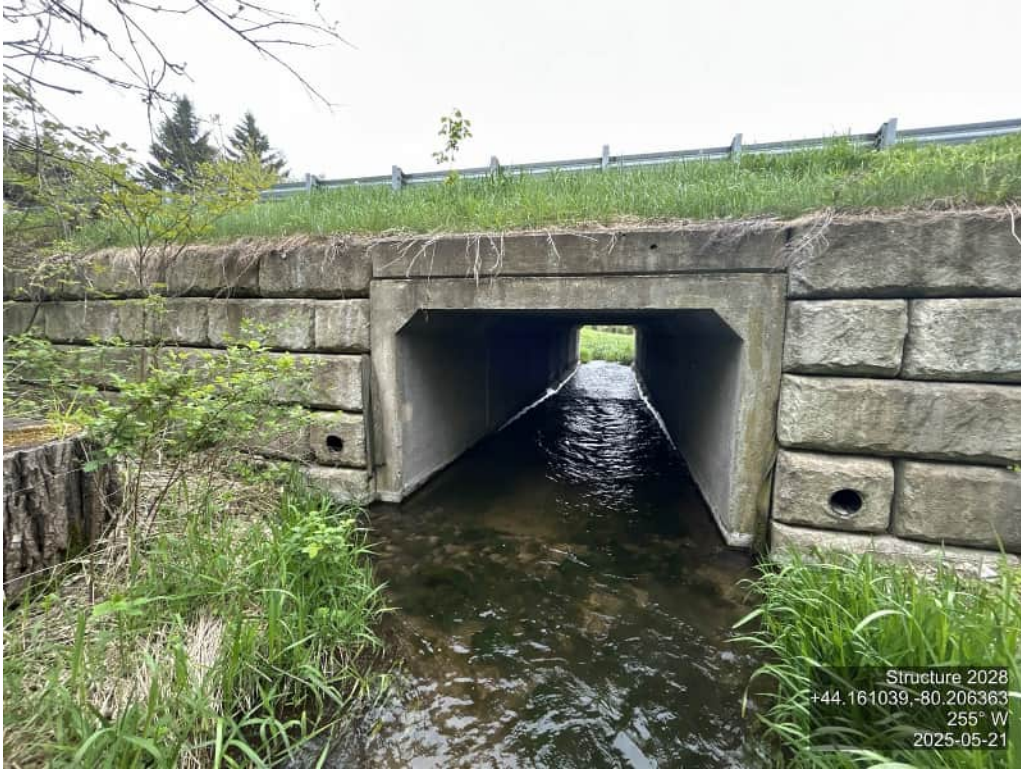
**OUTLET – EAST – SMALL POPOUT**

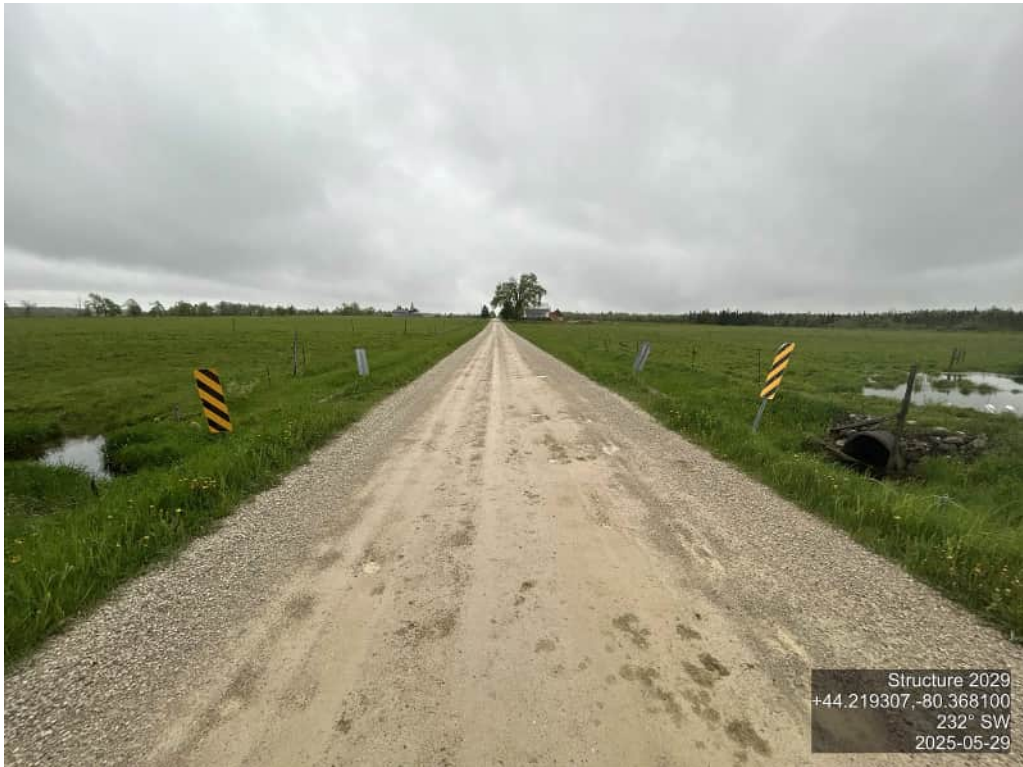
DECK WEARING SURFACE – OVER DECK TOP – SMALL TO MEDIUM POTHOLES

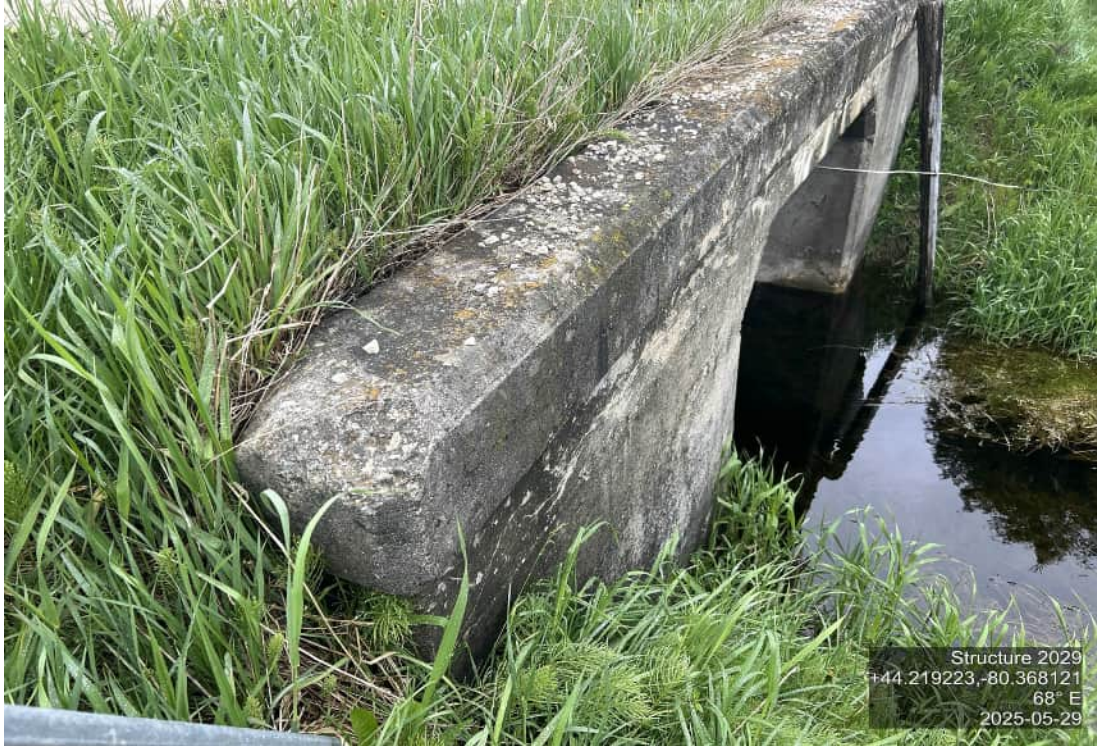
**CURB – SOUTH – IMPACT DAMAGE ON CORNERS AND WIDE CRACK AT CENTERLINE**

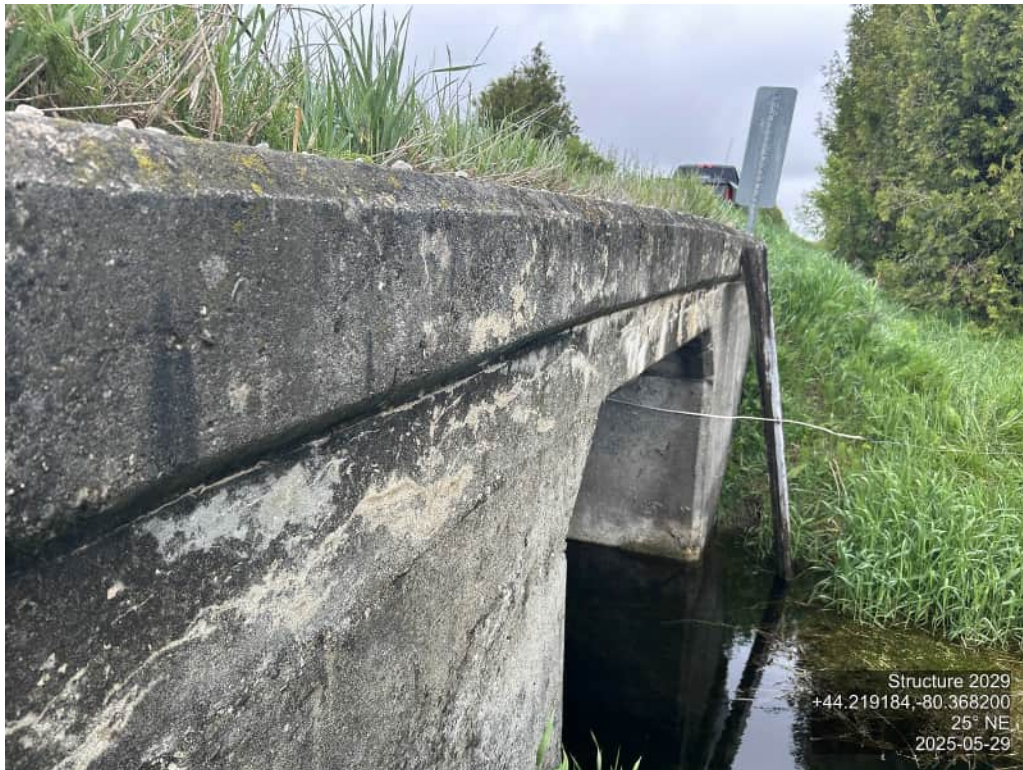
**WINGWALLS – NORTHEAST – HONEYCOMBING AND CRACKS THROUGHOUT**

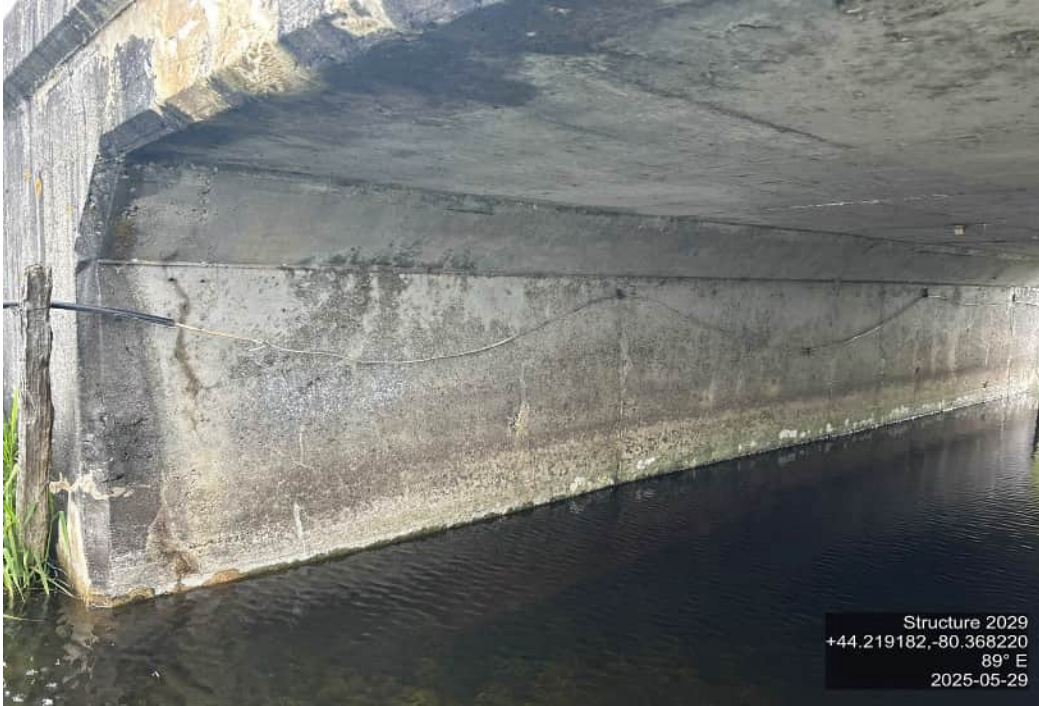
**ABUTMENT WALLS – INSIDE WALLS – TWO VERTICAL SHRINKAGE CRACKS IN EACH WALL AND HONEYCOMBING**

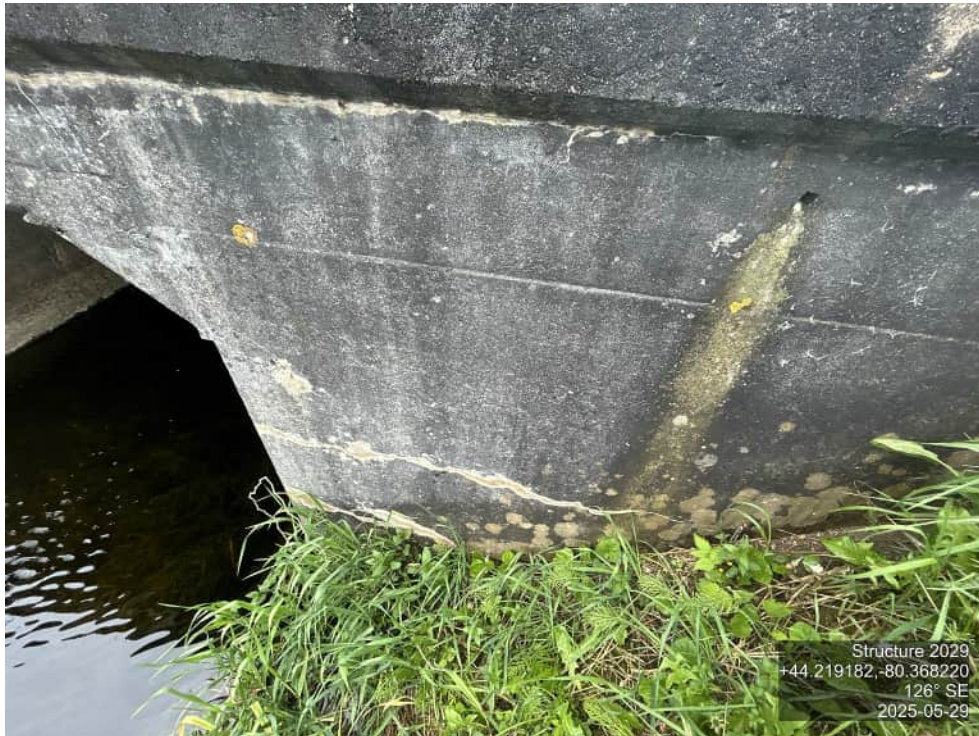
**SOFFIT EXTERIOR – LOCATION – HAIRLINE CRACKING AND STAINING WITH EFFLORESCENCE**
