**BURNSIDE**

## **2025 OSIM Bridge Inspections Report**

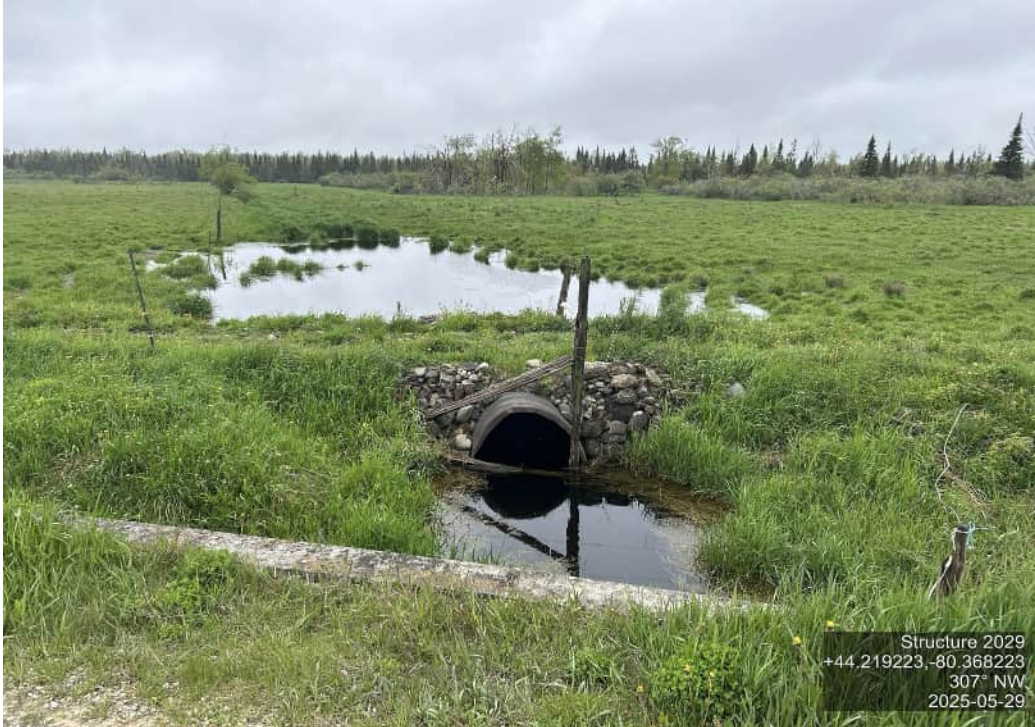
**STREAM – NORTH – SMALL POND AND CULVERT CROSSING STRUCTURE TO THE NORTH**

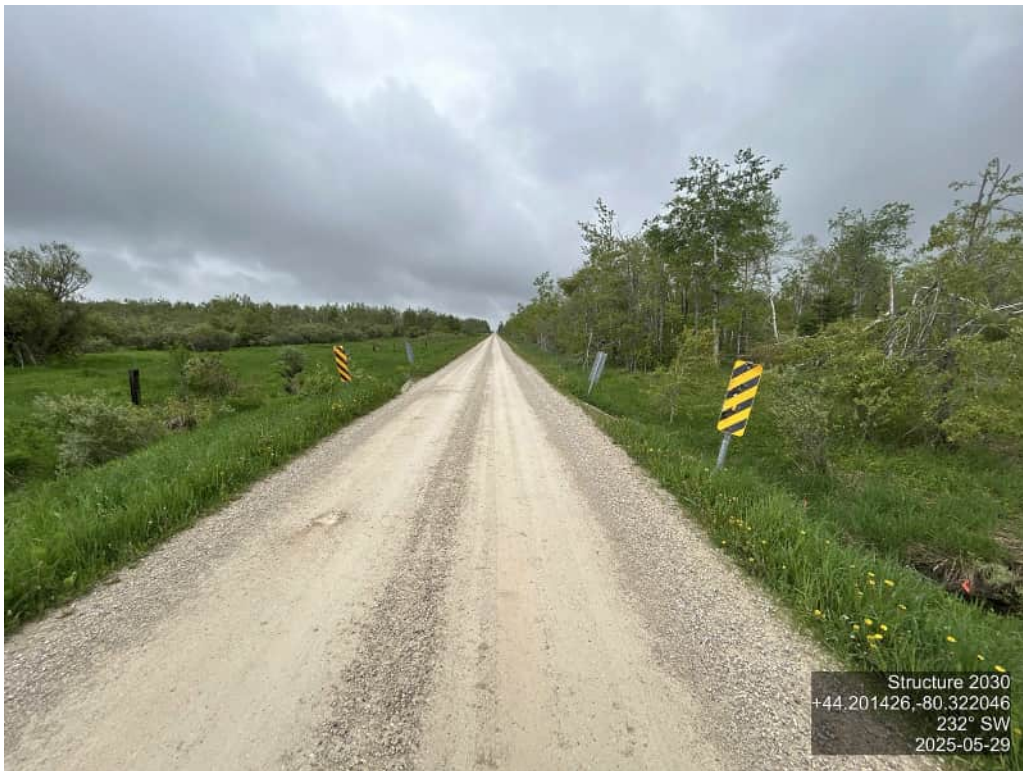
**DECK WEARING SURFACE – SOUTHWEST – SMALL POTHoles**

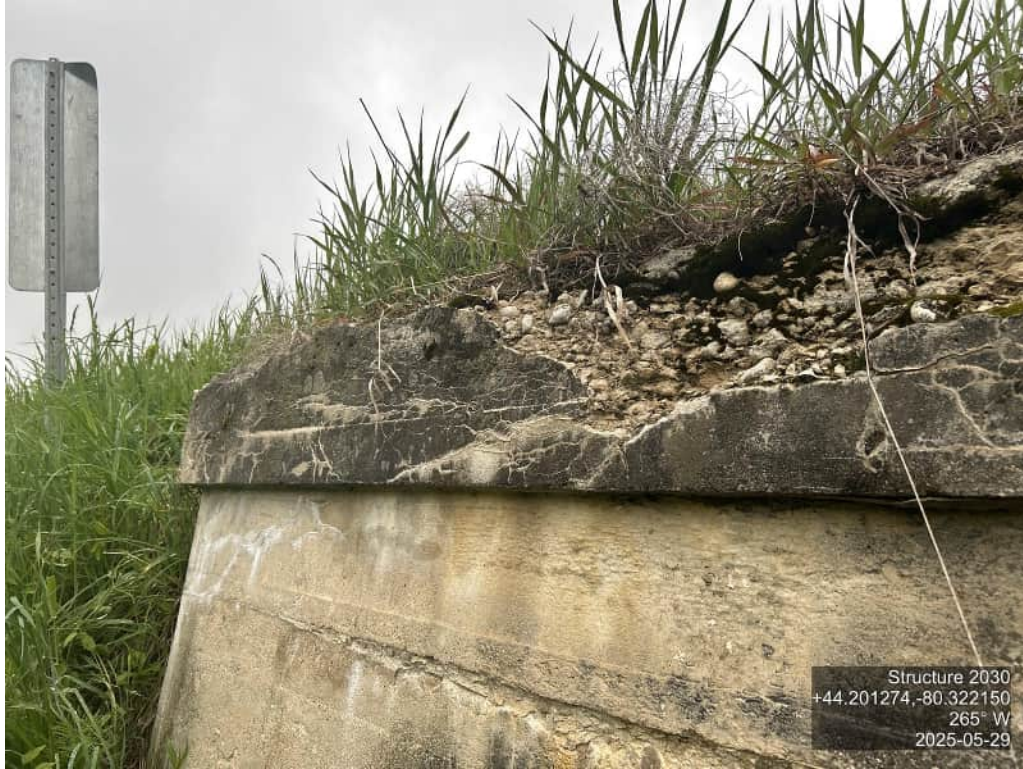
**CURB – NORTHEAST – SPALLING AND DELAMINATIONS**

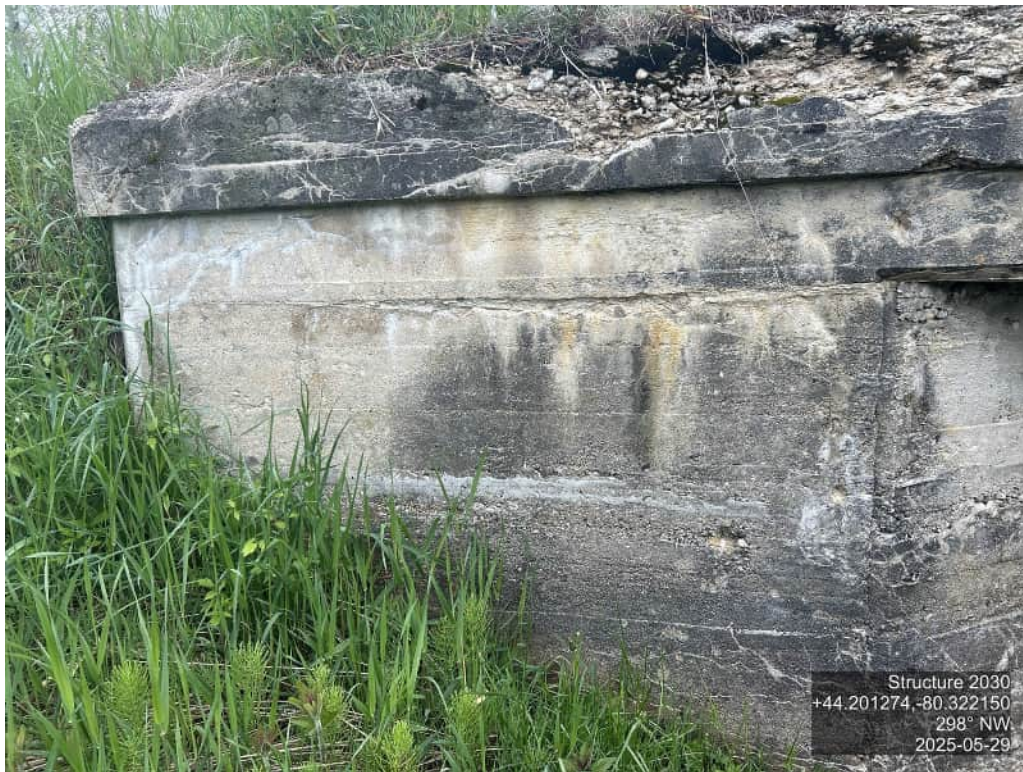
**WINGWALL – NORTHWEST – DELAMINATIONS AND COLD JOINTS**

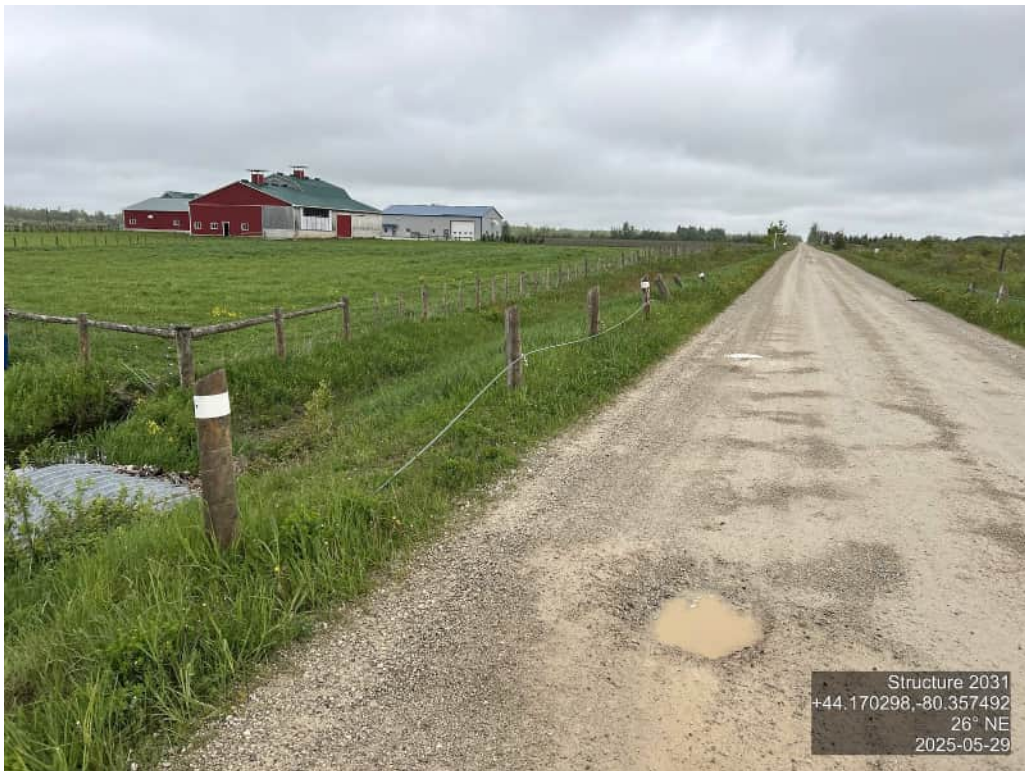
**DECK WEARING SURFACE – NORTHEAST – MEDIUM TO LARGE POTHoles**

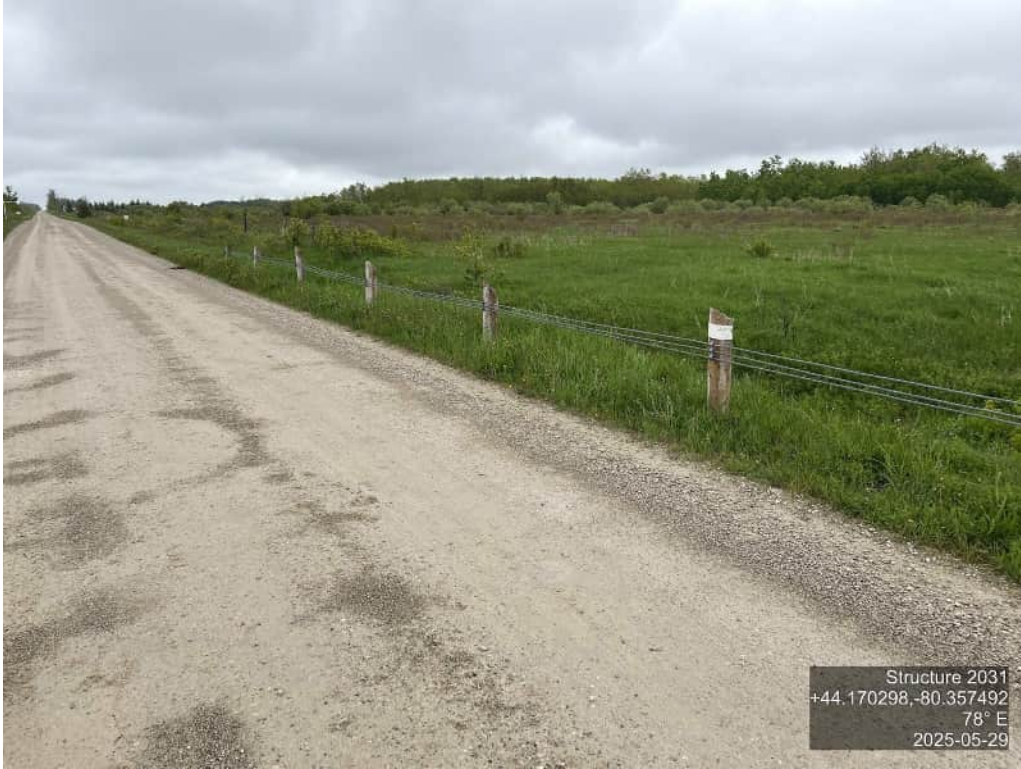
**GUIDERAIL – SOUTH – FEW ROTTEN POSTS AND CABLE IS LOOSE**

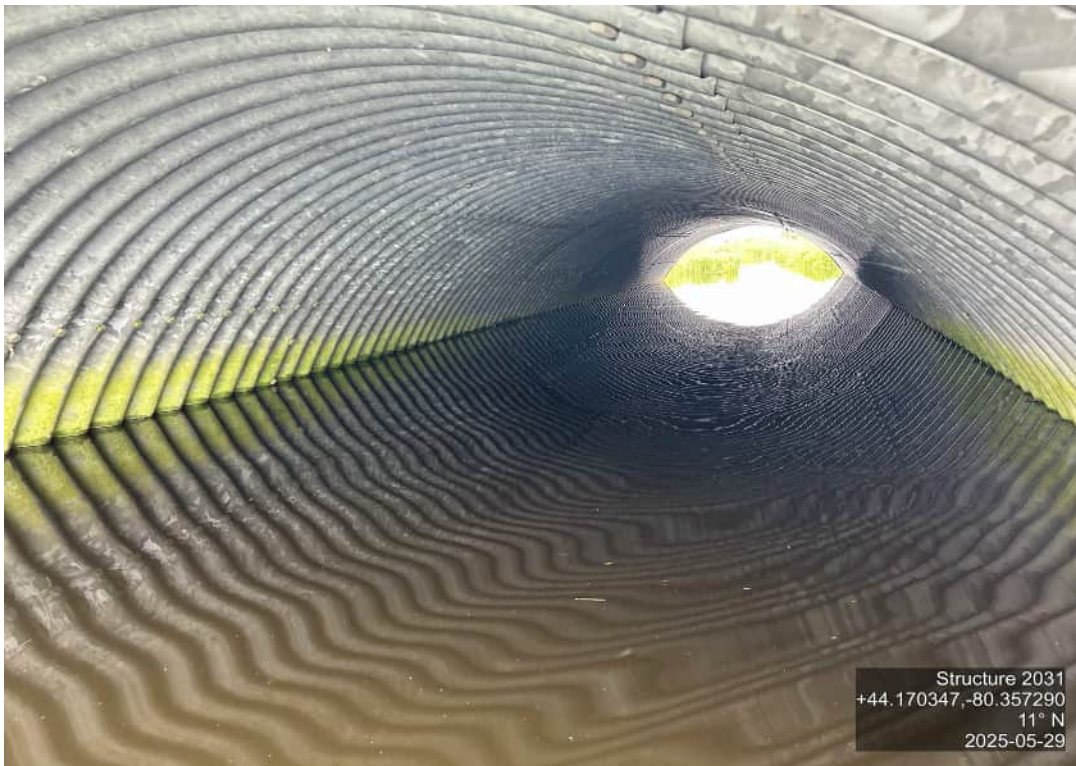
**BARREL – NORTH – DEFORMATION IN MIDDLE AND MISSING BOLTS**

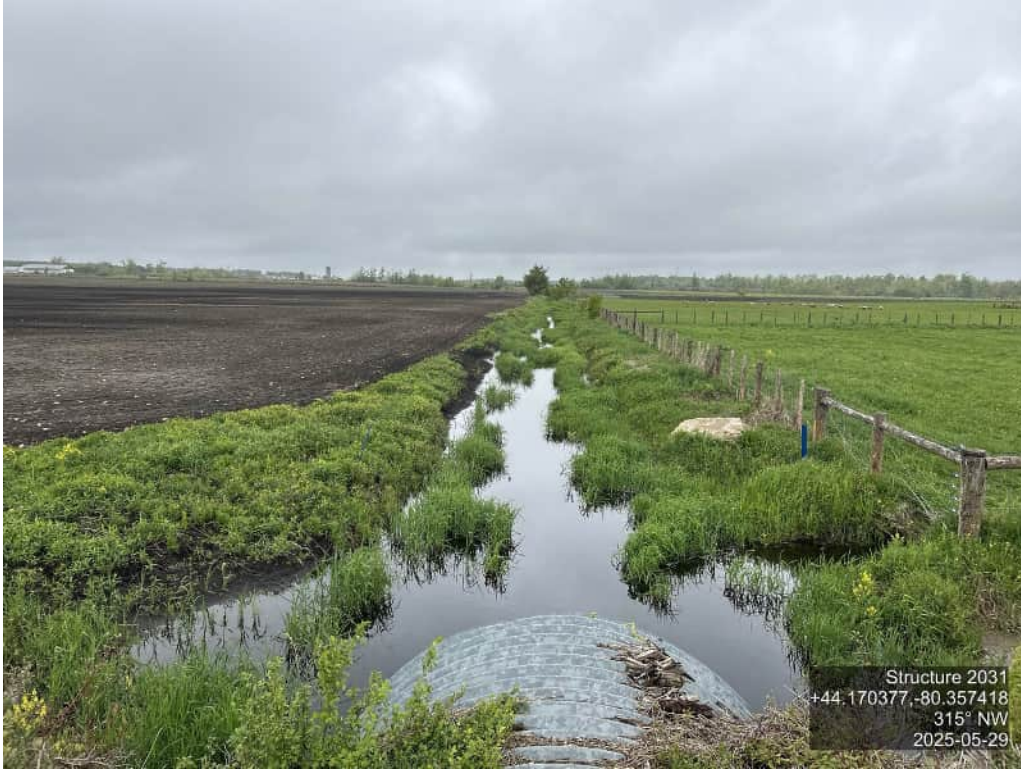
**STREAM – NORTH – NORTH TO SOUTH**

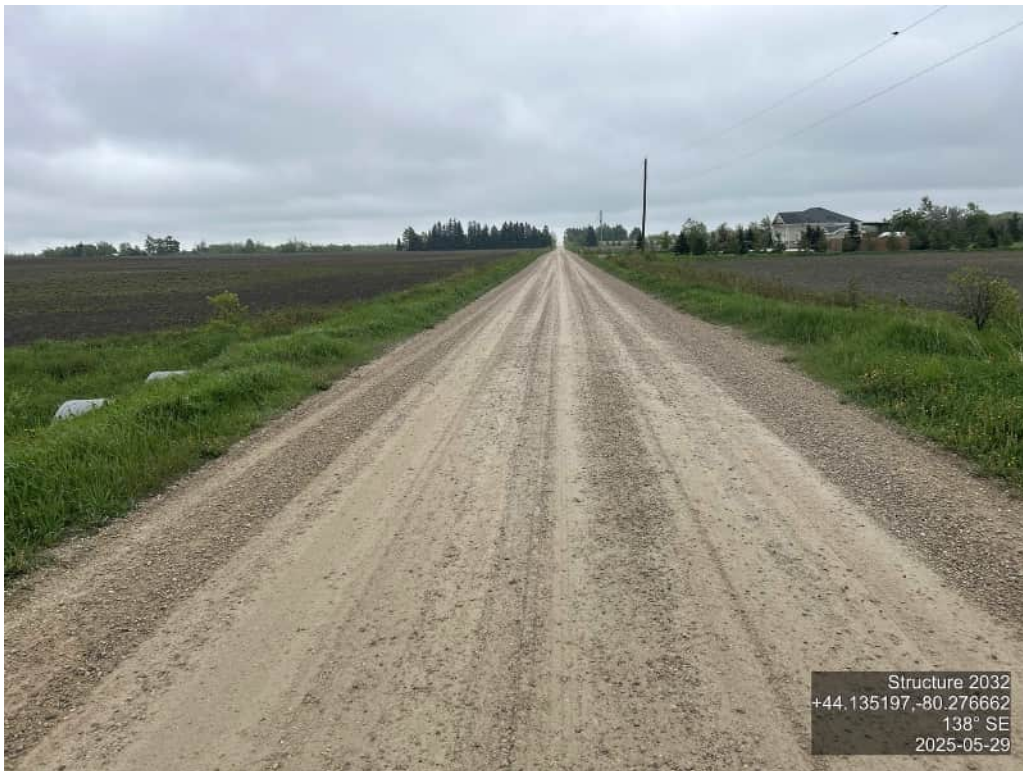
**DECK WEARING SURFACE – SOUTH**

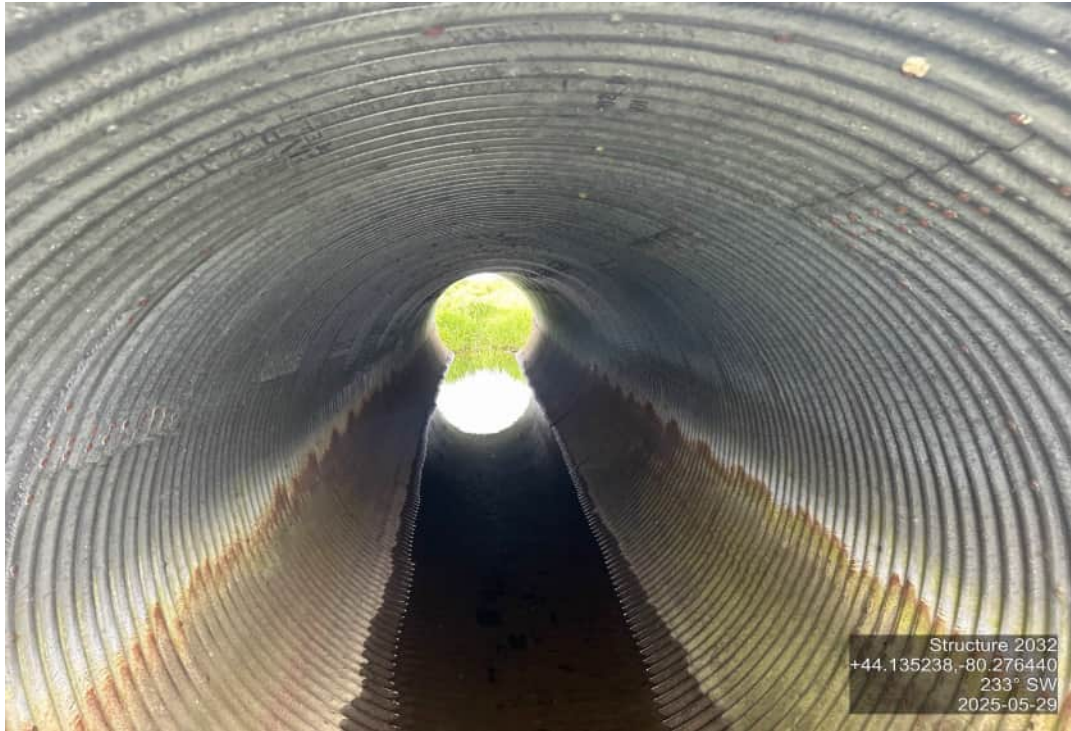
**BARREL – NORTH – MODERATE CORROSION, FLAKING AND SECTION LOSS ON FLOOR**

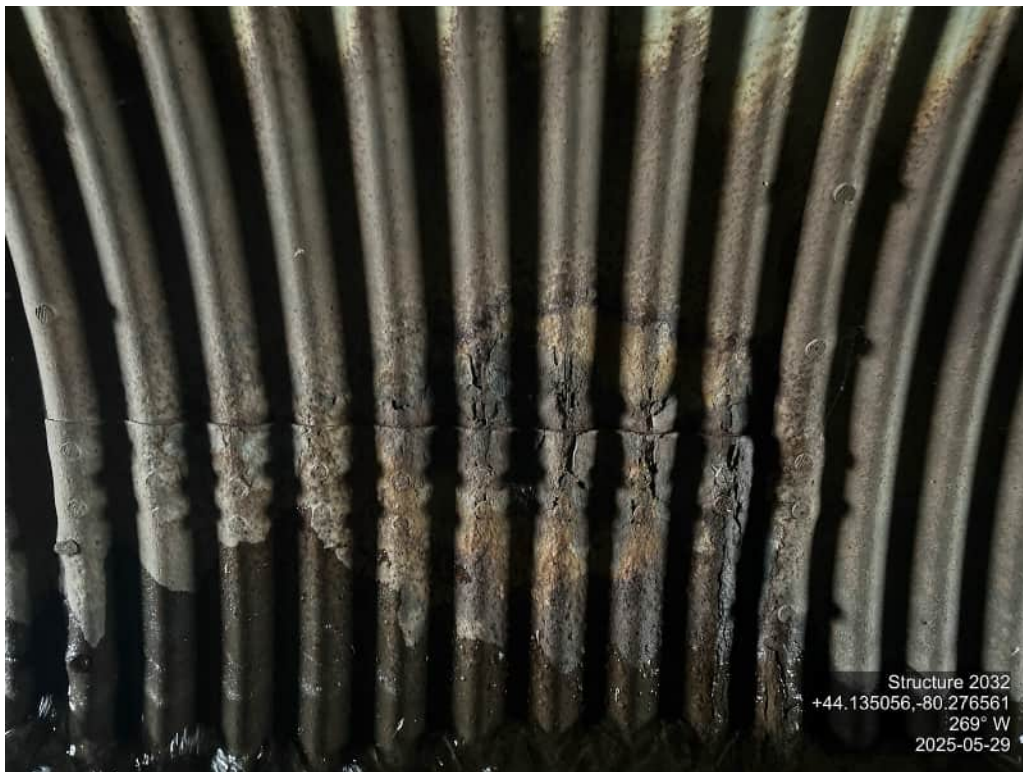
**BARREL – SOUTH – MODERATE SURFACE CORROSION, FLAKING AND SECTION LOSS**

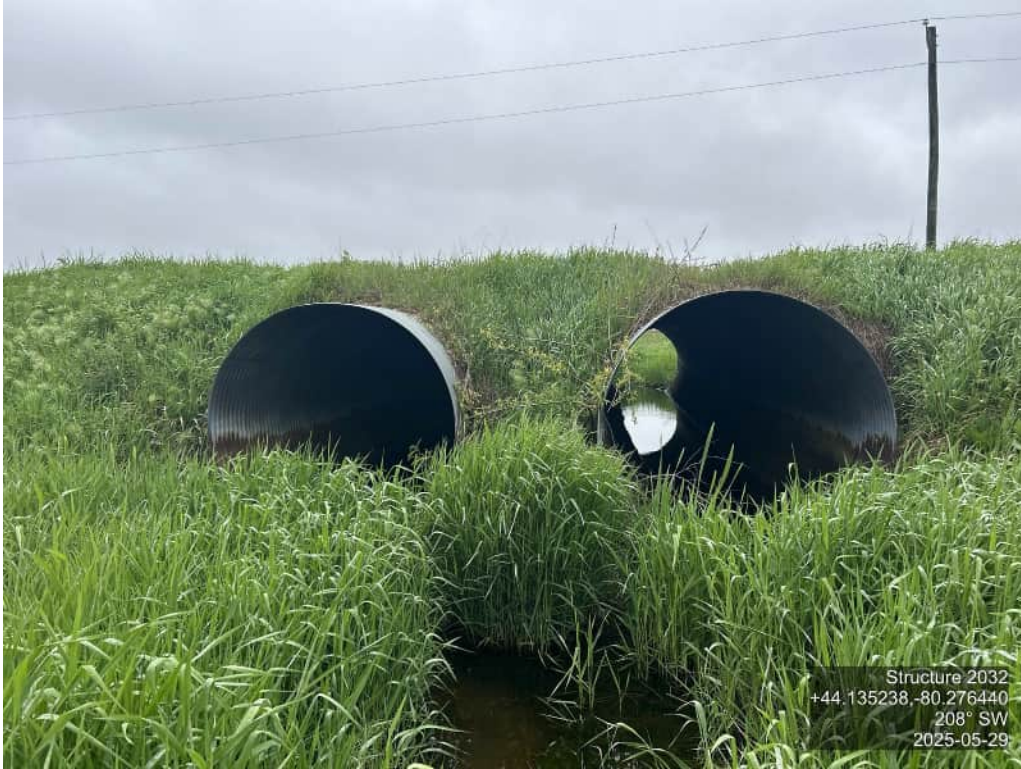
**STREAM – EAST – AGGRADATION PARTIALLY BLOCKING NORTH BARREL**

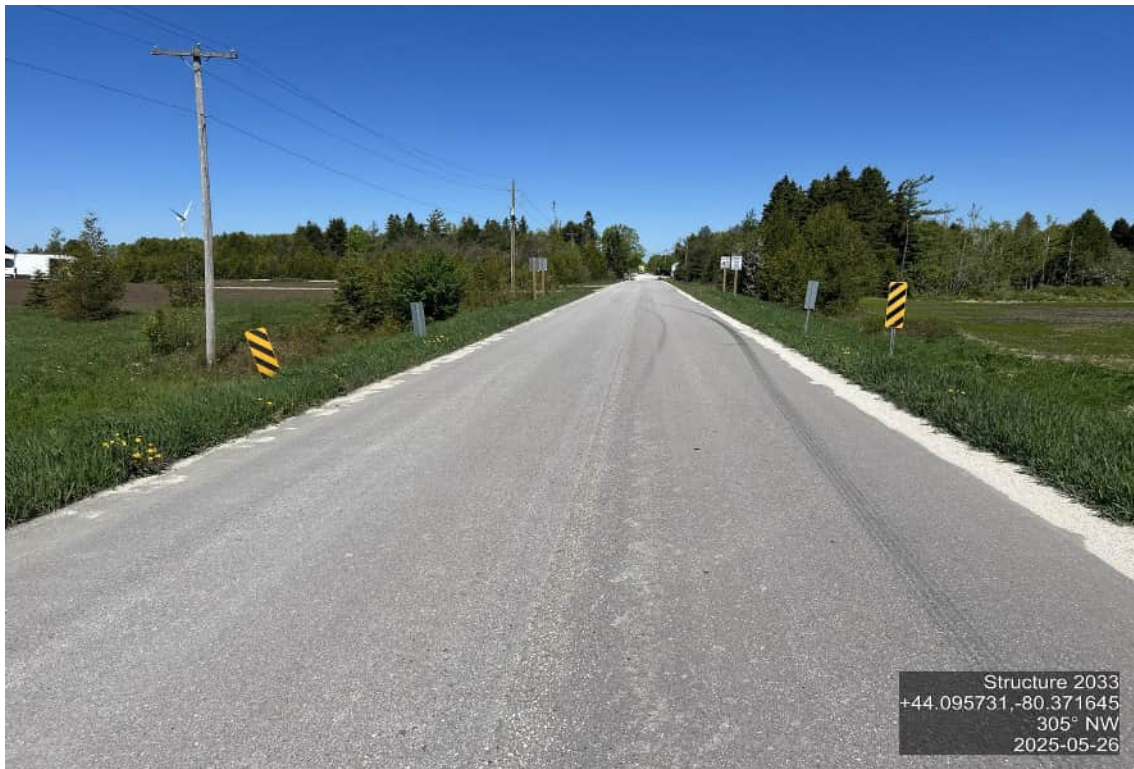
**DECK WEARING SURFACE – NORTH – RE-PAVED IN 2023**

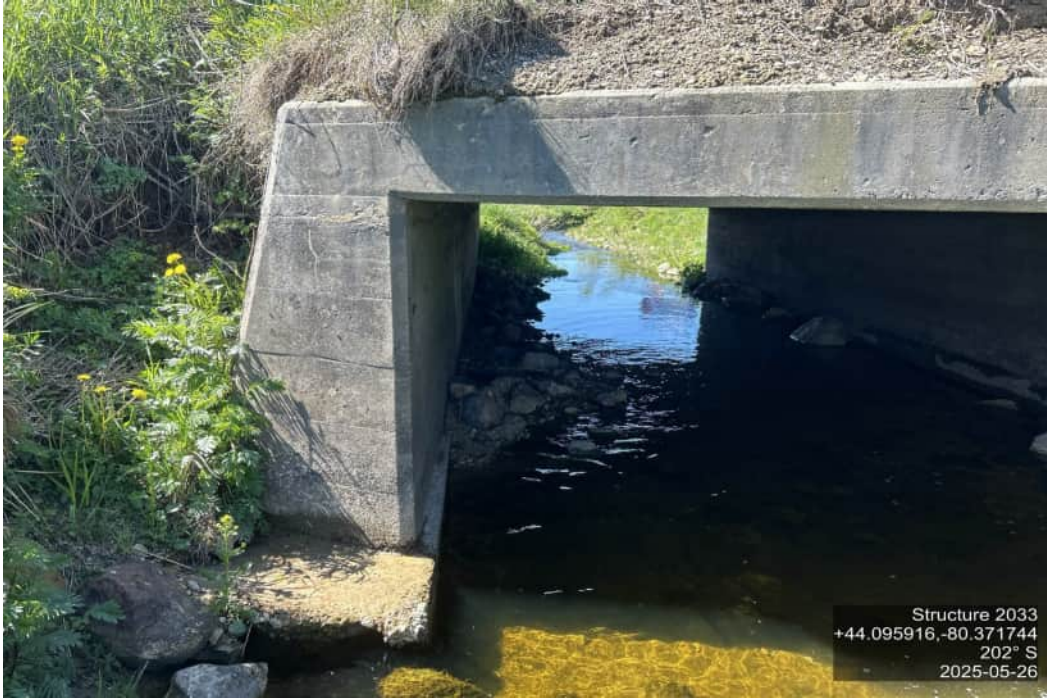
**INLET – SOUTHEAST – EXPOSED FOOTING, LARGE AMOUNT OF FILL ON CULVERT ENDS**

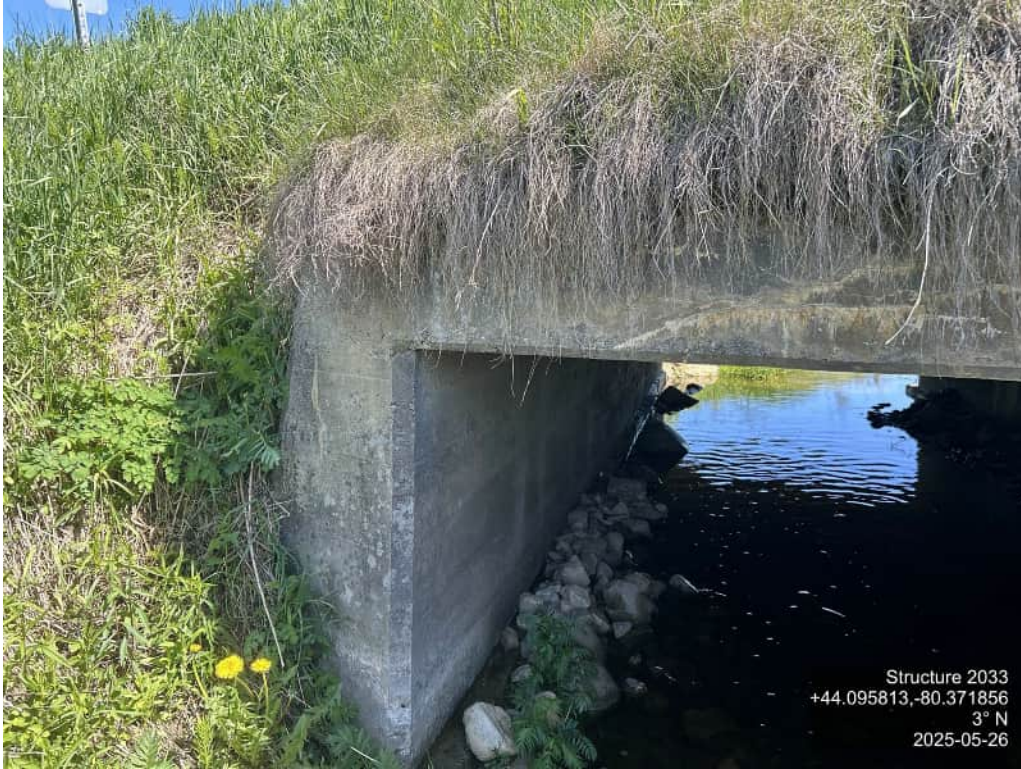
**OUTLET – WEST – MEDIUM SIZED EFFLORESCENCE STAINED CRACKS**

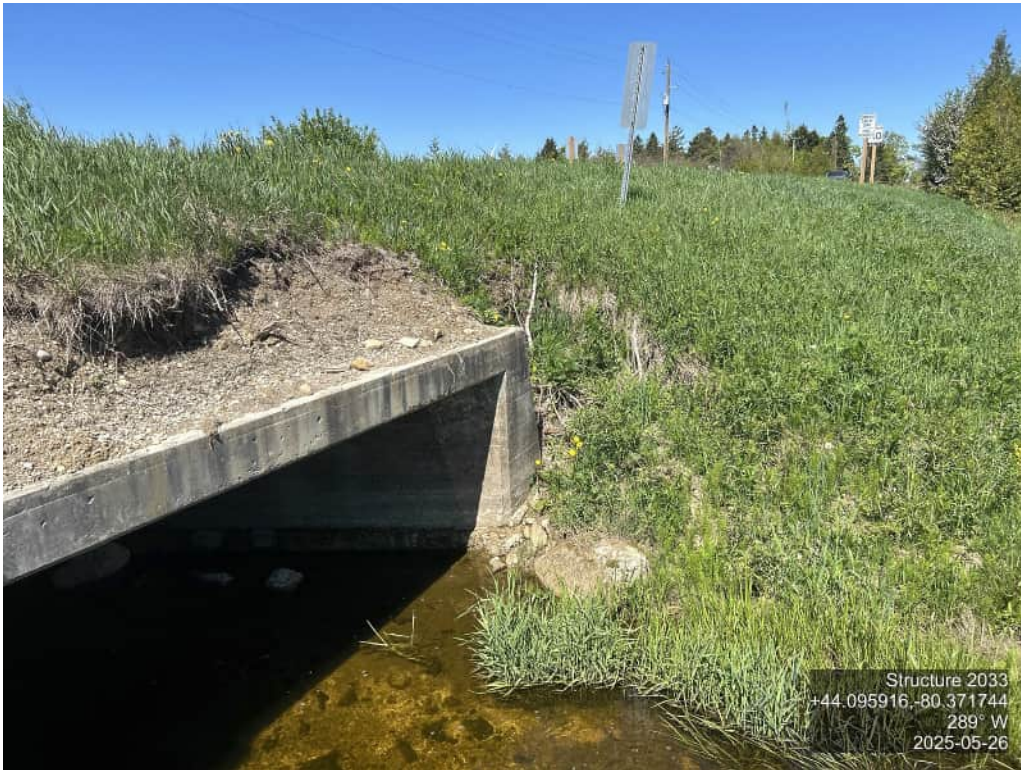
**STREAM – NORTHWEST – ERROSION AT CORNERS OF STRUCTURE**

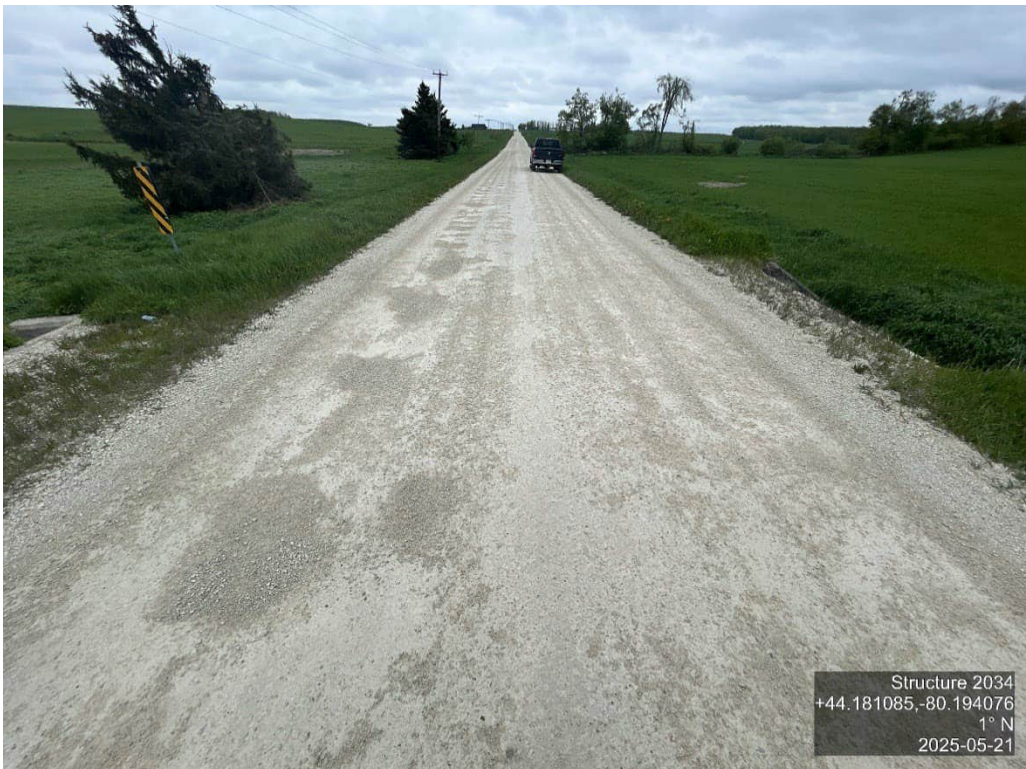
Structure 2034  
+44.181085,-80.194076  
1° N  
2025-05-21

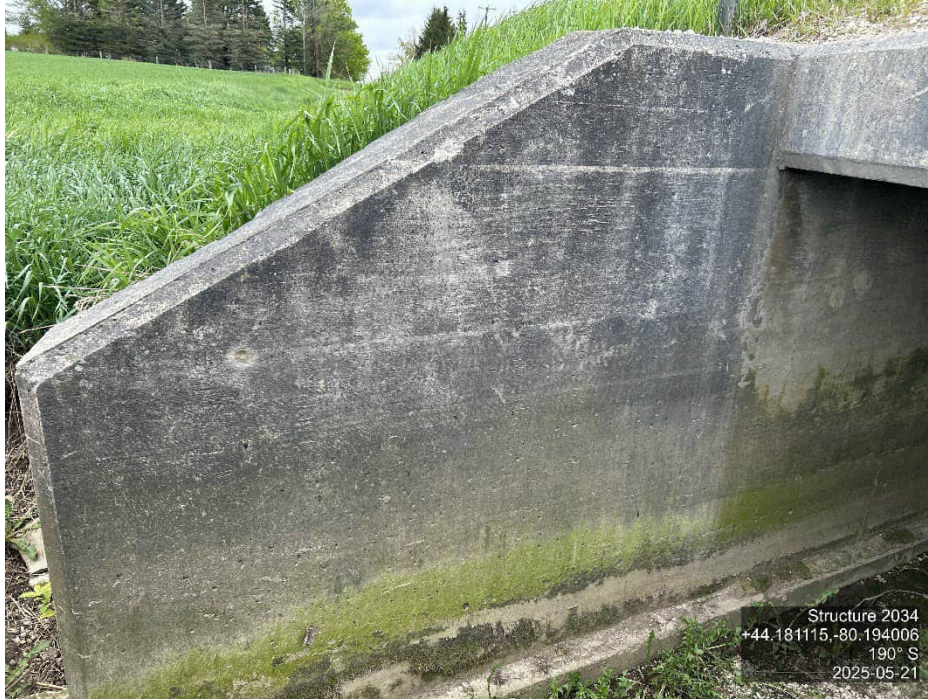
**WINGWALL- SOUTHWEST - MOISTURE STAINING**

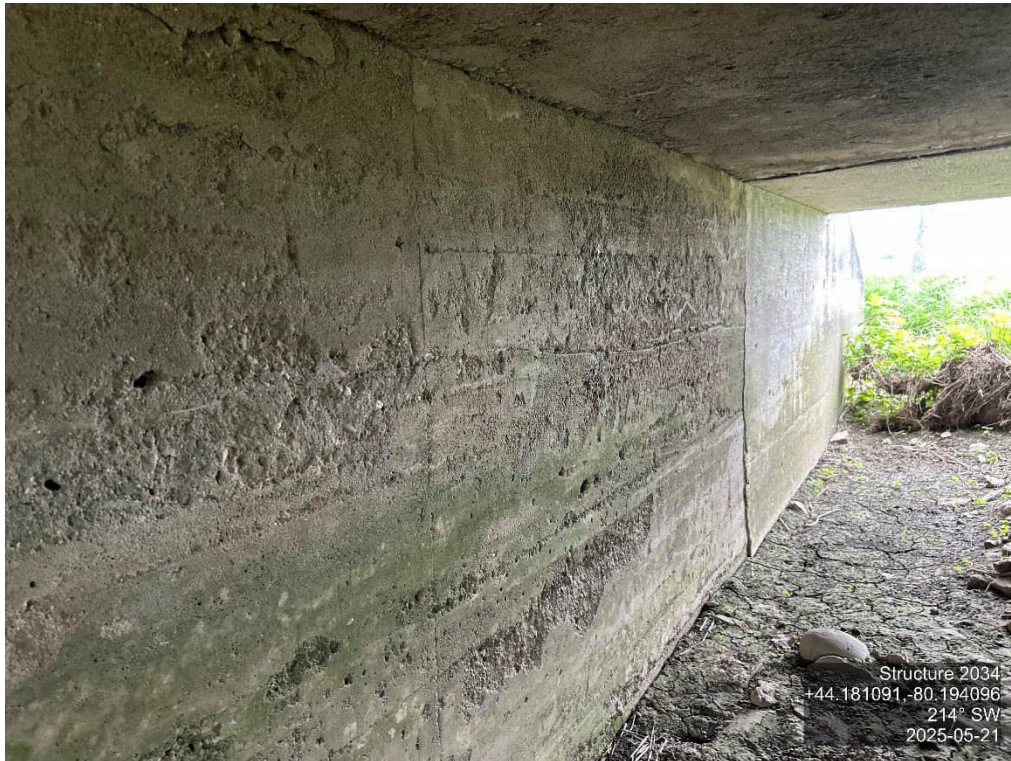
**ABUTMENT - SOUTH - MEDIUM SCALING**

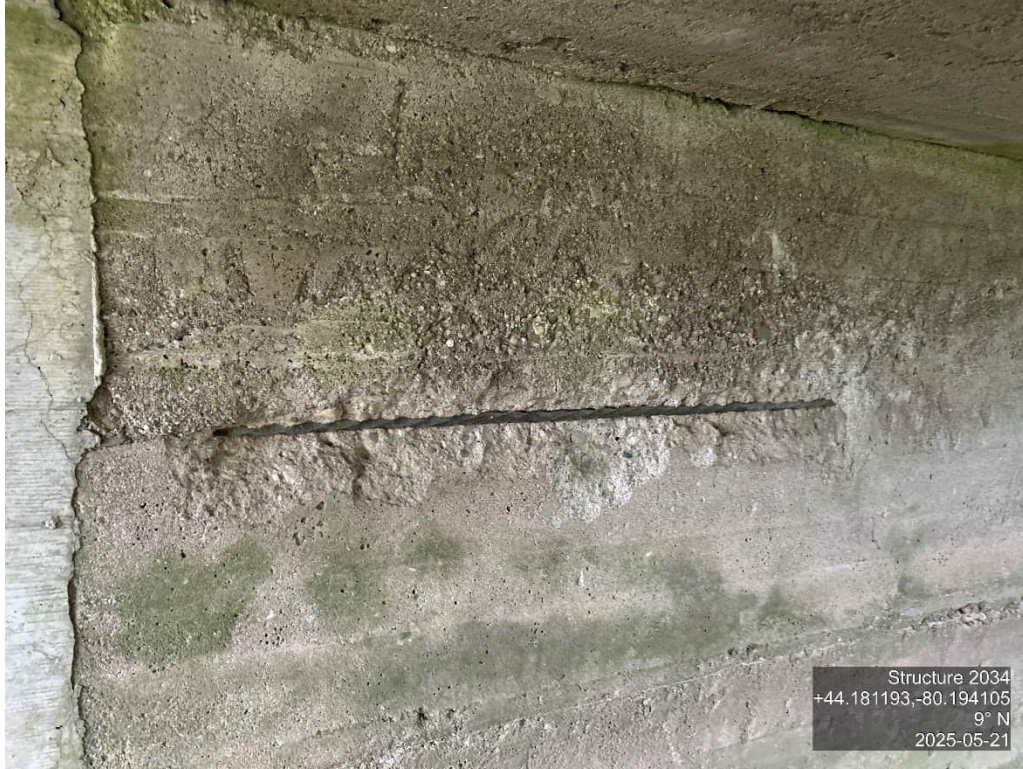
**ABUTMENT – NORTH – SPALL WITH EXPOSED REBAR**

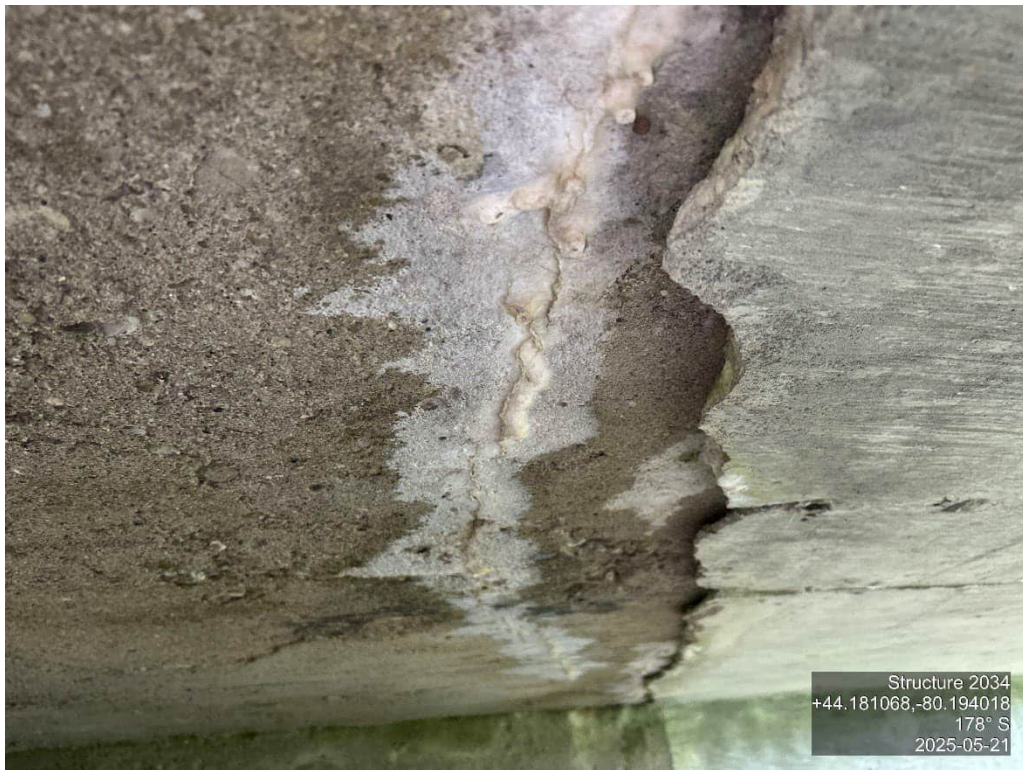
**SOFFIT- WEST – EFFLOURESCENCE STAINED CRACKS**
