**ROADS SUB-COMMITTEE MEETING AGENDA
TUESDAY, DECEMBER 10, 2019 - 1:30 P.M.
MEETING HELD IN THE COUNCIL CHAMBERS**

DETAILED CONDITION SURVEY REPORT

Bridge Check Canada Ltd. was retained by R.J. Burnside & Associates Ltd. to carry out detailed bridge condition survey for Bridge 013 – 260 Sideroad over Grand River located on 260 Sideroad, 200m East of 7th Line SW (Lot 21 & 22, Con. 6 & 7 SW) in Township of Melancthon, Ontario. First time field investigations were carried out on October 7, 2019. Field crew used chest waders, ladder, and delam 2000 for the inspection of the substructure components.

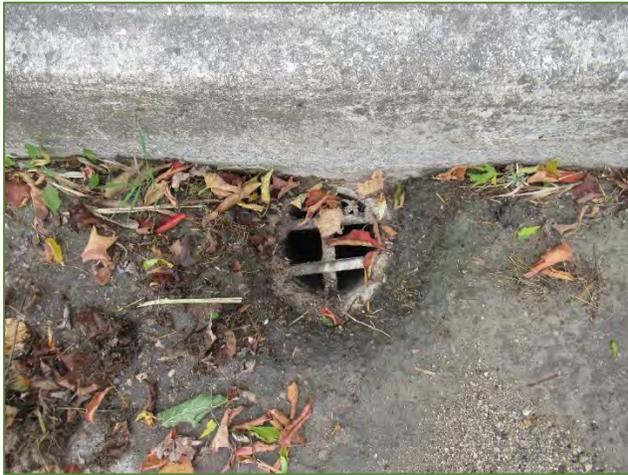
Typical Condition of South Deck Drain – 1st from west

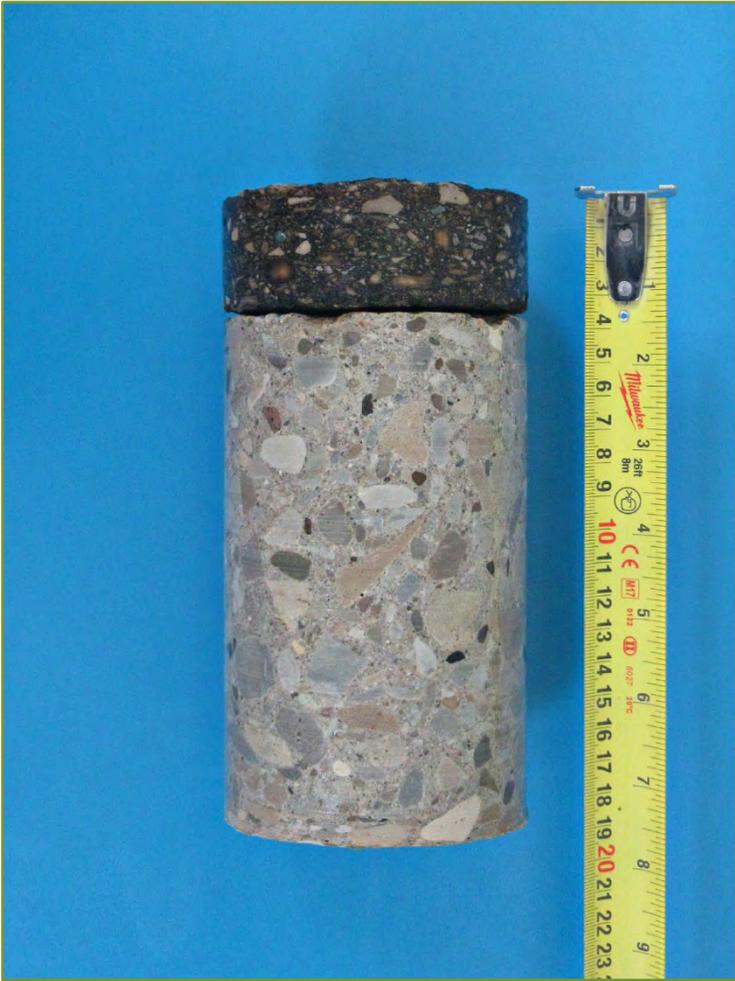
Full depth core C3 identified a 160 mm thickness for the deck slab at this corehole location. Presence of concrete patch was noted in cores C5, C8, C11. The concrete patch varied in depth from 45 mm to 65 mm. The concrete cover to the upper rebar layer measured in the cores and sawn asphalt samples ranged from 34 to 75 mm with an average cover of 48 mm. A review of the reinforcing steel revealed light rusting in cores C2 and C7 and severe rusting in core C11.

Core C3 was tested for compressive strength of the hardened concrete in accordance with CSA A23.2-14-14C. The compressive strength of the hardened concrete for this core was found to be 62.2 MPa.

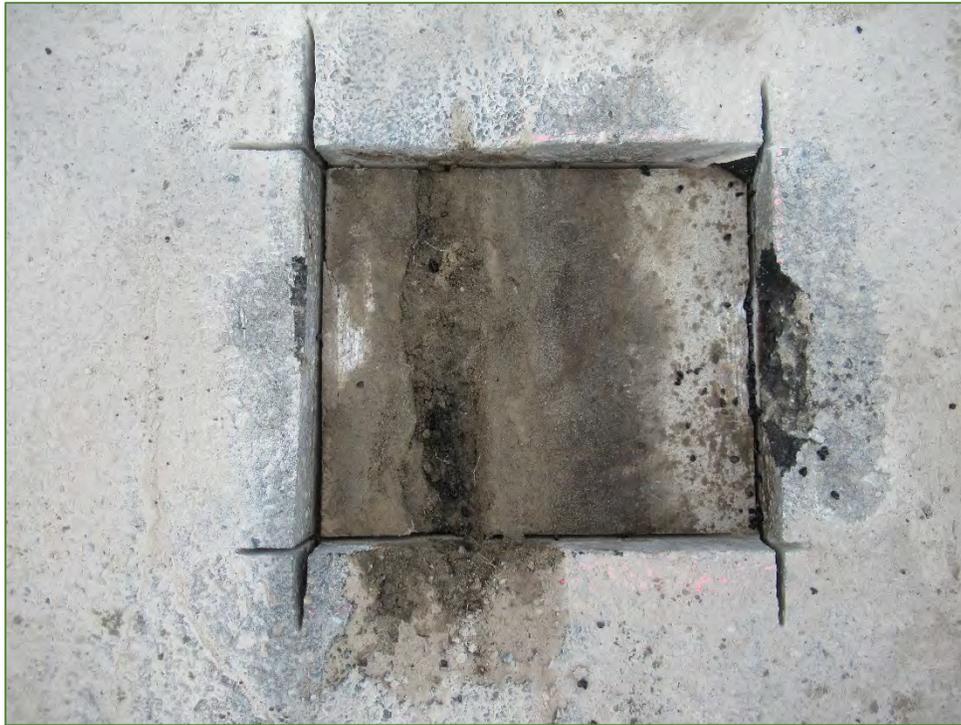
Photo S1 – Sawn Sample SS1 (over the joint)

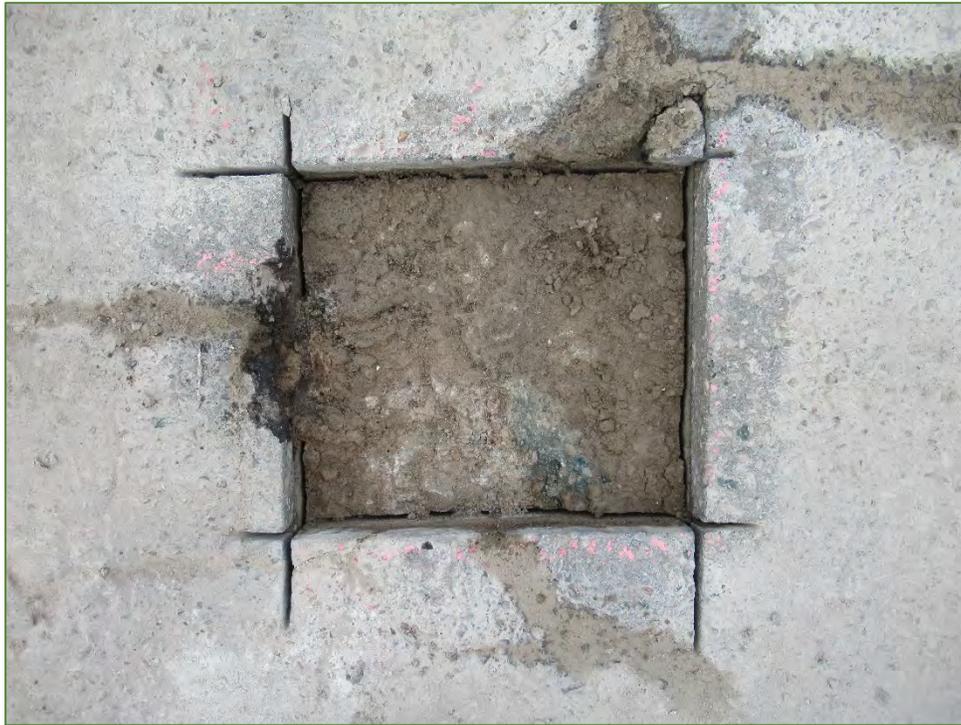
Photo S3 – Sawn Sample SS3 (severe scaling)

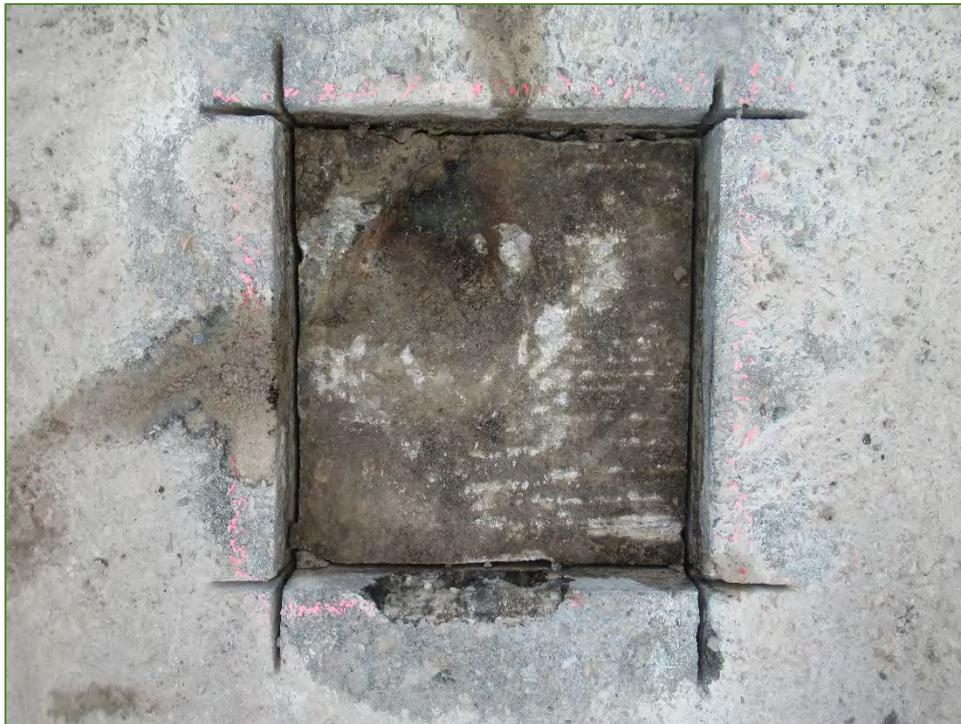
Photo S4 – Sawn Sample SS4 (spall)

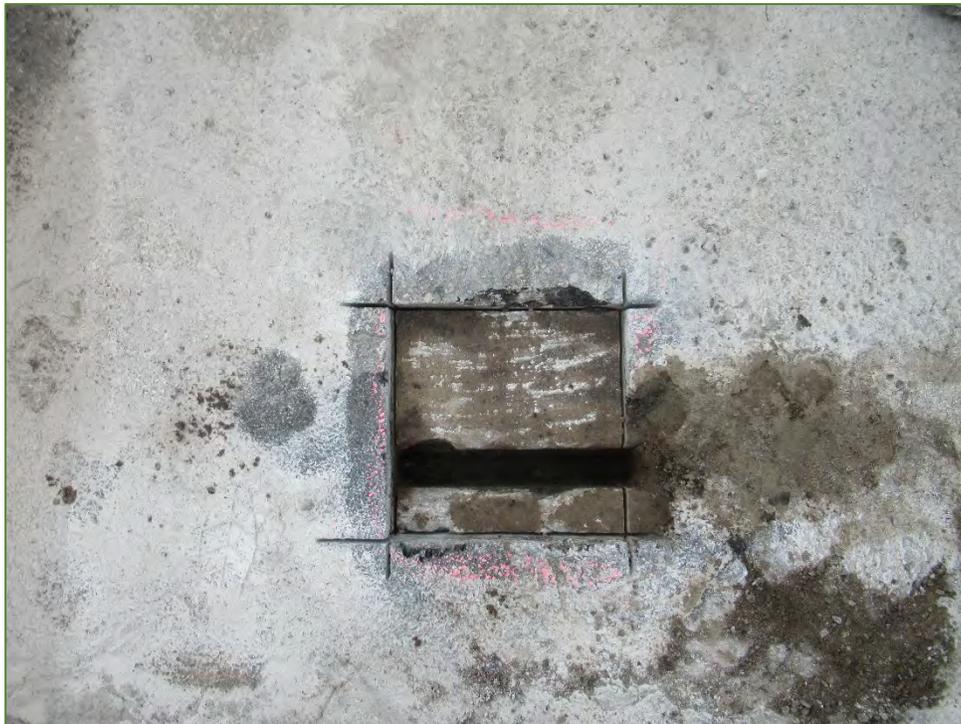
Photo S6 – Sawn Sample SS6 (over construction joint)

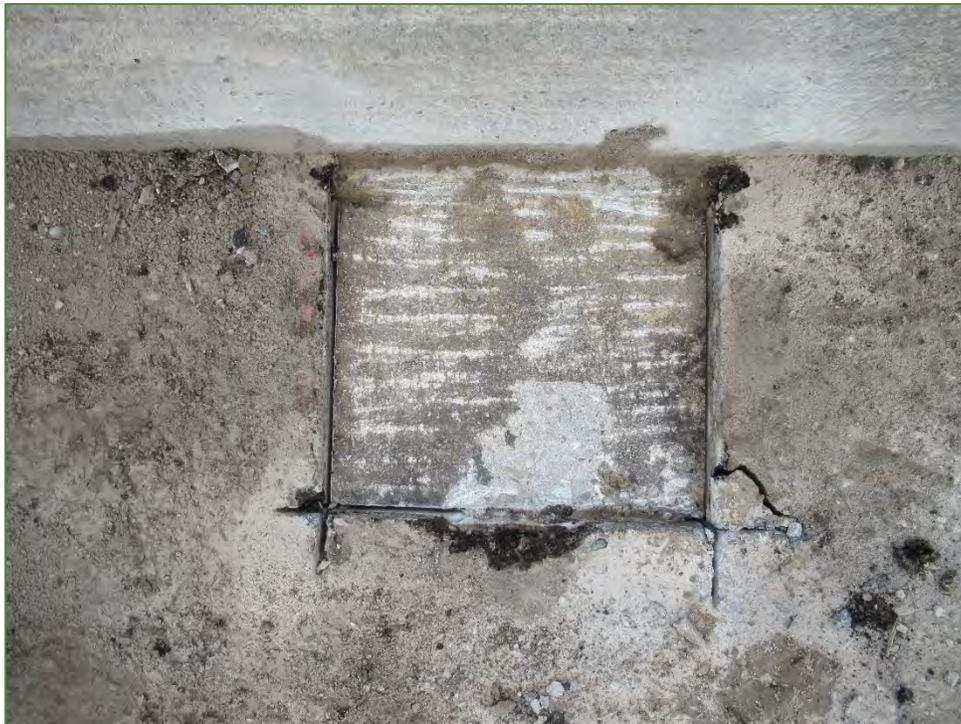
Photo S7 – Sawn Sample SS7 (spall)

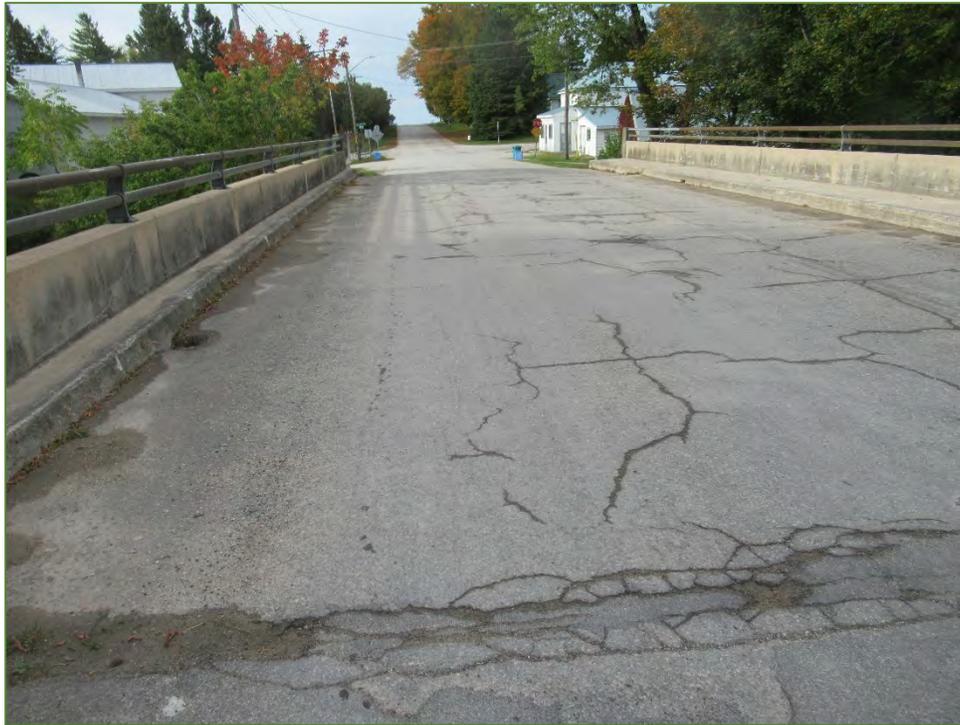
Photo P5 Deck Wearing Surface (poor condition –unsealed cracks, pot holes and patched area)

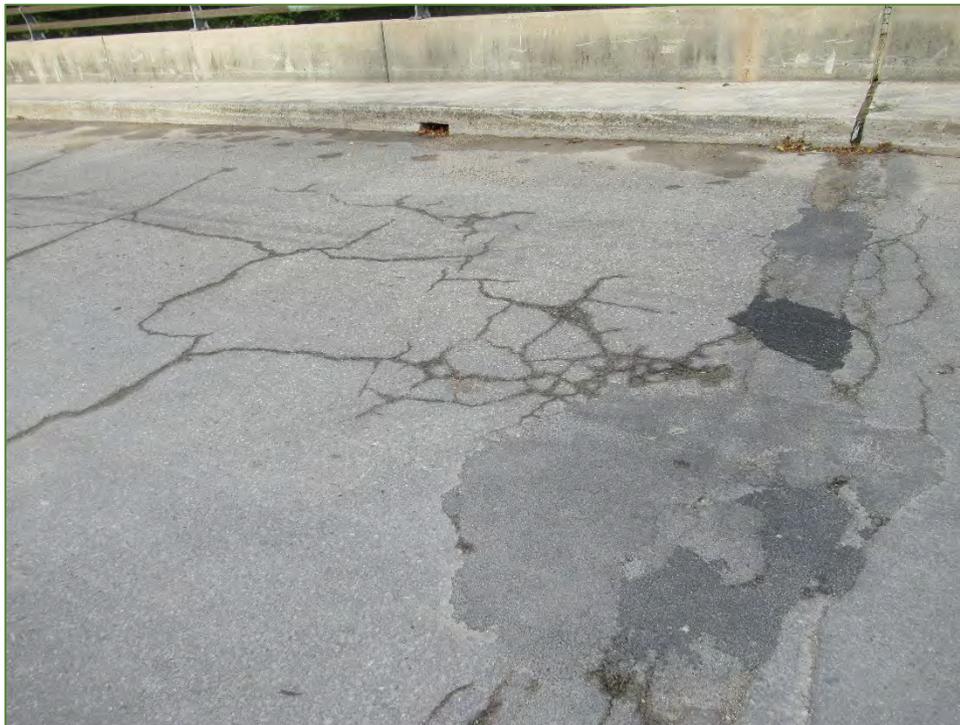
Photo P6 Deck Wearing Surface (unsealed cracks, pot holes and patched area)

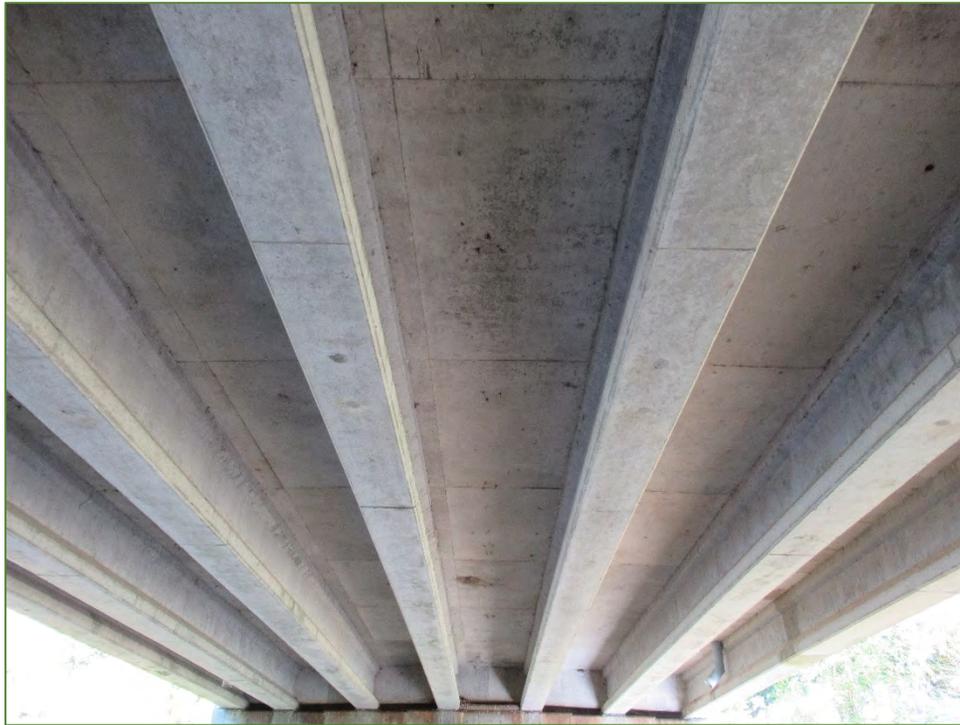
Photo P9 Soffit between East Abutment and West Abutment (fair-to good condition – cracks, spall, delamination, honeycombing and wet area) **and Girders** (good condition – cracks, spall, delamination and wet area)

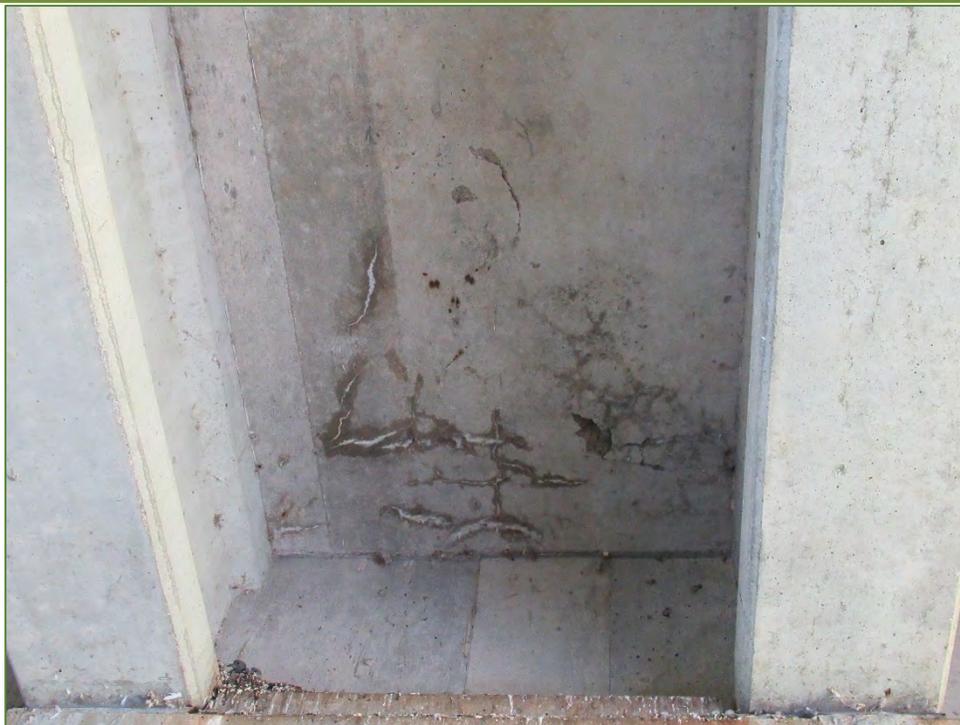
Photo P10 Soffit at East Abutment (cracks, spall, delamination and wet area) **and Girders** (cracks)

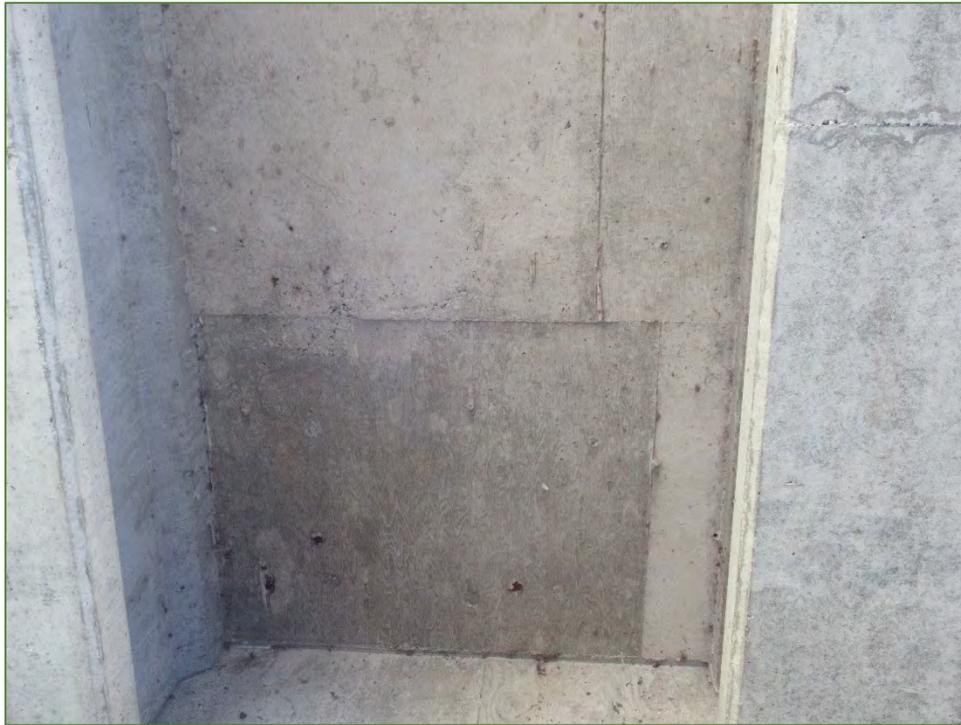
Photo P17 Soffit at West Abutment (honeycombing) and Girders

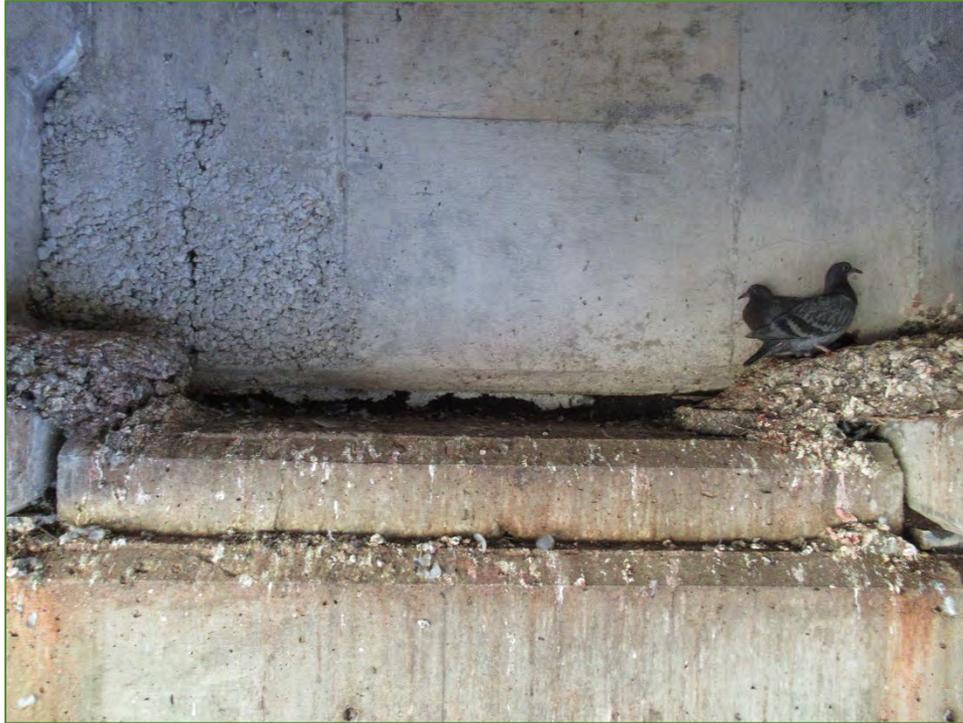
Photo P19 Typical Diaphragm at West Abutment (cracks and honeycombing)

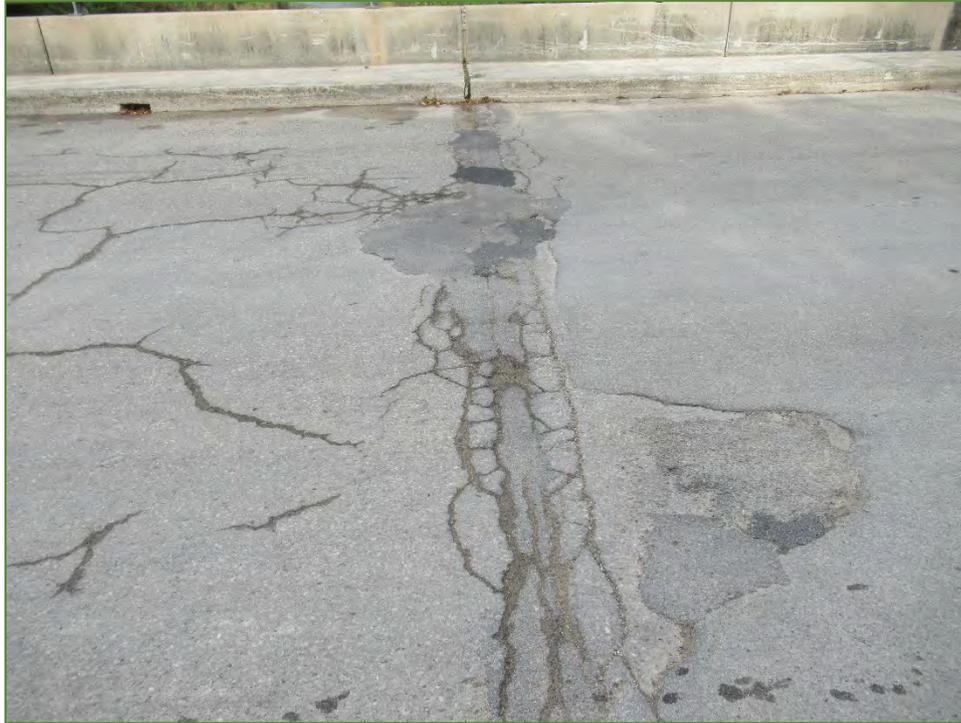
Photo P25 Condition of Pavement over East Abutment (unsealed cracks, pot holes and patched area)

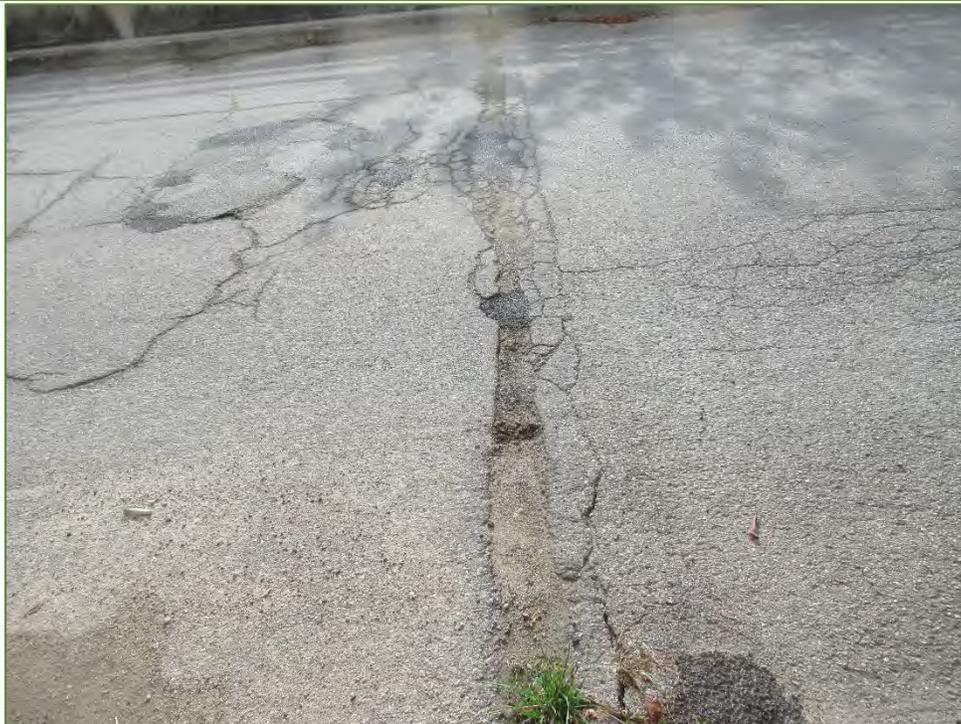
Photo P26 Condition of Pavement over West Abutment (unsealed cracks, pot holes and patched area)

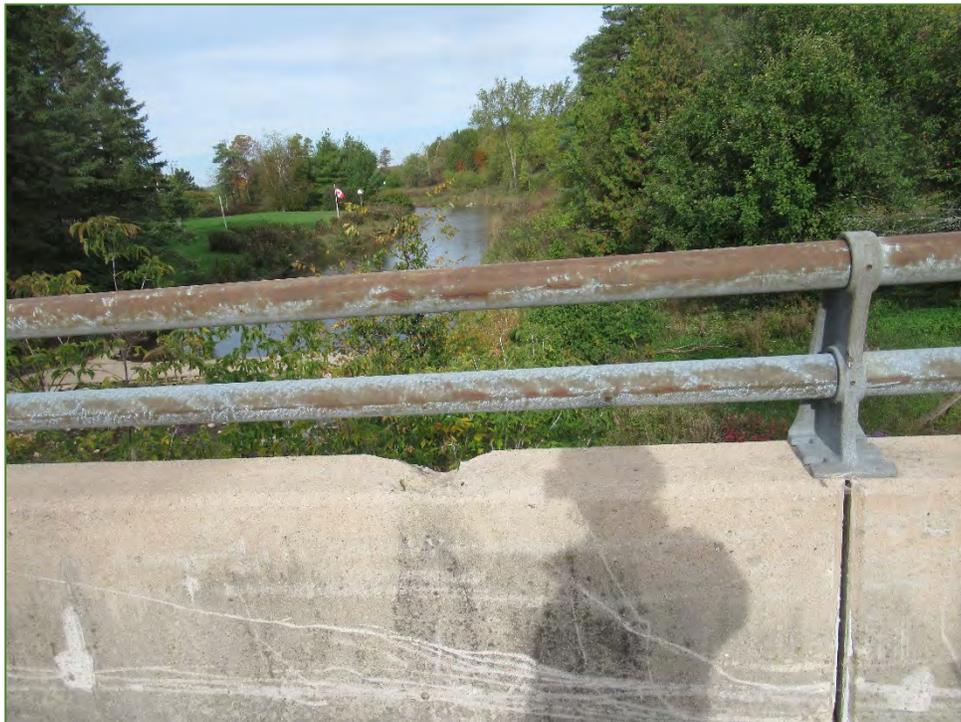
Photo P28 North Barrier Wall (spall) note, light corrosion on handrail

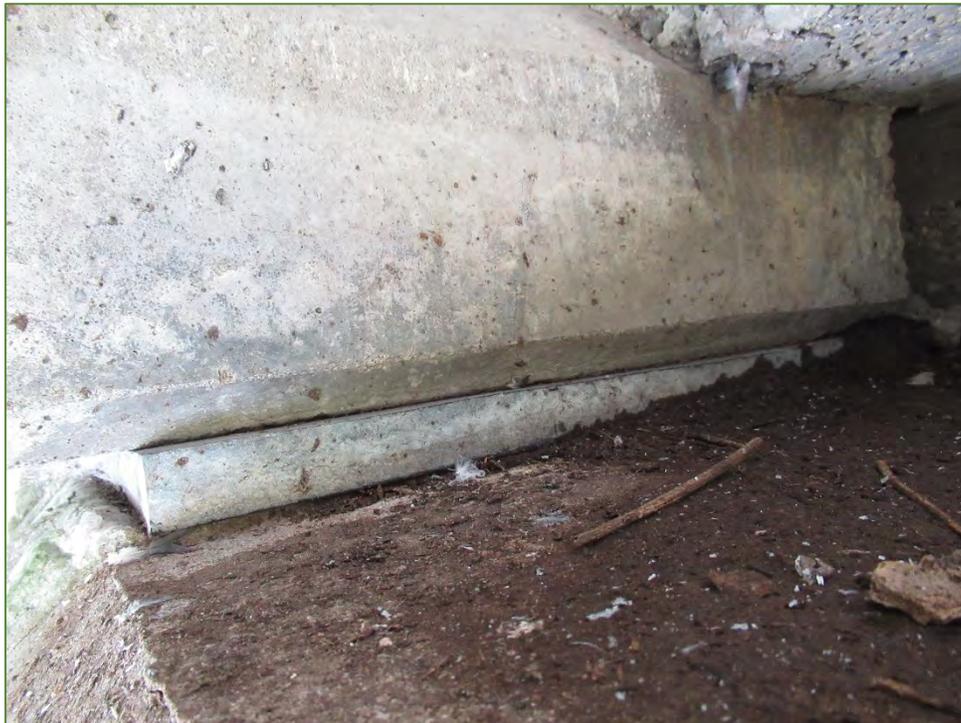
Photo P42 East Abutment Elastomeric Bearing – 2nd bearing from north (fair to good condition – squeezed)

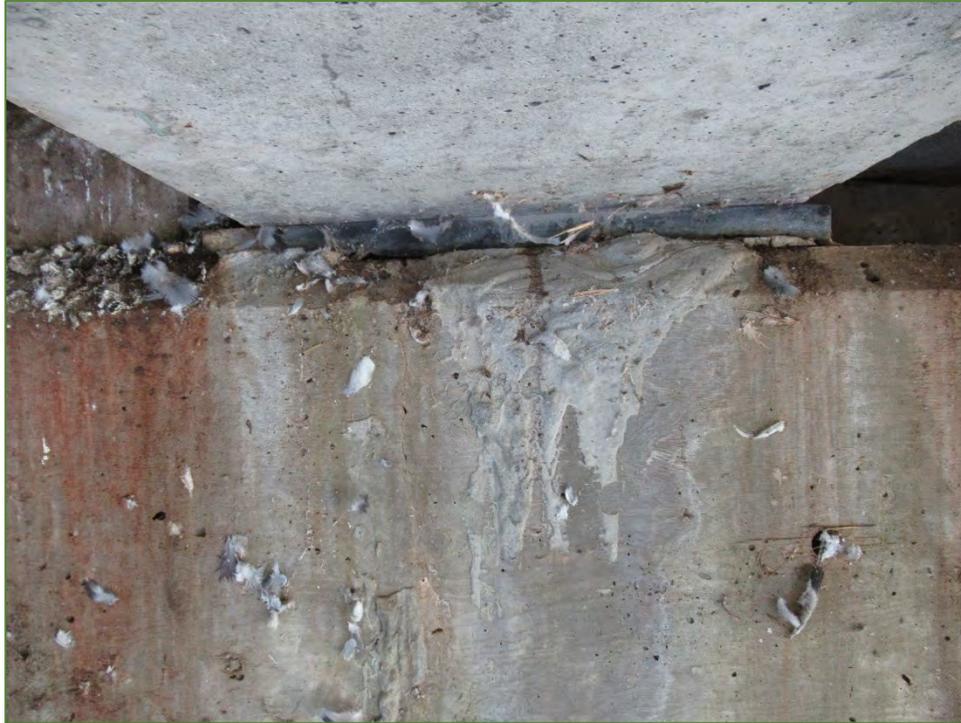
Photo P49 East Abutment Elastomeric Bearing – 5th bearing from north (squeezed)

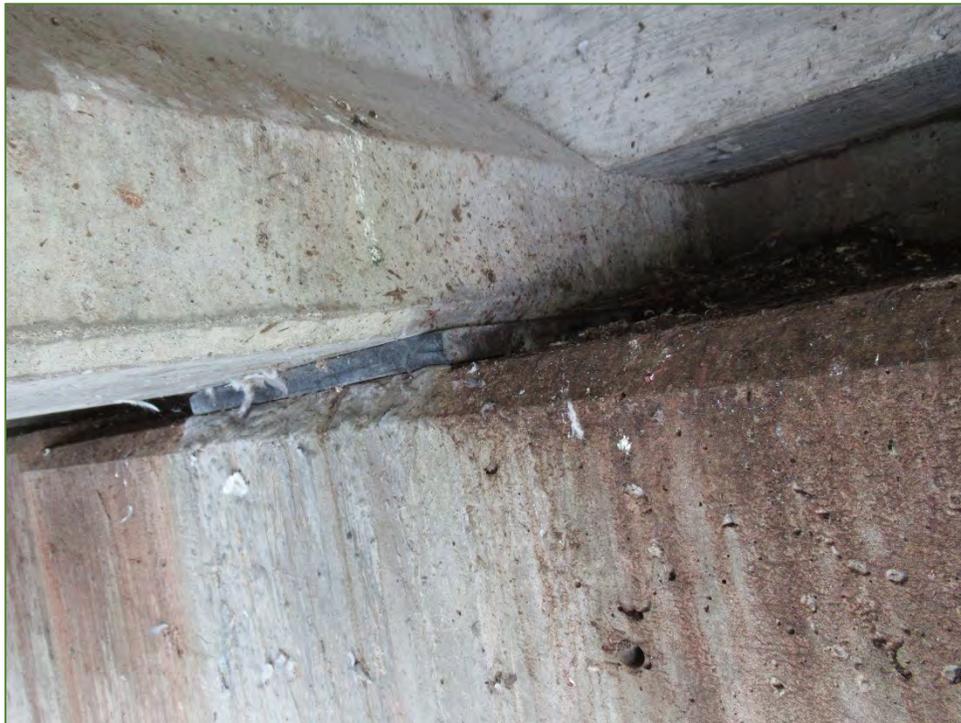
Photo P50 East Abutment Elastomeric Bearing – 6th bearing from north (fair to good condition – squeezed)

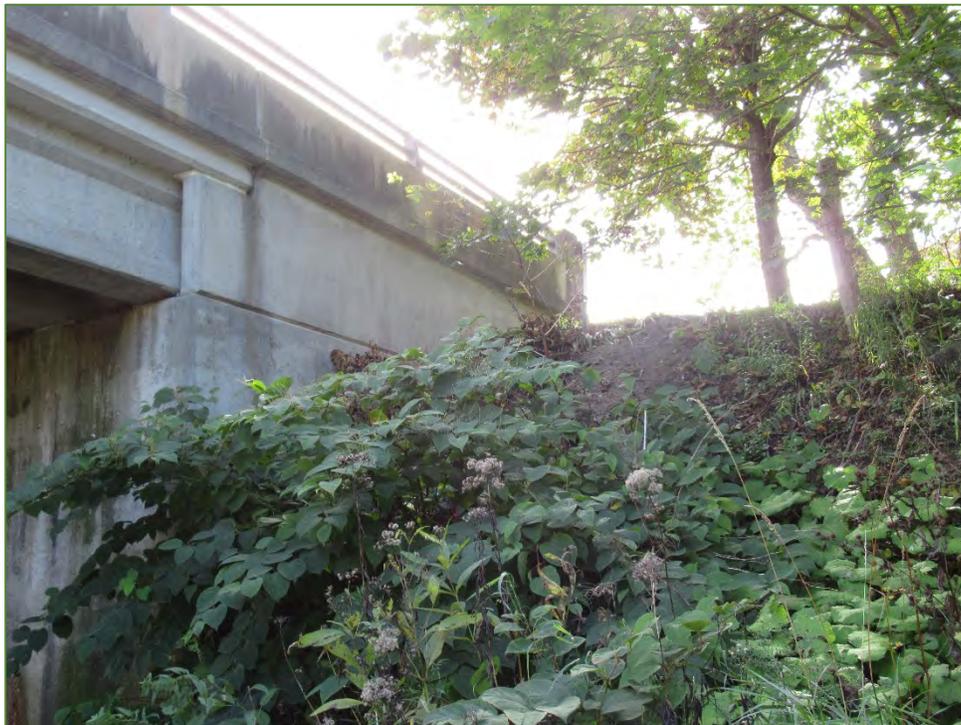
Photo P74 Southeast Wingwall (good condition – cracks and light scaling)

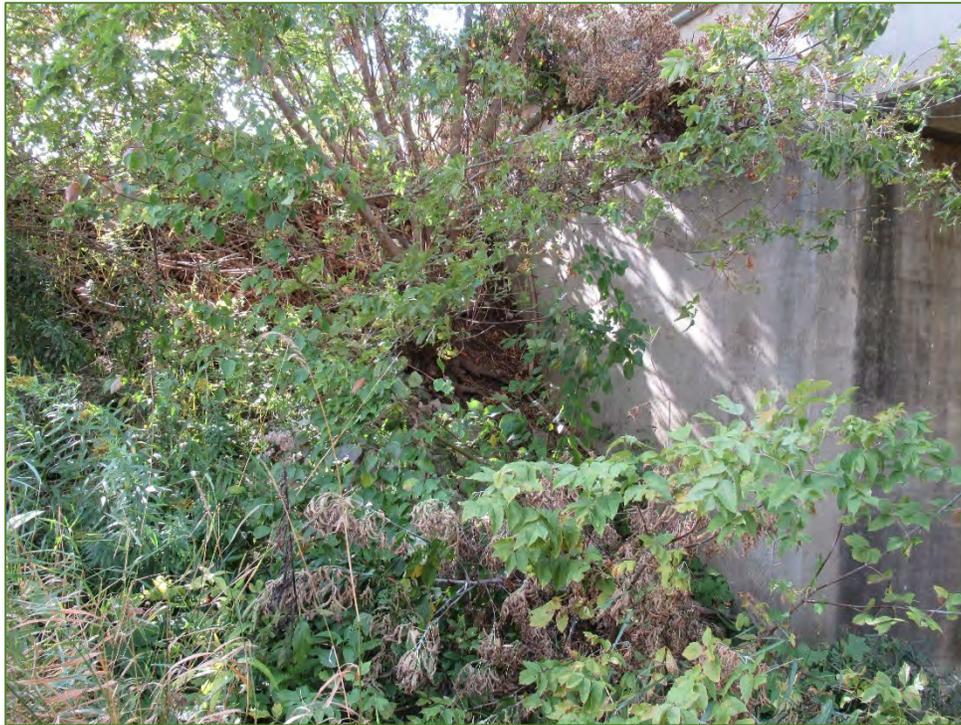
Photo P75 Southwest Wingwall (good condition – cracks and light scaling)

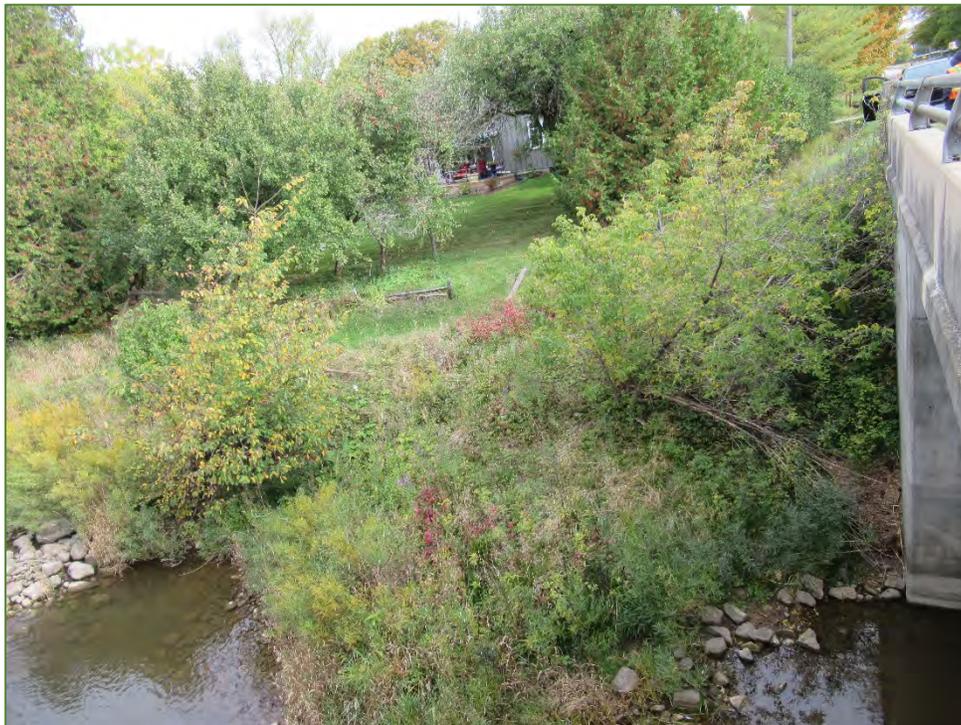
Photo P76 Northeast Embankment (Aggradation)

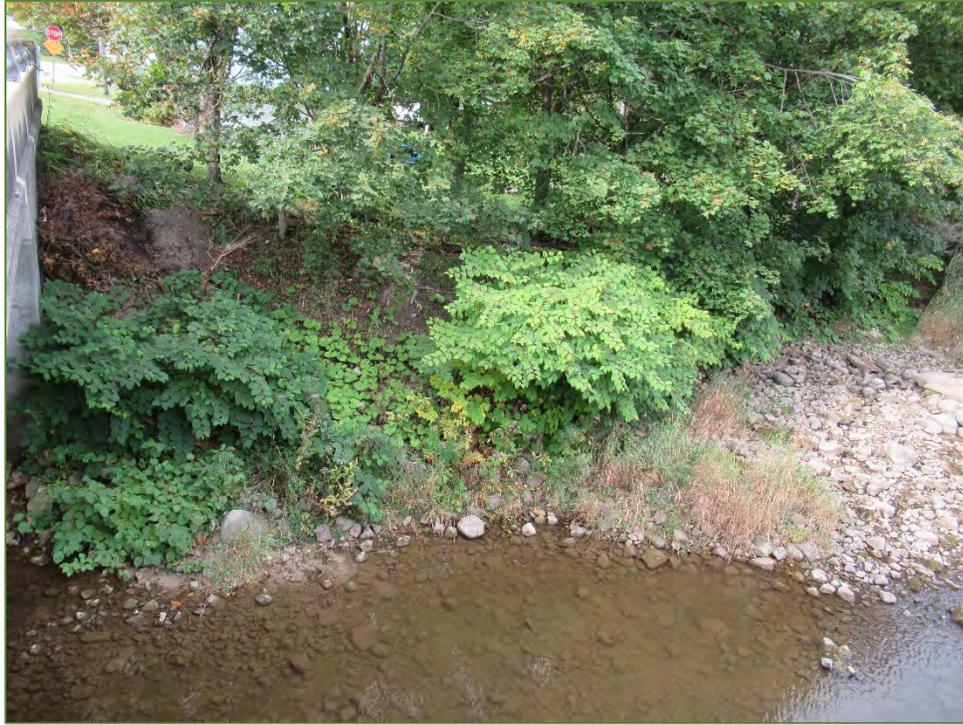
Photo P77 Northwest Embankment (erosion)

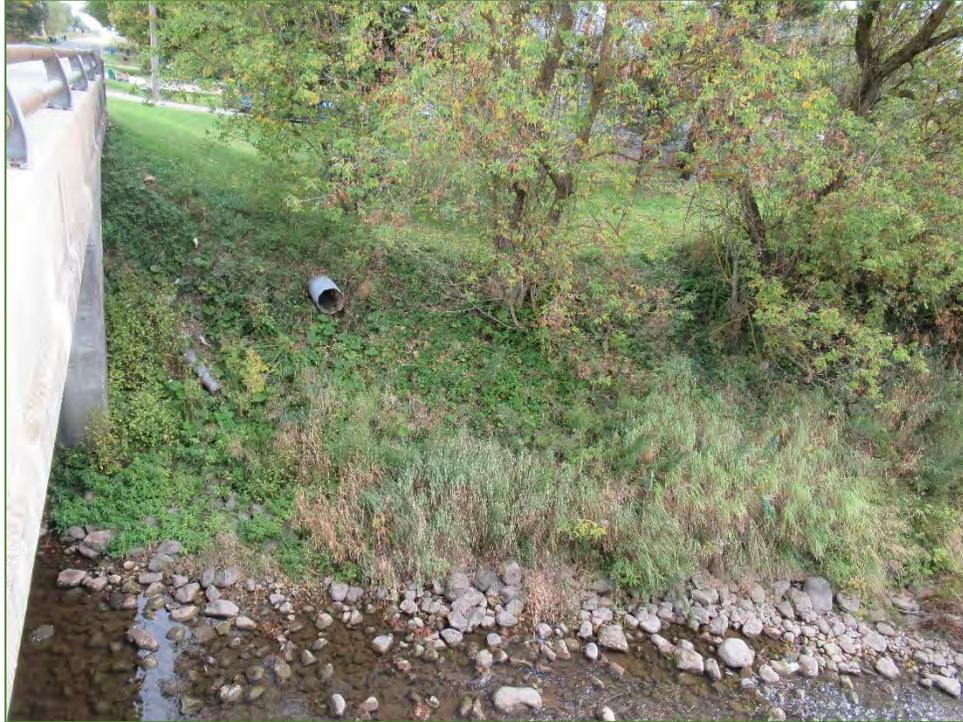
Photo P78 Southeast Embankment (soil erosion)

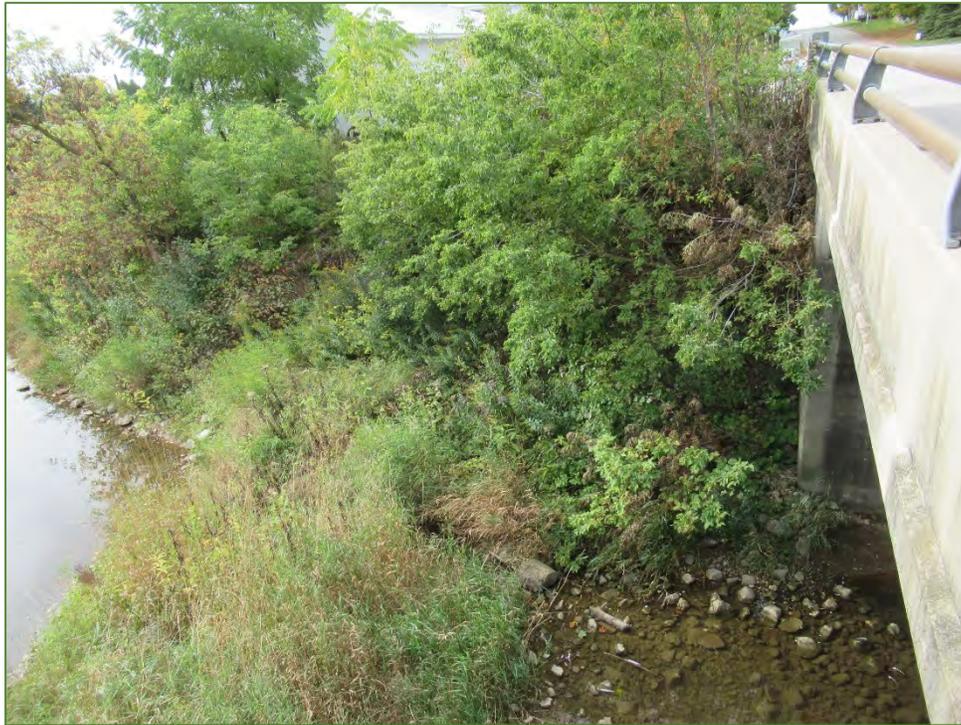
Photo P79 Southwest Embankment (soil erosion)

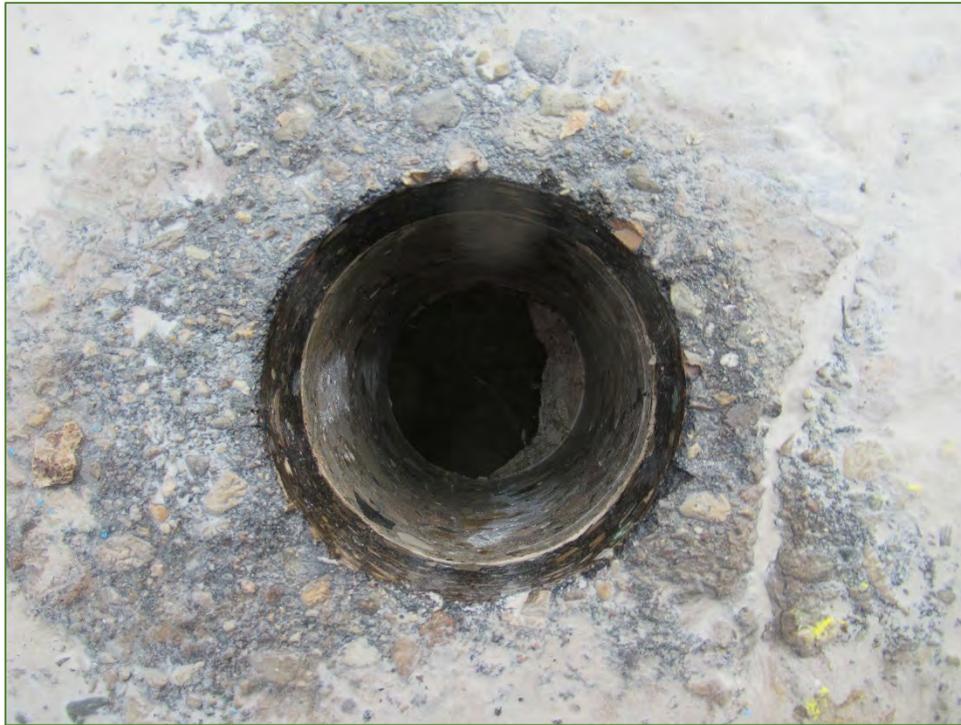
Photo P81 Typical Condition of Inside Core – C3

Core ID	C3
Location	Deck
Lab No.	L19-1262
Date Cast	-
Date Cored	Oct 7, 2019
Date Tested	Oct 21, 2019
Capped Height (mm)	147
Average Diameter (mm)	100.0
Density (kg/m³)	2435
Corrected Compressive Strength (MPa)	62.2
* Direction of Loading	Same as
Moisture Content at Time of Test	Moist
Remarks
